Four Landslide Investigations in Malaysia

Liew Shaw-Shong, Liong Chee-How & Low Chee-Leong

Gue & Partners Sdn Bhd, Kuala Lumpur, Malaysia.

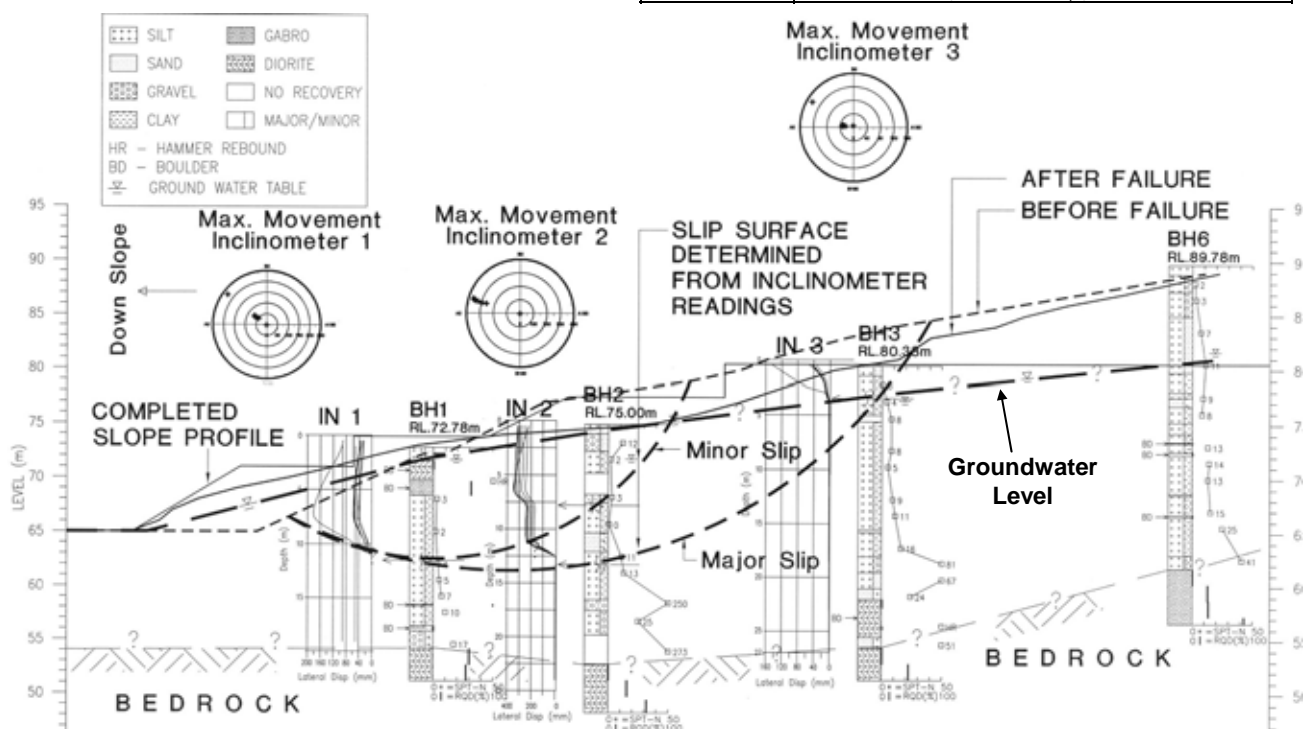
Fig. 2. Multiple Slip Surfaces interpreted from Inclinerometers

Subsurface investigation and instrumentation consisting of ten boreholes, three inclinometers, six observation wells and one standpipe piezometer were carried out. The layout of the boreholes and instrumentations is shown in Figure 1. A total of three inclinometers, IN1, IN2 and IN3, three observation wells, OW1, OW2, OW3 and one standpipe piezometer SP1 was installed within the failed mass. The inclinometers were sheared off shortly after the installation. Figure 2 shows the multiple slip surfaces and groundwater level interpreted from the instrumentations.

Based on the laboratory test and back-analysis results, it is credible to deduce that there is an existence of thin layer with low shear strength at the slip surface. The slip surface is difficult to be determine accurately in the subsurface investigation works unless with the help of inclinometer. Such weak layer is believed to have experienced sufficient shearing strain prior to the failure, therefore exhibits the average mobilized shear strength lower than critical state strength.

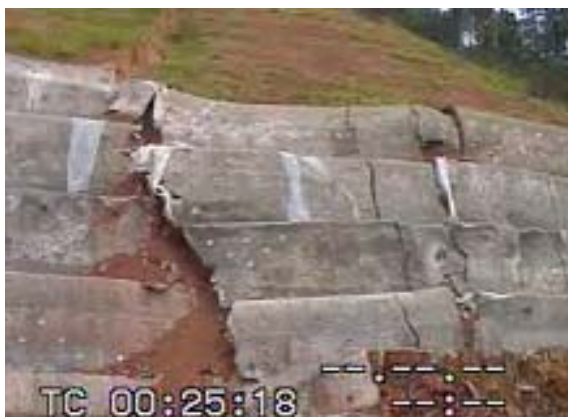
Fig. 4. Front View of Failed Slope

The original design of failed slope consists of seven (7) upper berms of 1V:1H cut slope and five (5) lower berms of 4V:1H cut slope with soil nails. A massive slope failure occurred before soil nails were installed at the lowest berm. The slope profiles of original topography and the original design are shown in Figure 3. Figure 4 shows the front view of the failed slope.

Geological mapping was also carried out during the subsurface investigation works. It was observed that the site was dry and no water seepage was seen. The joint sets mapped were day-lighting towards the road. Most of the exposed material on the slope surface were Grade III to V. The interpreted subsoil weathering profile is shown in Figure 5. Kinematic analysis was later performed on the collected geological mapping data using rock engineering software (Watts et al., 2003). It can be conceded that plane failure is more probable compared to other modes of failure due to the presence of day-lighting geological structure.

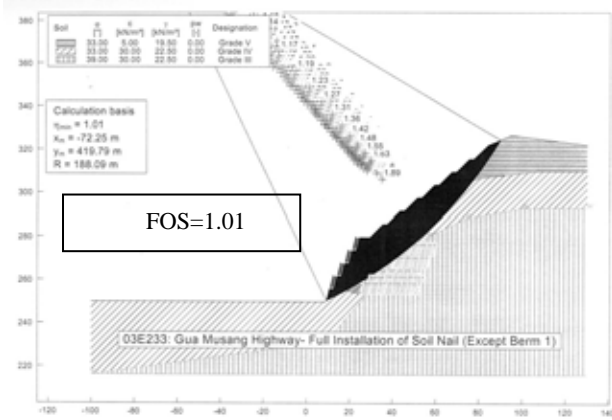
Fig. 6. Analysis Results for Global Slope Stability

The back-analyses were performed using GGU, a limit equilibrium program (Dr Johann) and Plaxis. As no undisturbed samples were collected for Grade V material, the shear strength parameters of $c'_p=5\text{kPa}$, $\phi'_p=33^{\circ}$ has been adopted. The limit equilibrium analysis indicated that global Factor of Safety is marginally more than 1.0 when the excavation was down to the lowest berm as per design as shown in Figure 6. Besides that, the Factor of Safety for local slope stability at the 1V:1H cut upper cut slopes is also marginally more than 1.0.

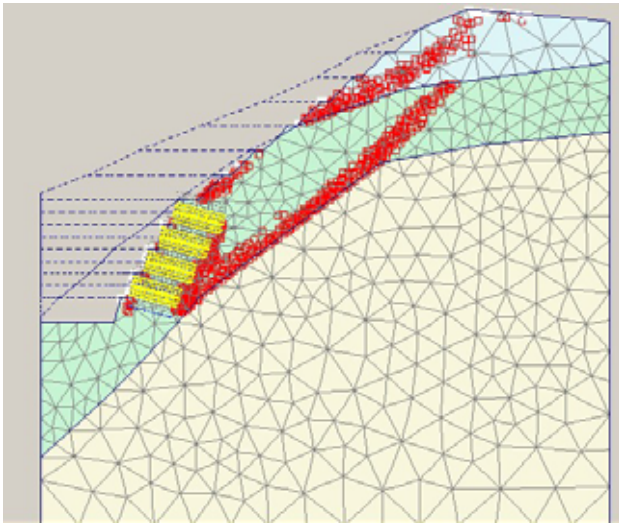
Fig. 7. Development of Plastic Points in Finite Element Model (After cutting of Twelve Upper Berms)

The finite element analysis was carried out using typical Mohr-Coulomb strength criteria and elasto-plastic models to simulate various excavation stages and the failure mechanism. The development of plastic points within the soil body during the cutting process indicated the mobilization of peak strength in these soil elements. Eventually a well-defined slip surface was formed when the excavation reached the lowest berm. Figure 7 shows the development of plastic points and slip surface in the finite element model. In short, the analysis demonstrates the phenomenon of progressive failure with the progressive cutting of slope. It was also shown that the installed soil nails failed to provide significant strengthening action to the overall slope due to inadequate nail length in relation to the entire failed slope geometry.

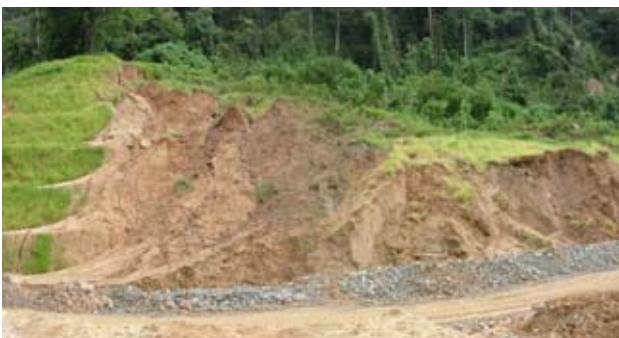
Fig. 8. Front View of Failed Slope

The cut slope involved in the failure was about 27m high (5 to 6 berms with gradient of 1V:1H) and was located beside a proposed road alignment. The failure occurred in two incidents, where a localized stretch of about 50m failed two months after formation of slope. A major failure of the cut slope with 250m length occurred a month after the localized failure following heavy rainfall. Figure 8 shows the front view of the failed slope.

The rainfall record obtained from the Meteorological Department shows that the rainfall amount was in a rising trend after the formation of cut slope. It can therefore be deduced that large rainfall amount had contributed to the increase infiltration and the rise of piezometric level in slope. With the rise of the piezometric level, soil suction and effective shear strength reduce, thus triggering the collapse of slope.

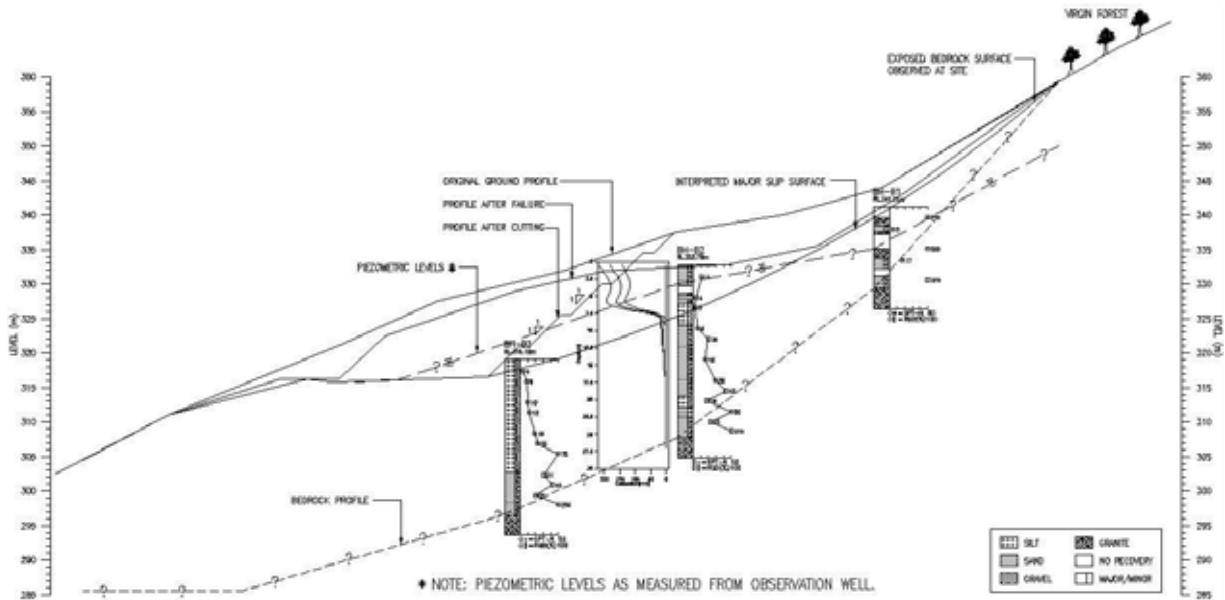
Fig. 10. Interpreted Slip Surface and Piezometric Level

Site observation and investigation revealed that the subsoil is fairly sandy, and is classified as silty sand according to the British Soil Classification System. A slip surface was also detected by the inclinometer installed in the center of the slope. Observation wells were also installed at the toe and top of the failed mass. It was observed that the piezometric level at the slope toe was high, with readings ranging from 0.37m to 2.2m above ground level. The interpreted slip surface and piezometric levels are shown in Figure 10.

The back-analyses were performed using PC-Stabl and Plaxis using interpreted slip surface and piezometric as established in the field investigation. The back analyses of mobilised shear strength at the identified slip surface was found to be $c'_m=0\text{kPa}$, $\phi'_m=30^\circ$ which agrees well with the C.I.U results. If the C.I.U results were adopted in a limit equilibrium analysis, the Factor of Safety would be less than unity, even without the effect of pie-

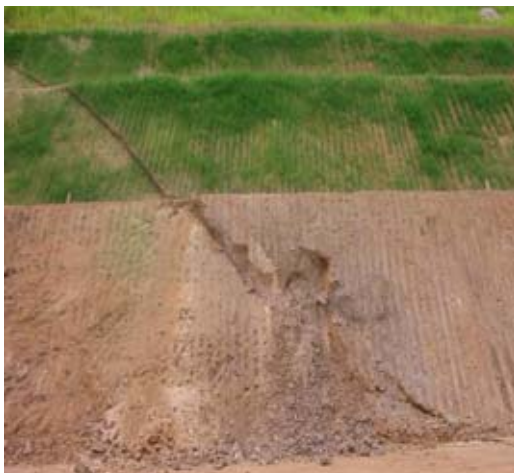
Fig. 11. Localised Failure of Slope

It would be noteworthy to mention that geological structure discontinuities seemed to be involved in the localized failure event. Based on the photos provided, the authors deduced that the cracks on the slope face correspond to the fault as discussed in Section 4.1. One of the photos is shown in Figure 11. Unfortunately, the authors were only involved in the investigation works after the major failure and no further information on the localized failure was available to warrant a detailed study.

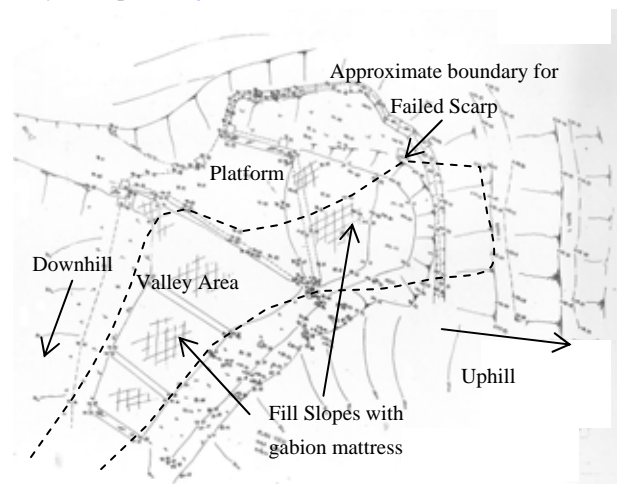
Fig. 12. Plan showing Fill Slope and Boundary of Failed Scarp

The failed slope involved three berms with a total height of 21m. The slope toe was retained by a two meter height gabion wall, followed by a 6m (1V:1.6H), 5m (1V:2.4H) and 10m (1V:1H) height slope respectively. On top of the fill slopes is the platform where the pipeline was laid. There were another three slopes sitting on top of the platform where two of the slopes were also covered with gabion mattress. All the three filled slopes and another two slopes on the platform collapsed following a series of heavy downpour. Figure 12 shows the extent of the failure.

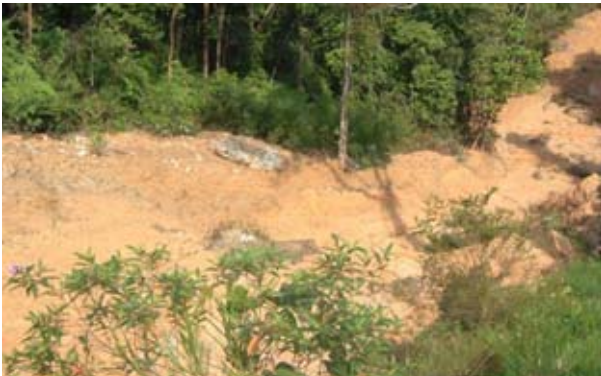
Fig. 13. Travel of Debris and Failed Mass Downhill

The observation at the site after the collapse indicates that the platform was saturated with water. Debris, tree trunks and vegetation on the platform indicated that surface runoff had overflowed the platform and traveled downslope to the lower portion of the valley. The debris and failed mass had traveled more than 120m downhill along the valley as shown in Figure 13. This indicates the high mobility of the collapsed debris, which could be in the form of mud or debris flow. Bedrock was observed at certain exposed surfaces after the collapse, indicating the bedrock level is shallow and the failure resembles a slide along the bedrock surface.
