Case Studies of Support of Open Excavations and Distressed Retaining Walls in Malaysia

S. S. Liew

G&P Geotechnics Sdn Bhd, Kuala Lumpur, Malaysia (www.gnpgeo.com.my)

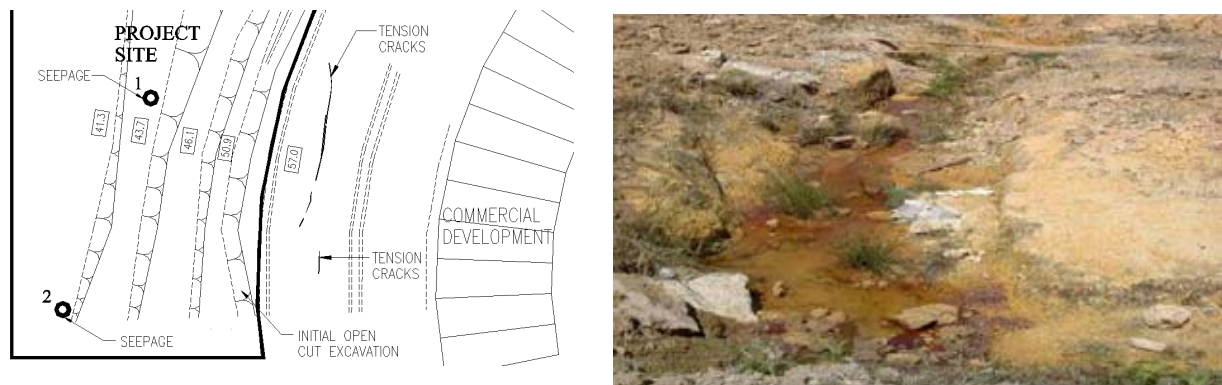
An inspection was carried out by the project team shortly after observing the tension cracks on the road pavement. The semi-circular crack pattern was generally observed on the top of the excavated slope as shown in Figure 20. Before excavation, water seepage at two locations were also observed indicating high groundwater levels within the filled slope (see Figure 20). At the time of investigation, the excavation at the southern portion of the site was in a more advanced stage. It was not surprising that more ground movements were occurring behind the excavation where the tension cracks were firstly observed.

Fig. 20. Tension cracks on Main Road at earlier excavation stage and Seepage at Cut Platform.

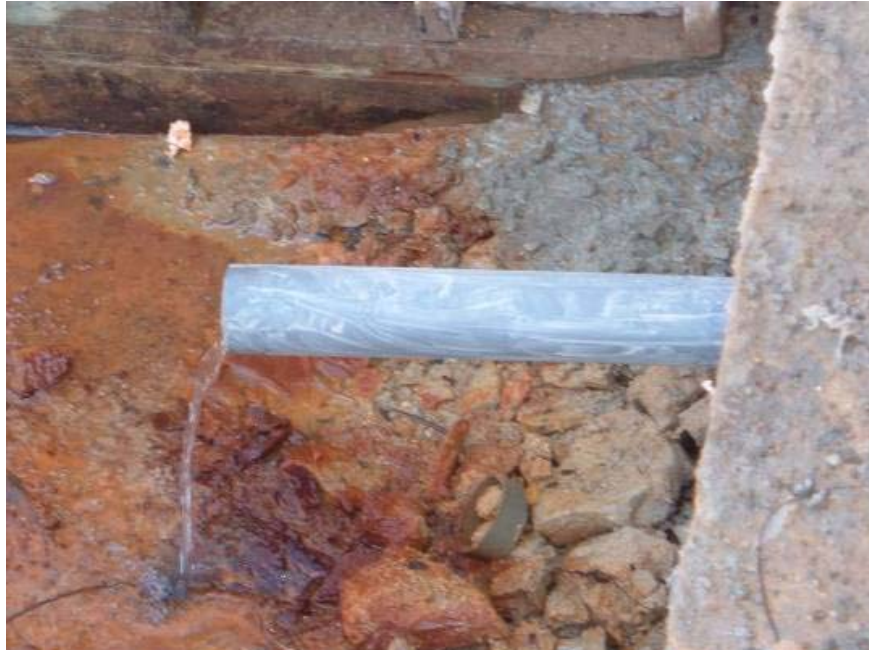
In one location, groundwater was observed continuously flowing out immediately after excavation. This particular location was believed to be the natural water path of the stream as revealed in the pre-development ground contour. Sufficient horizontal drains were installed at this location to release the perched groundwater. Figure 24 shows the water continuously discharging from horizontal drain after installation.

Fig. 24. Continuous seepage flow collected in Subsoil Drains.

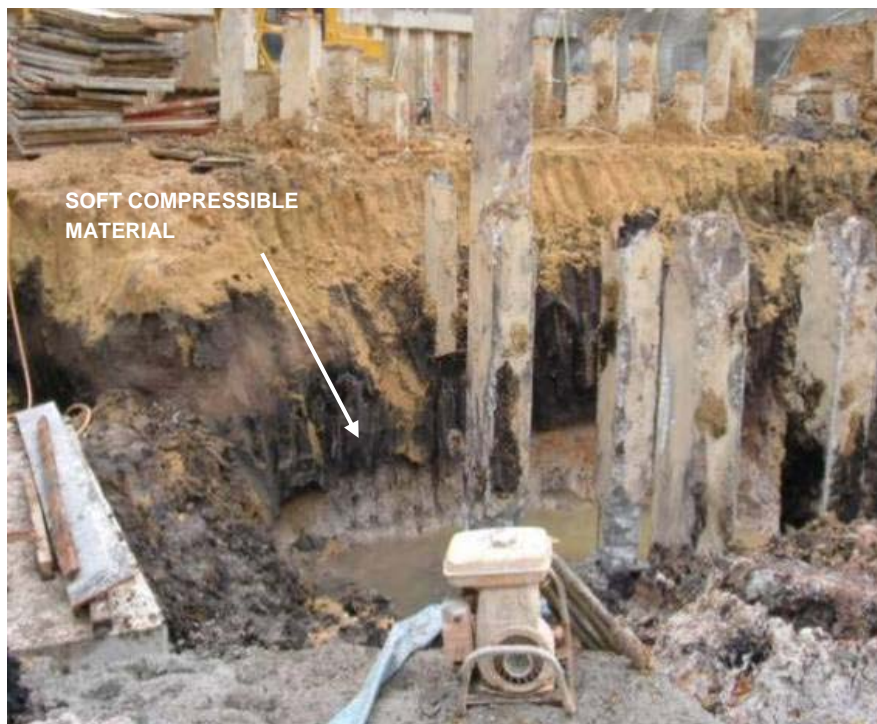
When excavation nearly reached the final excavation level, additional field testing such as Mackintosh probing and in-situ penetrating vane shear tests were conducted at the expected soft compressible layer to verify the soil parameters adopted in the remedial design. The localized excavation for pile cap construction further confirmed the existence of this soft deposited material as shown in Figure 25.

Fig. 25. Soft compressible material detected at localized pile cap excavation.

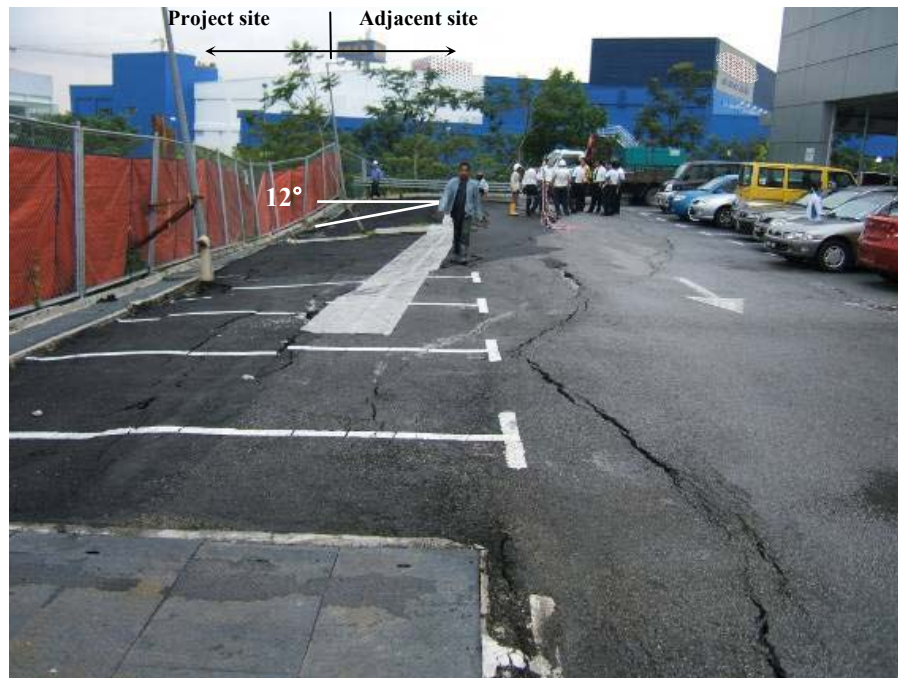
It was observed that continuous tension cracks appeared at varying distance away along the sheet pile wall of approximately 73m long. The tension cracks were more distant from the sheet pile wall at the southern end and become closer to the sheet pile walls toward northern end. At the time of inspection, more extensive excavation was carried out at the southern portion than the northern portion. The backyard car park platform of the adjacent lot had shown signs of subsidence and tension cracks as shown in Figures 36 and 37.

Fig. 36. Site conditions of adjacent lot after the incidence of wall and ground distresses (Southern view).

furthest crack line was measured at approximately 12m from the original fence line. In addition, the overall tilt angle of subsided platform at this area was crudely measured to be about 12° as shown in Figure 36. Sheet pile wall had also moved outward about maximum 1.2m from the designed wall alignment (at Gridline G). On the other hand, the measured pile top deviation of contiguous bored pile wall is also shown in Figure 38.

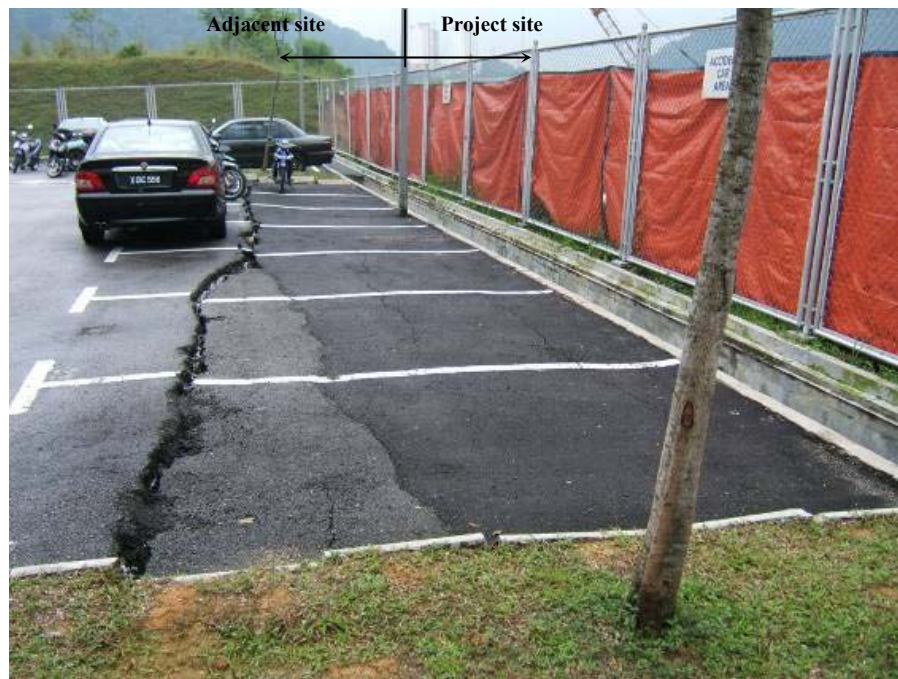
Fig. 37. Site conditions of adjacent lot after the incidence of wall and ground distresses (Northern view).

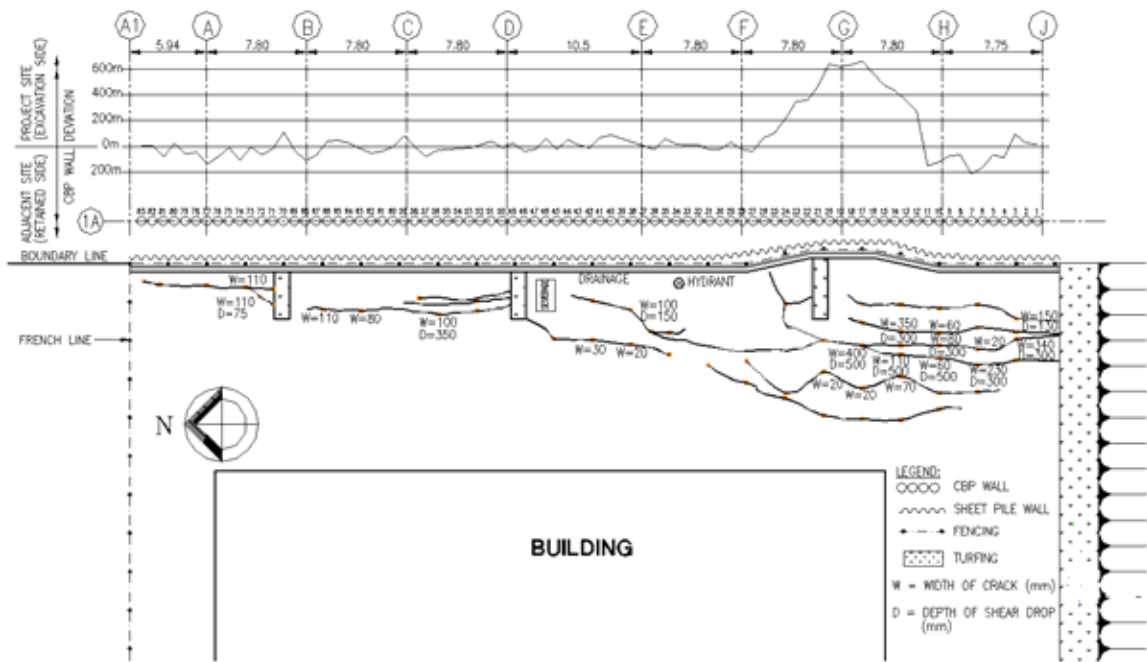
Site mapping had been carried out on the observed tension cracks and tilted sheet pile wall. Much more tension cracks were observed at the southern region. In this particular location, the sheet pile wall was seriously deviated outward relatively to the designed wall alignment. Efforts were made to map the crack lines by using measuring tape and slope meter. Figure 38 shows the details of mapped tension cracks.

Generally, the tension cracks were measured up to 400mm wide with shear drops between the two dislodged earth blocks. At the critical location (Gridline G), the major crack line was measured at approximately 6.2m from the original fence line. While, the

Fig. 38. Crack mapping layout.

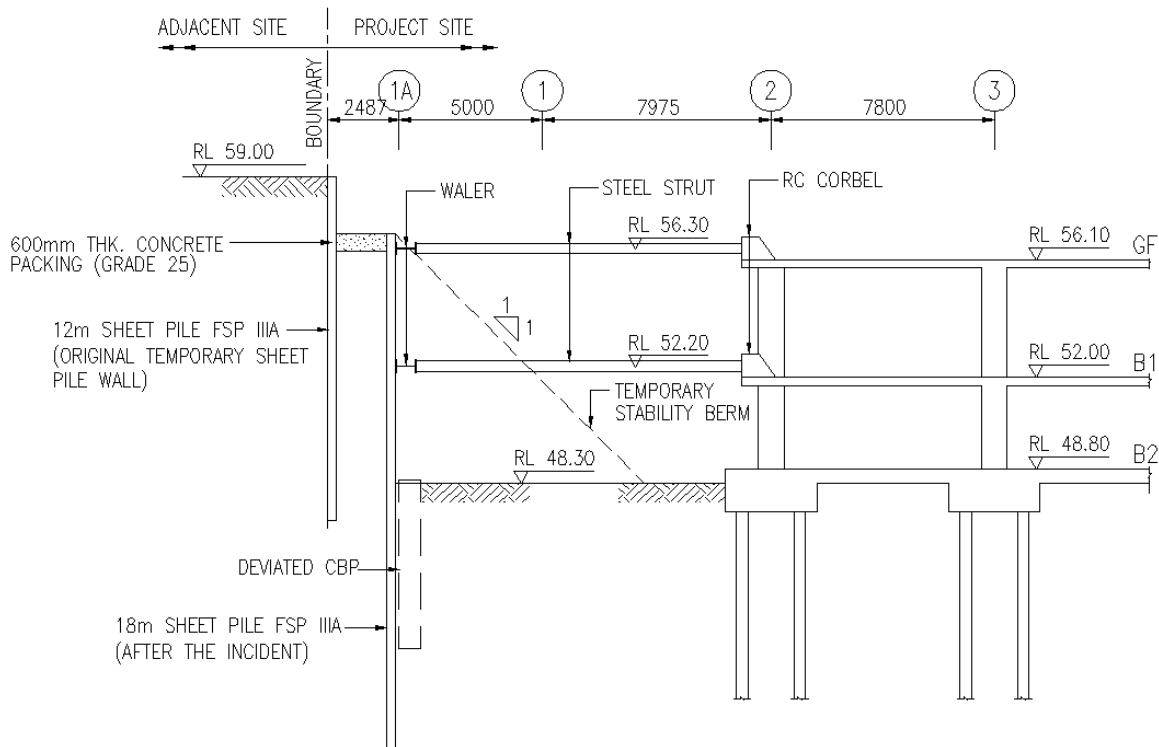
Fig. 42. Cross-section of remedial works.

The remedial works carried out included installation of additional row of 18m long sheet piles behind the deviated CBP area to stabilise the retained ground. Temporary strutted coffer-dam was constructed to facilitate the localized excavation of lift core. Two layers of temporary horizontal strut were installed propping the sheet pile wall against the permanent basement structures at distant before casting of remaining basement slab as shown in Figure 42. Excavation was only allowed to be carried out in stages after the struts were put in placed. Once the final excavation level (B2) was reached, the CBP wall was cut off at that level and verified with integrity testing (both low and high strain dynamic pile tests) to confirm structural integrity. Fortunately, most of the damages of the deviated CBP wall were well above the B2 level. Cast in-situ reinforced concrete wall was constructed over the starter bars from the intact CBP wall. The finished permanent basement structure is shown in Figure 43.

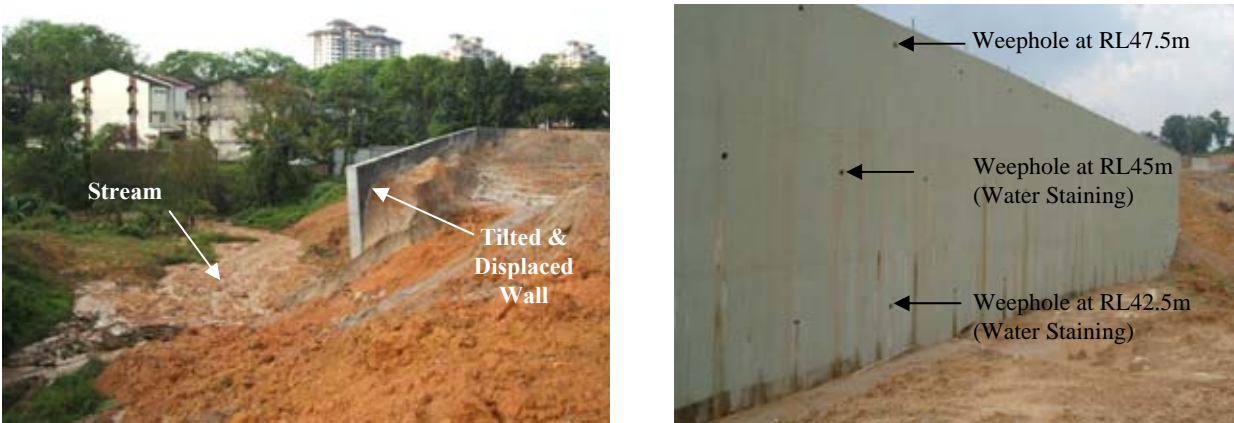
Site inspection was carried out immediately after the wall displacement and tilting were reported. During the site inspection, vertical flexural cracks were observed at the front and back of the displaced wall, particularly over the portion in close proximity to the return of the wall. Three (3) levels of weepholes had been installed in the retaining wall at RL42.5m, RL45.0m and RL47.50m. There was water staining from the weephole drains located at the mid height and bottom rows, revealing that groundwater level behind the retaining wall had previously risen above RL45m. The incident occurred after an intensive prolonged antecedent rainfall event. Figure 45 shows the overall site condition after the distress and the water staining at the weephole drains.

Fig. 45. Overall Site Conditions and Water Staining at Weephole Drains

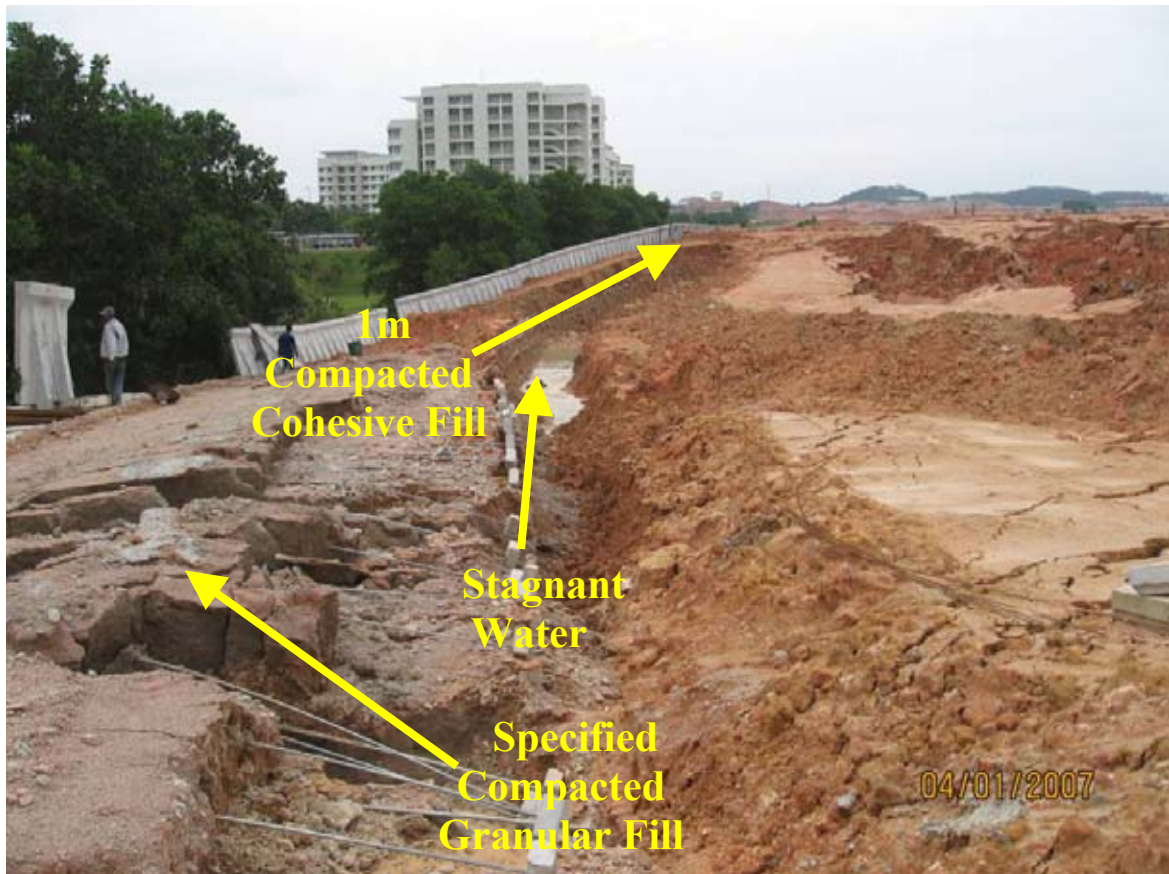
This case study presents the collapse of a portion of the reinforced soil (RS) wall. Investigation was carried out to determine possible causes of the collapse. Figure 47 shows the section of the distressed RS wall constructed in front of the monsoon drain.

Fig. 48. Collapsed Reinforced Soil Wall

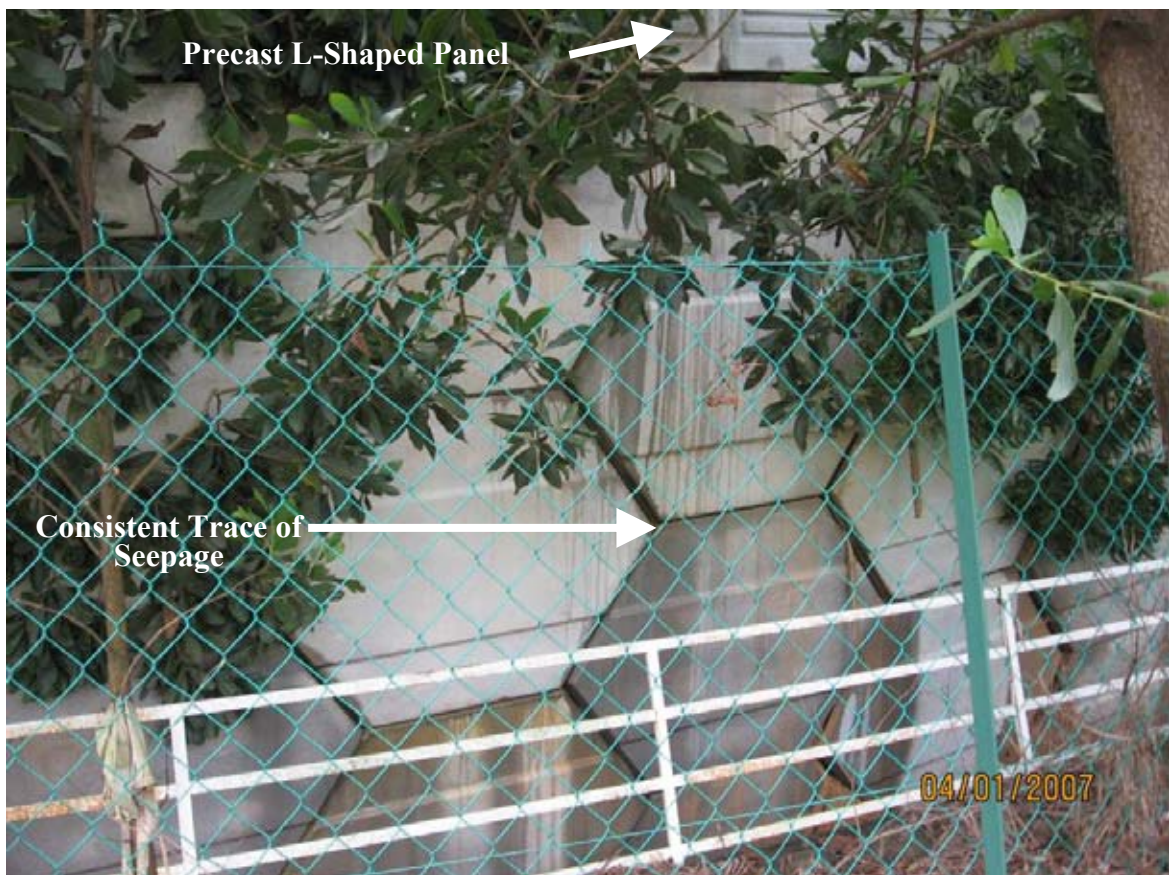
Fig. 49. Sign of Water Seepage on Top Wall Panels

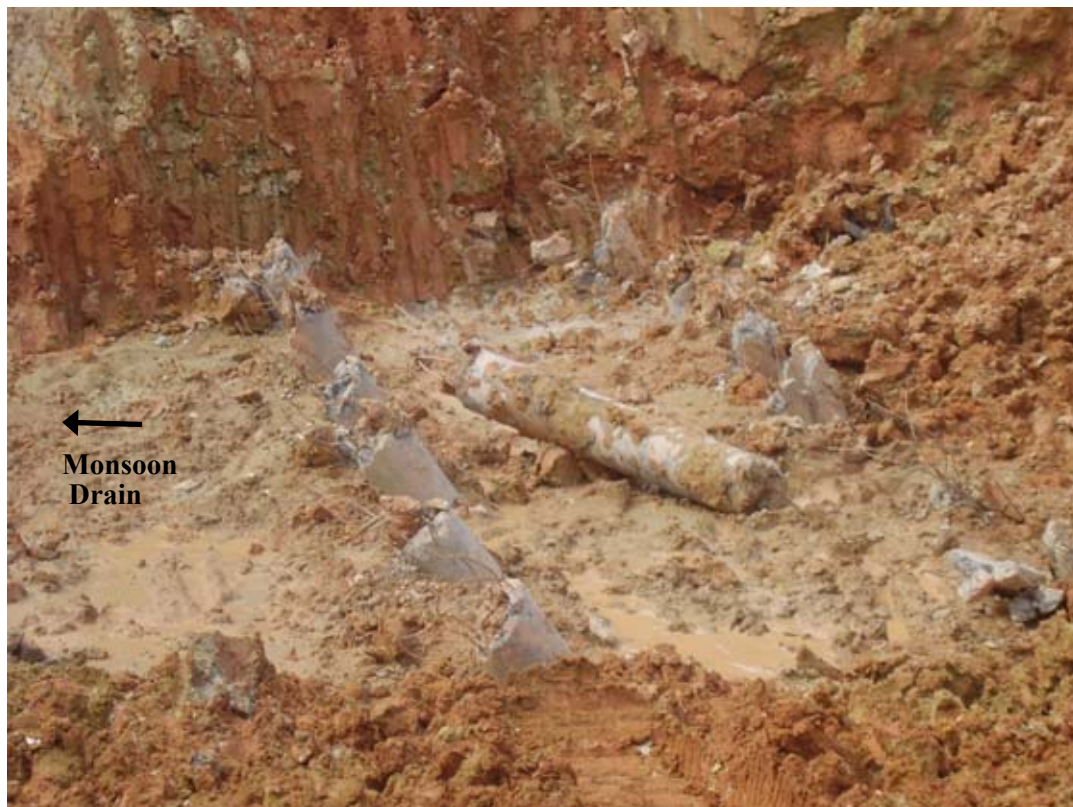
Fig. 50. Pile Head Connection Exposed after Removal of Collapsed Debris

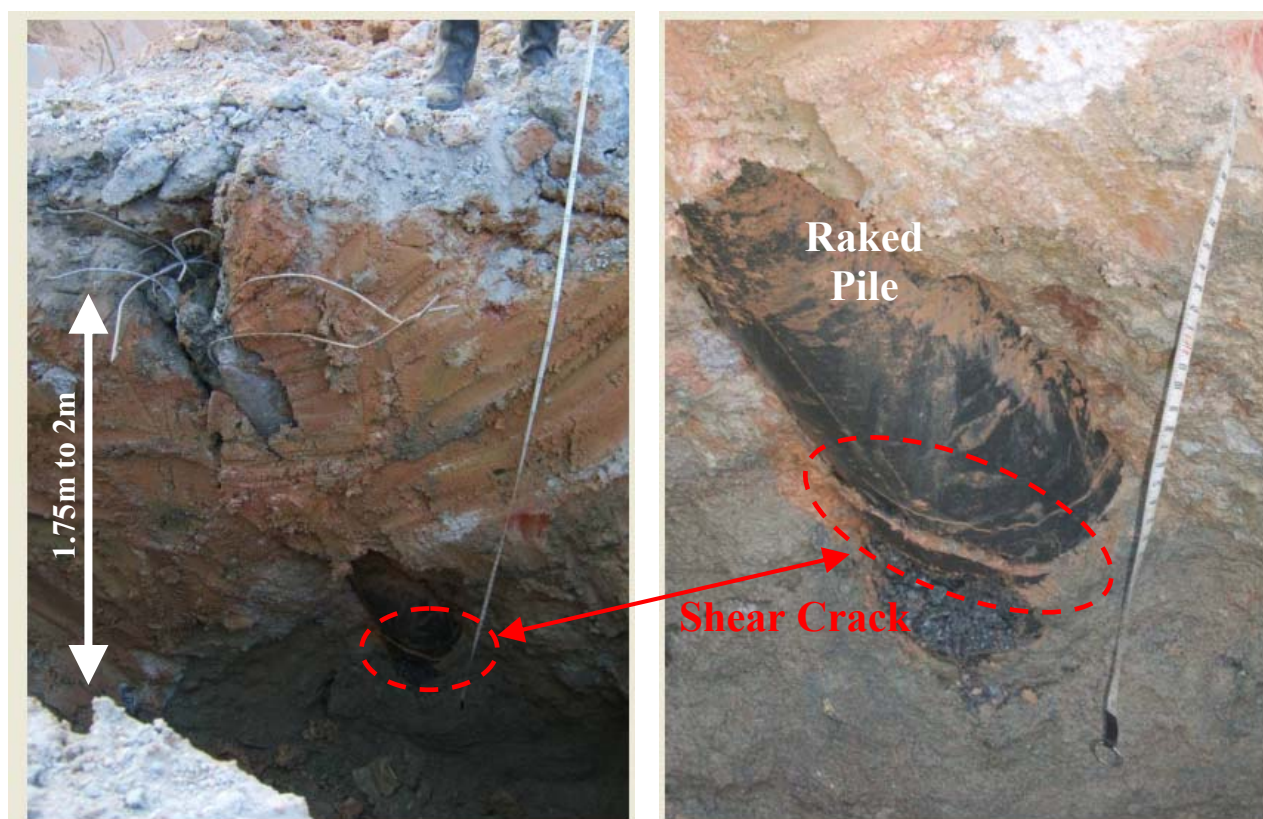
Fig. 51. Pile Damages Exposed after Trial Pit Excavation
