How to improve the Safety of Temporary Works in Construction

Presented by:
Ir. Tan Yean Chin
President of IEM
Secretary General of FEIAP

13 Jan 2017

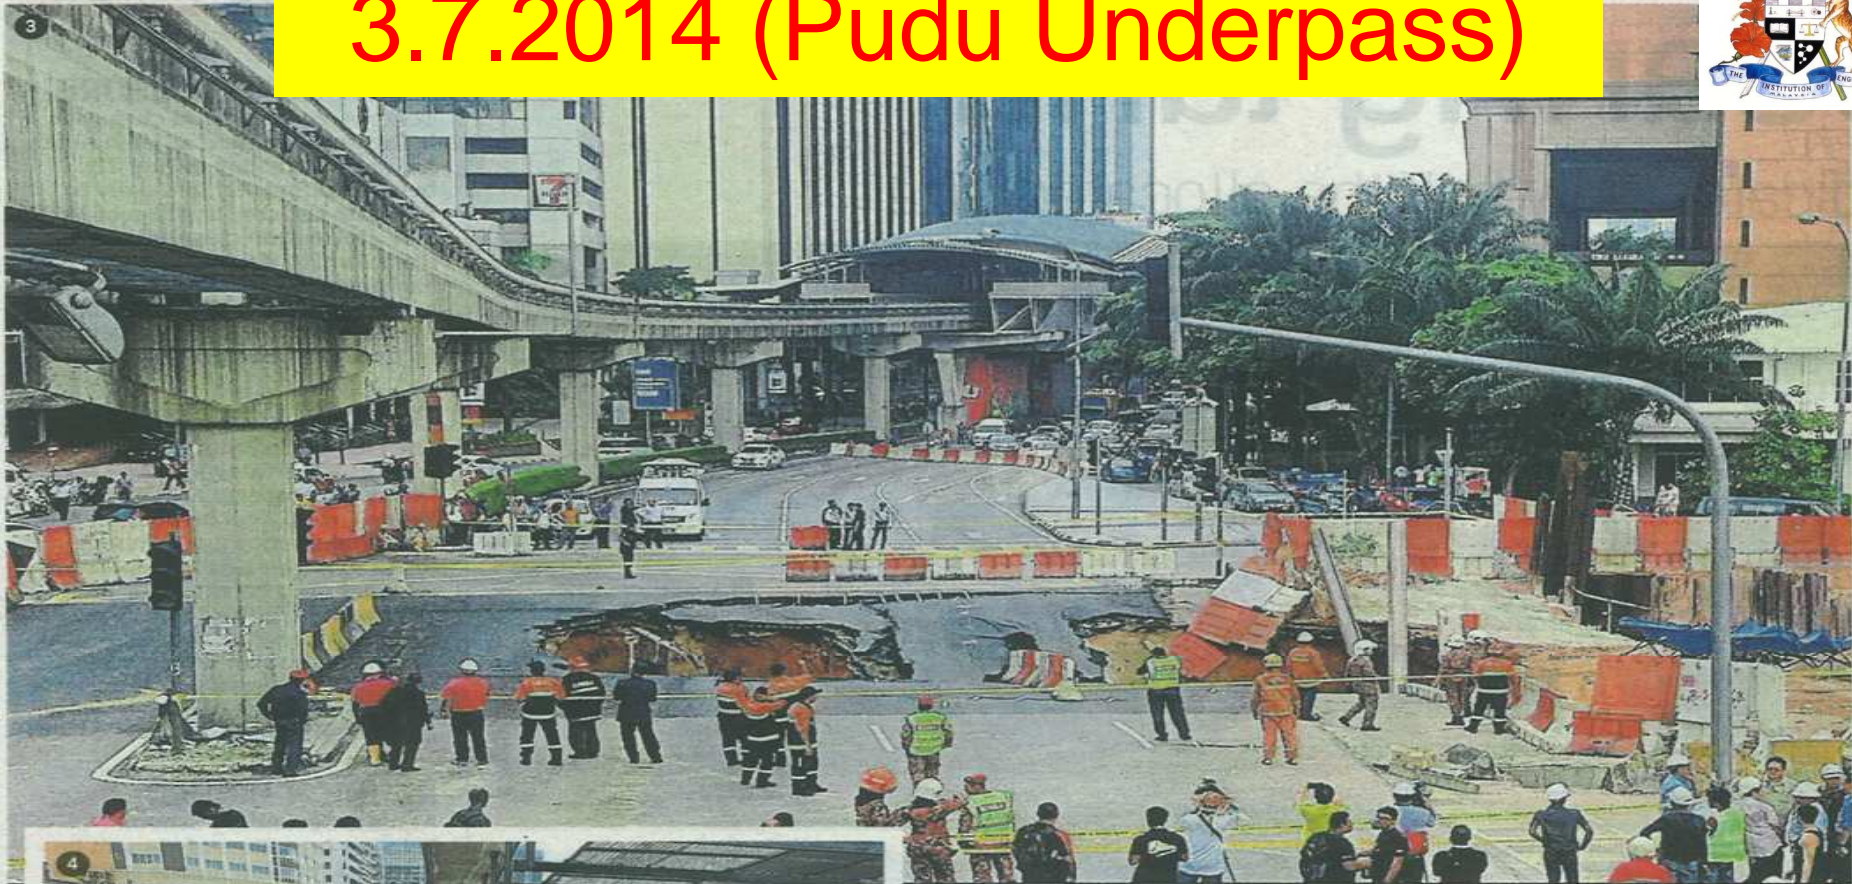
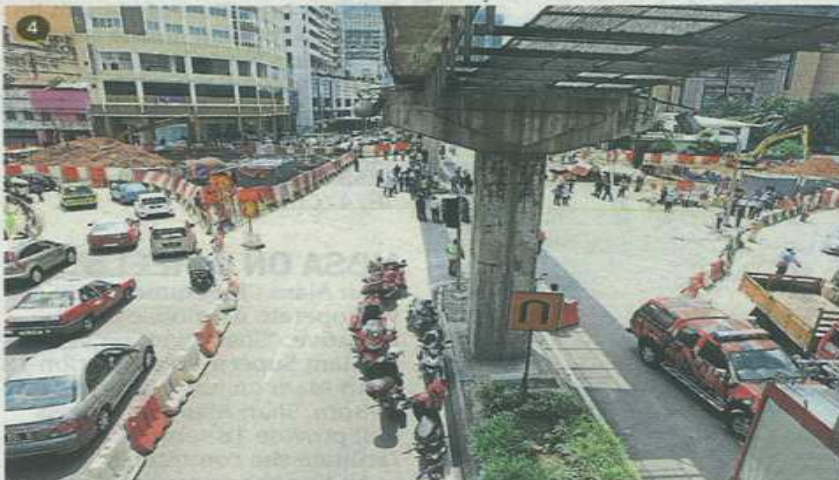
3.7.2014 (Pudu Underpass)

① An aerial view of the sinkholes at the Jalan Pudu-Jalan Imbi intersection.

② Ongoing construction of the tunnel is believed to be the cause of the road to collapse.

④ Traffic has been diverted following the collapse of the tunnel.

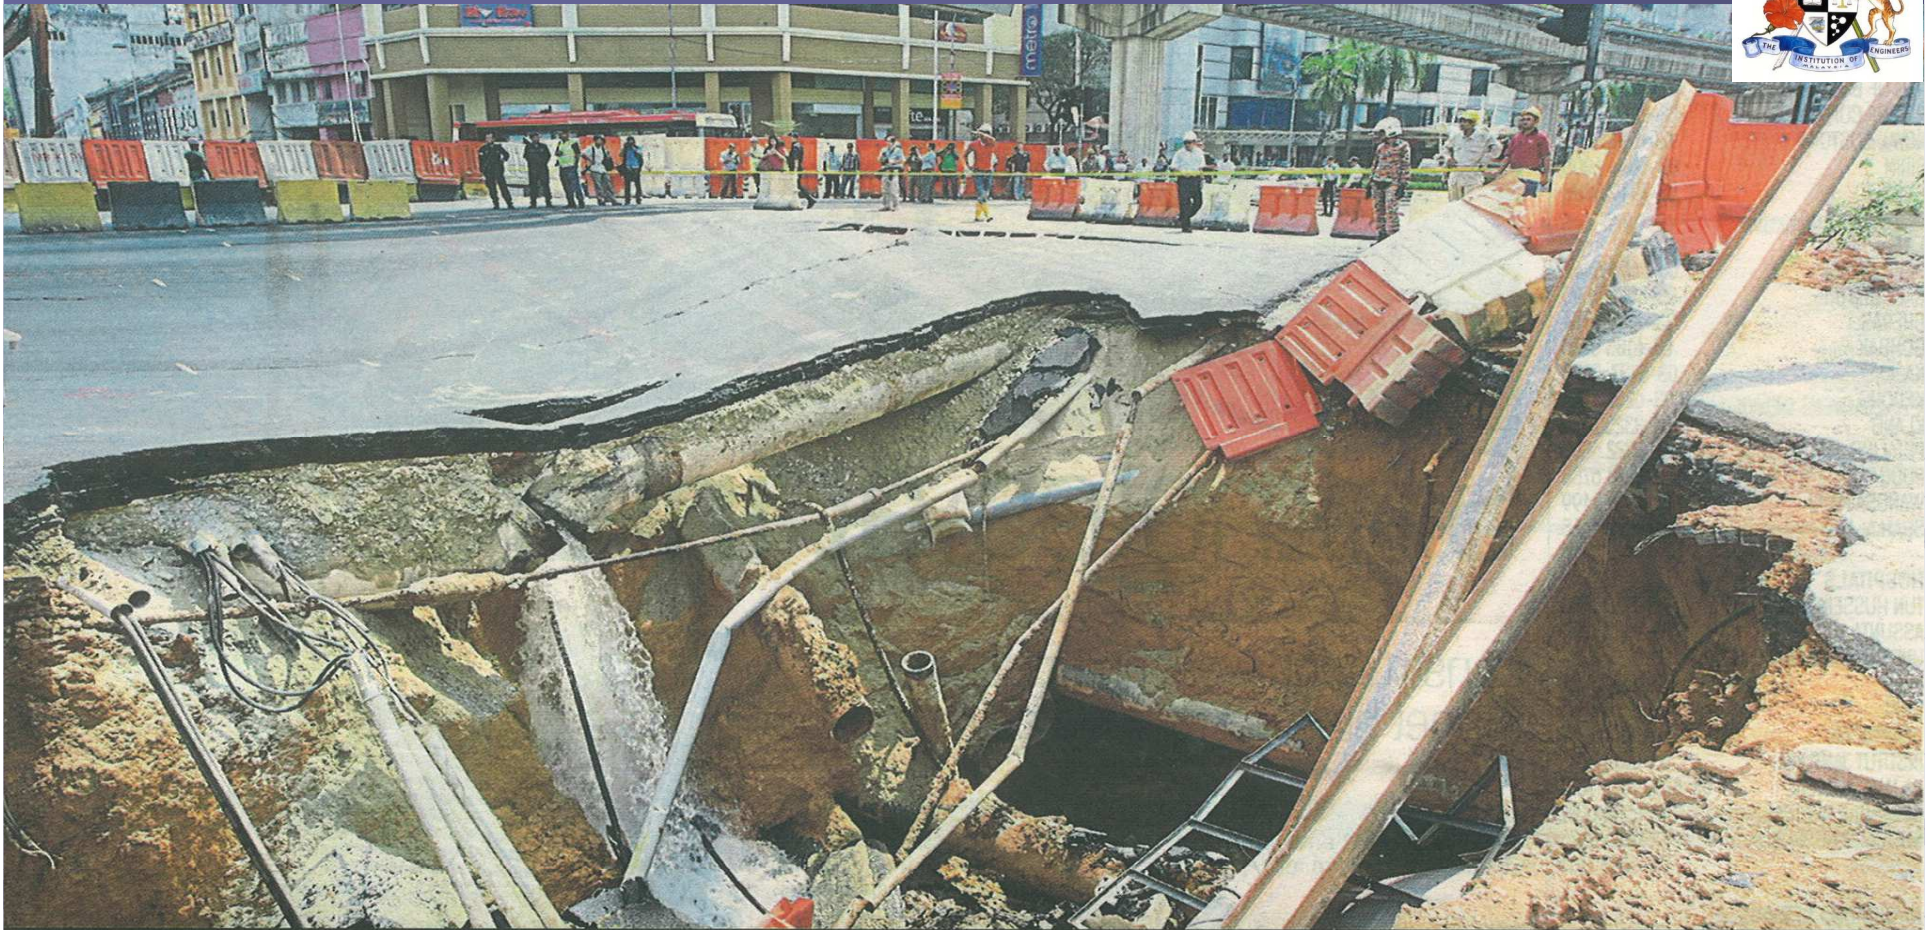
Rush hour chaos: One of the two sinkholes that appeared at the Jalan Pudu–Jalan Imbi intersection yesterday, disrupting traffic flow. – Photo by MUHAMAD SHAHRIL

Ongoing construction work on part of the Pudu Underpass project has caused the road above the tunnel to collapse leaving large holes at the intersection.

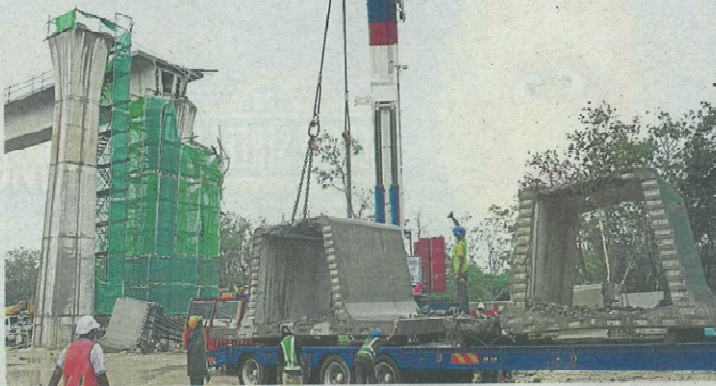
Recovery exercise: A crane being used to lift the concrete span as workers clear the debris to recover the bodies of the three Bangladesh workers.

ing 650 tonnes at the site collapsed at 8.30pm, pining them underneath.

The incident occurred while work to construct the parapet for the guideway, made up of 14 units of segmented box girders, was being carried out.

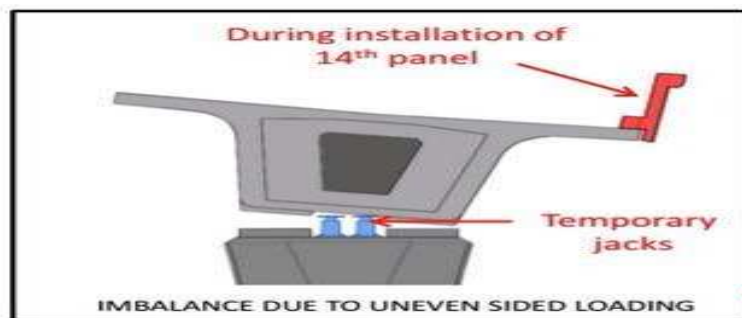
HOW IT HAPPENED?

1. No shims
2. Sitting on a temporary jack
3. Parapet installation on one side

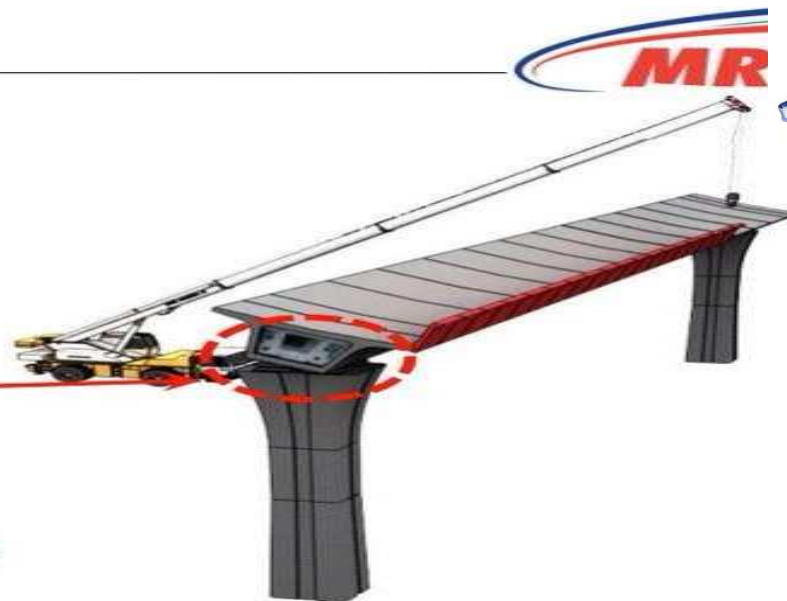
WHAT HAPPENED?

A SINGLE TRACK VIADUCT DECK UNDER CONSTRUCTION TOPPLED AND LANDED ON GROUND.

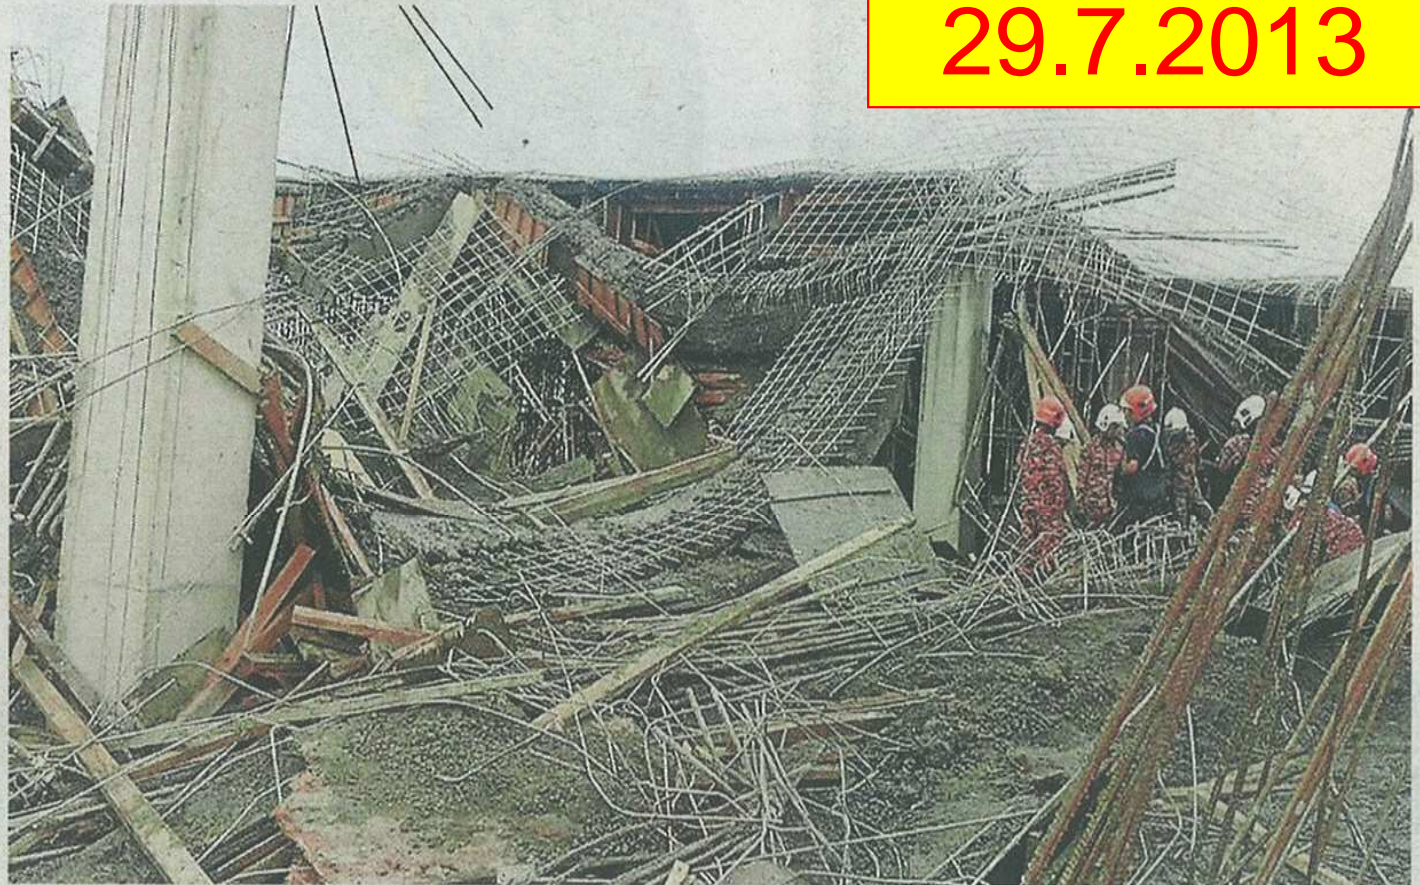
Johor Baru South OCPD Asst Comm Zainuddin Yaacob said the site supervisor had instructed the two workers to repair a cracked beam on the first floor of the building.

"While repairing the crack, the wet concrete ceiling above the beam collapsed on top of them," he said, adding that they died at the scene of the incident.

Deadly development: Fire Department personnel inspecting the scene of the deadly collapse in Ulu Tiram, Johor.

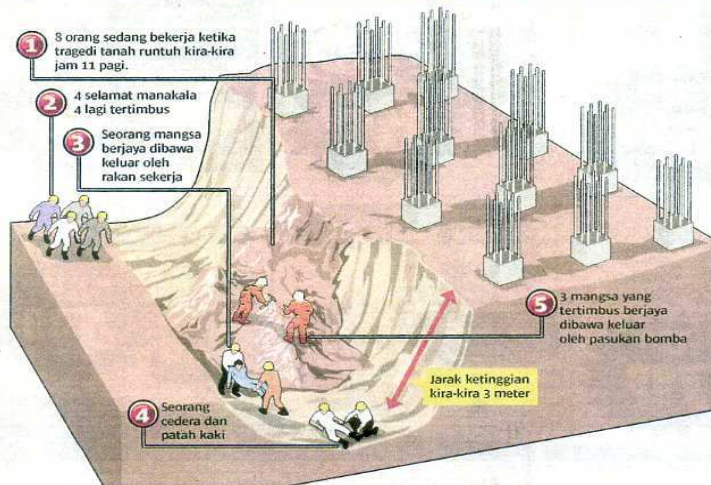
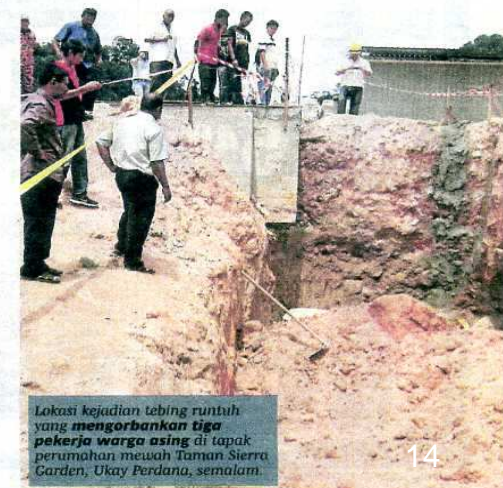
Tiga pekerja binaan mati tertimbus, manakala seorang lagi cedera dalam kejadian tanah runtuh di sebuah taman perumahan baru di Ukay Perdana.

Lokasi kejadian tebing runtuh yang mengorbankan tiga pekerja warga asing di tapak perumahan mewah Taman Sierra Garden, Ukay Perdana, semalam.

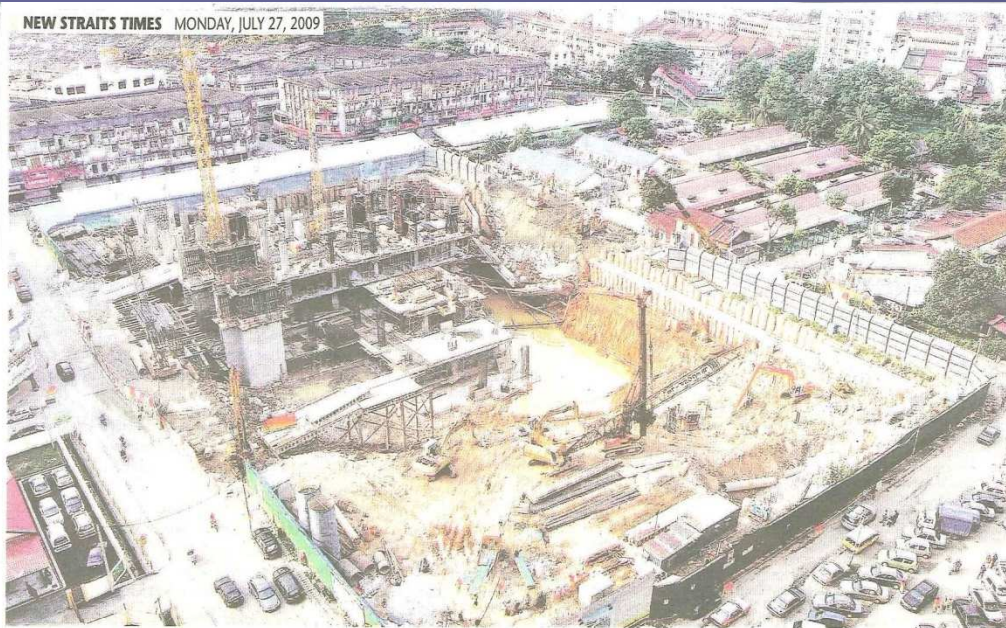
27.7.2009 (Lorong Gelugor – Basement Excavation)

There is development on one side of the Lorong Gelugor cave-in, which occurred near the houses with blue roofs. — NST pictures by Ahmad Ibrahim Mohd Noor

A couple of hours before, some residents of 22 units of Public Works Department (PWD) and City Hall quarters began to leave their homes after noticing cracks widening in the ground.

None of the houses collapsed, although cracks appeared in some of them.

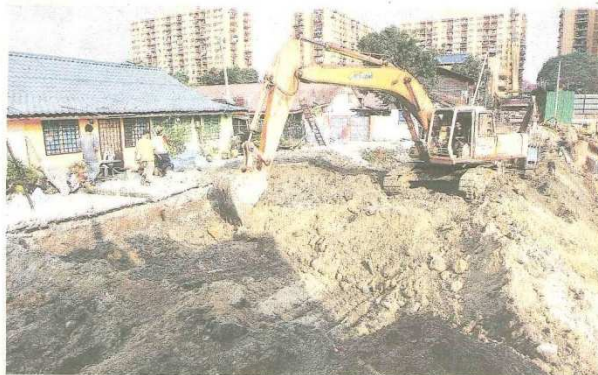
Work to clear the site of the cave-in has started.

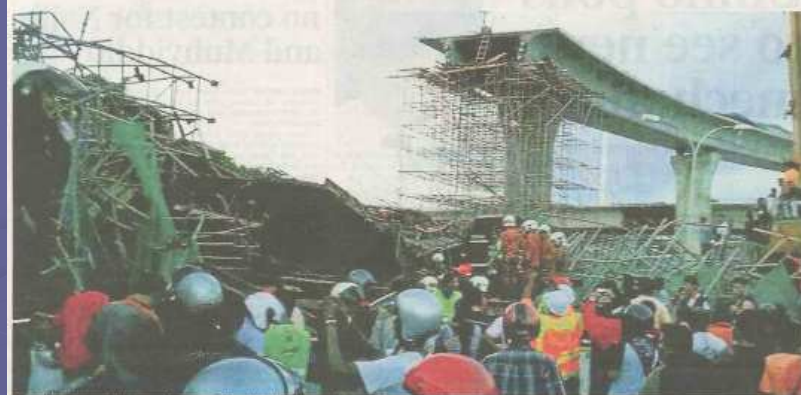
5.6.2013 (Bridge Ramp Falseworks collapse – 1 dead)

The collapsed ramp of the second Penang Bridge which buried a car and two motorcycles yesterday evening.

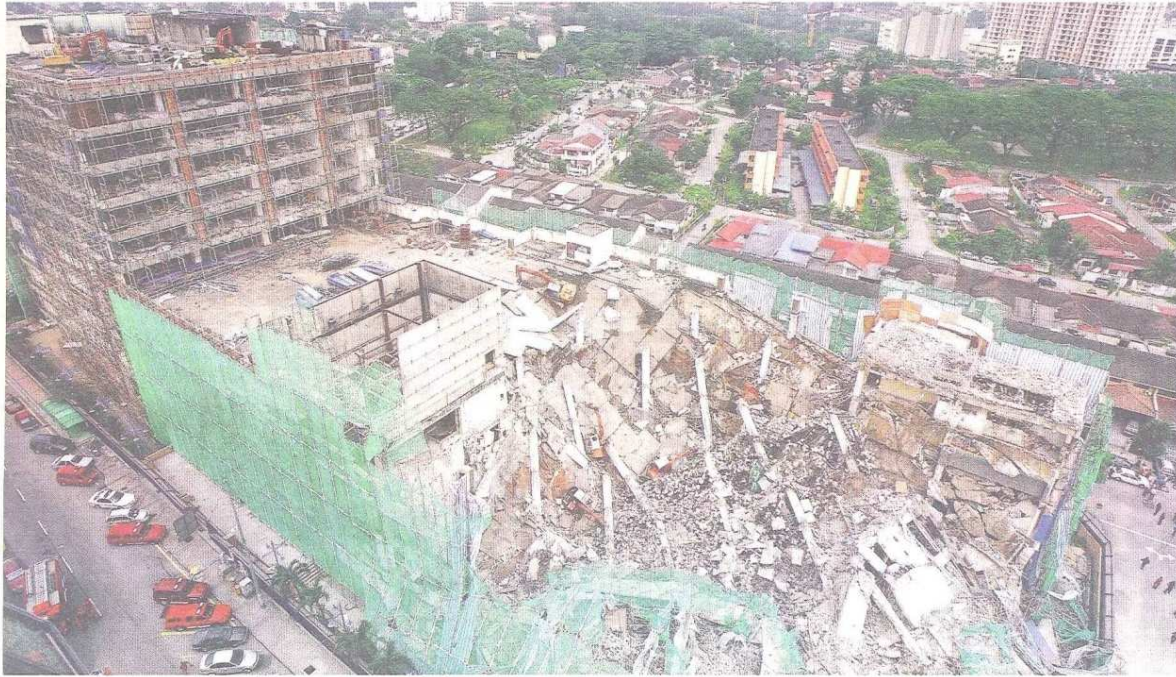
Once an icon: The old Jaya Supermarket building that was once a landmark in Petaling Jaya is now reduced to a rubble after it collapsed at about 5pm yesterday.

When asked if the overloading of machinery on the upper level of the building was the cause of the collapse, he said it could be one possibility but could not say anything until the investigation is completed.

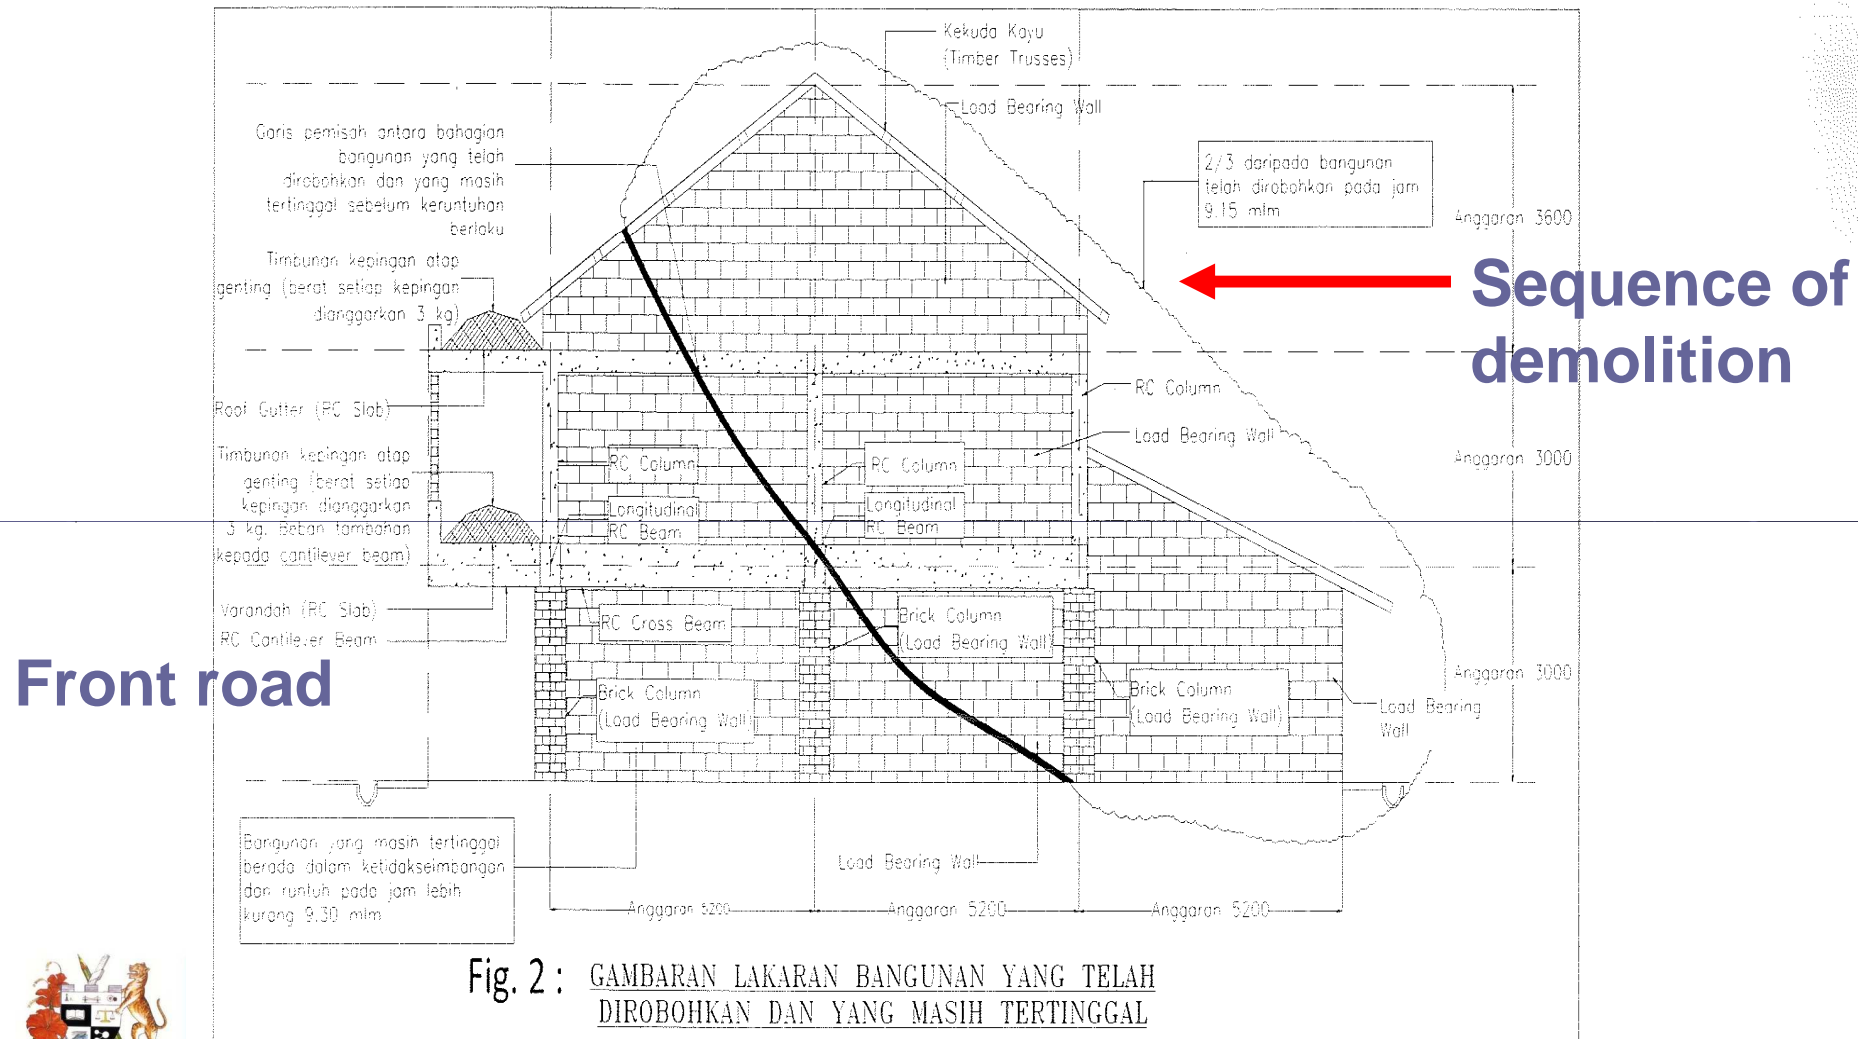
Ipoh shophouse demolition mishap causing 2 deaths of passing by motorists - 2009

Ipoh shophouse – cantelever collapse

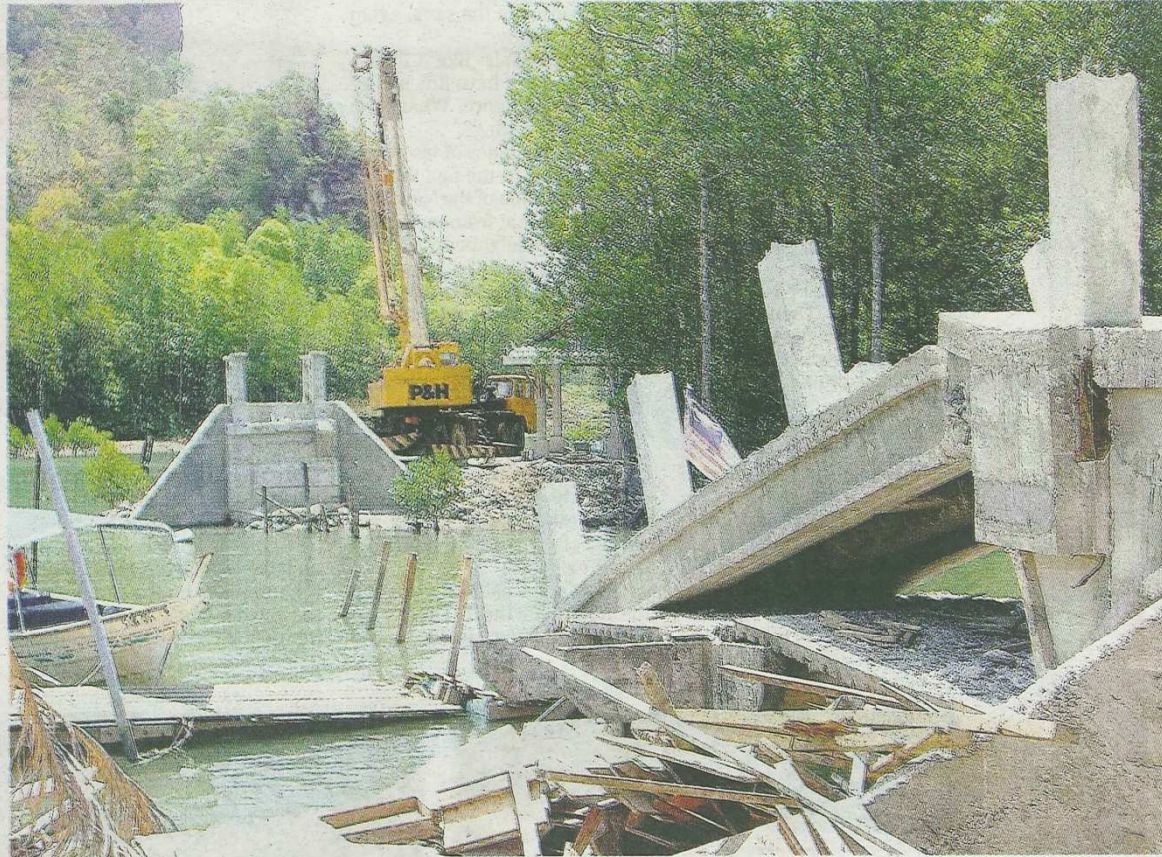
21.3.2008 (Bridge under construction collapses)

All that remains of the bridge being constructed over Sungai Kilim in Langkawi, Kedah. — NST picture by Hamzah Osman

State Works Committee chairman Datuk Nawawi Ahmad said initial investigations showed that cracks had appeared at the foundation of the bridge two days before it collapsed.

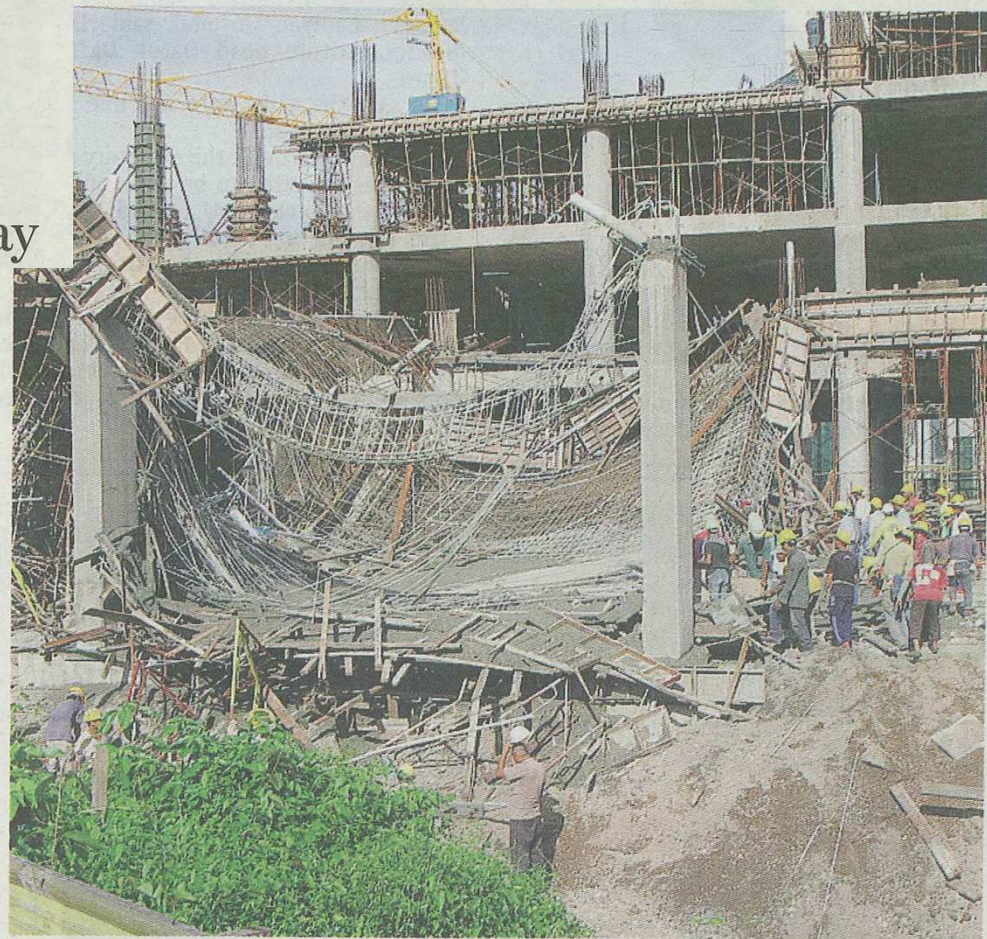
Massive clean-up job: Workers clearing the debris after part of the building structure collapsed in Kuching yesterday.

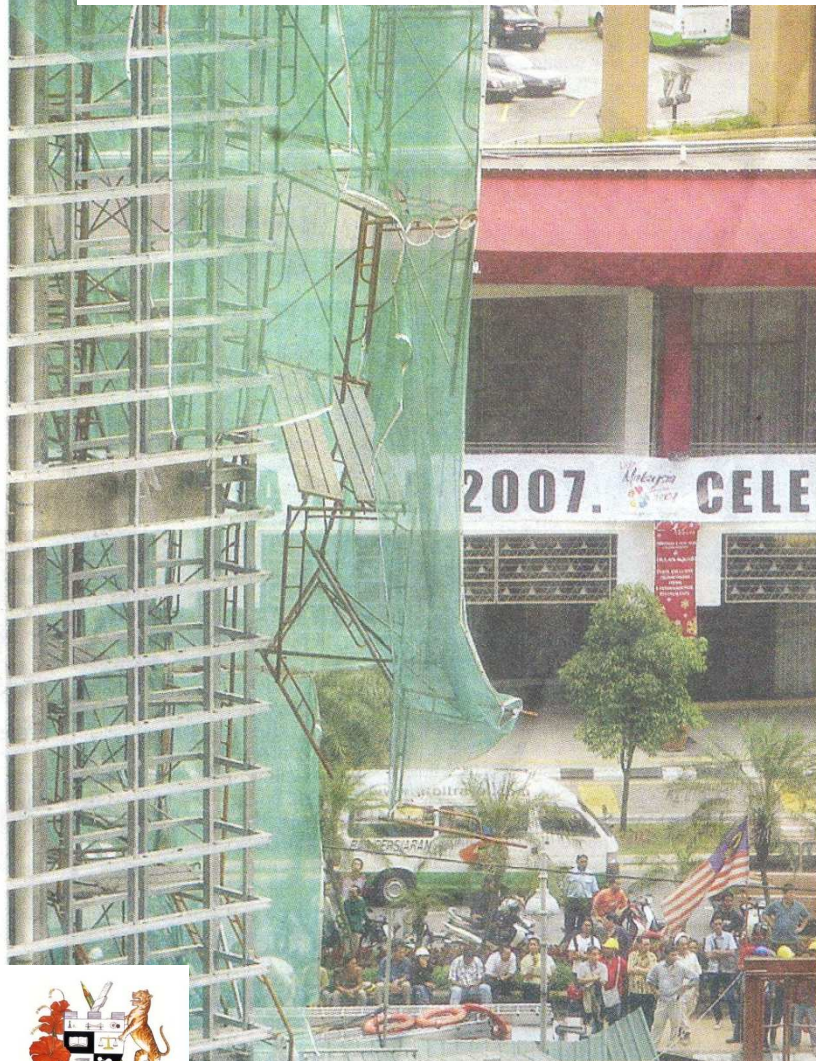
Workers and passers-by looking up at part of the collapsed scaffold after the 12.30pm mishap which killed two workers.

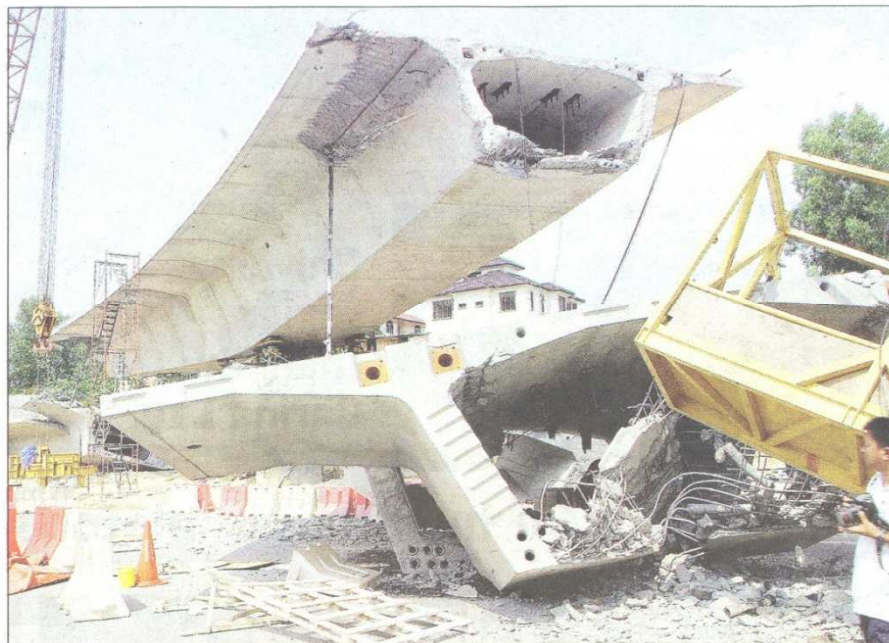
The collapse at 1.40pm today injured nine foreign construction workers working on top of the section, which fell five metres to the ground. The flyover is part of a 7.5-km interchange

MANGLED WRECK: A section of the collapsed flyover and the gondola of the NKVE-Jalan Meru Link flyover

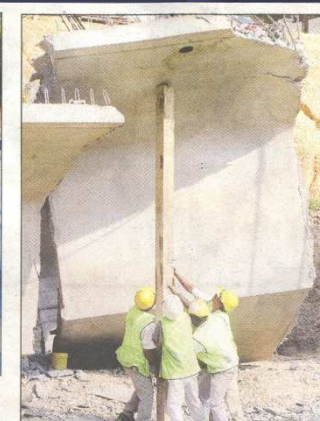
HEAVE-HO: Workers trying to prop up the collapsed bridge at the NKVE.

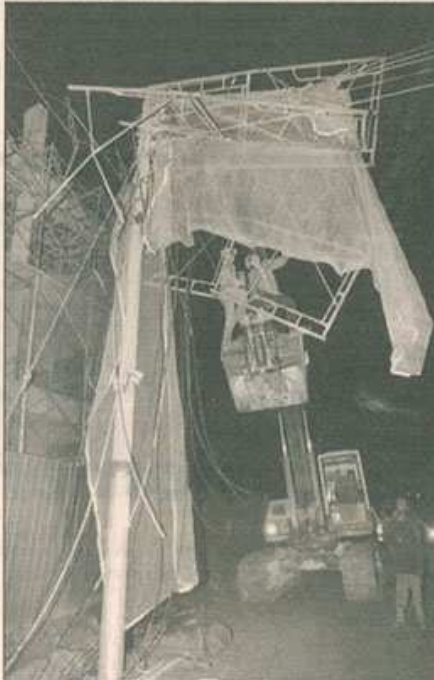
RIGHT:
Work to
dismantle
the
collapsed
structure
carried
on at
night
