GEOTECHNICAL SOLUTIONS FOR UNSTABLE ROCK MASS AT SG. BULOH AREA

S. S. Liew,¹ S. S. Gue,² C. H. Liang,³ & C. K. Yew⁴

ABSTRACT

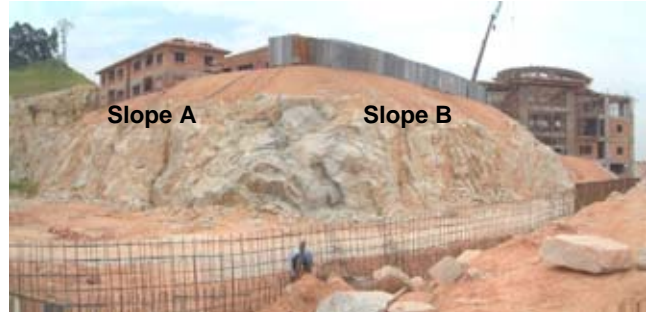
Figure 2: Unstable Rock Mass at Slope A and Slope B

Slopes A and B are located adjacent to a structure, which was already under construction at that time. Slope A and Slope B, which were formed at the edge of the building platform, were badly damaged by blasting works. A layer of soil is then placed over the overblasted bedrock platform for utilities laying purpose. Figure 2 shows some of the unstable rock mass at Slopes A and B.

Kinematic analysis on the geological mapping was performed using rock engineering software (Watts et al., 2003). The kinematic analyses for wedge failure and toppling failure are shown in Figure 3. It is generally summarised that toppling failure for the slopes are more probable compared to wedge failure, particularly on Slope A. For Slope B, some isolated blocky rocks require localised strengthening for stability.

Strengthening works were carried out at certain identified areas for Slopes A and B. Rock bolts and rock dowels had been used to strengthen the unstable block mass. Horizontal subsoil drains were also used to drain away the water in the rock mass. The details of the strengthening works are summarised in Table 1.

Scaling and removal of debris and rock fragments were carried out prior to the strengthening works. This is to expose the rock face to show other secondary geological features for detailed assessment of the stability. A preliminary pull out test for rock bolt was performed in accordance to BS8081:1989. The result of the pull out test is shown in Figure 4. The displacement measured at the maximum test load 465kN was 4.5mm confirming that the constructed rock bolt can perform satisfactorily.

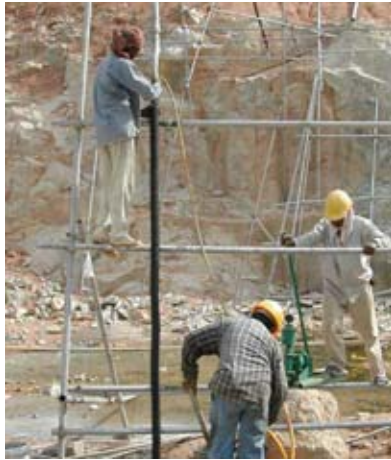
Figure 5: Vertical Grouting of Corrugated Pipe

Corrugated high density polyethylene (HDPE) pipe is used for the pre-grouted segment of the bond/fixed length of the rock bolt. Its main purpose is to provide the primary corrosion protection for the galvanized steel bar, in which the grout and the galvanized layer will form the secondary corrosion protection layer. The steel bar was pre-grouted in corrugated pipe. It was found that pre-grouting in a horizontal configuration was not effective due to the voids found trapped within the space between the corrugated pipe and the steel bar. Therefore, it was later decided to pre-grout the pipe in a vertical arrangement. Figure 5 shows vertical grouting of the corrugated pipe. During grouting the pipe from bottom up, constantly vibrating the HDPE pipe had been carried out to prevent trapping of air voids.

- c. During pre-grouting of the rock bolts, it is important to ensure that no air void is trapped in the corrugated pipe and sufficient vibration shall be applied to the vertically arranged grout column.

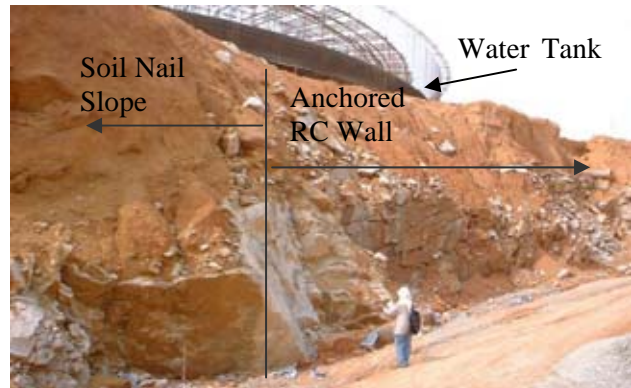
Figure 6: Slope C Before Strengthening Works

Geological mapping was carried out along vertical face of the rock slope. From site observation, the rock slope surface has very poor fragmentation without any smooth face. No traces of the pre-splitting lines were observed. Figure 6 shows the condition of Slope C before the rectification works. The visual inspection suggested that falling of loose and fragmented rocks from the slope was highly probable.

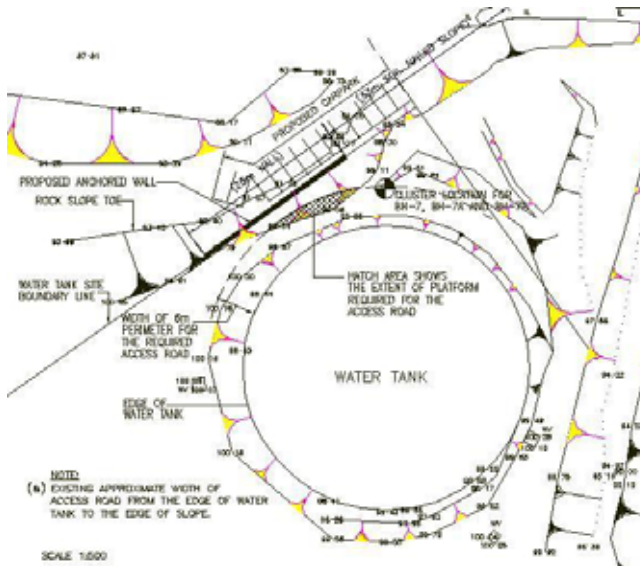
Figure 7: Layout Plan of Slope C Showing Borehole, RC Wall and Soil Nailed Slope Location

The exposed rock slope face had been overblasted to about 4m away from the nearest outer perimeter of the water tank. This setback was not sufficient as the authority required a 6m setback around the water tank for maintenance access. Furthermore, there were proposed car parks just adjacent to the boundary line at the

lower platform. (See Figure 7). However, the toe of the slope at that time had also encroached into the proposed car park. Thus, a retaining structure was required to retain the 6m perimeter road and, at the same time to provide the necessary space for the car parks.

The construction sequence as planned involved rock hacking to trim the rockhead encroaching into the car park boundary. Rock slope trimming was required from the existing slope toe to the boundary line as shown in Figure 7. A 0.5m deep trench had initially designed to socket the wall base on to the rock. The tieback anchors were then installed at required levels. The RC wall was later constructed to next level, where another tieback anchor will be installed, until reaching the platform level of the water tank. Well graded crusher run had been specified as the backfill material of the RC wall due to its effective drainage and ease of compaction in the narrow backfilling space.

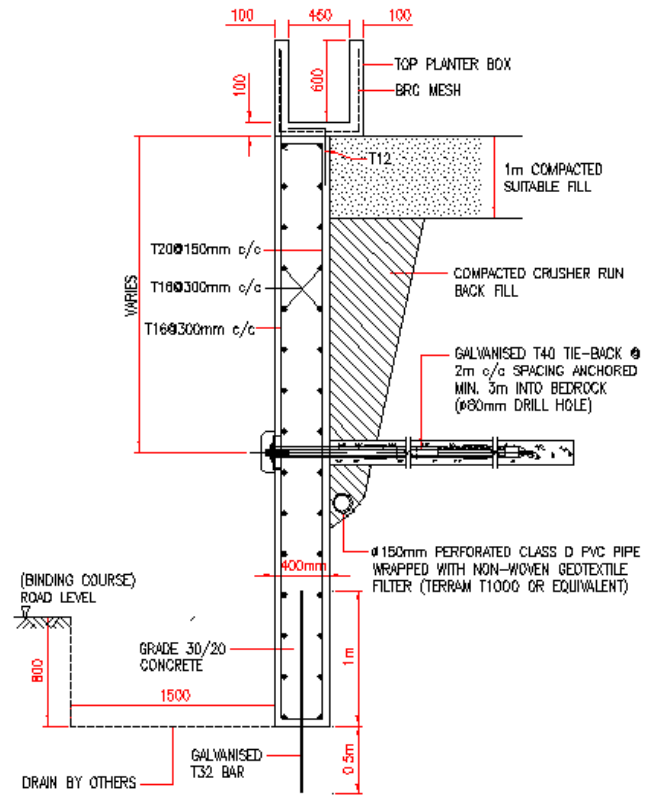
Figure 8: Schematic Diagram of Anchored RC Wall

The proposed retaining system for Slope C was a reinforced concrete anchored wall of about 10m height. The original design of the reinforced concrete wall was to socket the wall base into the bedrock and anchored by a series of tieback anchors at certain levels. The Finite Element Method (FEM) was employed for the soil-structure interaction analysis using computer program, PLAXIS. A $\phi 150\text{mm}$ perforated subsoil pipe wrapped with geotextile had also been provided to drain away potential groundwater seepage in the rock mass. The schematic RC anchored wall details can be referred in Figure 8.

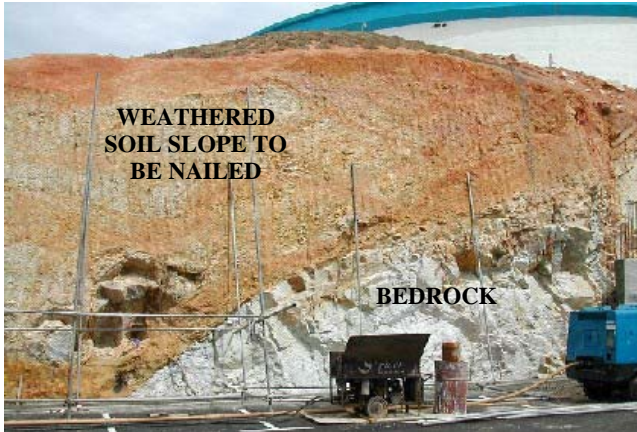
Figure 9: Slope Before Strengthening Works

Immediately adjacent to the rock slope as mentioned above was a residual soil slope with varying degrees of weathering. As the soil slope of 8m height had also encroached into the proposed car park, the soil slope needed to be trimmed back and strengthened. Soil nails of 12m length had been proposed to strengthen the soil slope after trimming it to a gradient of 4V:1H. The vertical spacing and horizontal spacing of the soil nails

was 1.6m and 1.4m respectively. The elevation view of soil nailed slope before and after strengthening works is shown in Figure 9 and Figure 10.

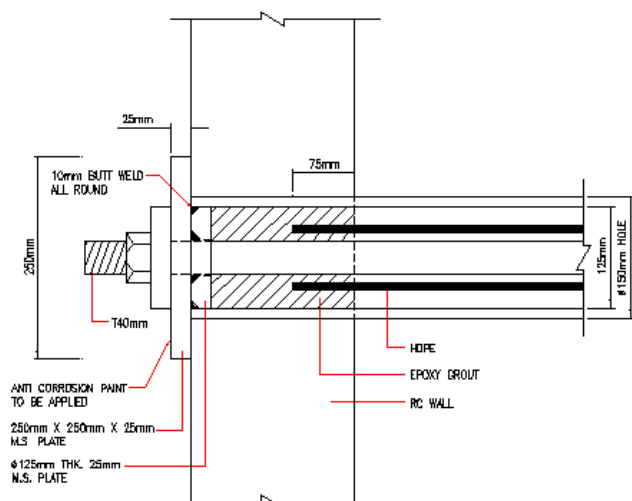
Figure 11: Anchor Head Details

During the construction of the RC wall, the contractor proposed to leave a $\phi 150$ mm PVC pipe in the wall to facilitate the subsequent installation of anchors in which its progress was slower than the RC works. However,

it was later discovered that the $\phi 150\text{mm}$ hole was too large and would cause high bending moment at the steel bearing plate when the anchors are in the working condition. An analysis was carried out using FEM to assess the bending moment induced in this case. It was later decided to weld an additional steel plate (thickness 25mm) to the steel bearing plate (250mm x 250mm x 25mm) to improve the bending capacity of the bearing plate. The revised anchor head details is shown in Figure 11. The subsequent level of anchors were then installed before casting the next segment of the RC Wall.

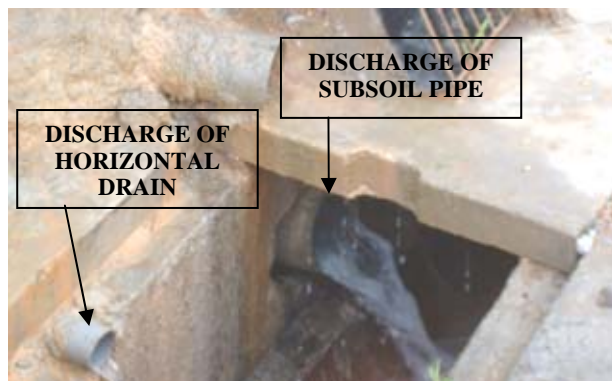
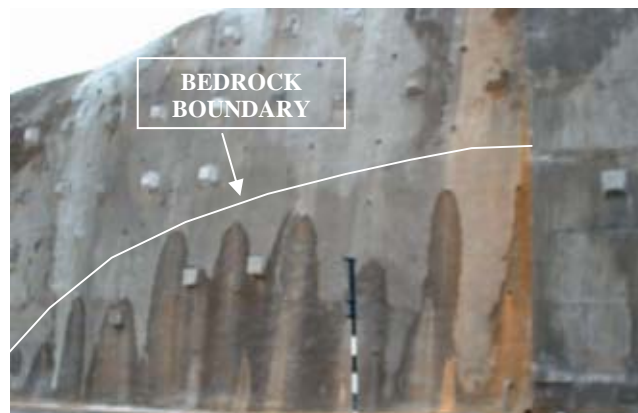
The construction of the RC wall and soil nailed slope was completed at the end of October 2002. It was observed that rain was frequent and heavy for the month of November. A site visit was specifically arranged on November a day after a heavy downpour. It was found that the discharged water from the subsoil pipe, horizontal drain and weepholes was of substantial amount as shown in Figure 13 and Figure 14. Water was also seen seeping out from the rock slope near by. It could therefore be conceded that groundwater perched up and flowed over the bedrock surface when the groundwater table built up.

Figure 13: Discharge of Weepholes After Heavy Downpour

Figure 14: Discharge of Weepholes After Heavy Downpour
