**10th International Conference on Piling and Deep Foundations, Amsterdam, The Netherlands
May 31 - June 2, 2006**

Design and Construction of Soil Nail Strengthening Work over Uncontrolled Fill for a 14.5m Deep Excavation

Liew, S. S. and Khoo, C. M.
Gue & Partners Sdn Bhd, Malaysia

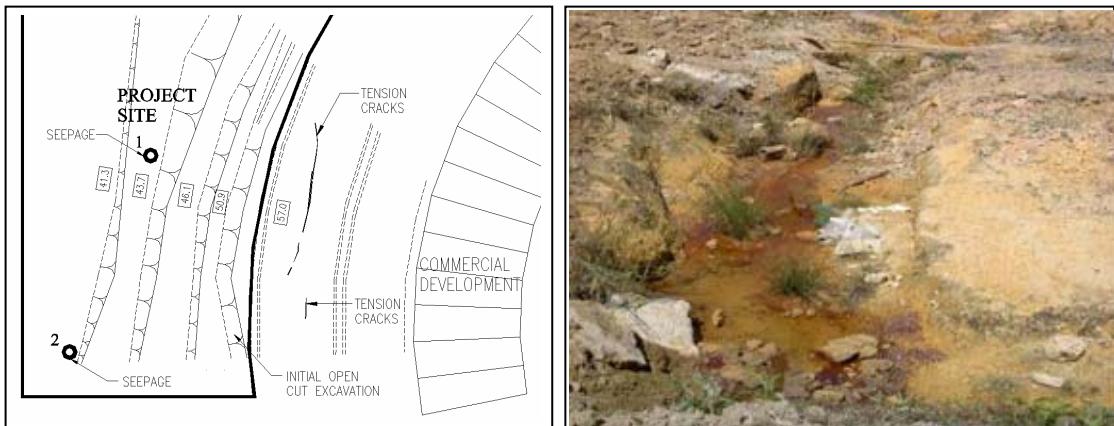
A site inspection was carried out shortly after observing the tension cracks on the road pavement by the project team. The semi-circular pattern cracks were generally observed on the top of the excavated slope as shown in Figure 3. Water seepage at two locations was also observed indicating potential high groundwater level within the filled slope (see Figure 4). At the time of investigation, the excavation at southern portion of the site was in a more advanced stage. It was not surprised that more ground movements were occurring behind the excavation where the tension cracks were first observed.

Figure 3: Tension cracks at earlier stage

Figure 4: Seepage (Location 1)

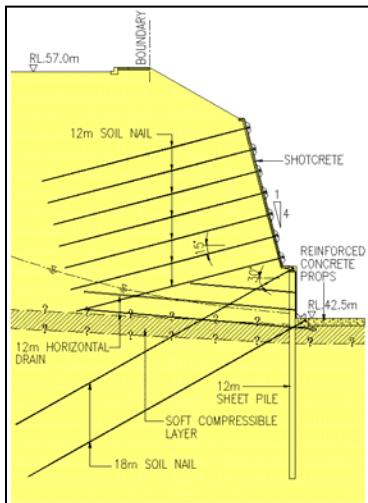
Figure 9: Cross-section of strengthening work at valley area

The proposed strengthening strategy is to reinforce the in-situ saturated loose fill with closely spaced soil nails of varying lengths from 6m to 12m with structural shotcrete facing and to drain out excessive groundwater freely from the saturated loose fill with subsoil drains. Nail spacing are limited from 1.25m to 1.5m center to center spacing horizontally and vertically. Generally, the excavation surface was finished with shotcrete facing in 4V:1H gradient. At the valley area where excessive creep movement was observed, 12m long sheet pile wall with two rows of 18m long soil nail anchorage and reinforced concrete props against the basement structure were used to enhance the passive resistance of the retained ground, which is seated over the 2m thick original soft deposits almost at the final excavation level (Figure 9).

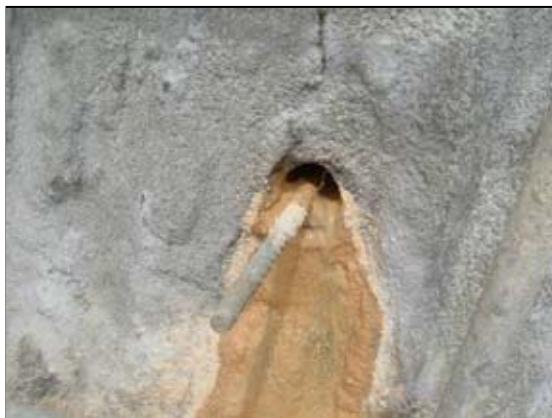
During drilling the lower rows of nail, unset grout and mud slime were observed flowing out from the freshly grouted nails adjacent to the drilling indicating high groundwater table and high connectivity of the poorly compacted fill (see Figure 11). In connection with this, site instruction was given to drill the holes in alternate sequence with reduced air pressure. The bond resistance of these doubtful nails was further verified by pull-out tests and re-analysis was conducted to re-assess the factor of safety of the overall stability.

Figure 11: Unset grout and mud slime flowing out during drilling at adjacent nails

- v. Drilling with reduced air pressure and alternate locations in loose fill material are strongly recommended to avoid disturbance to the previously completed nails.

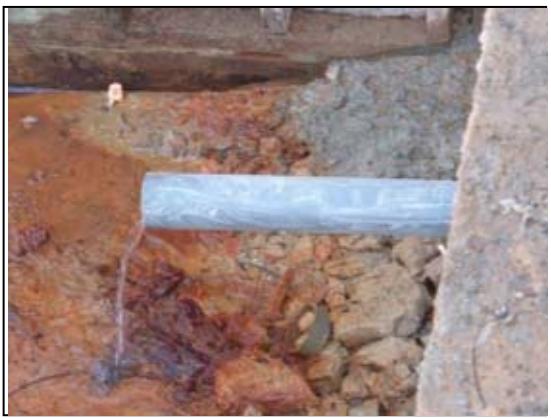
Apart from the nominal provision of subsoil drainage, additional subsoil drains were provided at the identified seepage spots on the exposed excavation surface. In one location, groundwater was observed continuously flowing out immediately after excavation. This particular location was believed to be the natural water path of natural stream as revealed in the original ground contour. Sufficient horizontal drains were installed at this location to discharge the groundwater. Figure 12 shows the water continuously discharged from horizontal drains after installation.

Figure 12: Continuously seepage flow

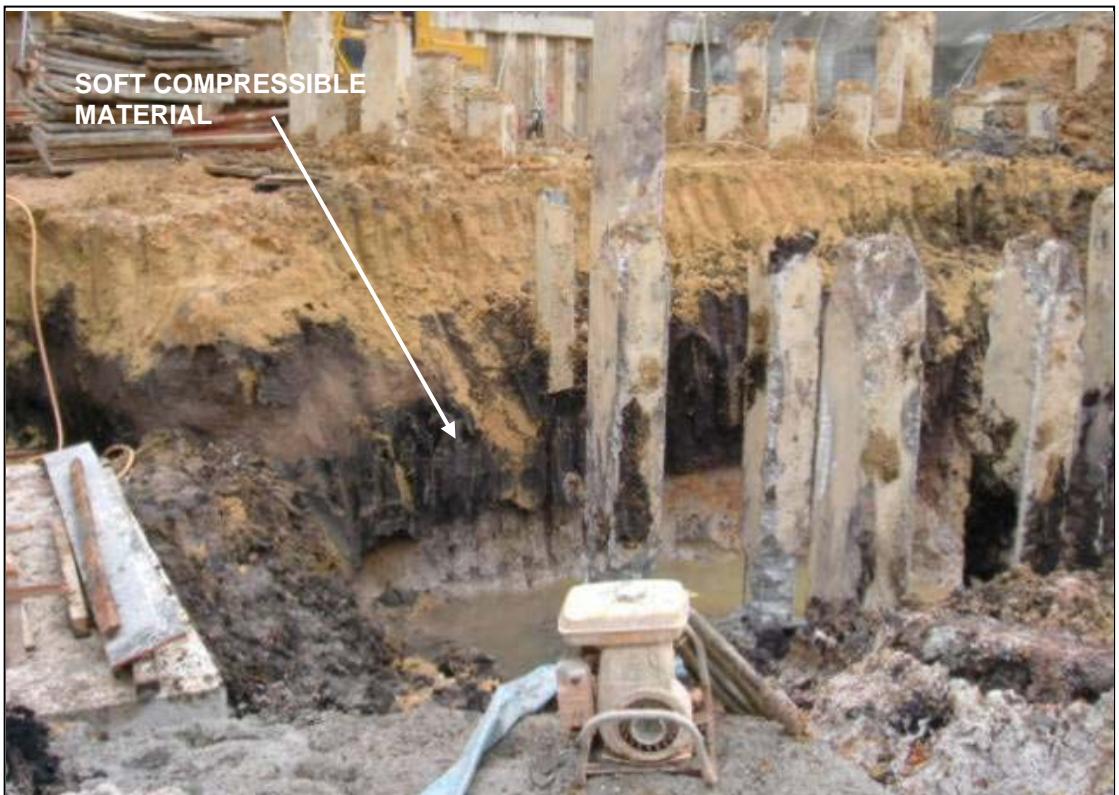
When excavation nearly reached the final platform level, additional field testing such as Mackintosh probing and in-situ penetrating vane shear tests were conducted at the expected soft compressible layer to verify the soil parameters adopted in the slope stability analyses. The localized excavation for pile cap construction further confirmed the existence of this soft deposited material as shown in Figure 13.

Figure 13: Soft compressible layer detected at localized pile cap excavation

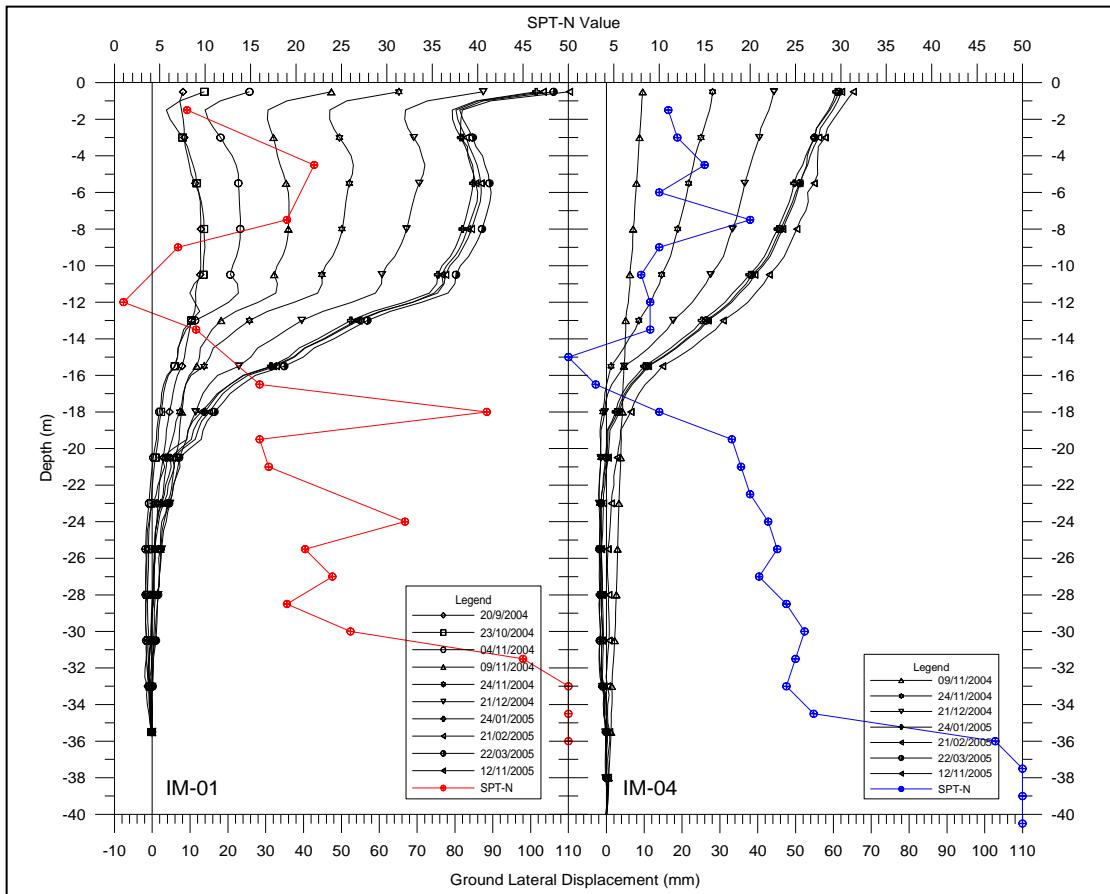
Basically, larger movement was observed during the initial stage of soil nailing for the upper rows as shown in Figure 14. This is likely due to the steep sub-vertical cut compounding with the extreme weather condition. However, the slope movement at the valley area was noted with stabilizing trend upon installation of sheet pile wall anchored with two rows of 18m long soil nails to improve the passive resistance at the toe of the excavated slope.

At the most critical location where the valley is located, the soil nailed wall has moved about 90mm laterally at the final excavation, which is about 0.6% of the depth of excavation and is slightly higher than the typical ratio of maximum wall deflection to excavation depth of the range from 0.2% to 0.5% presented by Ou et al. (1993) for numbers of deep excavation in Taipei basin. When the lateral movement reaches 0.5% of the excavation depth, distress would be expected on the retained side.

Figure 14: Measured ground lateral displacement

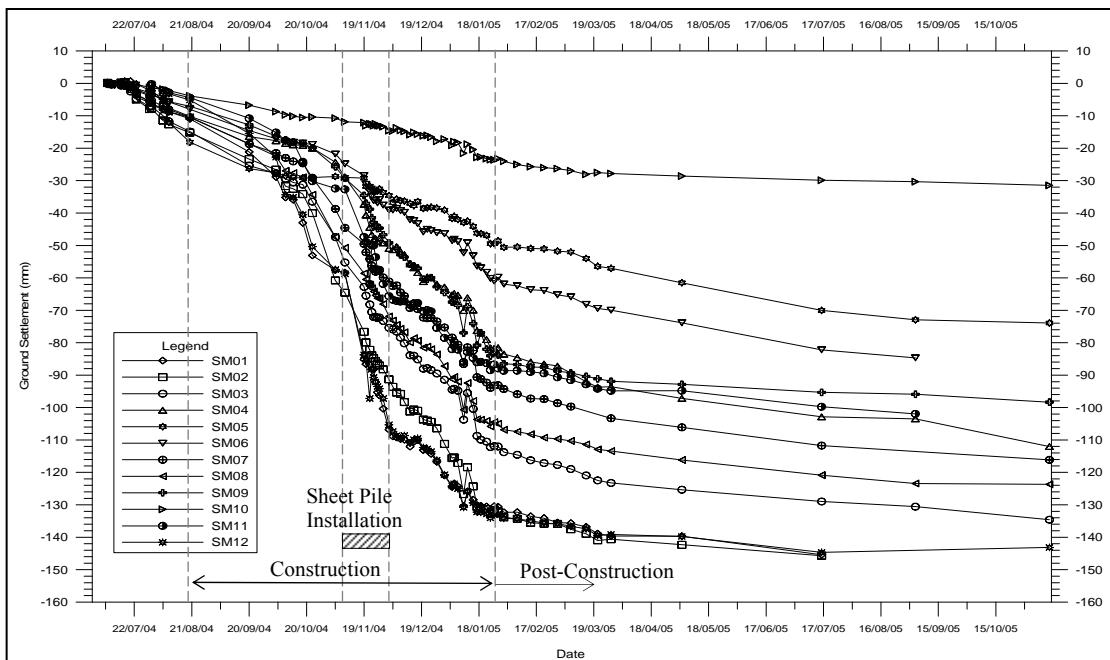
The cumulative ground settlements behind the soil nailed wall at various construction stages are shown in Figure 15. Similarly, larger rate of ground settlement had been observed during the excavation. The ground settlement had stabilized after the completion of slope strengthening works.

Figure 15: Measured ground settlement

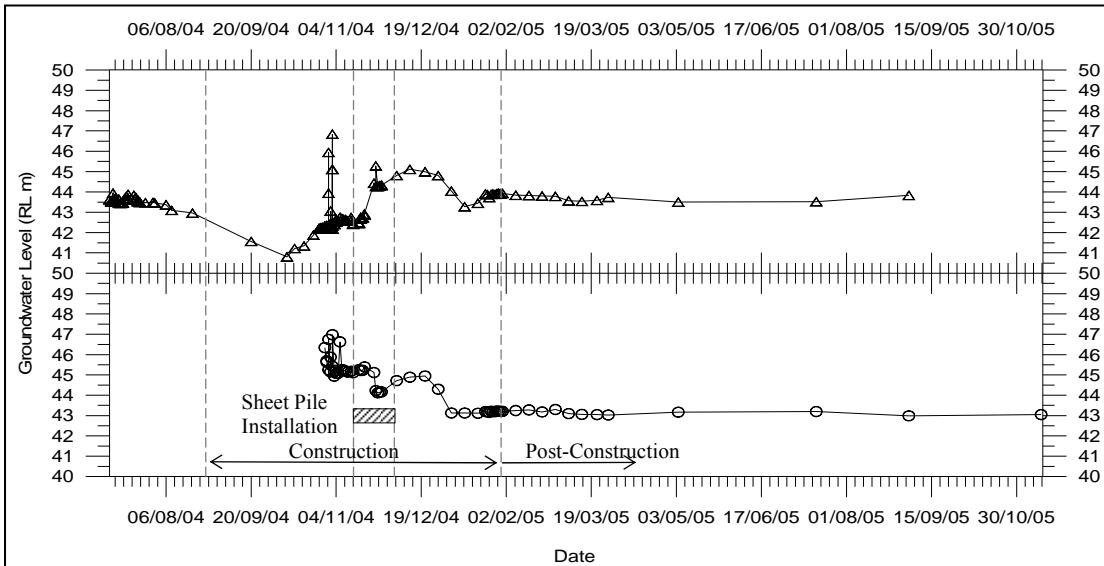
Figure 16: Measured groundwater level

In the initial stage of excavation, the groundwater on the retained side was measured at about RL 43.5m at the original ground level. Subsequently, the lowering of groundwater was noted during the localized excavation for pile cap construction at some distance away from the slope toe where the sheet pile wall was not installed cutting off the underground seepage. However, groundwater was gradually raised up to the top of sheet pile wall (RL 45.5m) after the sheet pile wall had been installed. The installation of this sheet pile had cut off the path of underground seepage and caused building up of pore pressure within the soil mass as indicated in Figure 16.

Interestingly, the groundwater was fluctuated as high as 3m during the occasional heavy down pour as measured by SP-01 and SP-03. Once the sheet pile wall was installed section by section, three rows of horizontal subsoil drains at levels of RL 41.975m, RL 43.0m and RL 44.0m were also installed immediately to relieve the build up groundwater behind the sheet pile wall. It was noted that the groundwater had successfully been discharged and lowered to RL 43.5m at the observation wells SP-01 and SP-03 reaching the steady state equilibrium after reaching the final excavation.
