# GEOTECHNICAL CHALLENGES IN SLOPE ENGINEERING OF INFRASTRUCTURES

Gue See-Sew<sup>1</sup> & Cheah Siew-Wai<sup>2</sup>

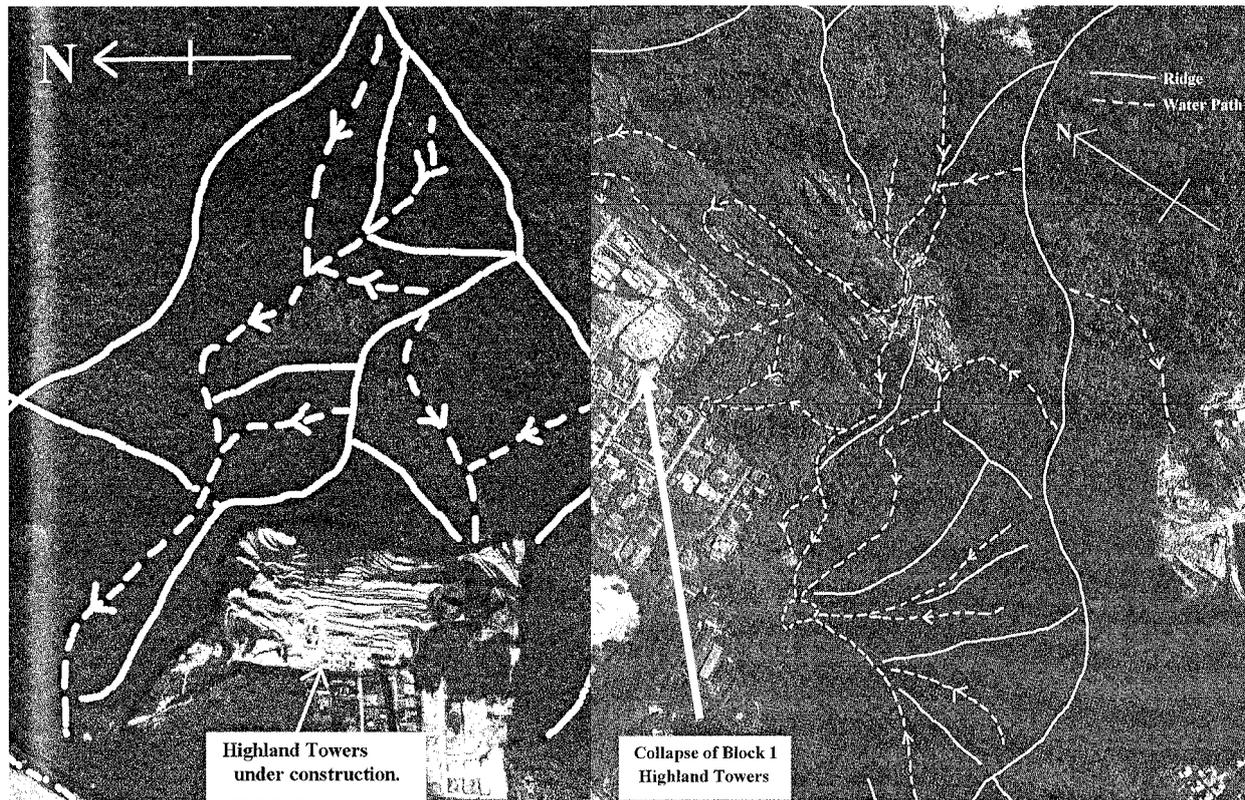
Figure 1 shows the water path before and after the completion of the Highland Tower Apartments. In the course of the Highland Towers development, the stream was diverted by means of a pipe culvert to flow northwards across the hill slope directly behind Highland Towers. The approved drainage system on the hill slope behind Highland Towers was never completed. Figure 1 shows the water path before and after the completion of Highland Towers.

**Figure 1: Water Path Before and After Completion of the Highland Towers Apartments**

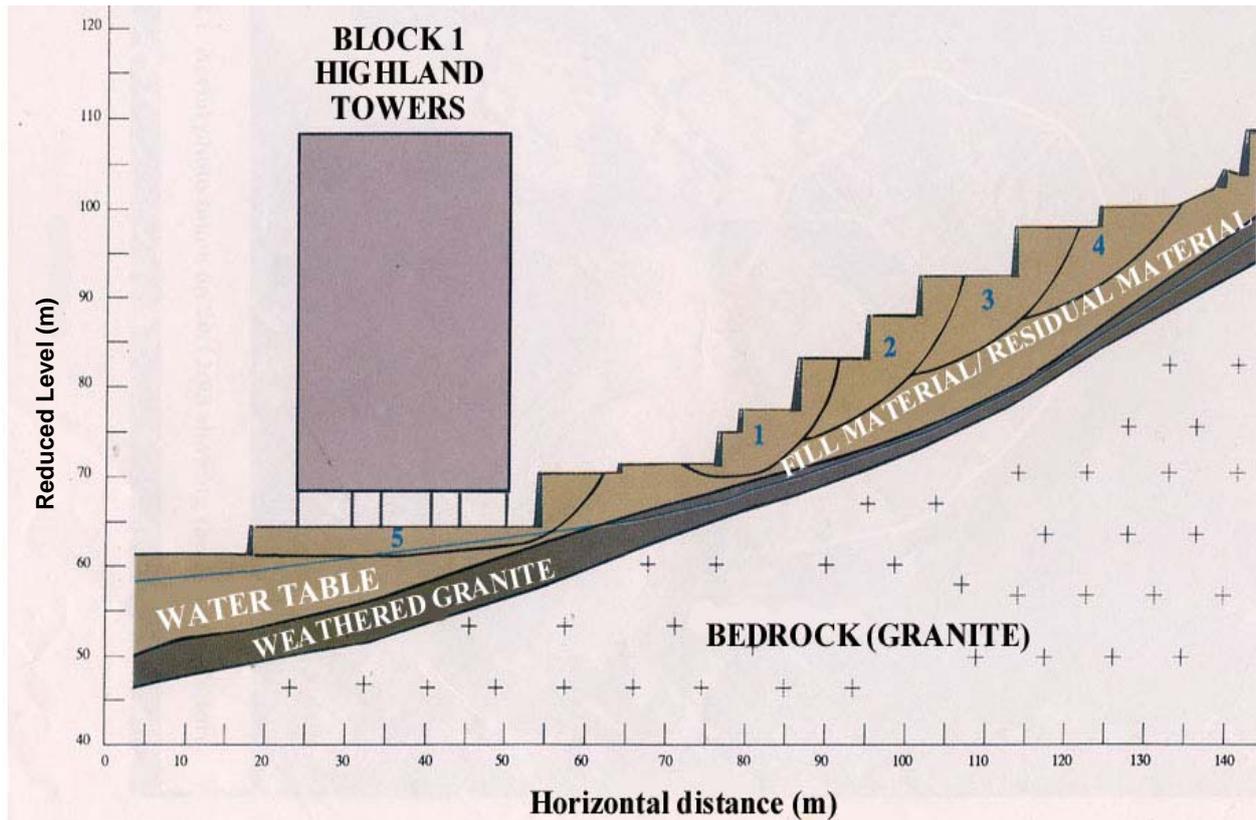
The landslide was triggered by inadequate drainage on the hillslope that had aggravated the surface runoff (MPAJ 1994). Slope and rubble walls behind and in front of Block 1 were also found to be improperly designed with an overall Factor of Safety of less than 1. Figure 2 shows the sequence of retrogressive failures that took place, causing large soil movement and piling up behind Block 1 and causing an increase in lateral pressure to the foundation of the building and the rubble wall in front of the Block until it collapsed and was followed by the toppling of the apartment. Figure 3 shows the collapse of Block 1 of the Highland Tower Apartments.

**Figure 2: Illustration of Retrogressive Slope Failure Sequence (after Gue & Tan 2002)**

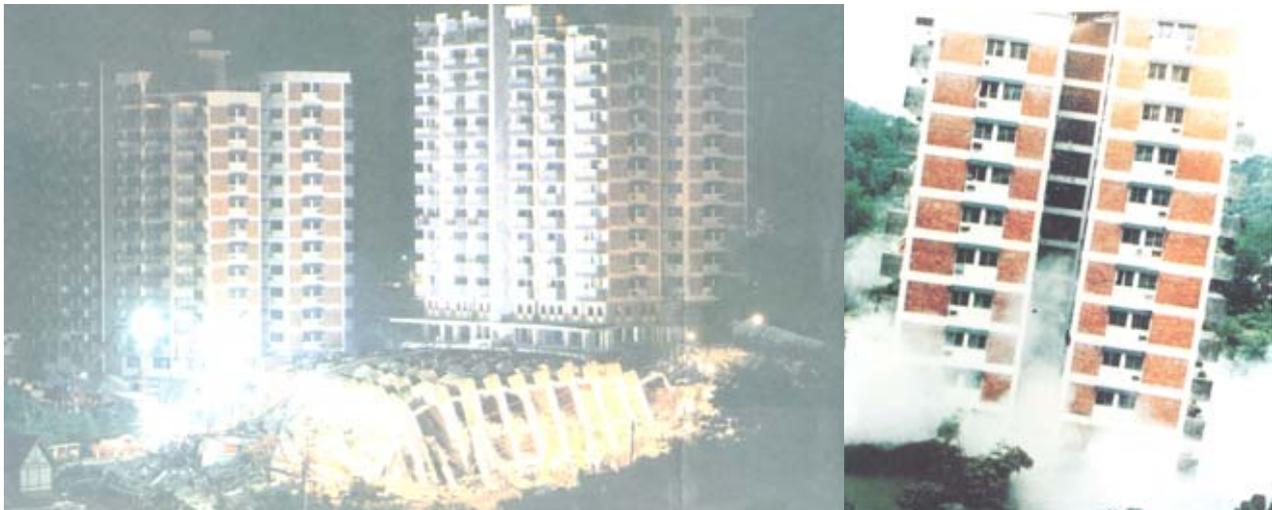
On Saturday, 11 Dec 1993, at about 1.30p.m., after 10 days of continuous rainfall, Block 1 collapsed and killed 48 people. The cumulative daily rainfall intensity measured from 1<sup>st</sup> to 10<sup>th</sup> December 1993 recorded at JPS Ampang was 177.5mm and the measured maximum daily rainfall intensity was 59.5mm. It was not exceptional rainfall as compared to previous measured rainfall intensity.

**Figure 3: Collapse of Block 1 of Highland Towers Apartments, 1993**

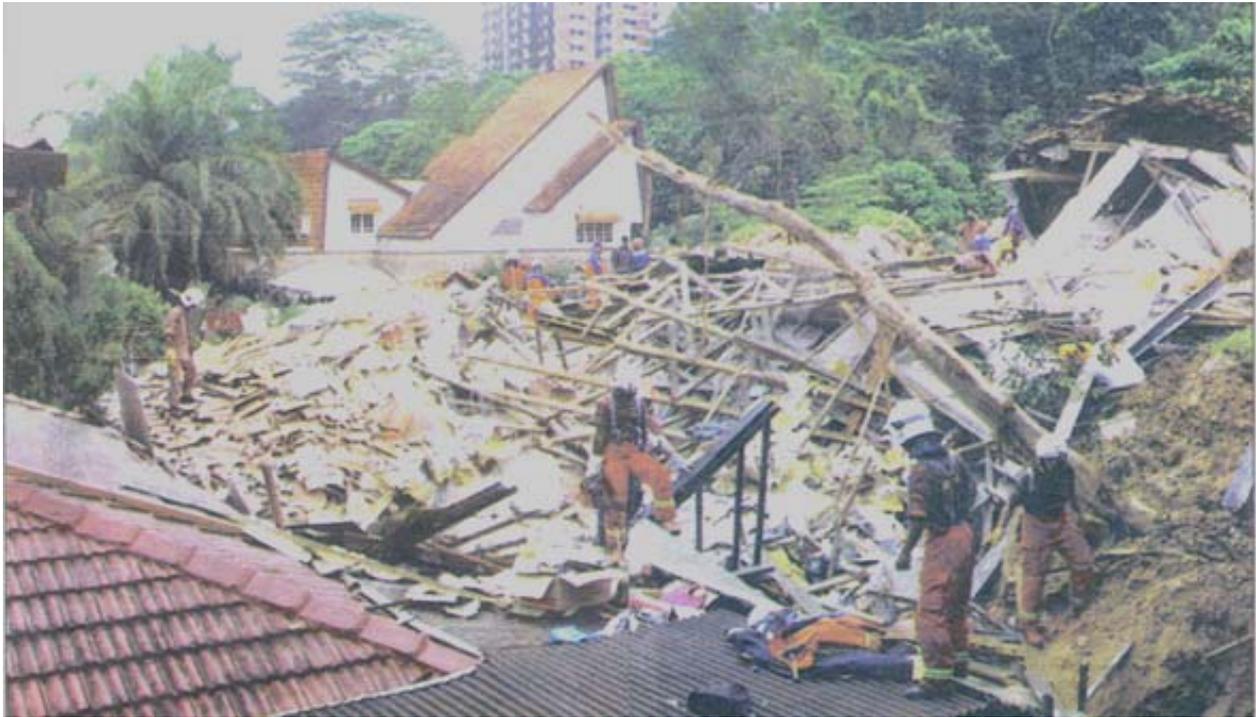
The collapse of a double storey bungalow at Taman Hillview in Ampang (Figure 4) occurred on 20 Nov 2002 and claimed 8 lives. The cause of landslide at Taman Hillview was similar to the Highland Towers tragedy, where failure of a rubble wall again triggered a landslide. The Factor of Safety of the rubble wall in the Highland Towers was found to be less than 1.0 even without

**Figure 4: Collapsed Bungalow at Taman Hillview in Ampang, 2003**

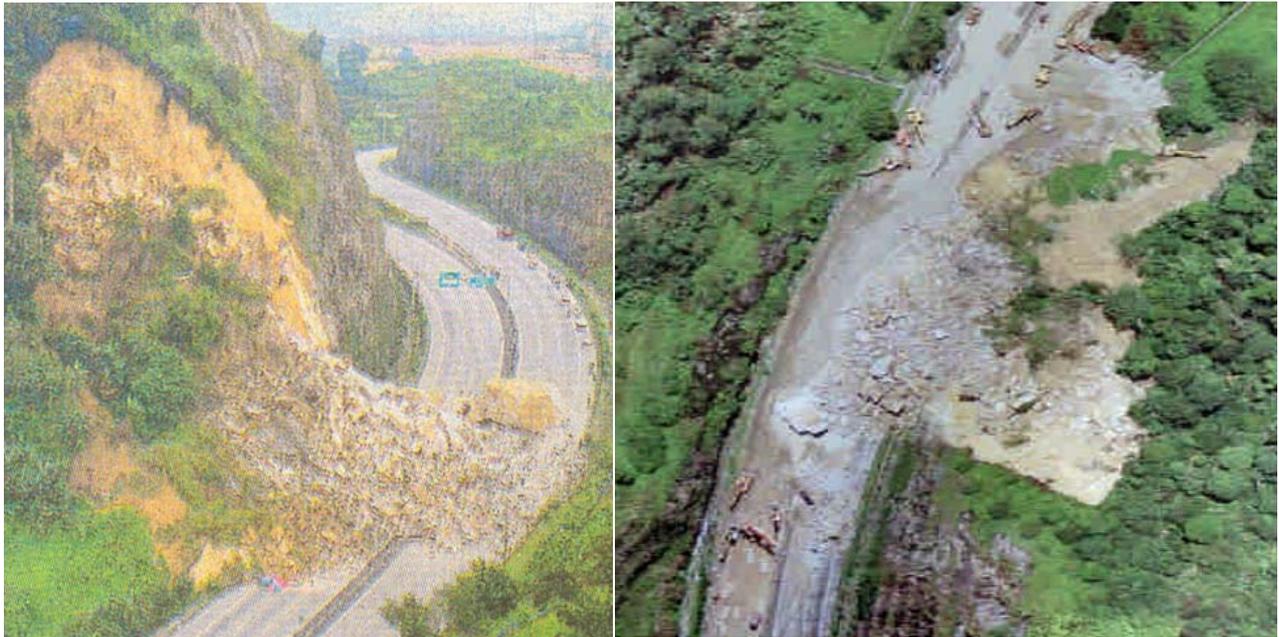
On 26 Nov 2003, a massive rock slope failure occurred at Bukit Lanjan Interchange which is part of the New Klang Valley Expressway (Mohd. Asbi et al. 2007). The failure occurred immediately after a period of heavy rainfall. The substantial large volume of rock debris (approx.  $35,000\text{m}^3$ ) that came to rest on the expressway blocked the expressway completely and forced the entire stretch of the expressway to be closed for 6 months for rehabilitation works (Figure 5). Immediately after the failure, the Highway Concessionaire commissioned site investigations that included surveys, geological mapping, deep boreholes and laboratory tests to assess the likely causes of failure and also to provide geotechnical information required to design for rehabilitation of the failed slope. From the site investigation results, it was inferred that the rock slope failure was a complex wedge type failure. The wedge was formed by two discontinuities that daylighted out of the slope and the third discontinuity acted as a release plane. It was also demonstrated that for the failure to occur there was a requirement for water pressure to be acting on the potentially unstable wedge. Figure 5 shows the elevation and plan view of the failed rock slope.

**Figure 5: Rock Slope Failure at Bukit Lanjan, 2003 (newspaper cutting, New Straits Times)**

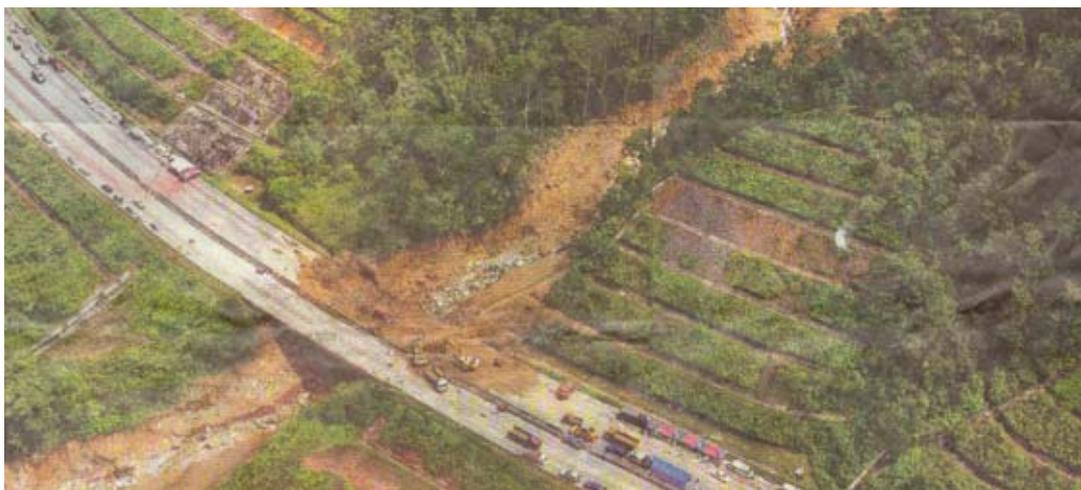
Two lanes for southbound traffic bridge of KM302, North–South Expressway near Gua Tempurung were closed for three months for rehabilitation works as the result of a debris flow that occurred on 12 Oct 2004. Tonnes of earth, boulders and trees went crashing down the hill slope in this incident, as illustrated in Figure 6. Three beams of the bridge were damaged and had to be replaced. This incident also caused one casualty, public and economic losses and a great inconvenience to the public.

**Figure 6: Debris Flow at KM 302 of PLUS Expressway, 2004 (newspaper cutting, Nanyang Siang Pau)**

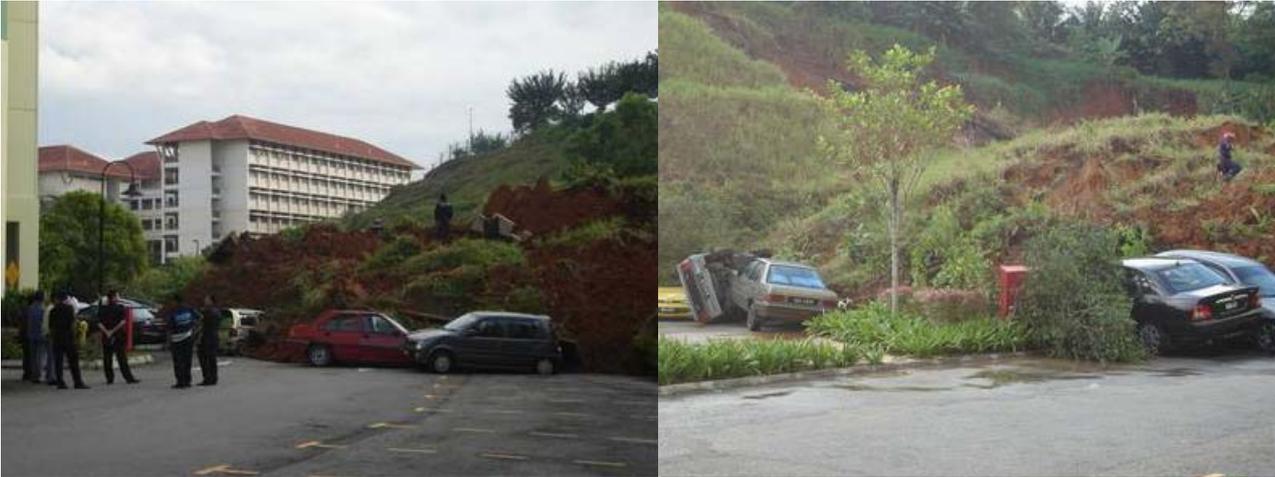
On 22<sup>nd</sup> March 2007, a massive slope failure occurred at Precinct 9, Putrajaya which twenty-three vehicles were buried in this landslide and forced about 1,000 residents to vacate their homes at 4.30am. This slope failure involved a 50-metre high hill with a man-made slope about 45 degrees which was located about 10 metres from the 15-storey apartment. It had been raining heavily in Putrajaya since the evening of 21 March 2007 till the early morning of 22 March 2007 before the slope failure happened. Figure 7 shows the collapsed slope with buried vehicles.

**Figure 7: Slope Failure at Precinct 9, Putrajaya, 2007**

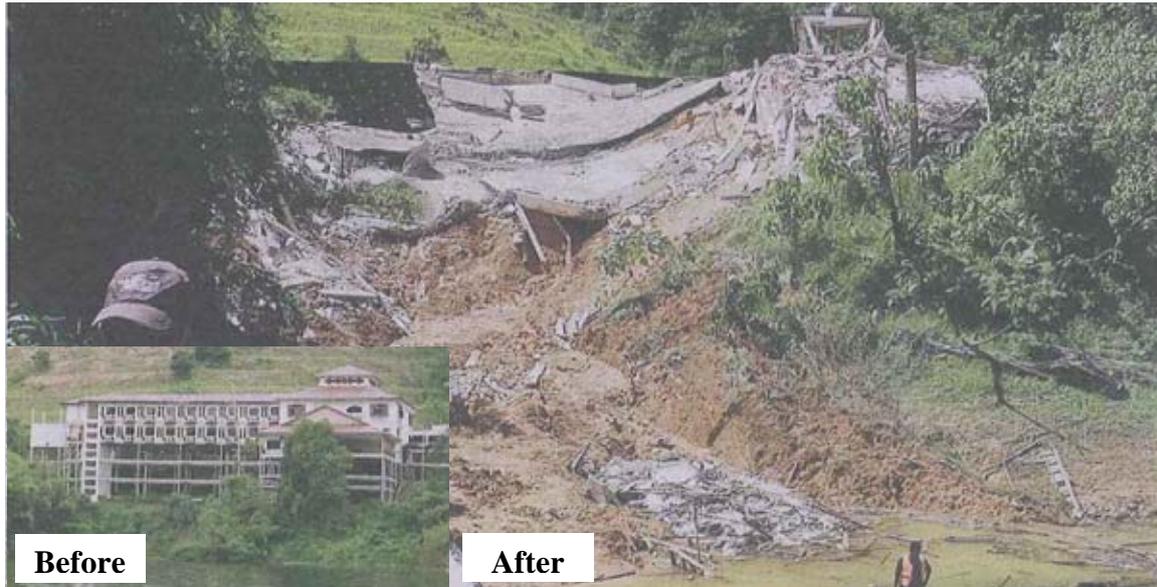
The slope extended down into the lake where the water level fluctuates to about 4 meters without toe protection in the area of fluctuation. The building was completed in 2004. The 15-room resort was not occupied, as defects such as cracks were found in the buildings. It was reported that a few months before the failure, a few piles beneath the columns of the building were found exposed and deflected. On 10<sup>th</sup> November 2007, part of the building collapsed, followed by a total collapse of the whole building on 13<sup>th</sup> November 2007.

**Figure 8: Collapse of Tourism Complex in Pulau Banding, 2007 (The Star, 15 Nov 2007)**

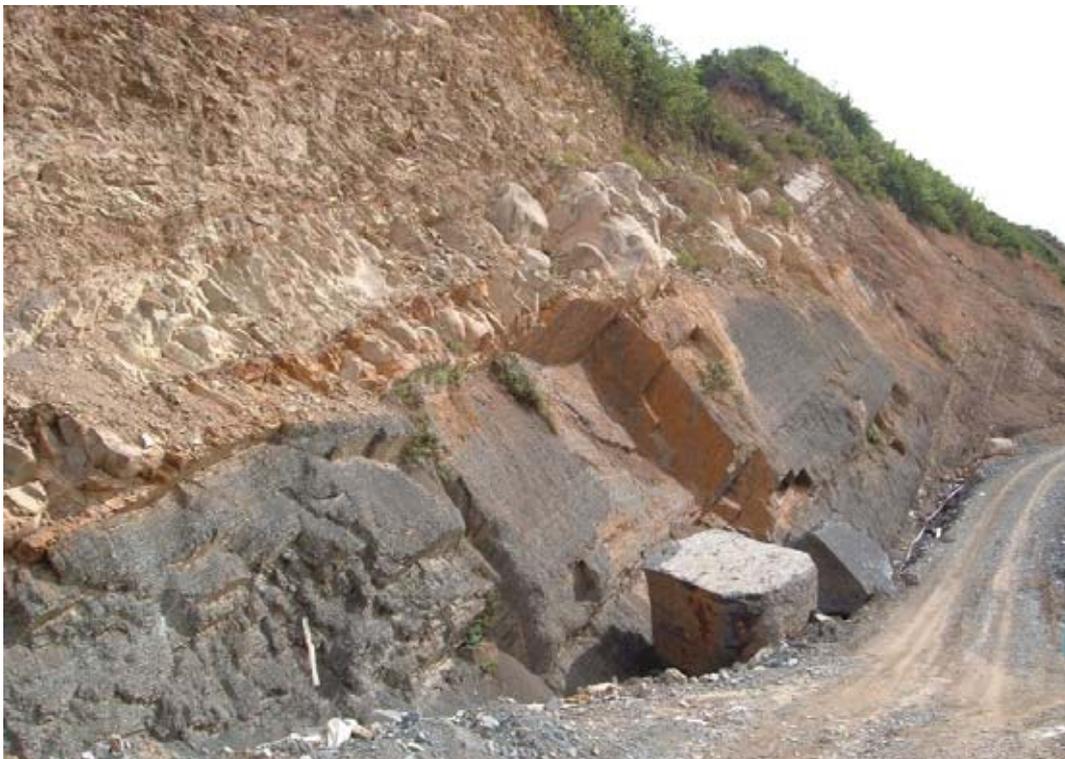
**Figure 9: Block Failure of Sedimentary Formation (After Liew S.S. 2005)**

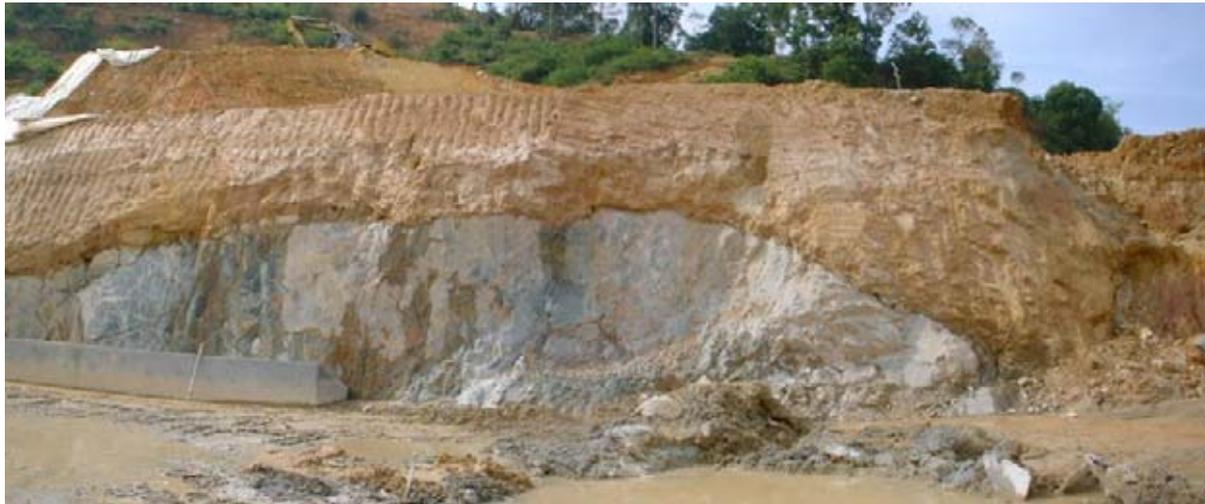
**Figure 10: Inconsistent Weathering Profile (After Liew S.S. 2005)**

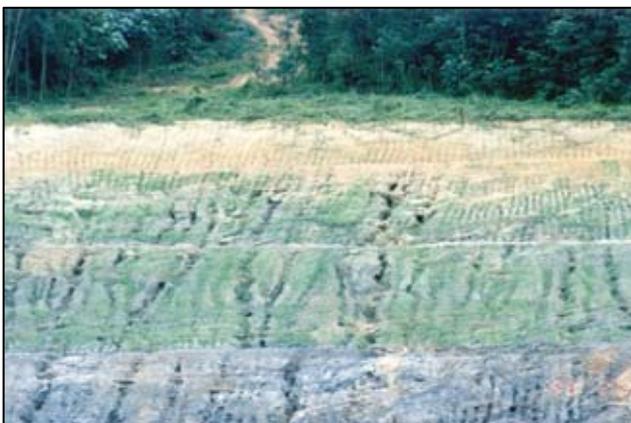
Figure 11 shows the formation of rills and gullies and Figure 12 shows localized landslips caused by erosion which will propagate with time into landslides if erosion control is ignored. If proper maintenance is carried out, then all these small defects would have been rectified and landslides caused by erosion would be prevented.

**Figure 11: Formation of Rills and Gullies  
(after Gue & Tan 2004)**

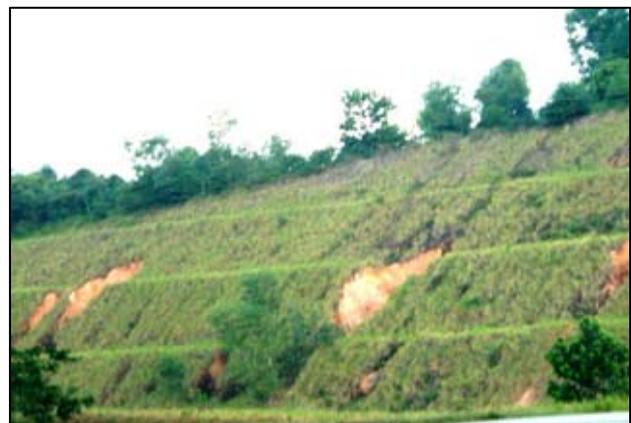
**Figure 12: Localized landslips  
(after Gue & Tan 2004)**

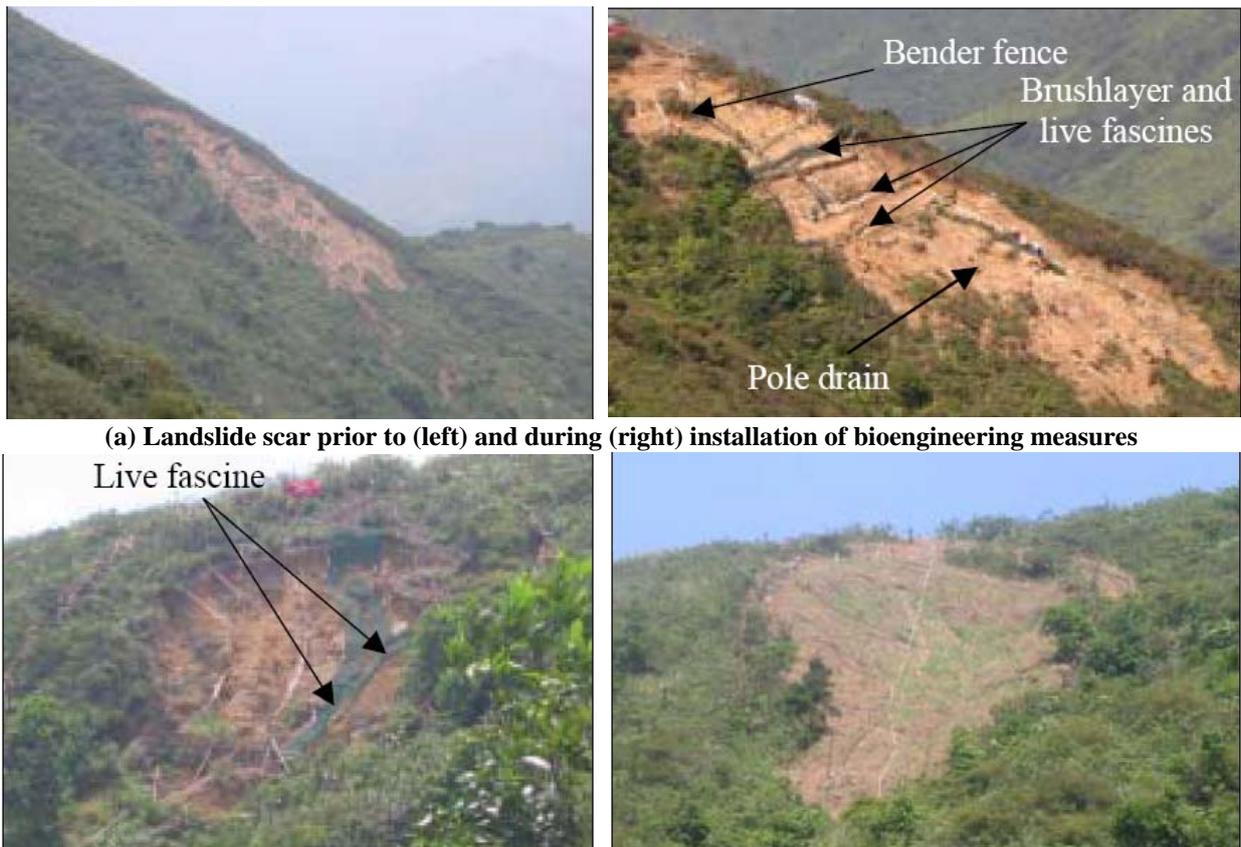
**Figure 13: Use of Bioengineering Measures for Repair of Natural Terrain Landslides (after Wong & Ho 2006)**

In 2003, the Hong Kong GEO completed a planting trial involving the use of native small tree and shrub species on steep slopes. Based on this, guidelines were promulgated on the selection of suitable vegetation species for man-made slopes. Trials were also initiated on repairing natural terrain landslide scars by means of predominantly native vegetation species (Figure 13). The interim findings are documented by Campbell et al. (2005).
