LESSONS LEARNED FROM TWO INVESTIGATION CASES OF GROUND DISTRESSES DUE TO DEEP EXCAVATION IN FILLED GROUND

Shaw-Shong, Liew
G&P Geotechnics Sdn Bhd
Kuala Lumpur, Malaysia

Chee-Min, Khoo
G&P Geotechnics Sdn Bhd
Kuala Lumpur, Malaysia

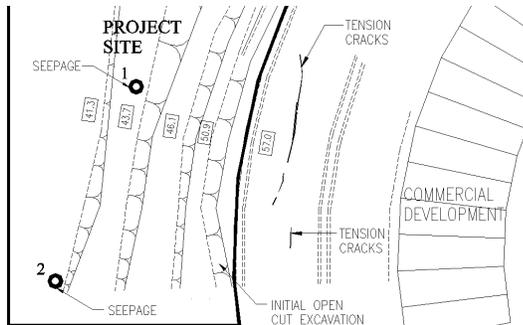
A site inspection was carried out by the project team shortly after observing the tension cracks on the road pavement. The semi-circular crack pattern was generally observed on the top of the excavated slope as shown in Fig. 3. Water seepage at two locations were also observed, indicating high groundwater levels within the filled slope (see Fig. 4). At the time of investigation, the excavation at the southern portion of the site was in a more advanced stage. It was not surprising that more ground movements were occurring behind the excavation where the tension cracks were firstly observed.

Fig. 3. Tension cracks at earlier stage.

For remedial and stabilisation works, the primary objective is to improve the safety factor of slopes to an acceptable design requirement. Soil nails with gunite surface was proposed to provide overall stabilisation and lateral support to the excavation for basement construction. The soil nail stabilisation works were designed to cater for a maximum retained height of 14.5m by reinforcing the in-situ saturated loose fill with closely spaced soil nails of varying lengths from 6m to 12m and structural gunite facing with sufficient weepholes/subsoil drains. The soil nailed slope was formed at steep angles of 4V:1H and the nails were installed at horizontal and vertical spacings of 1.25m centre to centre.

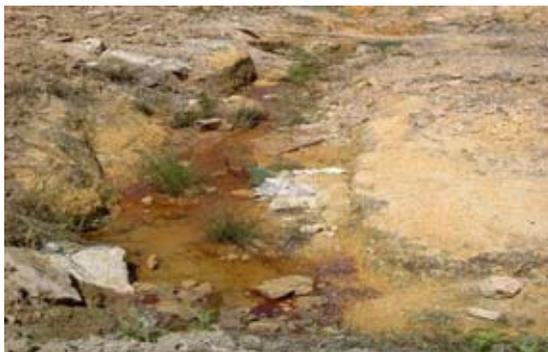
Fig. 4. Seepage (Location 1).

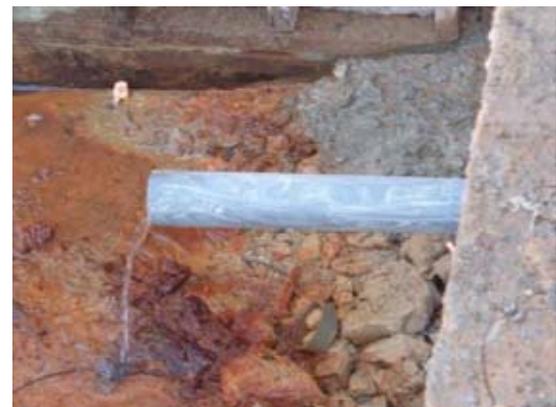
In one location, groundwater was observed continuously flowing out immediately after excavation. This particular location was believed to be the natural water path of the stream as revealed in the pre-development ground contour. Sufficient horizontal drains were installed at this location to release the perched groundwater. Figure 9 shows the water continuously discharging from horizontal drain after installation.

Fig. 9. Continuous seepage flow.

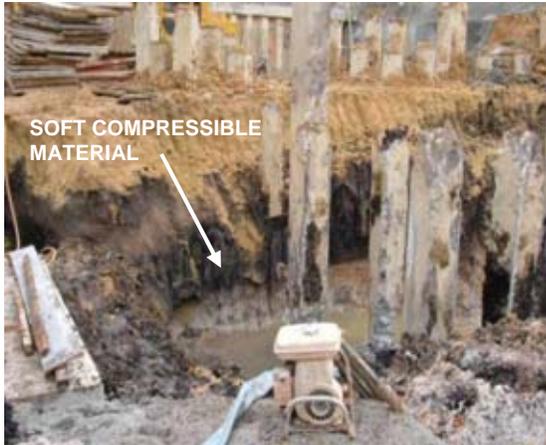
When excavation nearly reached the final excavation level, additional field testing such as Mackintosh probing and in-situ penetrating vane shear tests were conducted at the expected soft compressible layer to verify the soil parameters adopted in the remedial design. The localized excavation for pile cap construction further confirmed the existence of this soft deposited material as shown in Fig. 10.

Fig. 10. Soft compressible material detected at localized pile cap excavation.

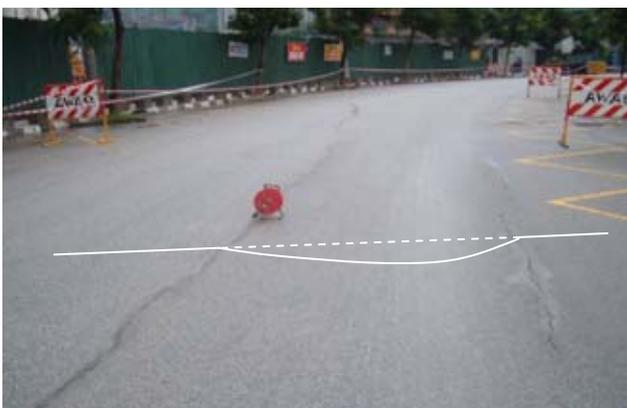
Subsidence troughs developed on the retained ground surface has been observed from the FE back-analysis results (see Fig. 14). The results show that surface subsidence is generally expected at a distance of 8m from the excavated face, which tallies extremely well with the site conditions as demonstrated in Fig. 15. The location of the trough is just immediately behind the end of the soil nail where a relatively large shear strain is developed along the potential slip surface behind the reinforced soil mass. This is fairly close to the formation of an active wedge in the retaining wall design. Two major tension cracks signify the extent of the developed active wedge behind the reinforced slope mass.

Fig. 15. Subsidence trough developed on the retained ground.

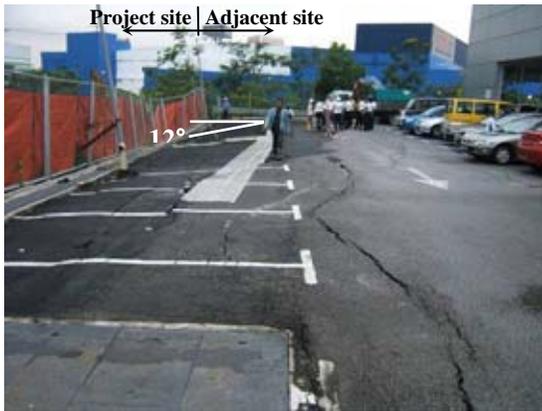
It was observed that continuous tension cracks appeared at varying distance away along the sheet pile wall of approximately 73m long. The tension cracks were more distant from the sheet pile wall at the southern end and become closer to the sheet pile walls toward northern end. At the time of inspection, more extensive excavation was carried out at the southern portion than the northern portion. The backyard car park platform of the adjacent lot had shown signs of subsidence and tension cracks as shown in Fig. 21 and 22.

Fig. 21. Site conditions of adjacent lot after the incidence of wall and ground distresses (Southern view).

The immediate remedial measure was to temporarily backfill the excavation adjoining the distressed area to the top of CBP wall with temporary stabilising berm (1V:1H). A variety of permanent remedial options have been explored. Finally, internal strutting against permanent basement structures was adopted to provide a safe and cost effective solution.

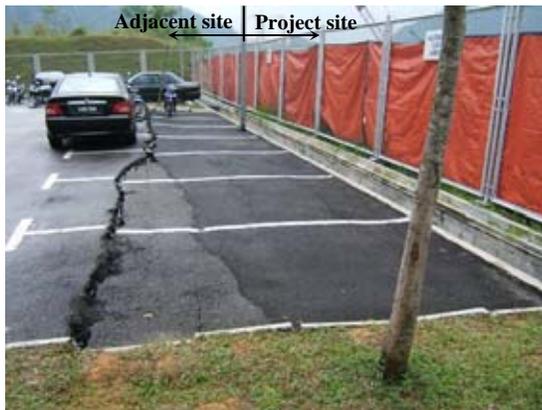
Fig. 22. Site conditions of adjacent lot after the incidence of wall and ground distresses (Northern view).

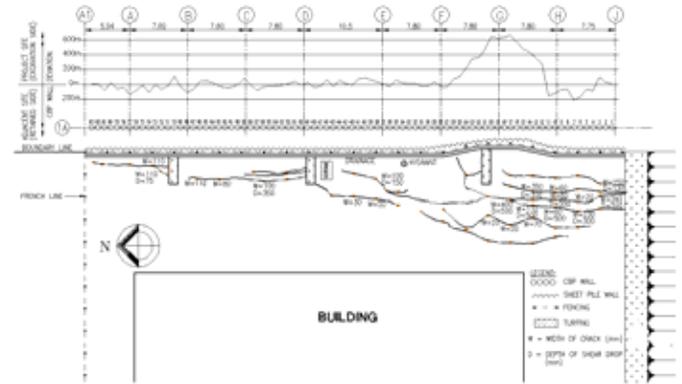
Fig. 23. Crack mapping layout.

Site mapping had been carried out on the observed tension cracks and tilted sheet pile wall. Much more tension cracks were observed at the southern region. In this particular location, the sheet pile wall was seriously deviated outward relatively to the designed wall alignment. Efforts were made to map the crack lines by using measuring tape and slope meter. Figure 23 shows the details of mapped tension cracks.

Generally, the tension cracks were measured up to 400mm wide with shear drops between the two dislodged earth blocks. At the critical location (Gridline G), the major crack line was measured at approximately 6.2m from the original fence line. While, the furthest crack line was measured at approximately 12m from the original fence line. In addition, the overall tilt angle of subsided platform at this area was crudely measured to be about 12° as shown in Fig. 21. Sheet pile wall had also moved outward about maximum 1.2m from the designed wall alignment (at Gridline G). On the other hand, the measured pile top deviation of contiguous bored pile wall is also shown in Fig. 23.

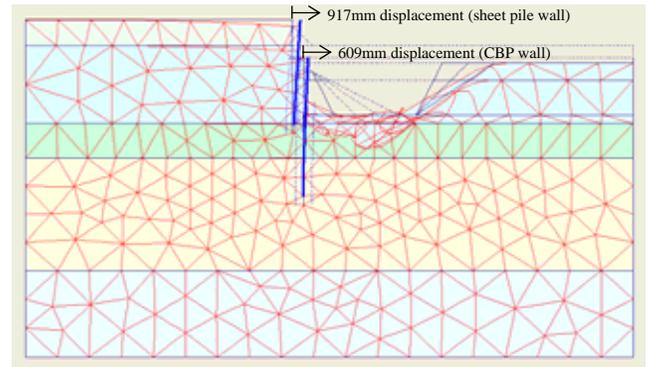
Fig. 26. Results of finite element analysis.

At one analysis stage where over-excavation in front of the wall was carried out, the analysis results revealed that the retained earth platform displaced excessively in the horizontal (settlement) directions with the temporary sheet pile retaining wall moving forward. As part of the lateral resistance to the temporary retaining walls by the passive berm was removed before installation of raking strut, over-excavation of this berm had reduced the lateral resistance to the sheet pile wall and subsequently mobilises the resulting strength of the retaining walls from serviceability state condition towards the ultimate limit state condition. The excessively displaced temporary sheet pile wall had induced additional lateral force to the installed contiguous bored piles (CBP) walls. The high induced flexural stress unavoidably damaged the CBP pile and led to excessive ground distresses. The results of FE analyses (see Fig. 26) reasonably well agreed with the measured wall movements and ground deformations (e.g. tension cracks, settlement and depression).
