Failure Investigation of Crib Wall, Piled Reinforced Concrete Wall And Geosynthetic Reinforced Soil Wall

Liew Shaw-Shong¹, Lee Peir-Tien² and Lim Fang-Liang³

¹Director, G&P Geotechnics Sdn Bhd, Kuala Lumpur, Malaysia

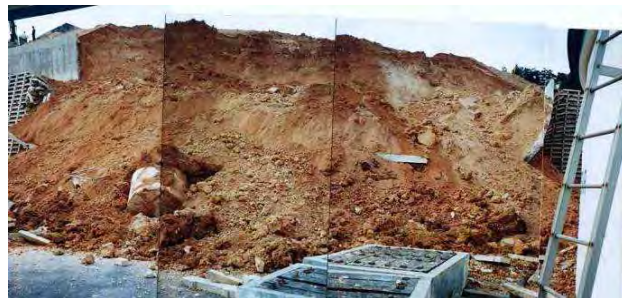
Figure 1 Collapsed Crib Wall and Piled RC Wall

- The FOS against sliding on the crib wall without considering groundwater table is marginally lower than 1.0. When groundwater is at 1/3 of the wall height, the sliding resistance of the crib wall is even lower. Therefore, the collapse of the cribwall was most probably triggered by the rise of groundwater table behind the wall backfill. This can be evidenced by the rainfall record as shown in Figure 6, which indicated high volume of antecedent rainfall before the collapse. The impact of antecedent rainfall will cause gradual rise of groundwater table reducing the wall stability.

- In view of insufficient FOS of the cribwall against sliding, the collapse of the crib wall likely occurred prior to the RC wall, in which the ribs of the crib wall were found at the front portion of the collapsed debris.

- Construct a 10m high reinforced soil (RS) wall after the debris removal of the collapsed cribwall.
- Provision of subsoil drainage behind the reinforced soil wall to prevent built up of water pressure within the retaining wall.
- The building platform is re-profiled to a lower platform level to reduce the RC wall height and the RC wall is designed directly founded on the retained backfill of RS wall instead of pile foundation.

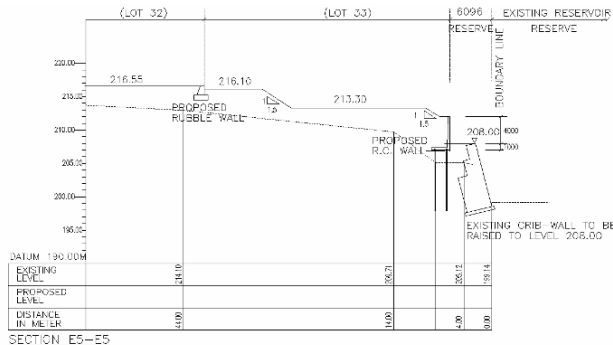
Figure 4 Earthwork Section of Collapsed Retaining Wall

- FOS on overturning stability, bearing failure and overall stability for both types of retaining wall are less than the required values especially when groundwater table is at 1/3 of the wall height. However, the FOS is greater than 1.0 indicating that the crib wall and piled RC wall shall not fail in overturning, bearing failure and overall stability.

- RC wall supported by pile foundation (vertical piles) is ineffective in taking lateral load. This is because overburden pressure from the wall backfill will be transferred directly to the pile foundation as the pile element is much stiffer than the soil underneath the wall base preventing development of the base contact resistance. As a result, the soil beneath the wall base would not experience much build up of overburden pressure from the backfilling of retaining wall until the piles had failed. Therefore, the lateral resistance offered at the wall base to soil contact is insignificant. This concurs with the findings published in a paper by Liew (2007).

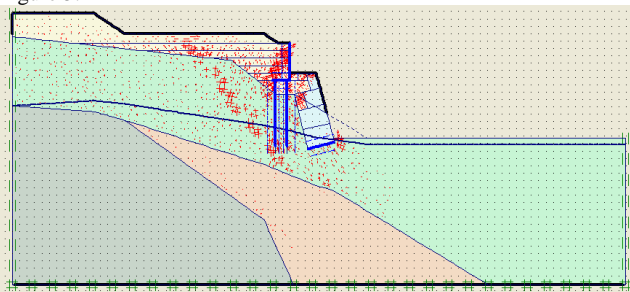
Figure 5 FEM analysis result

The analysis results reveal that the maximum movement of the retaining structures is about 95mm and the FOS obtained from strength reduction analysis against limit equilibrium is about 1.17.

Therefore, both the limit equilibrium and finite element analysis reveal that the marginal FOS for the retaining structures constructed at site is apparently inadequate.

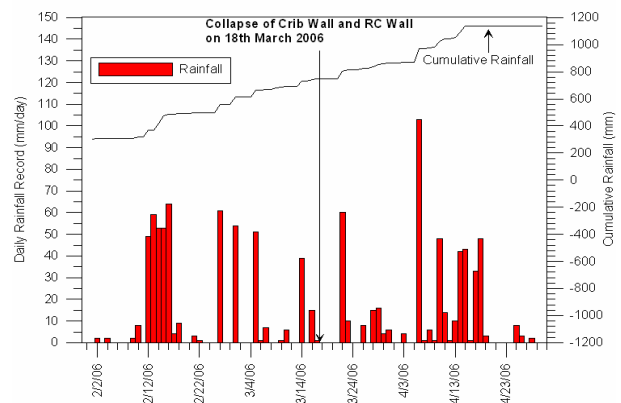
Figure 6 Rainfall Data

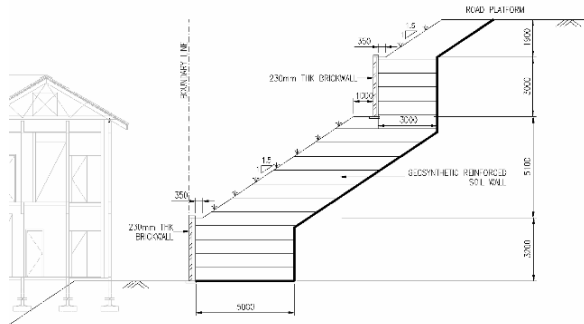
Figure 7 Earthwork Section of Geosynthetic RS wall

- The external stability (overturning, sliding and bearing capacity) and internal stability of the geosynthetic RS wall are adequate.
- Both the limit equilibrium and finite element analyses results revealed that the FOS against global stability are marginally inadequate, with the FOS against global stability of about 1.30, which is less than the required FOS of 1.4.

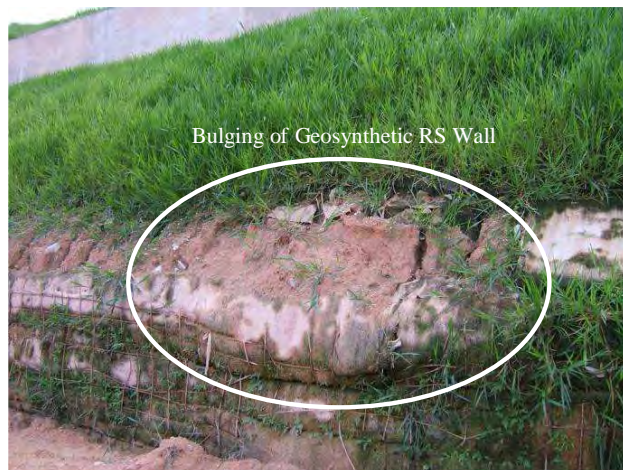
Figure 8 Bulging of Geosynthetic RS wall

- Bulging and outward movements of the geosynthetic RS wall at the lowest berm were observed as shown in Figure 8. The bulged wall alignment had encroached into the property boundary. In addition, it was also observed from site inspection that the wall surface was very wet.

- Although lower FOS does not imply that the geosynthetic RS wall and slope will fail, large creeping movement of the wall and slope could be expected, which may exceed the serviceability limit and certainly can not be captured by the limit equilibrium analyses. The finite element analysis had actually shown large movement of the geosynthetic RS wall.

- Install 10 rows of soil nail with various lengths ranging from 6 to 12m to strengthen the batter slope. The batter slope was then protected by a layer of shotcrete.
- Subsequently, trimming of the bulged geosynthetic RS wall by removing the excessive soil and re-wrapping of the geotextile.
- Constructing a 4m high RC wall by casting the concrete against the geosynthetic RS wall to retain the soil and batter slope.
- Provision of proper drainage system including subsoil drains and berm drains.

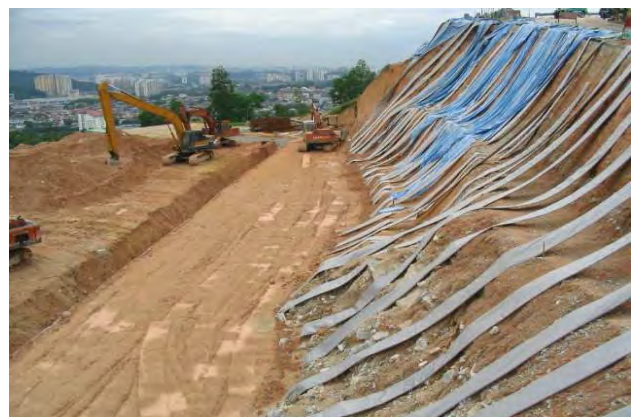
- A layer of strip drain was laid on the collapsed temporary cut slope prior to the construction of geosynthetic RS wall as shown in Figure 10.
- The backfill materials for the geosynthetic RS wall consist of high moisture content as shown in Figure 11.

Figure 10 Laying of Strip Drain

- The finite element analysis also revealed that the use of closely spaced strip drain behind the geosynthetic RS wall and batter slope will promote tendency of developing preferential slip surface and induce further instability to the geosynthetic RS wall and slope, thus lowering the FOS. This is due to the reason that the interface friction between the strip drain and soil is lower than internal friction between soil particles.

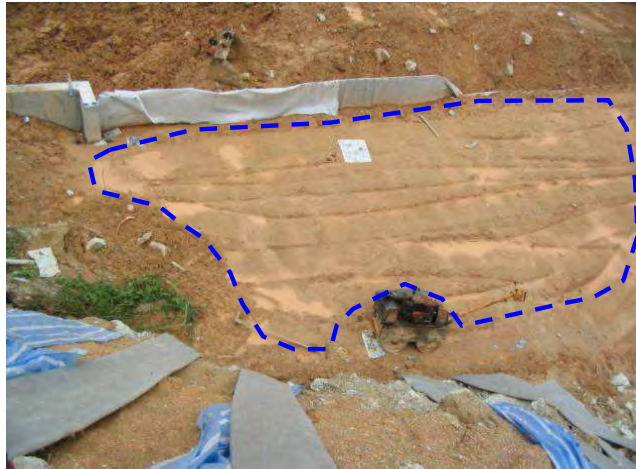
Figure 11 Wet Backfill Material

- The rainy weather continued to prevail during the construction of the geosynthetic RS wall and batter slope. Therefore, it can be reasonably expected that the compaction to achieve the required compaction effort was difficult due to high moisture content of the fill material.
