Failure Investigation of Piled Reinforcement Soil Wall & Excessive Movements of Piled Embankment at Soft Ground, Malaysia

ABSTRACT: This paper presents two case histories covering a collapsed piled supported reinforced soil wall at weak deposits under extreme weather condition and another case of excessive movement of piled road embankment approaches affecting the bridge abutments. The first case history demonstrates an ultimate limit state condition under the most unfavorable meteorological events of which the failure was expected and justified from the design review, whereas the second case shows the problem of the consolidation settlement of working platform resulting free standing condition of the embankment piles with high lateral loading from the non-pile supported approach earth embankment of lower height. Both cases involve the reaching of ultimate lateral pile resistance of the supported structure. Sequence of events established from investigation evidences leading to the failure are illustrated in the paper and remedial solutions are also presented.

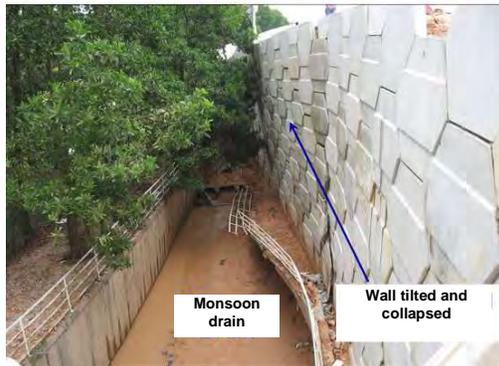
- b. Wet wall panels and traces of watermarks were observed implying evidence of seeping water through the panel joints. The highest level of observed seeping watermarks was at the top of the RS wall indicating high water level behind the wall panels as shown in Figures 4 and 5.
- c. The base slab was still well attached to the laterally translated RS wall. As shown in Figure 6, the upper part of the exposed piles had suffered flexural hinge damage at both the pile head and 1.8m below the slab soffit probably under excessive lateral loading resulting in lateral translation and rotation of piles towards the monsoon drains.

Figure 4 Side view of the collapsed combined wall

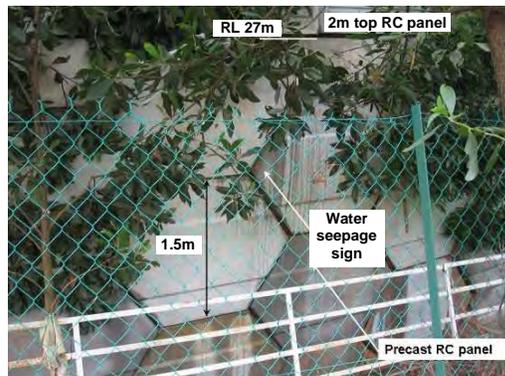
Figure 5 Observed watermarks on wet wall panels

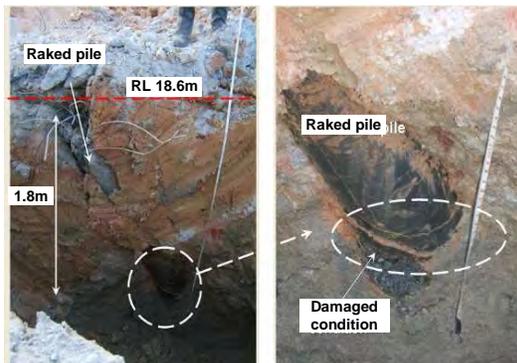
Figure 6 Damaged foundation piles

- a. The foundation pile design, at service groundwater condition, had achieved optimum design requirements with adequate safety factors.
- b. Rise of water table to RL25m after prolonged antecedent rainfall and follow by a triggering rainfall induced excessive lateral force on the foundation piles supporting the combined walls, in which the ultimate limit condition was reached.
- c. Excessive imposed lateral stress exceeded the ultimate lateral resistance of the foundation piles resulting in the collapse of central portion (CH40-CH70) of the combined wall and pulling the adjoining wall from both ends.

- a. Dismantle the collapsed combined wall and demolish the original RC slab,
- b. Replace the disturbed weak foundation soils with crusher run,
- c. Install 6 rows of new offset raked and vertical foundation piles,

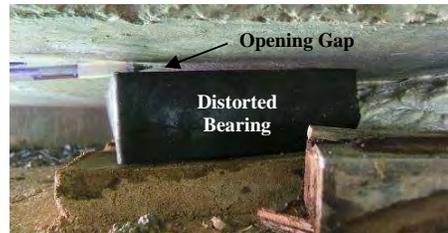
- First failure occurred at the PVD treated area immediately next to the piled approached embankment after the embankment fill was completed 6 days later.
- Subsequently, development of tension cracks leading to sudden collapse of embankment fill was reported at the EVD treated area and the adjoining piled embankment after reaching 5m fill height.
- Thereafter, spalling of concrete and gap opening at the bridge deck near Abutment B were observed.
- After the failure of EVD embankment and piled embankment, most electrometric rubber bearings at Abutments A and B suffered observable shearing deformation as shown in Figure 9.
- From the bridge bearing distortion at abutments and piers, it was confirmed that there was clockwise rotation on plan and

Figure 9 Shearing distortion of rubber bearing

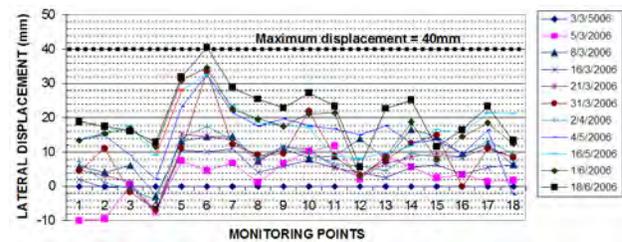
global lateral movement of the bridge deck in the direction from Abutment B towards Abutment A. Bridge movement monitoring layout in Figure 10 revealed maximum bridge movement of 40mm in longitudinal direction as show in Figure 11. However, movement of the bridge before commissioning the monitoring works was not registered.

Figure 11 Movements in the longitudinal direction

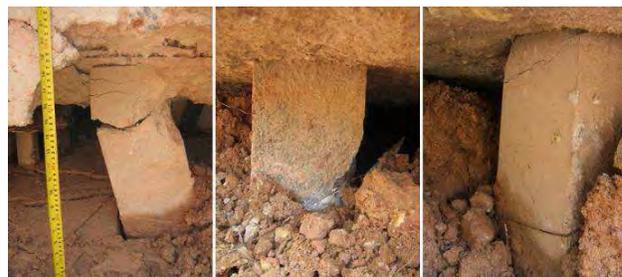
- As shown in Figure 12, the filled piling platform has settled about 400 to 1000mm in magnitude beneath the piled RC slab and flexural cracks were observed at numbers of free standing piles at the piled embankments.
- Slab of piled embankment was damaged and the slab movement led to 100mm gap at joints of the slab.

Figure 12 Settlement of piling platform and flexural damage of embankment foundation piles

For the remedial design, it was crucial to simultaneously remove the active lateral earth pressure behind both abutments to avoid unbalanced lateral loading and replace with geotextile reinforced backfill preventing lateral load from imposing to the abutments. The embankment removal and reconstruction were closely monitored using the movement markers. As for the distressed pile embankment structure, it was suggested to demolish and reinstall with new piles and RC slab for the embankment height exceeding 2.5m.

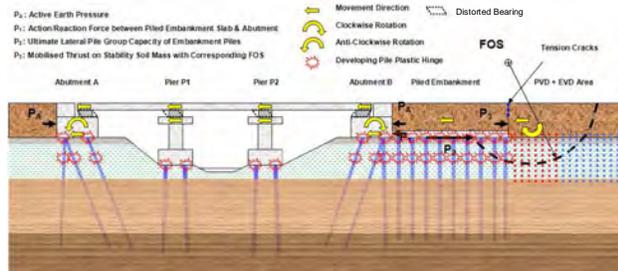
embankment could have also imposed excessive flexural stress to the RC piles. The net horizontal thrust after deducting the lateral resistance of the group piles beneath the embankment then pushed Abutment B, bridge decks and Abutment A. The bearing distortion shape agrees well of the load path traversing from the Abutment B through bridge decks and the piers and finally reaching Abutment A. A schematic diagram of such scenario is shown in Figure 13.

Figure 13 Schematic bridge movements

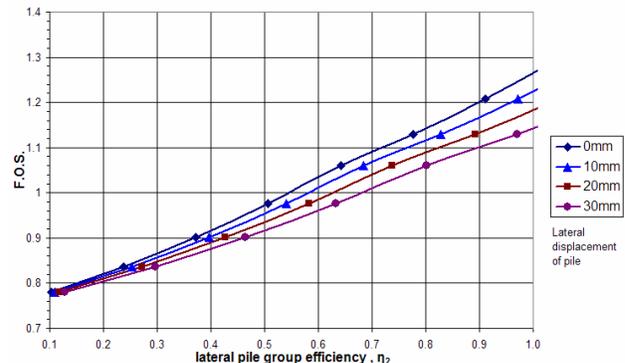
Assuming both abutment piles and piled embankment foundation piles had reached the ultimate pile group capacity, the safety factor of the embankment stability in longitudinal direction is at best 1.14 to 1.26 depending on the pile eccentricity due to lateral displacement. Creeping foundation movements due to occurrence of plastic deformation of underlying weak subsoil will cause unacceptable serviceability conditions of piles and gradually undermine the structural integrity of the bridge structure. In fact, the entire system including the bridge, pile embankment and the embankment was at the marginally stable condition with very low safety factor. The summary of the safety factor of the embankment stability at the PVD and EVD treated embankment behind the piled embankment with consideration of the pile eccentricity effect as shown in Figure 13 is presented in Figure 14.

Figure 14 Safety factor of embankment stability with lateral pile group efficiency and pile eccentricity effect
