Investigation of Soil Nailed Slope Distress at Fill Ground & Remedial Solutions

ABSTRACT: This paper presents a case history of a distressed 6m to 10m high soil nailed slope formed for basement excavation at fill ground over a natural valley. Above the soil nailed slope, there is an existing 8m to 11m high reinforced soil wall, located 23m away from the soil nailed slope. During the early stage of excavation for soil nailing works, distresses like ground surface cracking and settlement were observed. Perched groundwater at the natural valley during the heavy monsoon season posed further difficulties to the drilling works and induced instability in the steep excavated face of the fill materials. As such, a well planned instrumentation programme was implemented to monitor the construction safety of the on-going soil nailing works. Remedial solution using permanent steel sheet pile wall with two rows of soil nail anchorages is presented in this paper. The performance of the remedial works through instrumentation results and design verification tests of nailing are presented to illustrate their effectiveness and satisfactory performance even with the adverse rainfall event.

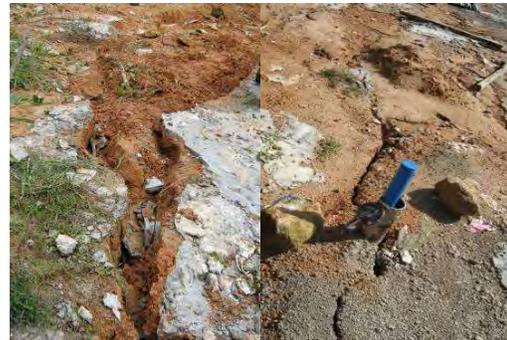
Figure 3 Tension cracks at the crest of the soil nailed slope

Immediate mitigation action was promptly taken at site by constructing a passive berm in front of the slope and seal up the tension cracks using bentonite-cementitious grout slurry to stop infiltration of the surface runoff when the first surface slip failure happened on 1st April 2008. Inclinometer monitoring frequency had been revised to daily basis to closely monitor the distressed slope behaviour and also monitor the daily site activities which might potentially further endanger the slope. Soil nailing contractor was also instructed to rectify the cave-in collapse with sand bricks and cement grouts as dental filling.

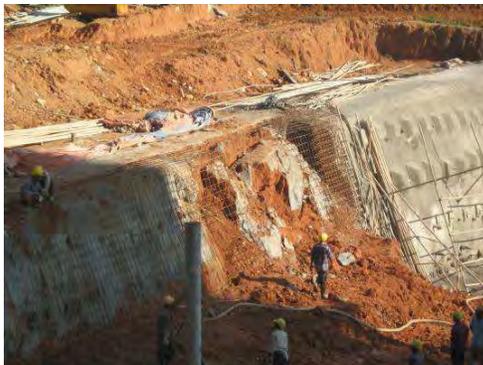
Figure 2 Localised surface slips occurred during soil nailing work

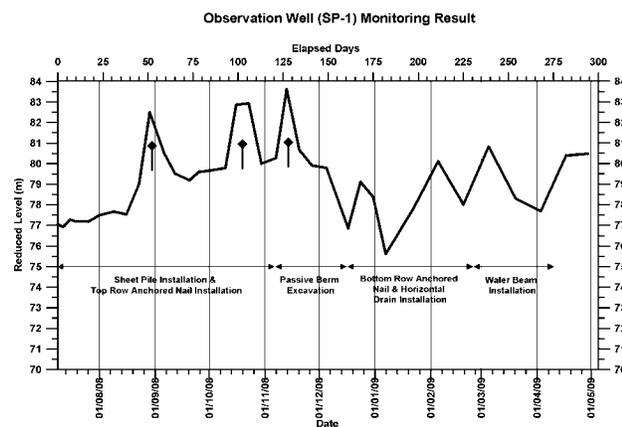
Two observational wells (SP-1 and SP-2) were installed in July 2008 to measure groundwater level on a weekly basis during the period of unexpected prolonged rain storm between March and April 2008 (Figure 6). Monitoring results of SP-1 (Figure 7) located at slope crest showed that groundwater levels changed erratically indicating rain storms during the construction of soil nailed slope especially between August and December 2008. Surface runoff filled up the tension cracks and created perched groundwater. The excavated bare slope was susceptible to shallow surface collapse after saturated by water.

Figure 7 Fluctuation of water level with time

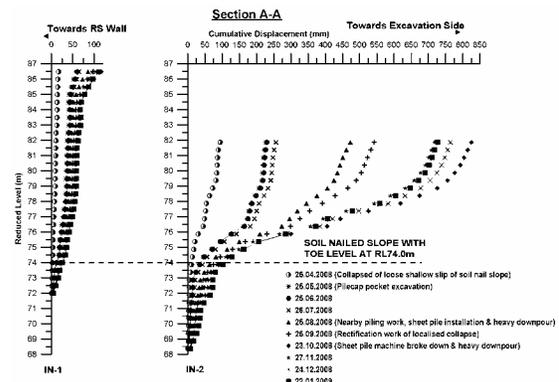
Slope movement was first detected in April 2008. IN-1 and IN-2 indicated lateral creeping of the slope. Site assessment was immediately carried out to investigate the causation of slope creeping. Preliminary suspicion was attributed to the pocket excavation of pilecaps which were located less than 500mm away from the slope toe. Torrential rain further aggravated the slope movement. Perennial surface collapse and tension cracks at slope crest were noticed as the bare cut slope left unattended by the site team and only focusing on rushing the construction of substructure works. Figure 8 and 9 show inclinometers monitoring results (IN-1, IN-2 and IN-5 respectively) corresponding to the various activities triggering the distressed slope to creep laterally. Tension crack mapping was shown in Figure 10 and displacement markers indicated that the distressed slope formed a bowl-shape unstable slope mass.

Figure 8 IN-1 and IN-2 monitoring results at Section A-A

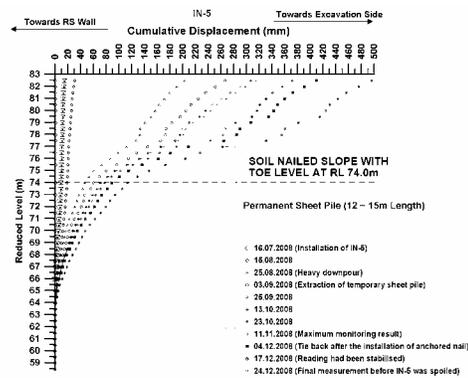
Figure 9 IN-5 Monitoring results

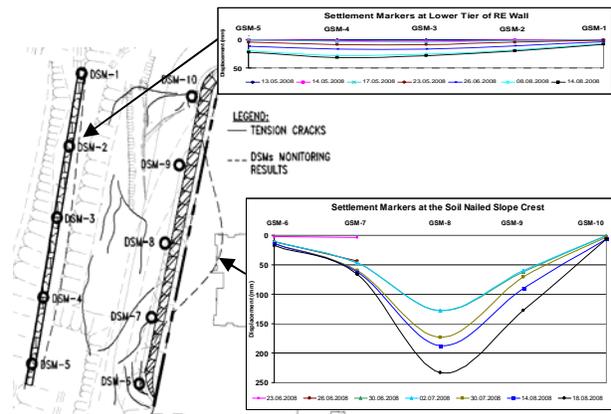
Figure 10 Lateral slope creep movements from DSMs monitoring results and tension cracks

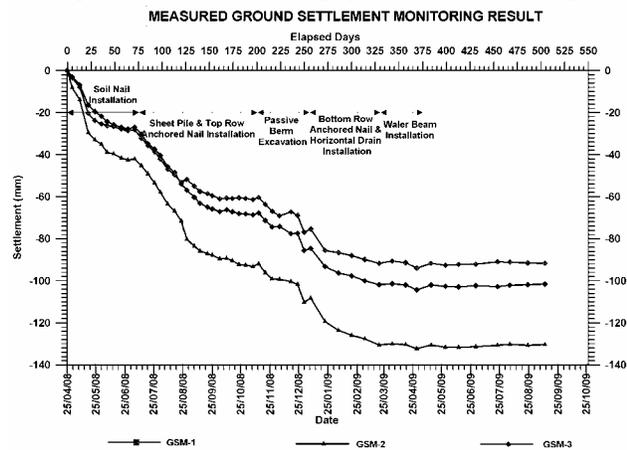
The slope was further disturbed due to the vibration of sheet pile penetration agitating the loose fill. Air flushing in the open-hole drilling using high compressed air by portable spider drilling rig had also been modified by using water flushing technique with protective casing to minimise the soil disturbance in the anchor nails installation. Due diligence was exercised by the contractor in handling the construction at this highly sensitive distressed slope.

Figure 11 Measured ground settlements

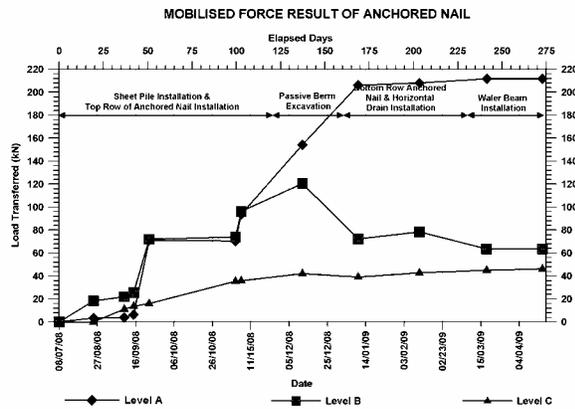
An instrumented anchor nail was installed at the top row of anchored nails to be monitored on fortnightly and monthly basis during the anchored nails installation and further excavation stages. The setting out of vibrating wire strain gauges was shown in Figure 13 and the mobilized force of the instrumented anchored nail was presented in Figure 14. The results indicated the top row nail started to gradually mobilise as a result of earth pressure after progressive removal of passive berm for the installation of bottom row anchored nails. The monitoring results indicated that the anchored nail had mainly mobilized the nail resistance from Level A to B. It is clearly evidenced that the unstable slope mass transferring most of the unbalanced force to the sheet pile wall. The subsequent anchored nail performance had evidenced that the remedial solution had successfully arrested the potential failure.

Figure 14 Mobilised force result of instrumented anchored nail

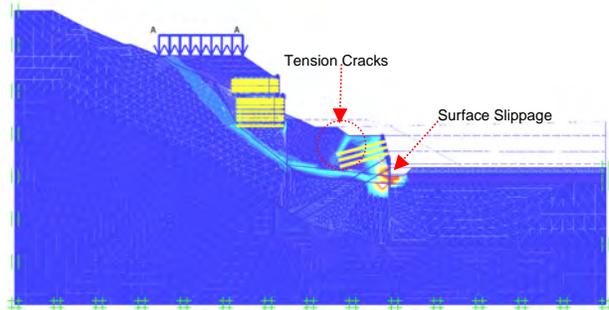
The FEM results confirmed the zoning with high shear strain within the unstable slope mass tally reasonably well with the occurrence of tension cracks location as depicted in Figure 15. A band of potential slip surface was developed in the form of semi circular failure and cutting through the earlier installed nails. The analysis also showed the potential circular slip which was similar to the one detected from the inclinometer results. The c - ϕ reduction method was also performed to confirm the said local potential failure surface. In such cases, the permanent sheet pile with approximately 12 to 15m is essentially required to provide sufficient resistance to maintain the equilibrium and arrest the slope lateral movement.

Figure 15 High shear strain area showing potential locations of tension cracks and potential slip surface developed during pilecap pocket excavation
