Investigation of Creeping Slope Movements of a Suspected Colluvium Deposit

ABSTRACT: This paper describes a case study with an initial failure incident of a pile supported retaining wall of a development whereby the investigation reveals the presence of colluvial deposits at the hill along a river valley floor. The approach of the investigation starting from desktop study, site reconnaissance, borehole exploration, laboratory and field testing, field instrumentation is presented to show the importance and proper investigative procedures of these interlinks of evidence. Clear evidence from visual observation on the presence of matrix of round cobbles, pebbles and unsorted angular gravels confirms high possibility of colluvium from deposition of earlier river alluvium with continuous cutting by a river system. One of the important aspects of the observed slope creeping movement relates to the perched hydrogeological regime of the region, which was likely be evidenced as a triggering factor of the on-going creep movement of the inherent marginally unstable colluvial deposits. The inclinometer profiles also show the extent of unstable colluvial mass over the identified slip surface.

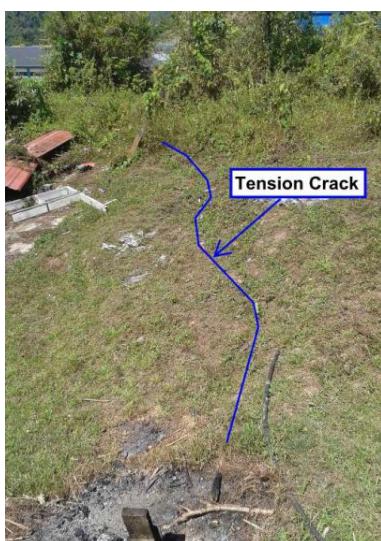
1. Global slope movement towards south (towards the river) was observed as evidenced from the tension cracks on slope with crack width of about 150mm as shown in Figure 4.

Figure 4 Observed tension crack on slope

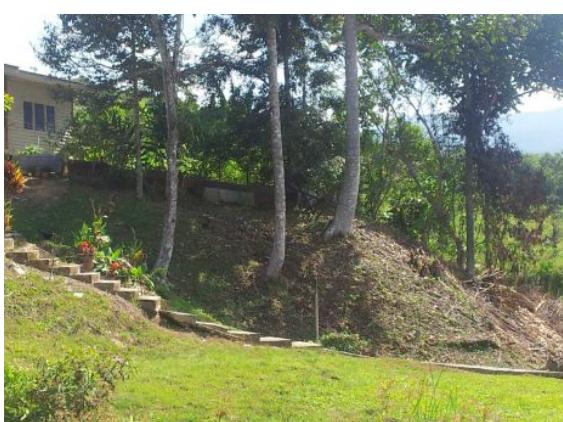
2. Some existing trees on the adjacent slopes were observed with bottom stems tilted at early stage of the growth whereas the upper stems grew vertically. This implies that some slope creeping movements may have occurred some time ago during the earlier stage of the tree growth, thereafter the slope movement may have been stabilised and allowed the trees to develop vertical growth. Condition of the tilted trees was as shown in Figure 5.

Figure 5 Existing tree condition

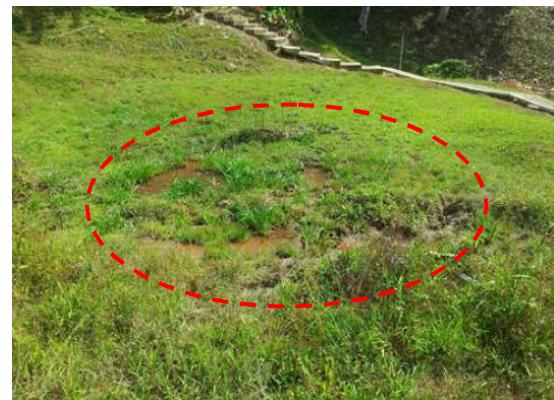
3. Water springing out / ponding on the distressed slope was observed at eastern side of the distressed slope as shown in Figure 6.

Figure 6 Existing water ponding and wet patches on site

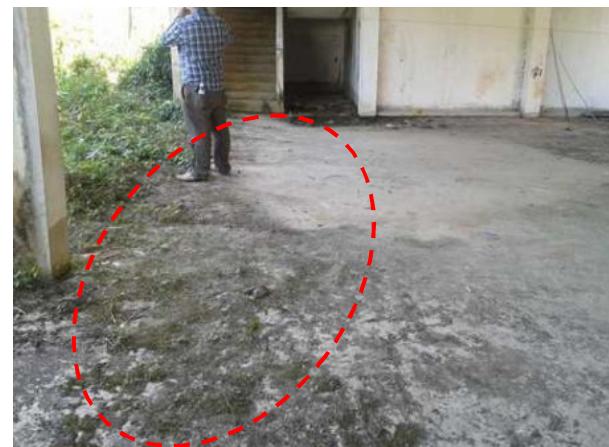
4. Heaved reinforced concrete slab of the existing building in front of the retaining wall was observed. The ground floor slab has heaved up of about 150mm, which is likely due to the creeping slope movement extending beyond the wall toe as shown in Figure 7.

Figure 7 Heaving ground slab near distressed wall and creeping slope movement beyond the wall.

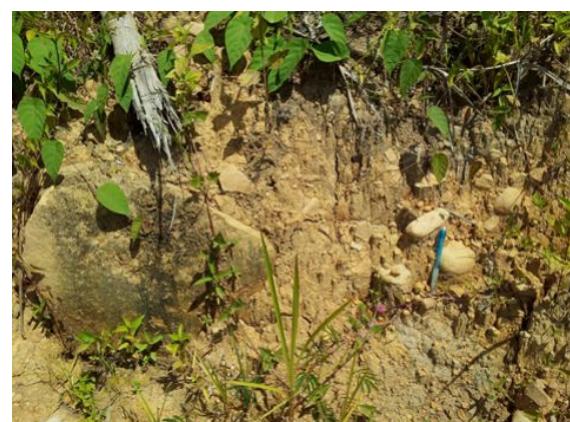
5. There is no outcrop of parent bedrock observed within the site. Some boulders mixed with small cobbles were observed as shown in Figure 8. The mixtures of the unsorted round and angular shape rocks or cobbles implied the possibility of alluvial deposits. This is not uncommon at the foot hill of mountain range and valley flood with thickly deposition of transported material at higher elevation by river flow before further hydraulic cutting of river to deeper invert level. The rock fragments with angular shape suggest possibility of colluvial deposits which intermix with the alluvial deposits mentioned earlier.

Figure 8 Observed boulders mixed with small rounded cobbles.

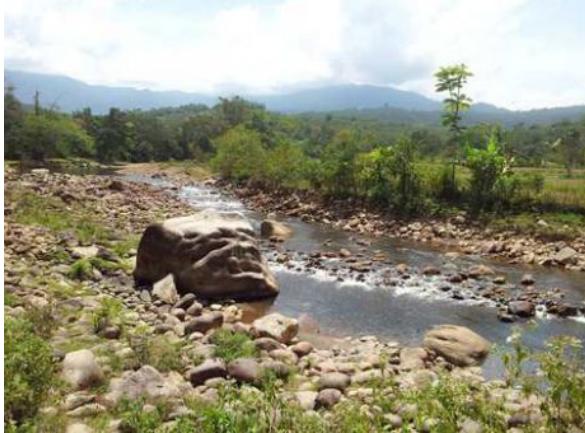
6. The site is located at reduced level of about RL384m. Northward direction of the site is uphill slopes while Southward direction of site is generally a flat ground toward river with plenty of round boulders (Figure 9). It is believed that the southern relatively flat area is deposited with the river deposits carried down from far up stream of the river where various sizes of round boulders and pebbles along the river course were observed.

Figure 9 Existing river condition

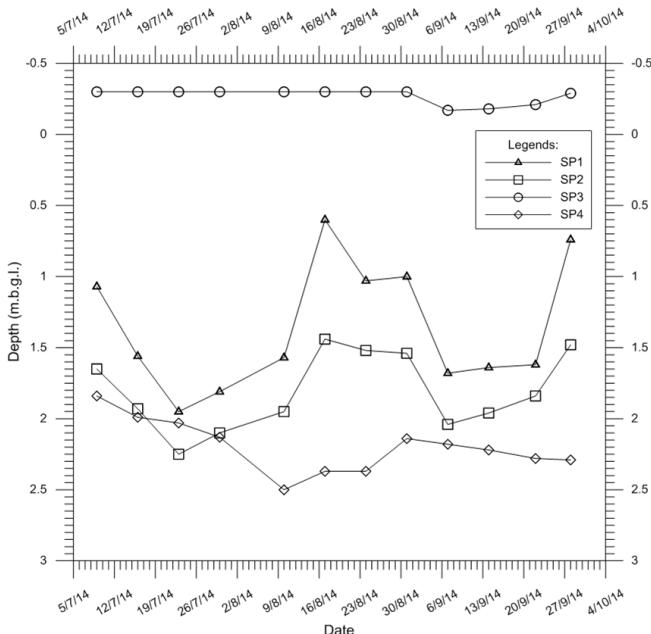
Figure 14 Groundwater Monitoring

Groundwater level of the slope was monitoring from four standpipes in the second stage SI works. The groundwater levels recorded from standpipes namely SP1, SP2, SP3 and SP4 ranged from 1.5m to 2.5m below ground level excepted for SP3, where the groundwater level was consistently at 0.3m above ground level as shown in Figure 14. This phenomenon is consistent with observed perched water at area of the wet patches and water ponding spot near to SP3.

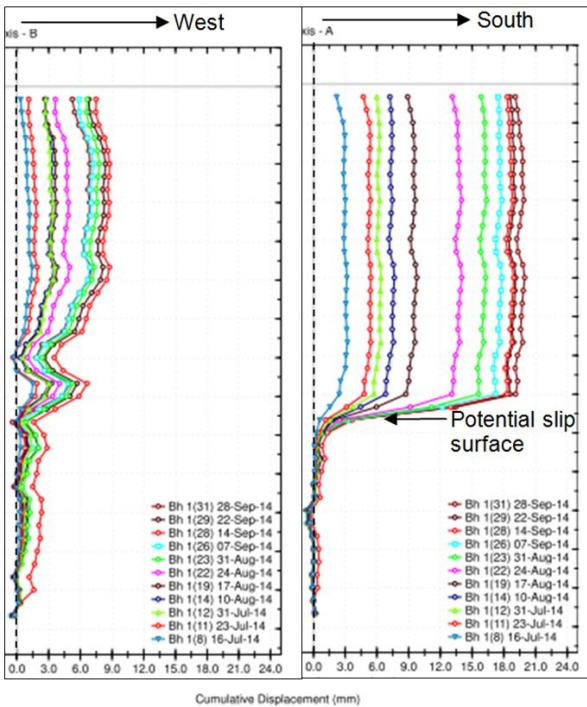
Figure 15 Inclinometer (IN1) Monitoring Results

2014 until end September 2014. There were some discrepancies of the inclinometer installation by the SI contractor, where the principal and secondary groove directions could have been misaligned due to forced rotation in inserting the inclinometer tubes. However, the significant slope creeping movements still permit the direction of the slip surface of the unstable slope mass. The maximum lateral displacement for slope movements were about 21mm to 28mm with average displacement rate of 2.4mm per week during the monitoring period.

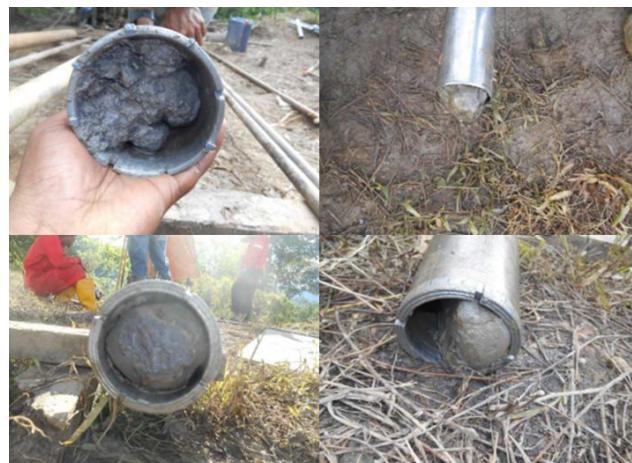
Figure 19 shows the multiple cobbles stuck in the casing of undisturbed sampling tube during Subsurface Investigation (SI).

Figure 19 Cobbles Encountered During SI
