### Common Blind Spots in Ground Investigation, Design, Construction, Performance Monitoring and Feedbacks in Geotechnical Engineering

Shaw-Shong Liew

G&P Geotechnics Sdn Bhd, Kuala Lumpur, Malaysia

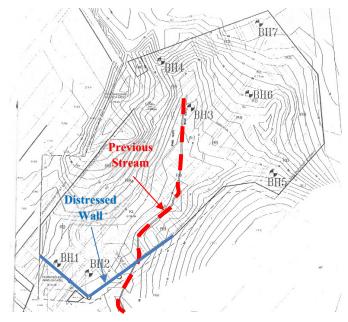
Figure 2 Predevelopment Stream and Distressed Wall

This case study involves a distressed piled retaining structure of 7.5m high over soft soils as shown in Figure 1. In view of the underlying weak alluvial deposits at the predevelopment natural stream as shown in Figure 2, the retaining structure was supported by five rows of vertical 200mm driven precast concrete square piles with carrying capacity of 450kN. During backfilling of the constructed retaining wall, excessive lateral movement was observed. As evidenced in Figure 1, rising groundwater level was evidenced from the water staining at weephole drains probably resulted from building up of seepage at the previous stream.

Investigation was conducted to assess all possible modes of wall failure and reveal the probable causes of the wall distress. From Table 1, it was obvious that the overall stability assessment using limit equilibrium method by slide method had over-estimated the safety margin of the piled wall and same for the lateral resistance of the foundation piles. The vertical effective stresses at the underlying soil beneath the wall for computing the sliding resistance of the wall were over-estimated without considering the reduction of vertical effective stress in the foundation soil due to the vertical support from the piles. An unrealistically optimistic safety factor was computed for accepting the wall foundation design. The lateral structural resistance of the vertical piles was also not adequate to provide the required equilibrium for lateral stability of the wall under the increasing lateral earth pressure after rising of groundwater level within the wall backfill due to extreme raining event.

The remedial solution is to excavate down the foundation formation further to cut off the piles to a lower level after demolishing the distressed wall. Then a compacted free draining crusher run material was placed over the cut piles to rebuild the same retaining wall with internal drainage and a low stabilising berm in front of the new wall. The details of this case study presented by Liew (2007) shows a treacherous situation on adding the vertical piles to support the wall, but in fact jeopardising the wall stability instead.

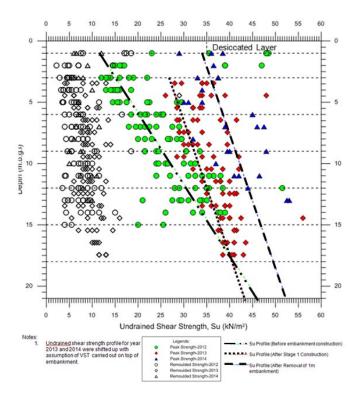
Figure 5 Interpreted Undrained Shear Strength at Different Stages of Embankment Construction

Generally, the development is within a relatively flat original ground and underlain by soft alluvial soils. There were three (3) stages subsurface investigation (SI) works carried out in year 2012, 2013 and 2014 respectively. All SI works mainly consist of vane shear tests to obtain and verify the performance of gain-in undrained shear strength after consolidation at each rest period. Figure 5 shows the profiles of vane shear test results before embankment construction in 2012 and after embankment construction in 2013 and 2014.

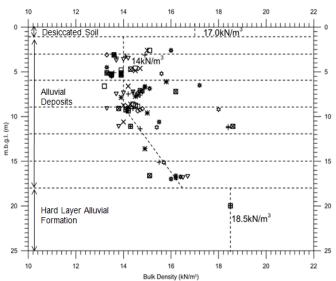
Figure 6 Interpreted Subsoil Bulk Density

Bulk density of the proposed site prior to embankment construction works were summarised in Figure 6. The average bulk density of the alluvial subsoil samples obtained from the SI is 14kN/m3 for top 9m soil and gradually increases to 16.5kN/m3 for the subsequent depth from 9m to 18m of the alluvial clay layer.

It was worth to mention that bulk density at the surficial desiccated soil layer of 1m thick is taken to be about 17kN/m3 as top soil layer has subjected to compaction during the construction of the drainage blanket and subsequently improving its density.

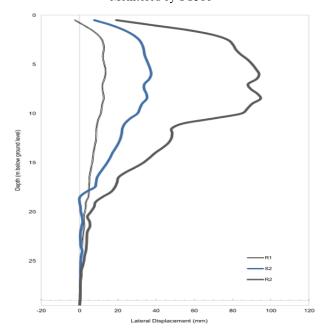
Figure 10 Inclinometer I6 Monitoring Results

Figure 10 presents the inclinometer monitoring results from inclinometer I6 installed at a location of about 4m beyond the embankment toe. It shall be noted that the inclinometer monitoring was only started 2 month after Stage S1. As such, it was expected that portion of lateral displacement will not be recorded in the inclinometer monitoring results. The recorded maximum lateral displacement is about 100mm. The top 11m indicated more lateral soil displacement implying larger plastic straining in the subsoils, which can develop into a slip surface leading to embankment distresses.

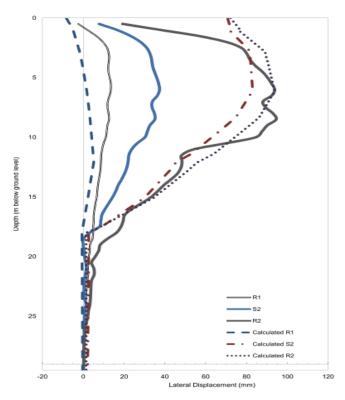
Figure 13 Comparison of Lateral Displacement Profile

In order to best simulate the actual condition of the constructed embankment, both settlement trend and lateral deformations profiles from back analysis are required to reasonably match with the actual performance of embankment. The lateral deformations from back analysis was plotted and compared with the actual conditions in Figure 13.

As portion of the lateral displacement is not recorded in early stage of the embankment filling due to delayed installation of the inclinometer, thus, the back analysis was performed to estimate the possible lateral displacement before installation of inclinometer while the incremental lateral movement profile at subsequent construction stage still match well with the measured profiles. It was found that the subsoils have undergone lateral displacement of 160mm prior to the monitoring and it is expected that total lateral displacement of 260mm was experienced in the subsoil beneath the embankment before the cracks were observed. If taking this lateral subsoil movement of 260mm at 4m beyond the embankment toe and where the crack was discovered, the average mobilised tensile straining of the subsoil from the crack location to the embankment toe plus the distance of inclinometer I6 of 18m would be estimated to be 1.44%. This strain level is no way close to the characteristics strength of the basal reinforcement.

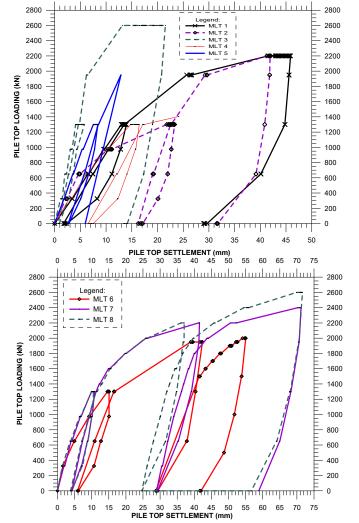
Figure 25 Pile top loading (kN) versus pile top settlement for (a) contractually scheduled MLT results and (b) additional MLT results

All additional MLT piles (MLT 6 to MLT 8) had been previously installed with termination criterion reaching 2.2 times of working capacity but MLT 6 and 7 piles failed to achieve the required maximum test load, except for MLT 8. This clearly implies the high possibility of pile capacity degradation resulted from stress relaxation. MLT for piles with deeper penetration below the base of pre-bored hole have obviously shown better settlement performance at one (1) time working load in the first cycle. The load-settlement curve of all three test piles in Figure 25(b) has gentler gradient in the first loading cycles whereas the gradient of subsequent reloading cycles becomes steeper. This is the clear evidence of phenomenal soil softening after the termination of jack-in pile. However, further reloading of the pile to higher load in the subsequent load test cycles had allowed the founding soil stratum regaining the soil compactness rendering stiffer pile base response. The test results further enhance the findings of potential stress relaxation at pile tip due to insufficient stress confinement within the effective stress bulb of the end bearing pile tip as a result of insufficient pile penetration below the base of prebored hole. The restoration of initial higher pile capacity in second load cycle as a result of further pile penetration into soften subsoil near to the pile tip implies that this is solely a pile settlement problem.

Piles installed into pre-bored hole without backfilling the annulus are exposed to the risk of pile tip softening and consequently leads to reduction in pile load carrying capacity and softer response in pile tip stiffness. The base softening effect in the bearing soil stratum affecting the end bearing capacity of the pile can be logically expected when the empty annulus in the pre-bored hole is nearer to the pile base. The empty annulus with virtually zero confining stress provides pre-requisite condition for time dependent stress relaxation of soils to take place especially when the free surface is exposed to water. When the pile has sufficient penetration below the pre-bored base, the stress relaxation effect at the upper most soil (beyond influence zone of the stress relaxation above pile tip) would not affect the effective stress bulb near the pile tip, thus the pile end bearing capacity. Figure 26 shows a schematic diagram of the stress relaxation and the stress bulb of pile tip end bearing. 15 20 25 30

Meanwhile, the influence zones for sand with  $\phi' = 30^{\circ}$  are 1D to 3D upwards and 3D to 5D downwards (Hideki Hirayama, 1988). As such, it is worthwhile to seal-off the annulus between oversized pre-bored hole and pile shaft to remove the condition of free surface and to prevent ingression of water potentially leading to softening of pile tip founding materials within the plastic zones of pile tip.

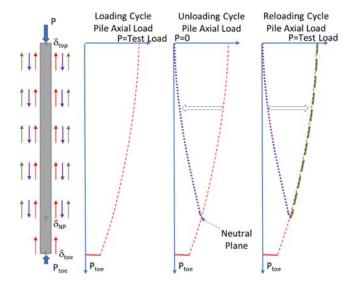
Figure 28 Schematic diagram of Pile Load Test Results

Figure 27 shows a typical load settlement curve of static maintained load test results. The portion from Point 1 to 2 denotes linear elastic behaviour when there is no part of the pile-soil system attaining either interface slippage and dislocation of soil grains. Full recovery of elastic strain of pile structure and foundation soil is possible with this range of loading. However, when the pile loading enters beyond Point 2, either soil yielding or interface slippage at the upper portion of the pile-soil system occur. The lower pile segments may remain elastic behaviour. When the loading is stressed beyond Point 3, more soil yielding and interface slippage occur and extend to lower pile segments resulting more irrecoverable straining. Upon reaching the first maximum test load at Point 4 following with unloading process to Point 5 and subsequently to Point 6, partial restoration of the stored elastic strain energy in the pile-soil system takes place.
