TECHNICAL TALK ON TWO CASE STUDIES OF COLLAPSED TEMPORARY EXCAVATION USING CONTIGUOUS BORED PILED WALL

7 JULY 2020

SPEAKER Ir. Liew Shaw Shong

TWO CASE STUDIES OF COLLAPSED TEMPORARY EXCAVATION USING CONTIGUOUS BORED PILE WALL

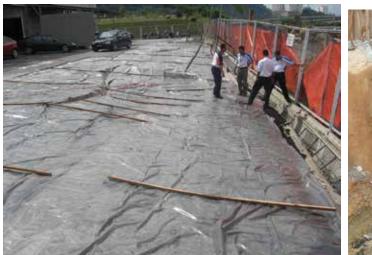
Ground Distress at Active Wedge

Repairing of CBP Pile

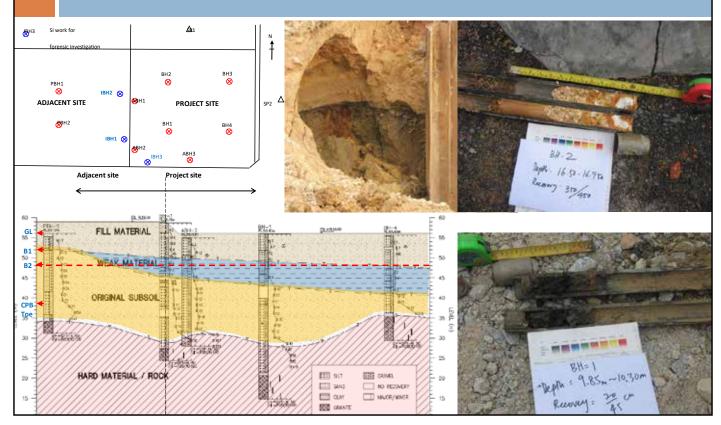
Back Analysis

- Finite Element analysis (PLAXIS) to simulate the construction sequences of excavation & to investigate the probable causes of ground distresses & wall movements.

- Over-excavation of passive berm before installing raking struts
 reduce lateral resistance to sheet pile wall & subsequently mobilise structural strength of the CBP walls beyond serviceability state condition & reaching ultimate limit state condition
 - Excessively displaced temporary sheet pile wall → induced additional lateral force & flexural stress to the installed contiguous bored piles (CBP) walls unavoidably damaged the CBP piles.
- The results of FE analyses agree reasonably well with the measured wall movements and ground deformations (e.g. tension cracks, settlement and depression)

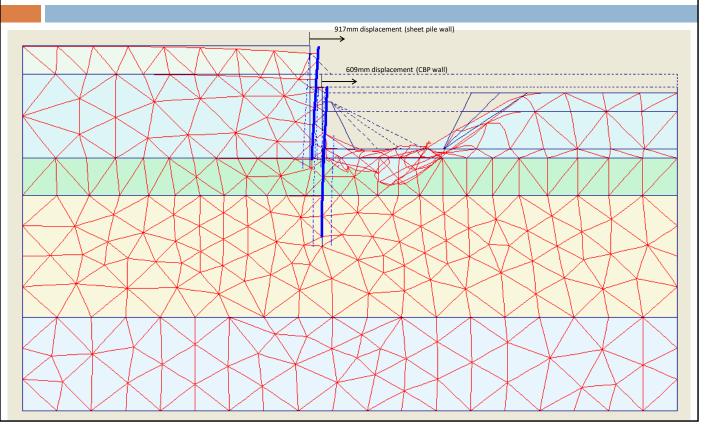
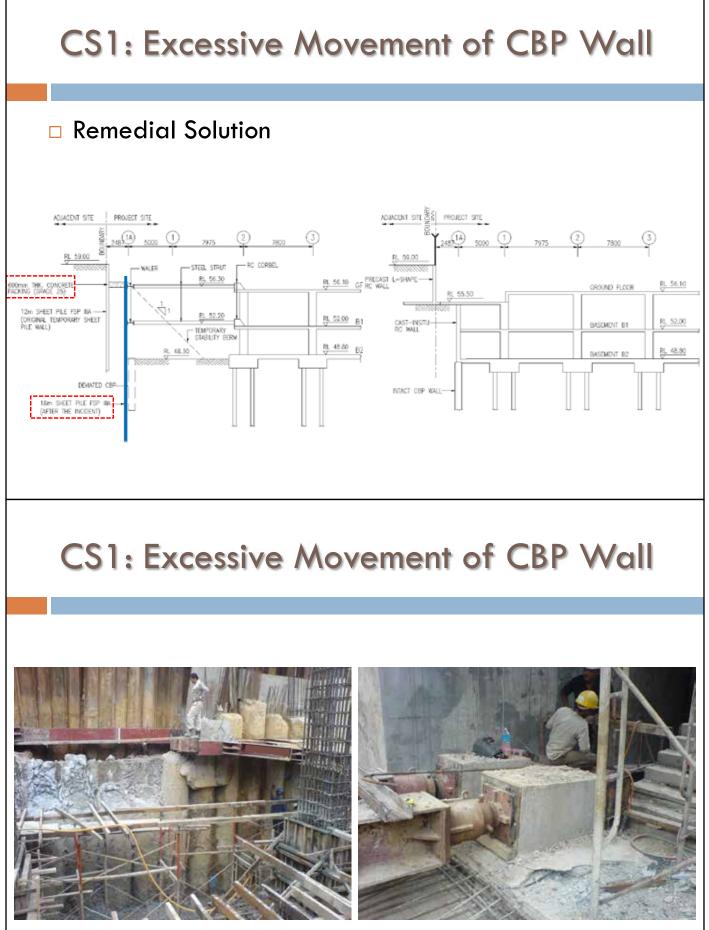
Repairing Crushed CBP

Shear Failure of Corbel Support

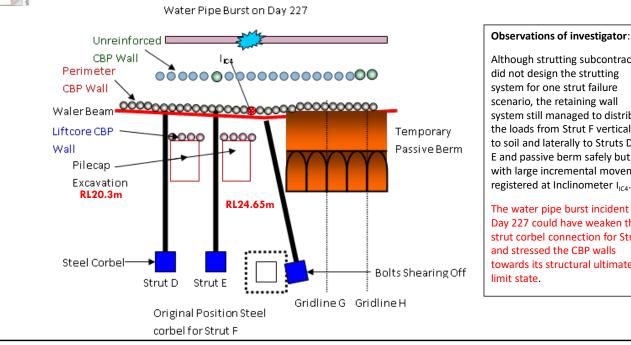
Water pipe burst incident on Day 227 which caused the steel corbel for strut F being sheared off as reported.

Although strutting subcontractor did not design the strutting system for one strut failure scenario, the retaining wall system still managed to distribute the loads from Strut F vertically to soil and laterally to Struts D & E and passive berm safely but with large incremental movement registered at Inclinometer I_{IC4} .

The water pipe burst incident on Day 227 could have weaken the strut corbel connection for Strut F and stressed the CBP walls towards its structural ultimate limit state.

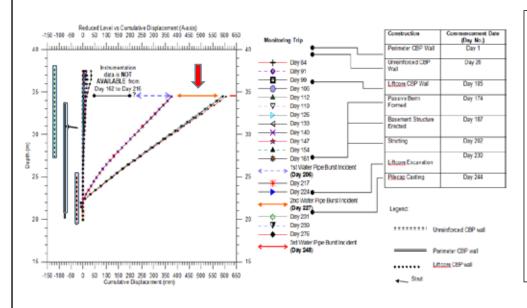
Water pipe burst incident on Day 227 which caused the steel corbel for strut F being sheared off as reported.

Although strutting subcontractor did not design the strutting system for one strut failure scenario, the retaining wall system still managed to distribute the loads from Strut F vertically to soil and laterally to Struts D & E and passive berm safely but with large incremental movement registered at Inclinometer I_{IC4}.

The water pipe burst incident on Day 227 could have weaken the strut corbel connection for Strut F and stressed the CBP walls towards its structural ultimate limit state.

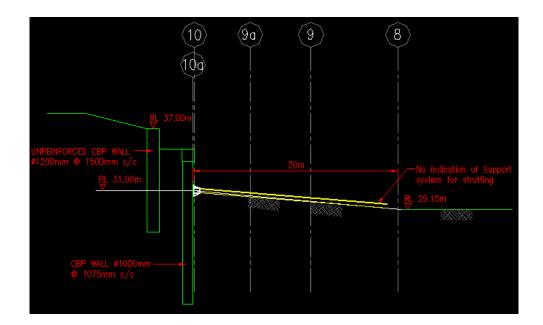
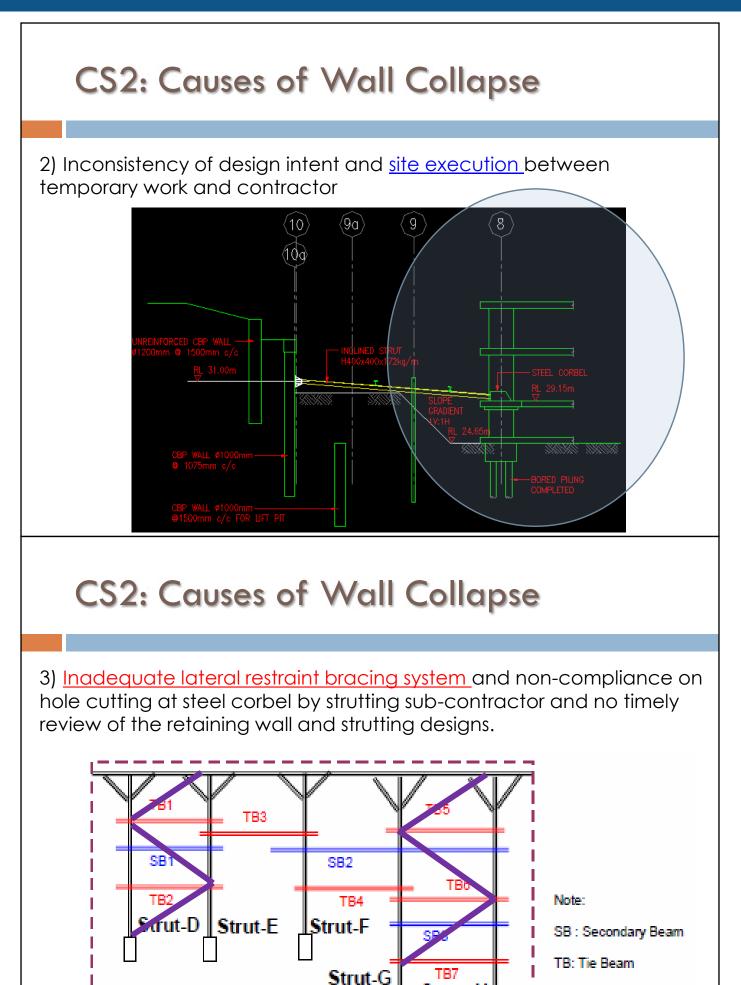
2) Inconsistency of <u>design intent</u> and site execution between temporary work designer and contractor

Strut -H

Triangular system
