Massive Creep Movements of Post-Glacial Deposits in Kundasang Areas

S. S. LIEW & S. S. GUE
Gue & Partners Sdn. Bhd., Malaysia

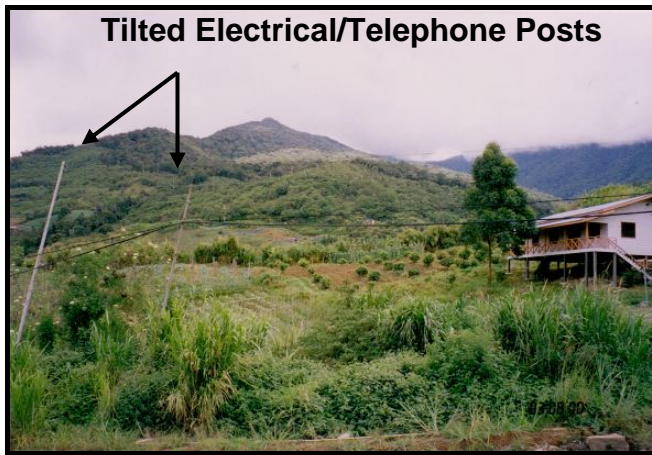
Photo 2: Tilted Electrical/Telephone Posts

There are a power transmission line running across the cattle farm and a telephone line running along the road alignment. The posts on the sloping ground were tilted due to the ground movements and the tensioning electrical cables was observed holding the top of the posts in place whereas the posts on the higher flatter and stable ground were being pulled at the top becoming tilting posts towards downhill. Photo 2 shows the tilted posts with tensioned cables.

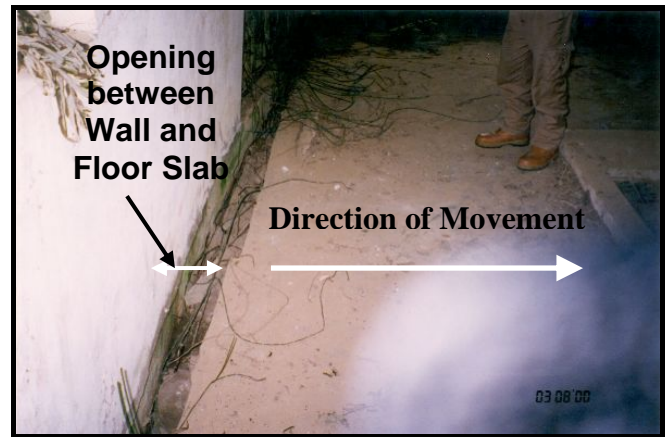
Photo 5: Distressed Pump House

It was also intended to be the power scheme for Sabah Electricity Board (SEB). The Mesilau Mini Hydro project was commissioned in 1983 but has not been used since 1985. In October 1987, a massive slip occurred and tilted the pump house, PH-2 and part of the pipeline. From the site observation, the pump house has suffered distresses due to differential settlement and lateral

ground movements. Photos 4 and 5 show the shear cracks and the detached floor slab respectively as a result of the ground movements.

2. The pump house, PH-2, at the left-hand-side of Jalan Cinta Mata near to the road junction shows a substantial displacement as the structure has tilted and displaced significantly from its original location.

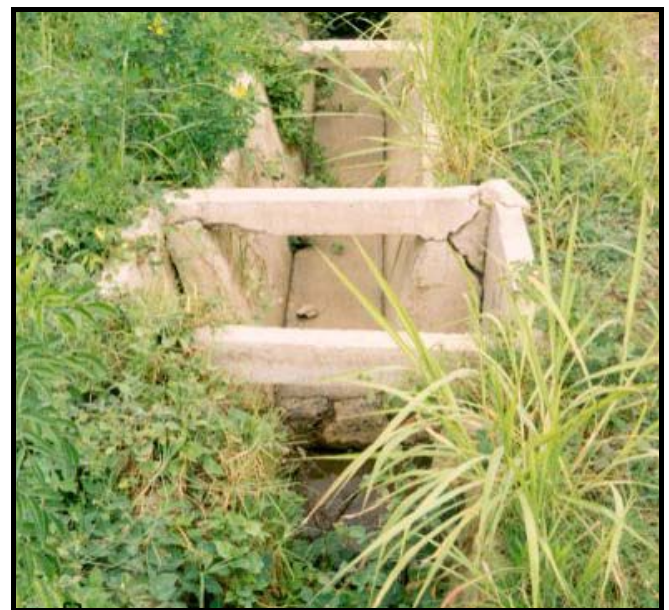
Photo 6: Distorted Drain Sump

As a result of ground movement, the concrete drains on the higher ground along the roadside also show serious cracks due to shearing and tensioning. No indication of damage on drains due to compressive thrust at the lower passive zone was observed except some distortions of the T-junction concrete drain sump as shown in Photo 6. This is because the concrete drains were constructed across the active wedge areas where tension cracks occur and probably did not extend to the passive wedge at the lower portion of the landslide masses. Repair works have been carried out to seal the cracked drain. Photo 7 shows the repaired drain.

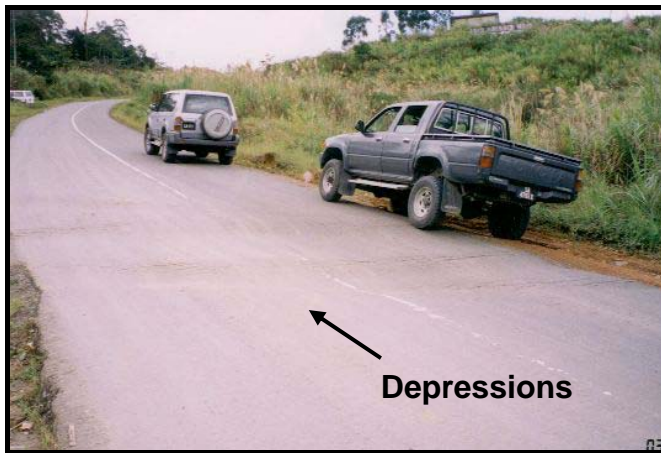
Photo 8: Depression on Road Pavement

The road pavement along the affected chainage generally shows tension cracks, potholes, Settlement and bearing capacity failure, probably due to weak subgrade as a result of ground

movement. This is shown in Photo 8. The rapid rate of distresses on the pavement indicates that the ground movements are still very active.

3. The repaired and new tension cracks along the roadside drains were observed.
4. The road pavement at the affected areas was all damaged primarily due to differential displacement on the road subgrade. It was also observed that the development of new tension cracks within the affected area was fairly active. Within few months of monitoring period, the changes of the site condition were obvious.

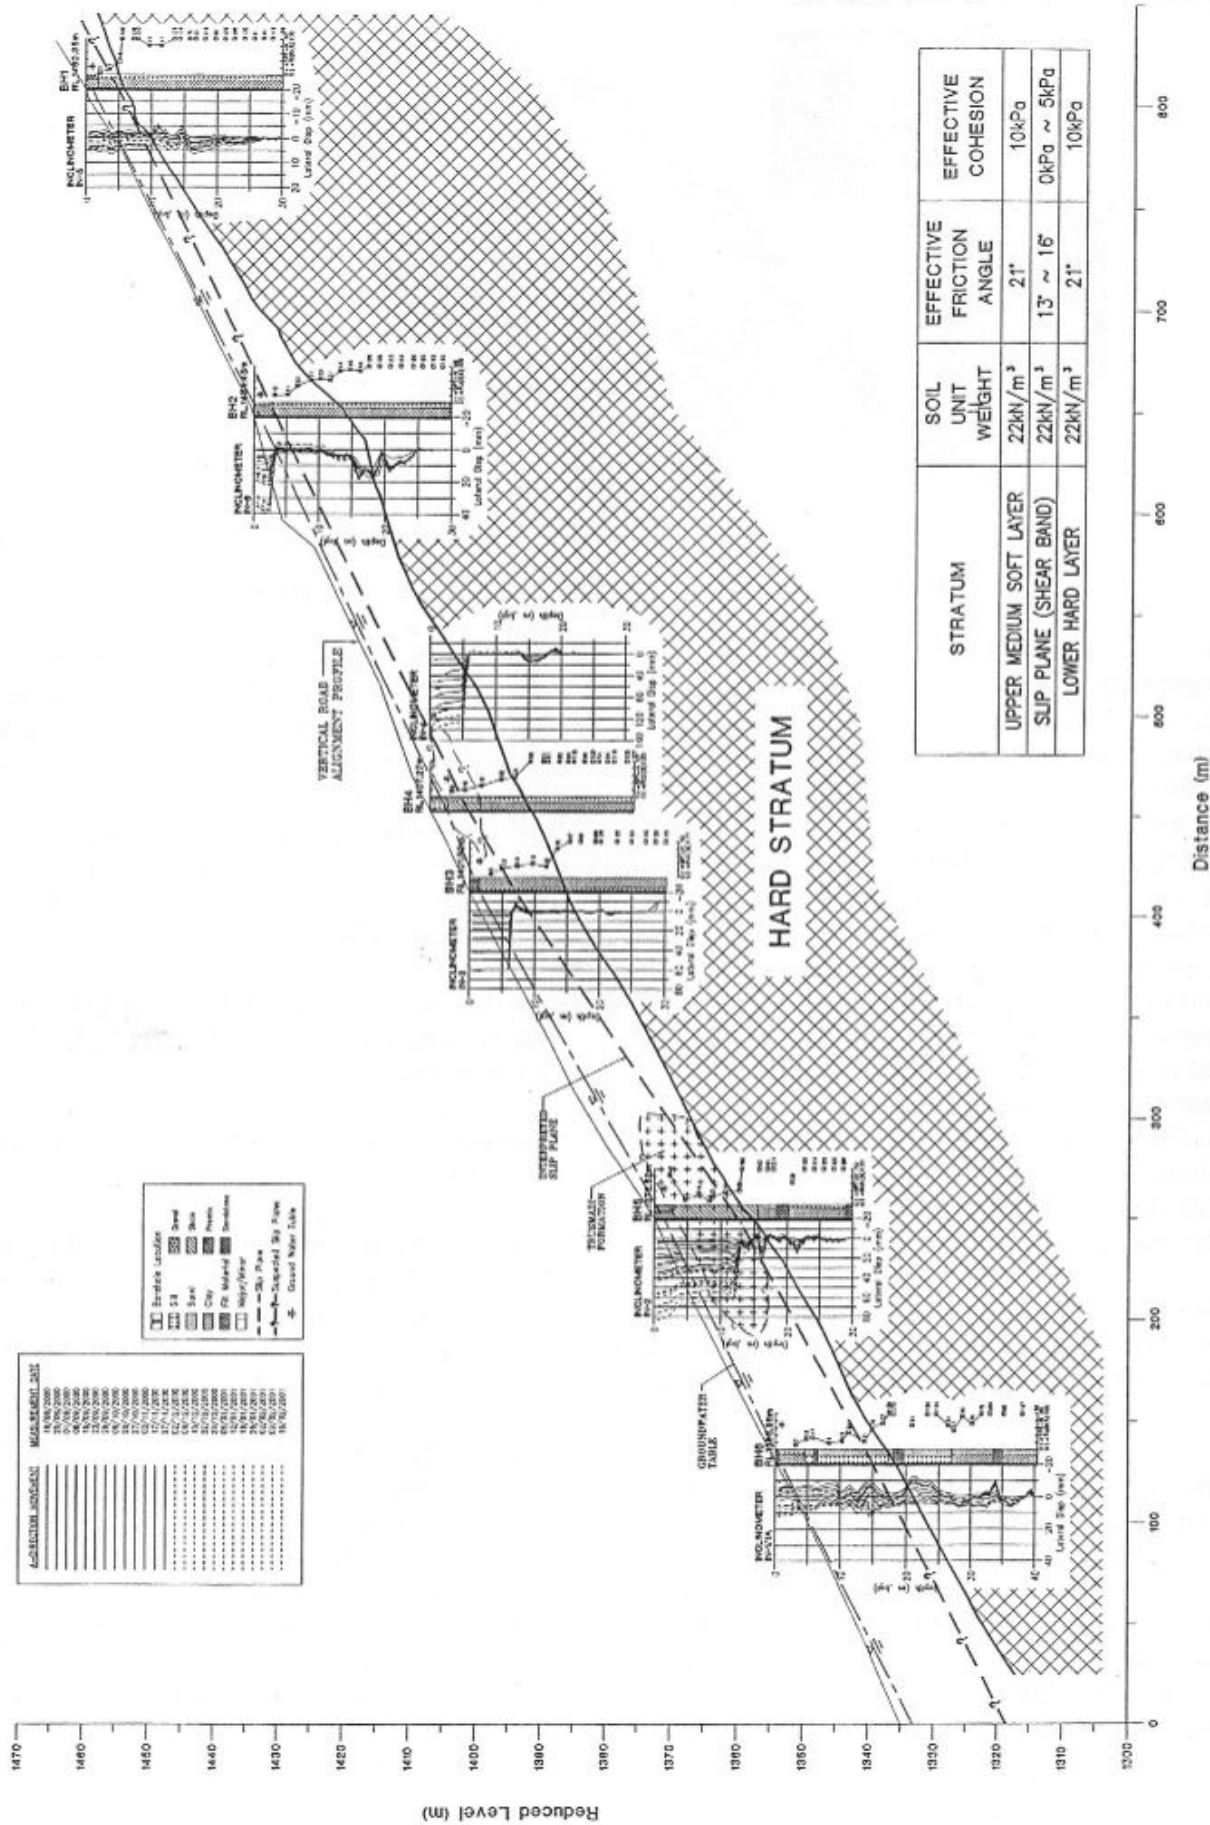
Figure 6: Subsurface Profile and Inclinerometers Results

The interpreted borelog profile and the groundwater conditions are shown in Figure 6. From the inclinometer results, it is observed that distinct shear planes can be identified, particularly at inclinometers, IN-2, IN-3, IN-4 and IN-6. The direction of lateral movement of these inclinometers is in the narrow range between 225° and 250°. The maximum lateral movement is 140mm, which is in Inclinometer IN-4. The rates of maximum lateral ground movements in these inclinometers are generally in the range of 2mm/week to 14mm/week with few exceptional cases of maximum up to 21mm/week as shown in Figure 7. Whereas, inclinometers IN-1, IN-1A and IN-5 show lateral movement profile of a buckling casing and indicate that there is some compression within the subsoil at these inclinometers.

Findings: The existing road alignment is confirmed located on the Pinusuk Gravels of glacial deposit. An obvious slip plane has been detected from the inclinometer results and the fairly high piezometric level of groundwater has been established in the standpipes. The depth of slip plane varies from about 6m at the higher ground to about 15m at the lower ground near the starting chainage of Jalan Cinta Mata. The direction of ground movement is generally towards south-west (approximately 225° to 250° clockwise direction from the north).

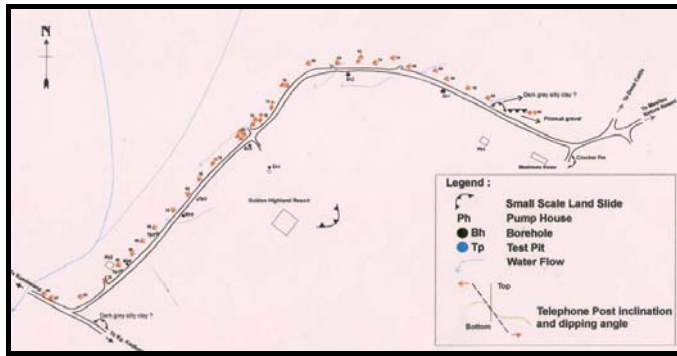
Figure 10: Site Mapping on Ground Objects

1. The electrical posts and telephone posts show tensioning in the wires or cables within the affected area. Some of the posts were tilted and indicating direction of ground movements. The mapping of relative ground movements based on the conditions of the tilted electrical and telephone posts is shown in Figure 10.

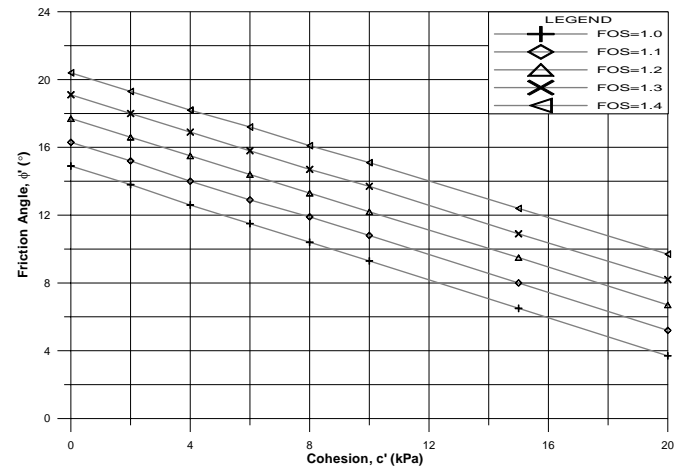
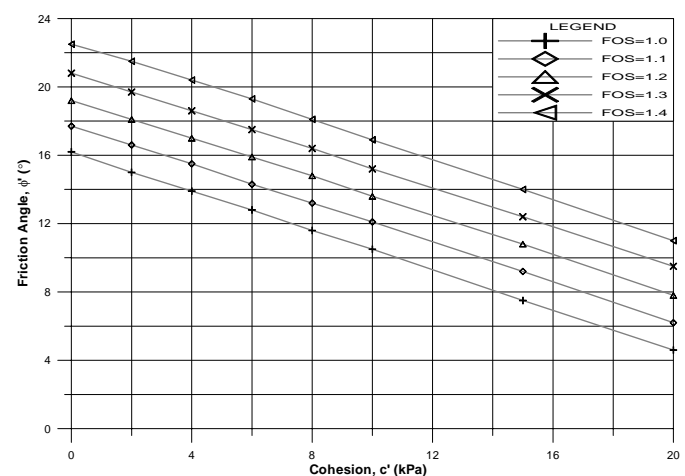
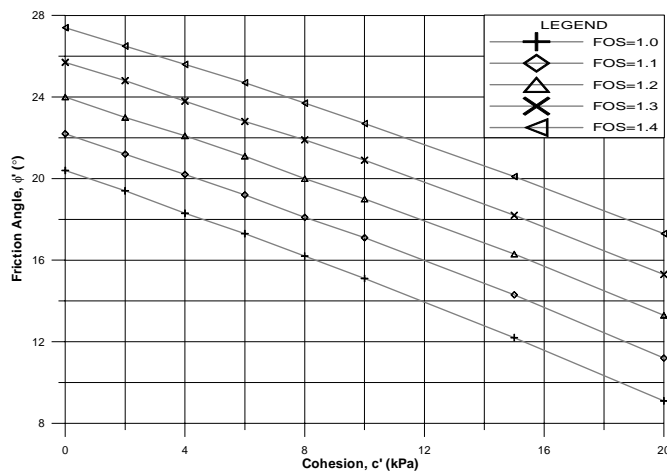
The results of these analyses are shown in Figures 11, 12 and 13. The possible range of the back-analysed shear strength parameters at the shear plane are : $c' = 0$ to 5kPa , $\phi' = 13^\circ$ to 16° . These back-analysed soil strengths should be verified by appropriate testing on the soil samples within the slip surface during the detailed SI

The interpreted strengths of the subsoil have sufficient safety factor, i.e. at least more than 1.5 from the back-analyses for Case A, against slope instability as the topography of the road alignment indicates the general gradient of about 10°, which is much gentler than the internal friction angle of the subsoil at the site. Therefore, it is believed that there should be some small but important geological features not detected in the investigation works. The back-calculated strength parameters are: Cohesion, C' = 0 to 5kPa and Effective Friction Angle, φ' = 13° to 16° respectively. These ranges of strength parameters are believed to be the residual strength of the landslide masses as the magnitude of slip movement is significant. These back-calculated

Recommendations: Further investigation works are needed for the detailed design of the remedial works.

A detailed second stage investigation programme and topography survey of wider coverage shall be carried out for the detailed remedial design of the unstable soil masses at the original alignment upon deciding to remedy the existing road alignment. It shall include: A) Trial pits excavated down to the detected shallow shear plane shall be carried out to obtain high quality block sample containing the shear plane for direct shear box tests. B) For deep seated slip plane, continuous undisturbed sampling using borehole can be considered. Multiple reversal shear box test can be carried out to obtain the residual strength at the slip plane of the landslide masses and compare the residual strength with the back-calculated strength parameter to improve confident level. C) Those recommended earlier, such as Total Station Survey on wider coverage of the studied area and the downhill river areas.
