Geotechnical Investigation and Monitoring Results of a Landslide Failure at Southern Peninsular Malaysia (Part 1: Investigating Causes of Failure)

A proposed building was constructed on a cut platform. After cutting of a two-berm slope (gradient 1V:1.5H) for the building platform, the cut slope collapsed following a heavy downpour. On top of the failed cut slope, there was another proposed structure yet to be constructed. A comprehensive geotechnical investigation was carried out to investigate the causes of the failure and to propose remedial measures.

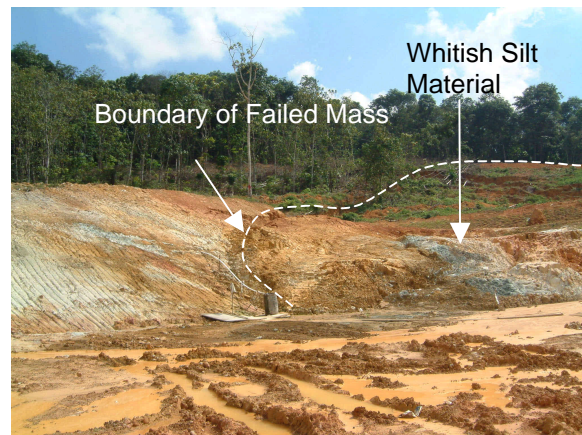
Figure 2 Front View of Failed Slope

A site inspection was carried out shortly after the slope collapsed. Whitish silt material was found on the cut surface of the failed slope as shown in Figure 2. Tension cracks were also observed at top of slope as shown in Figure 3.

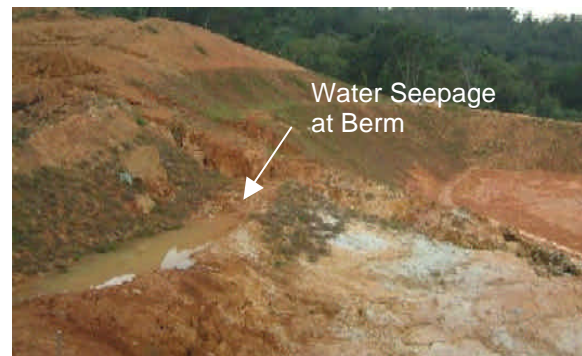
Figure 4 Water Seepage at Berm

Figure 4 shows water seepage at various locations, indicating potential high groundwater level at the failed slope. Small boulders were also observed on the surrounding of the slope. The existence of boulders (diorite and gabbro) within the subsoil was further confirmed during the borehole exploration.

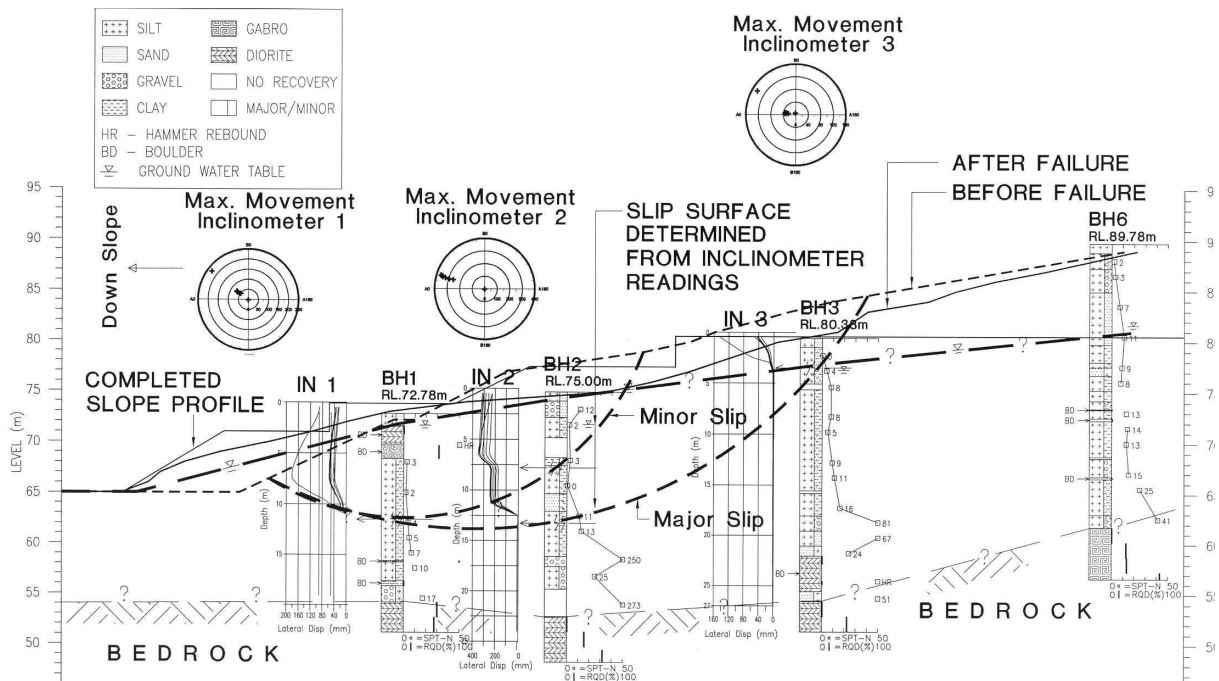
Figure 7 Multiple Slip Surfaces Interpreted from Inclinerometers

Inclinometers, IN-1 and IN-2, were sheared off at 10.5m and 12.0m below ground level shortly after installation. Subsequent monitoring revealed that inclinometer, IN-2, was sheared off again at another higher location, 6.0m below ground level. Finally, IN-3 was sheared off at 2.5m below ground level. The first major slip surface was identified when the three inclinometers were sequentially sheared off. The three shear-off points of the inclinometers resemble a well defined circular slip surface when joined together. The circular slip surface also agrees well with the tension cracks and bulging of the slope toe indicating where the slip surface starts and ends on the slope profile. The second shear off point at inclinometer, IN-2, revealed another minor slip surface formed after the first major slip surface. The inclinometer results are shown in Figure 7, which shows the interpreted multiple slip surfaces in the failed slope. Figure 7 indicates that collapsed mass has resultant movements towards south-west direction.

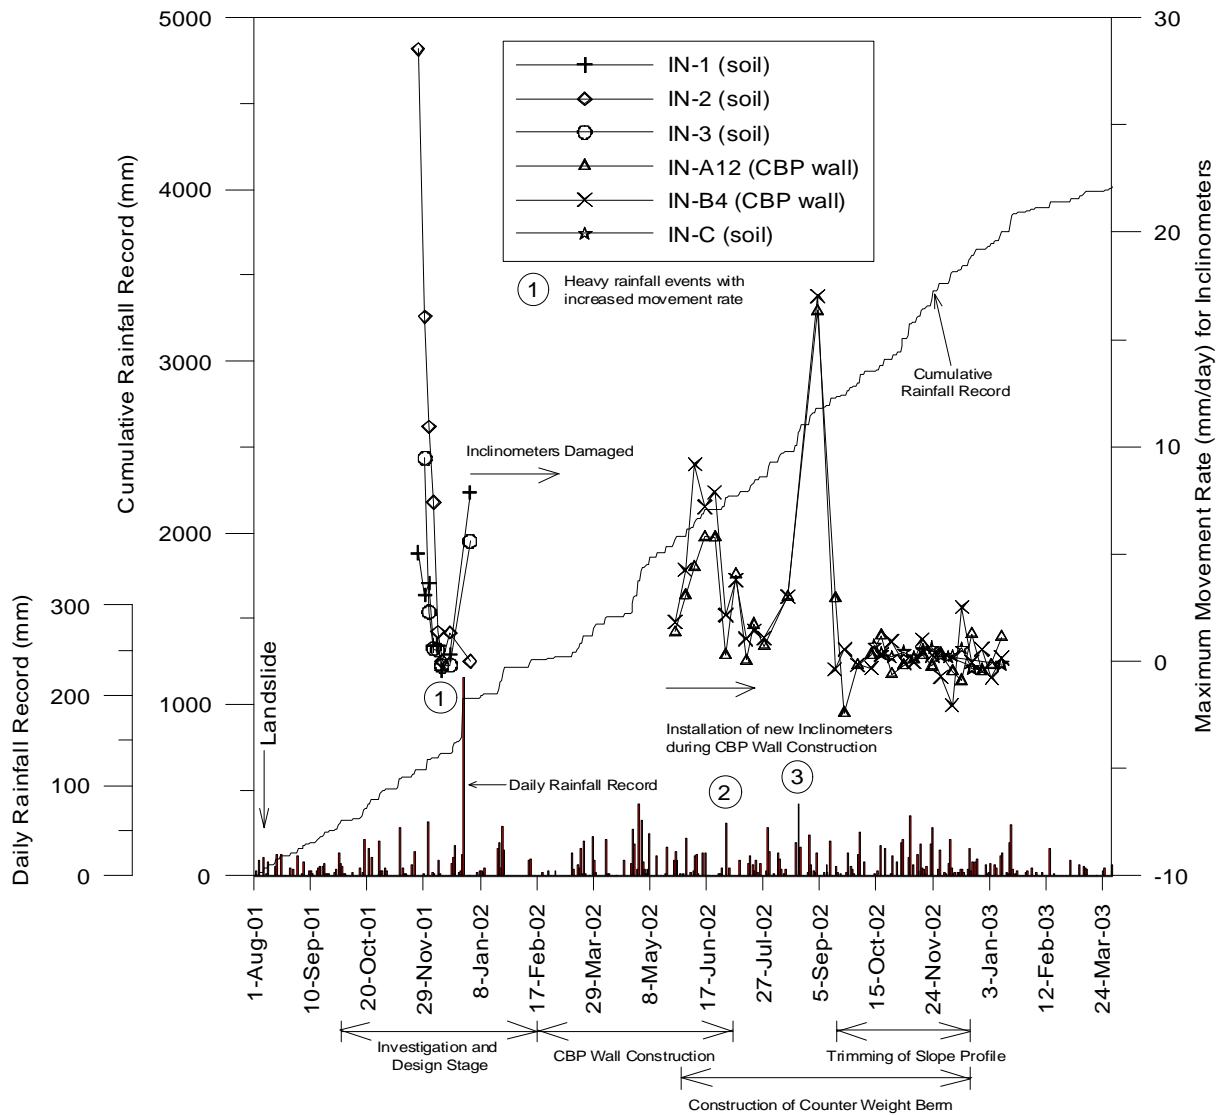
Figure 8 Rainfall Record and Maximum Movement Rate for Inclinerometers

The rates of maximum movement of the inclinometers are shown in Figure 8 together with the daily and cumulative rainfall records. Inclinometer, IN-2, registered the largest movement rate during the initial monitoring period as it was installed in the middle of the collapsed mass. The trend of movement rate for the other inclinometers was very similar and consistent. The movement rate started with a peak and reduced gradually. However, during investigation, the movement rate increased before the inclinometers were damaged. It is observed that the increased movement rate corresponds with an extremely heavy rain recorded on 27 Dec 2001.
