Slope Failures in Tropical Residual Soils

Presented by:
Ir. Dr. Gue See Sew
21 April 2005

- Creep Movement of Slopes, Sabah.
- Cut Slope Failure in Skudai, Johor.
- Cut Slope Failure at Gua Musang, Kelantan.
- Cut Slope Failure at Kuala Lumpur.
- Filled Slope Failure at Salak Tinggi.

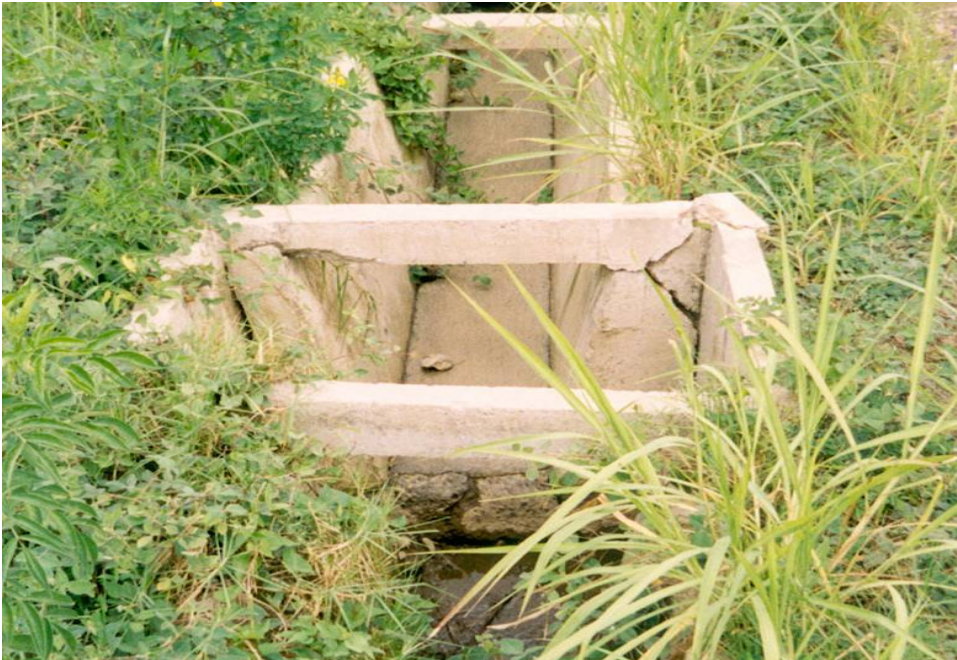
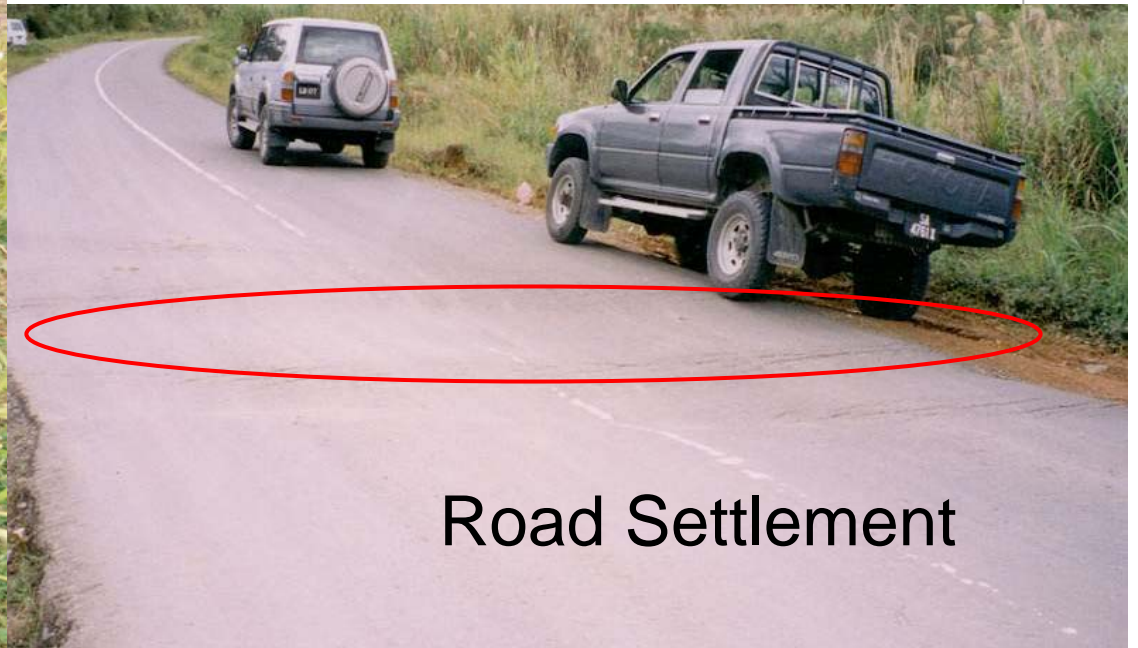
Road Settlement

- Damage of road pavement and drains.
- Tension cracks, settlement and lateral movement.
- Investigation of root causes.

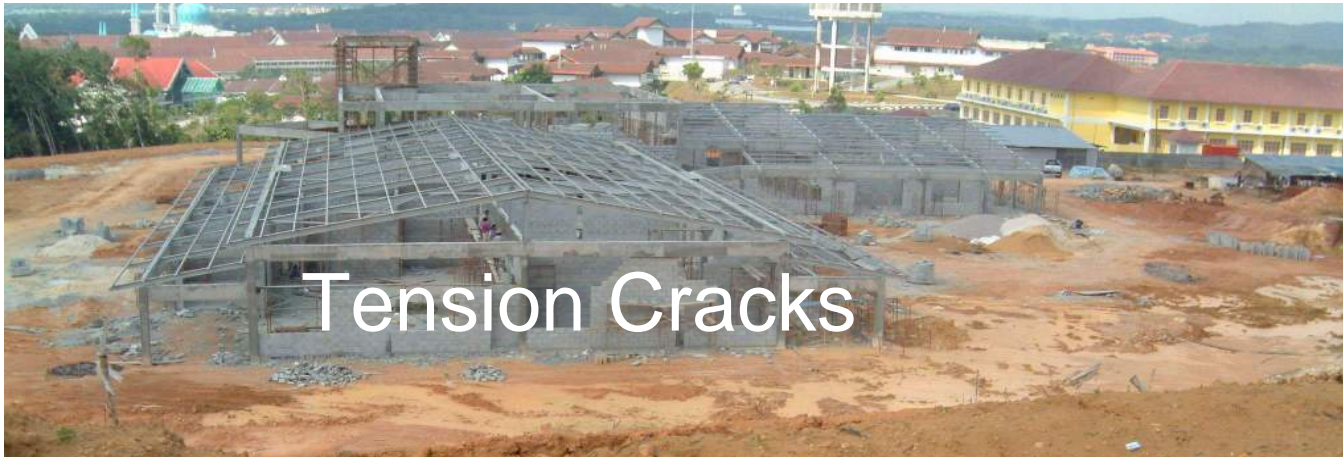
Tension Cracks

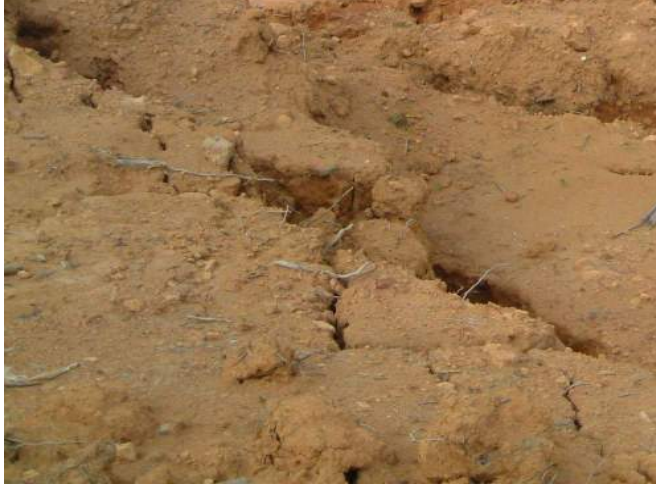
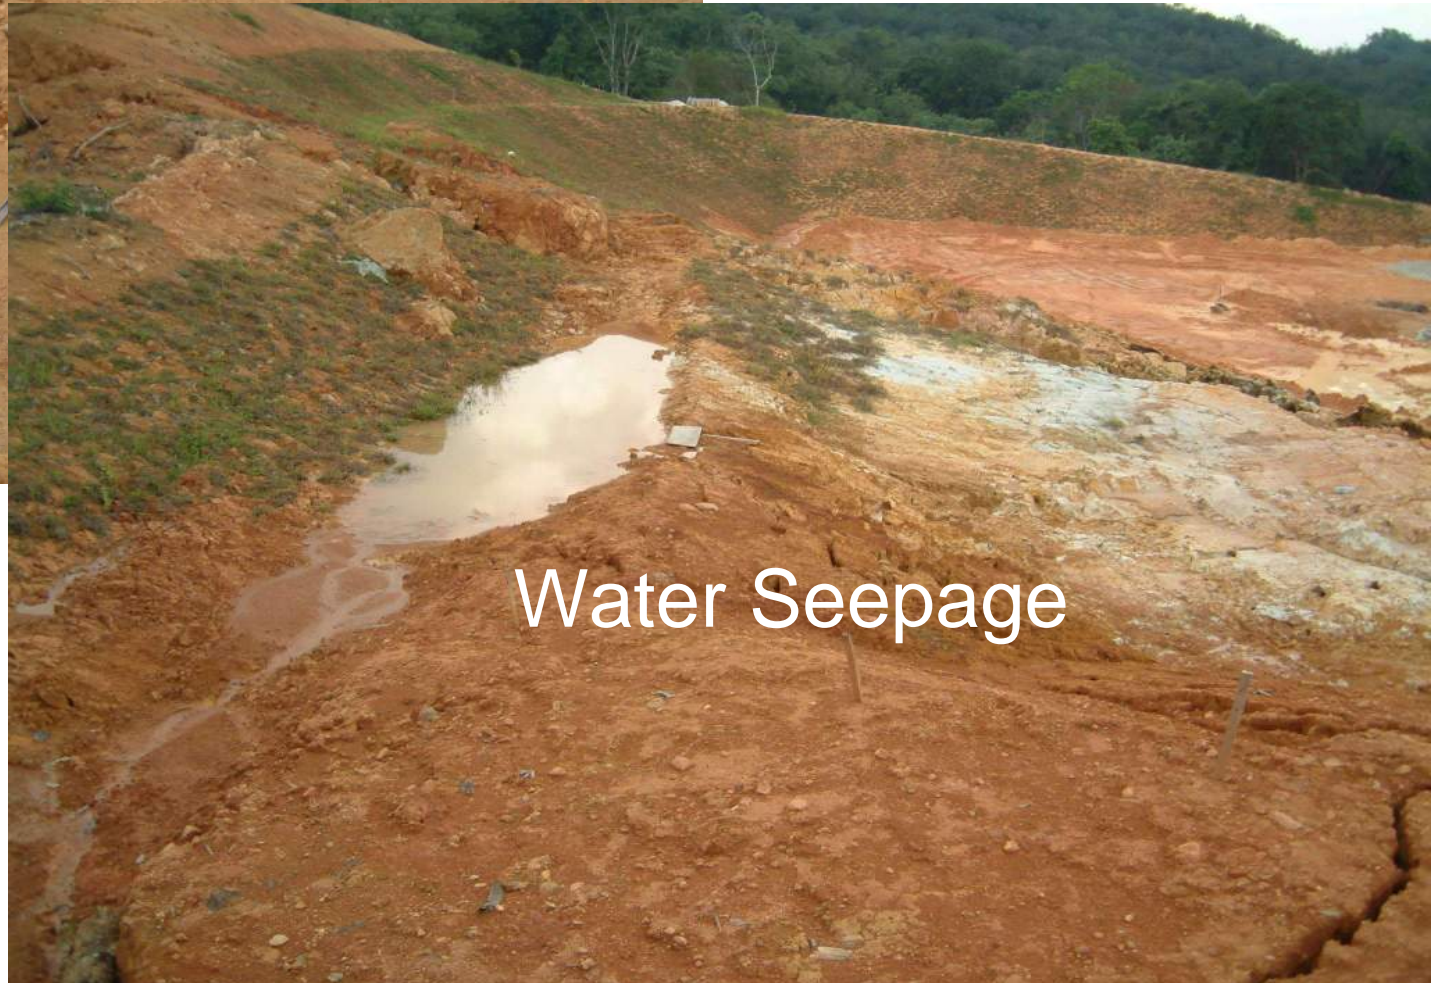
Water Seepage

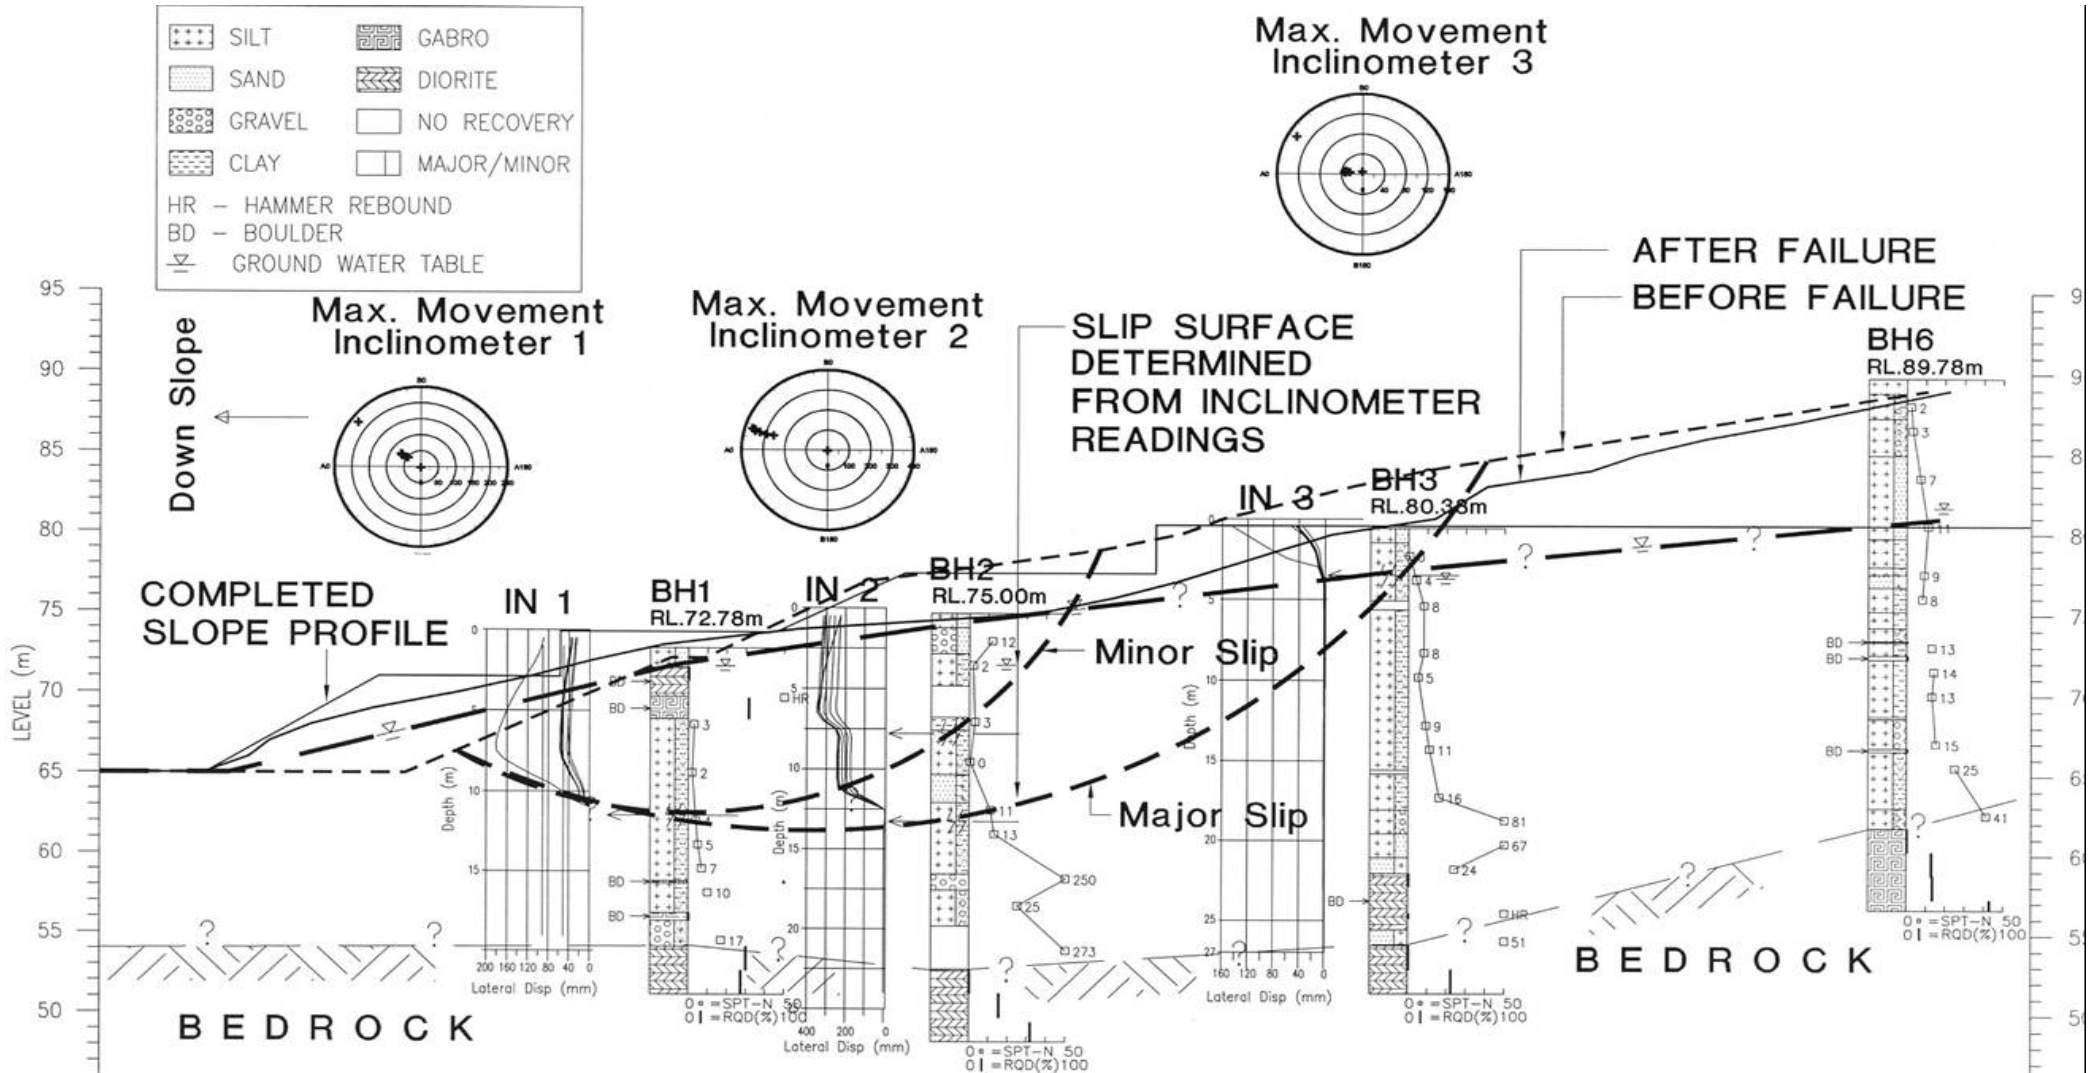
Interpreted Slip Surfaces

- IN-1 and IN-2 were sheared off at 10.5m and 12.0m below ground.
- IN-3 sheared off at 2.5m below ground.
- Observation wells were also sheared off.

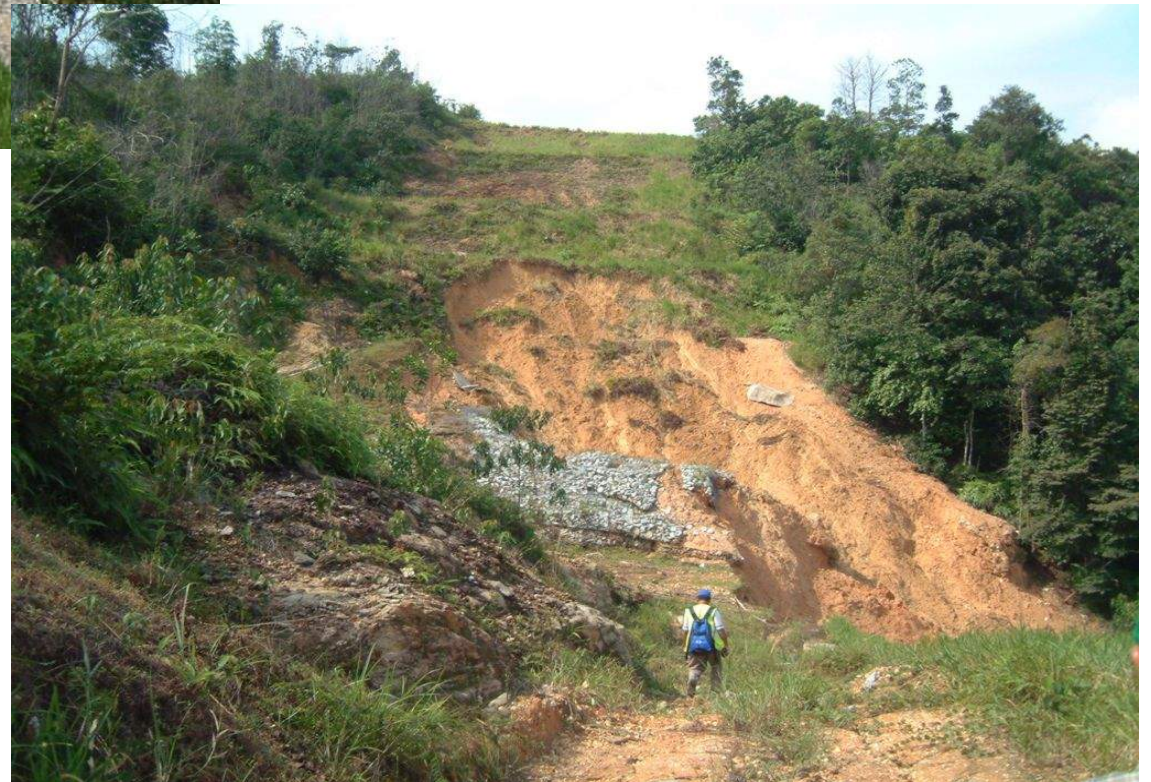
After Failure

- The platform of pipeline was saturated.
- Concrete drains were clogged.
- Debris, tree trunks and vegetations indicated surface runoff overflowed the platform and traveled downslope to valley.
- Failed mass traveled more than 120m downhill along valley.

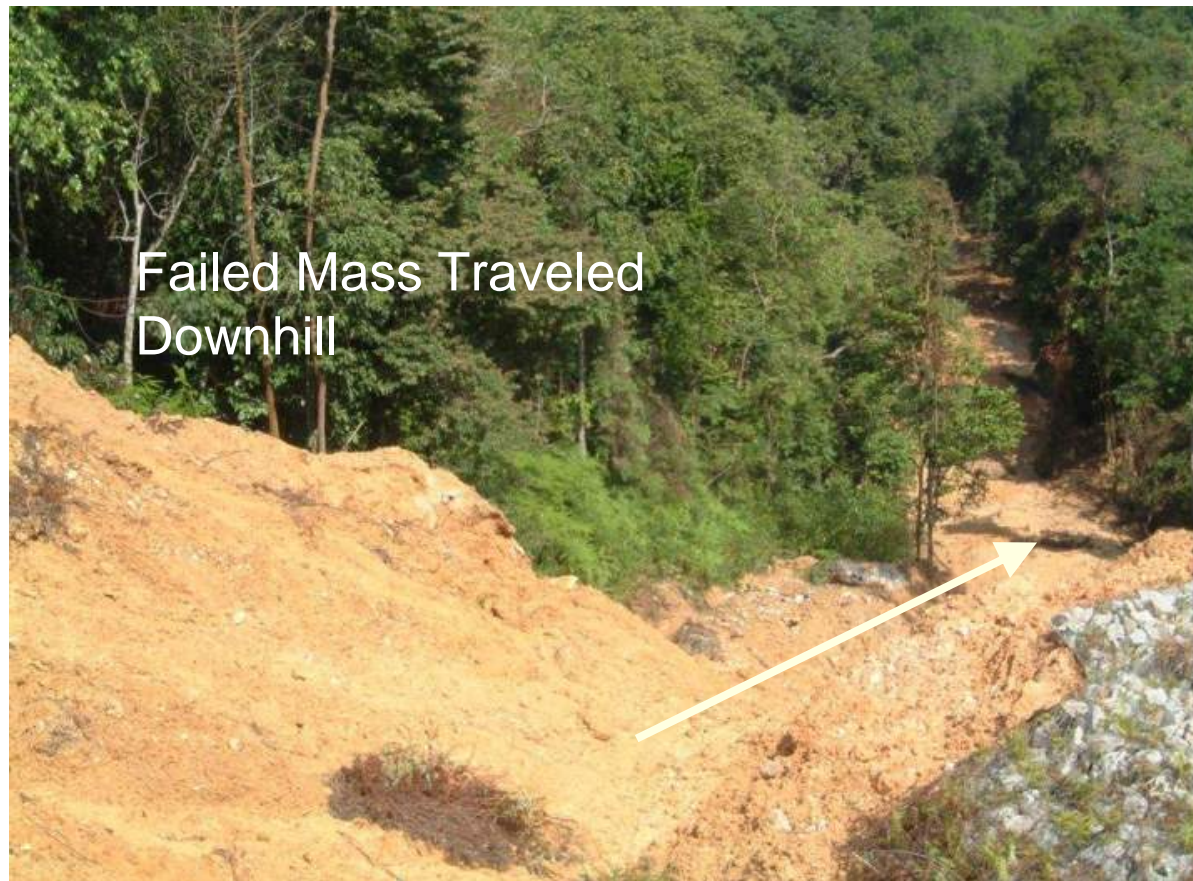
- Bedrock was observed at certain parts, indicating the failure resembles a slide along the bedrock surface.
