Two Case Studies of Collapsed Temporary Excavation using Contiguous Bored Pile Wall

Liew, Shaw-Shong & Loh, Yee-Eng G&P Geotechnics Sdn Bhd, Kuala Lumpur

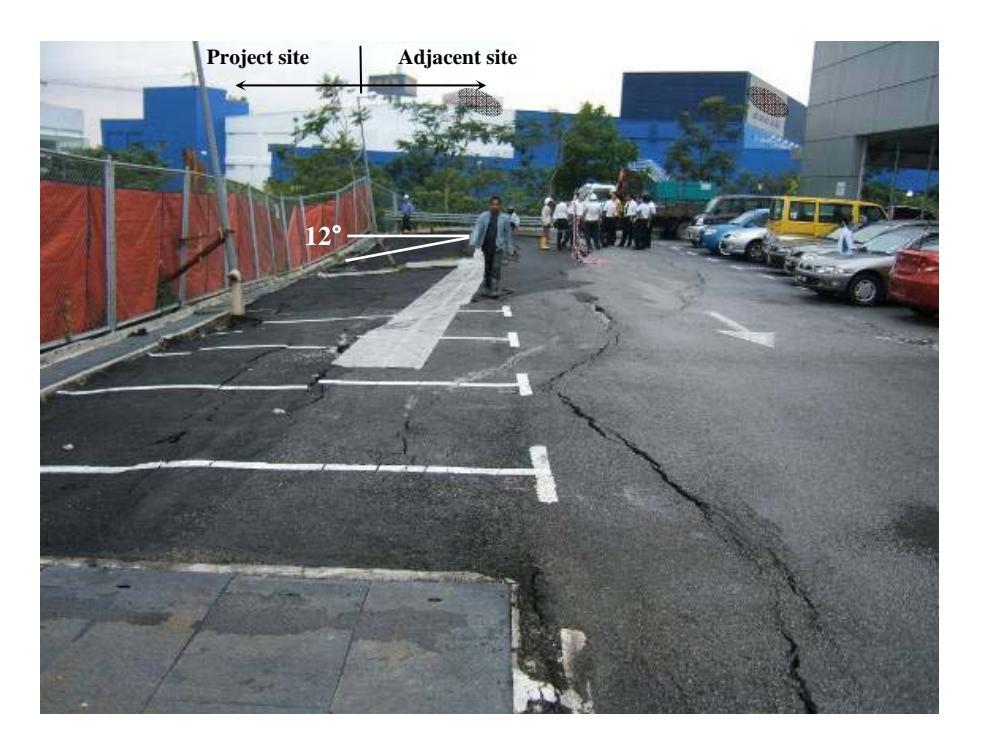
Figure 6. Site conditions of adjacent lot after the incidence of wall movement and ground distresses (Southward view).

It was observed that continuous tension cracks appeared at varying distance away along the sheet pile wall of approximately 73m long. The tension cracks were more distant away from the sheet pile wall at the southern end and became closer to the sheet pile walls toward northern end. At the time of inspection, more extensive excavation was carried out at the southern portion than the northern portion. The platform for the backyard car park of the adjacent lot had shown ground subsidence with tension cracks as shown in Figure 6 and Figure 7.

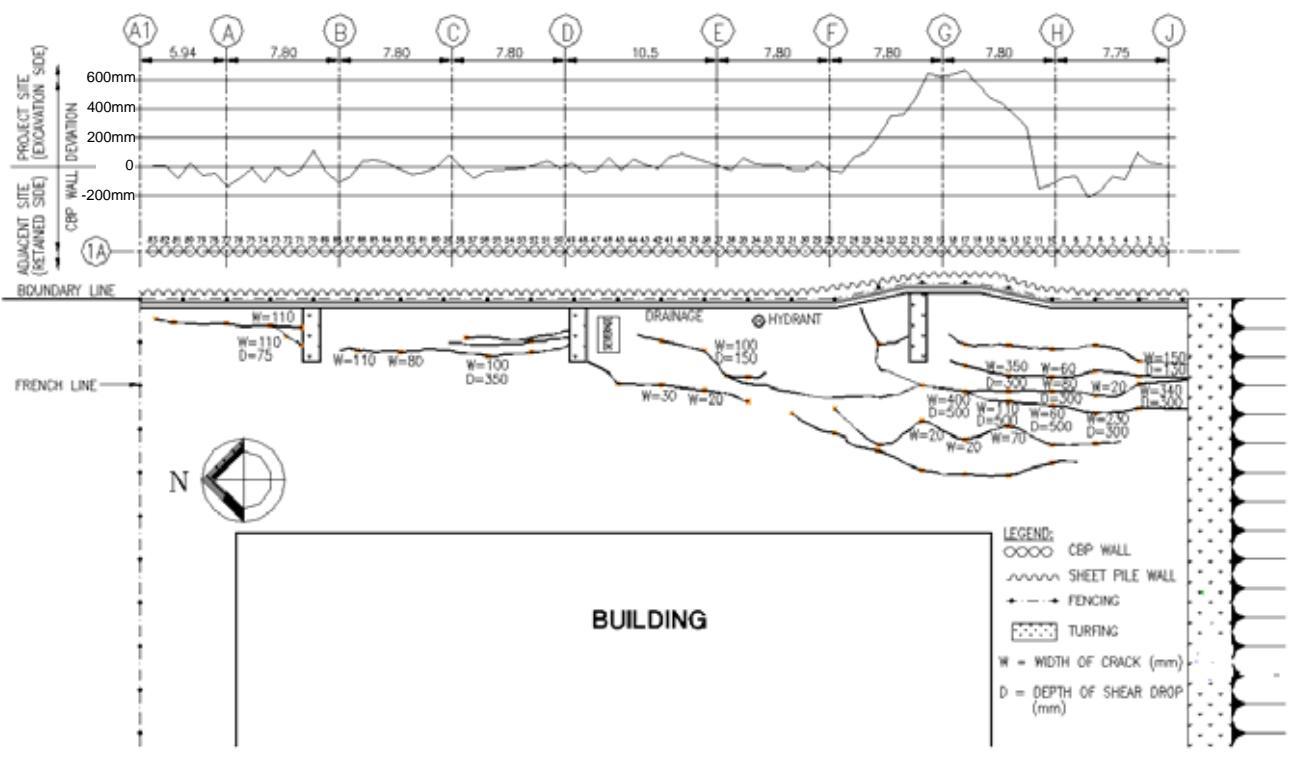
Figure 8. Crack mapping layout and CBP wall movement.

Site mapping had been carried out on the observed tension cracks and tilted sheet pile wall. Much more tension cracks were observed at the southern region. In this particular location, the sheet pile wall was seriously deviated outward relatively to the initial wall alignment. Efforts were made to map the crack lines by using measuring tape and slope meter. Figure 8 shows the details of mapped tension cracks. Generally, the worst tension cracks were measured with crack width of up to 400mm and shear drop of 500mm between the two dislodged earth blocks. At the critical location (Gridline G), the major crack line was measured at approximately 6.2m from the original fence line. While, the furthest crack line was measured at approximately 12m from the original fence line. In addition, the overall tilt angle of subsided platform at this area was crudely measured to be about 12° as shown in Figure 6. Sheet pile wall had also moved outward about maximum 1.2m from the initial wall alignment (at Gridline G). On the other hand, the measured pile top deviation of contiguous bored pile wall is also shown in Figure 8.

During the emergency repair work, the vibration effect of re-installing the temporary sheet piles wall by vibro-hammer had caused further tension cracks at the backyard car park platform. Therefore, it was suspected that the platform was of filled ground, which might not be well compacted as the effect of vibration might have caused soil densification and aggravated the creep movement.

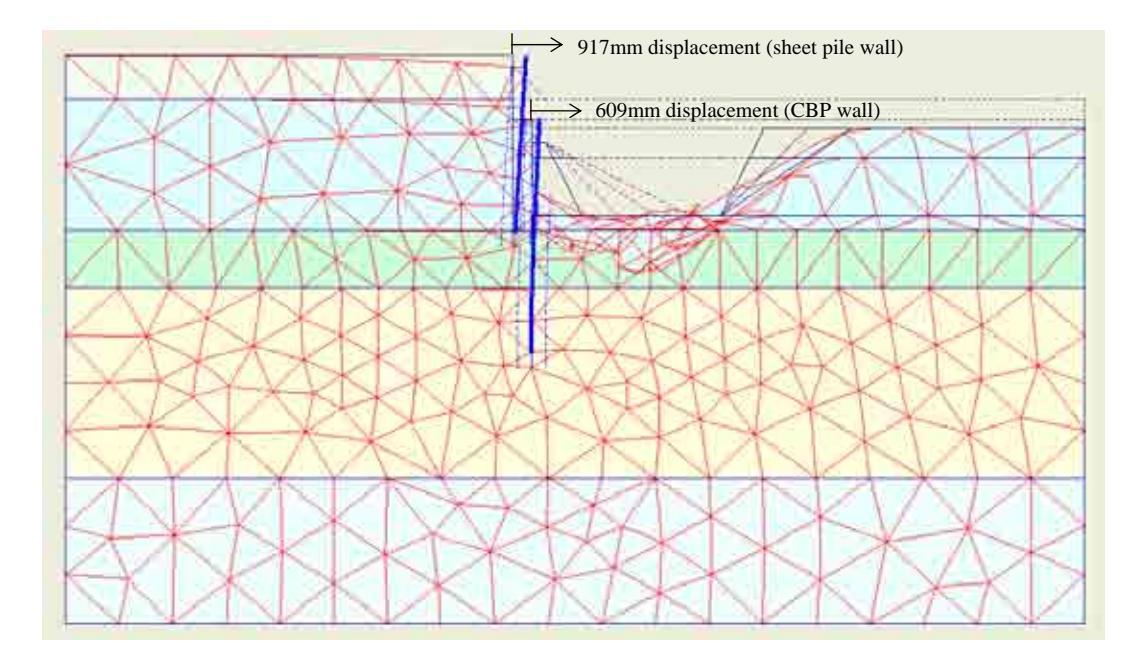
Figure 11. Results of finite element analysis.

At the analysis stage where over-excavation in front of the wall was carried out, the analysis results revealed that the retained earth platform displaced excessively in the horizontal and vertical (settlement) directions with the temporary sheet pile retaining wall moving forward. As part of the lateral resistance to the temporary retaining walls by the passive berm was removed before installation of raking strut, over-excavation of this passive berm had reduced the lateral resistance to the sheet pile wall and subsequently mobilised the structural strength of the retaining walls beyond serviceability state condition reaching towards the ultimate limit state condition. The excessively displaced temporary sheet pile wall had induced additional lateral force to the installed contiguous bored piles (CBP) walls. The high induced flexural stress unavoidably damaged the CBP pile. The results of FE analyses (see Figure 11) reasonably well agreed with the measured wall movements and ground deformations (e.g. tension cracks, settlement and depression).

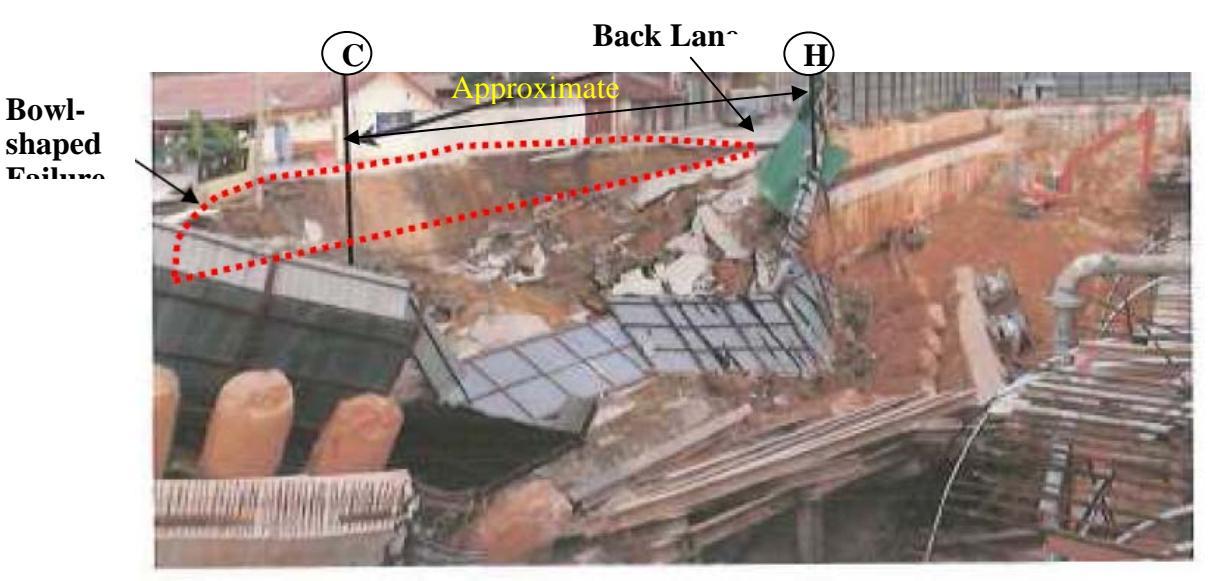
Figure 14. Collapsed CBP between Gridlines C and H.

This case history involved construction of two-level basement in city area using CBP wall with temporary strutting. About 40m stretch of CBP wall collapsed, after the water pipe burst incident at the back lane reported 3 hours ago as shown in Figure 14.

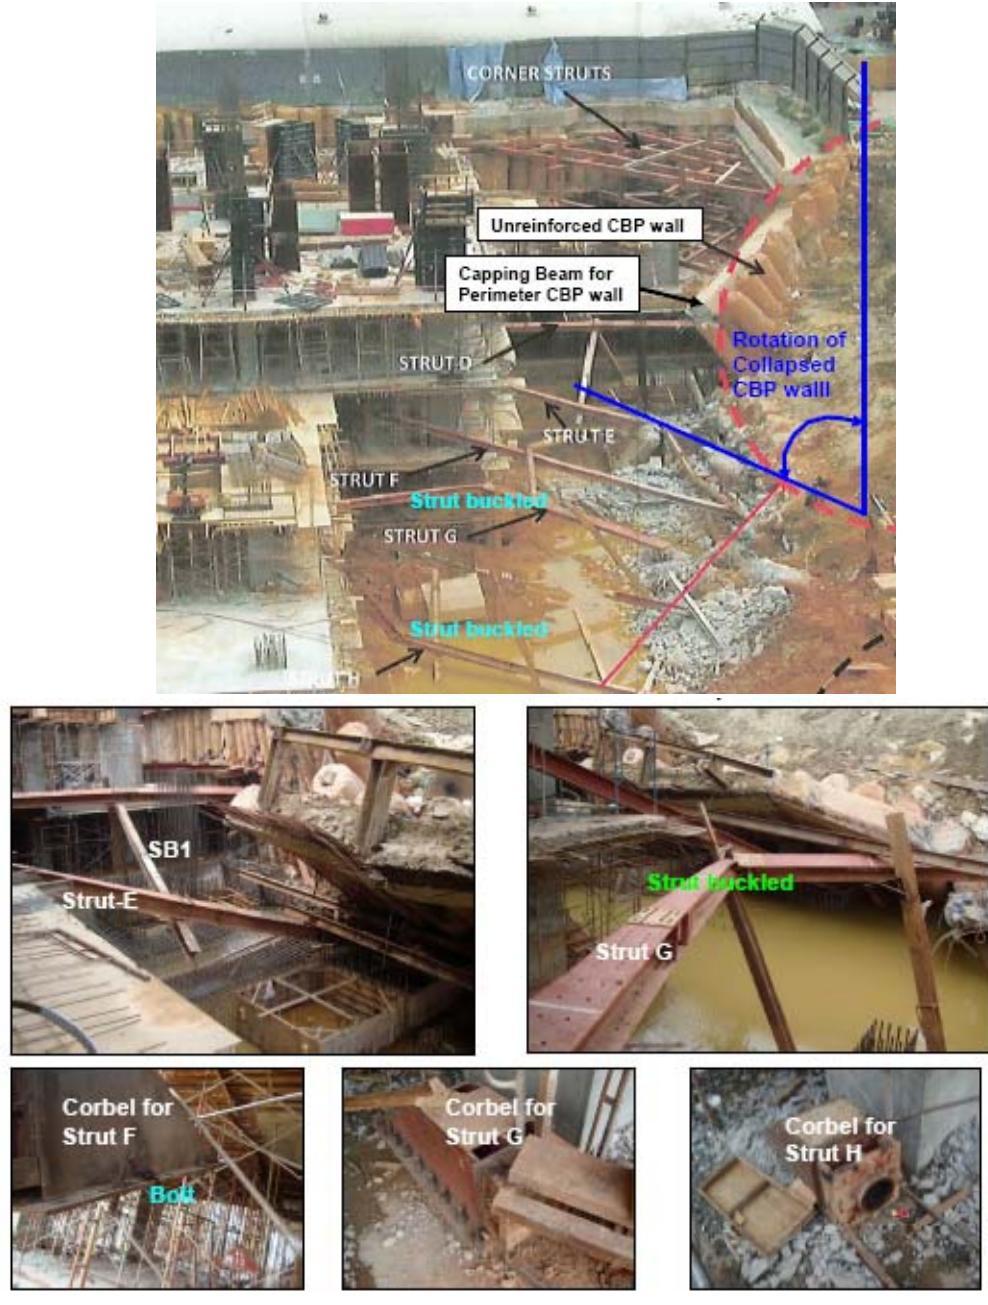
Figure 16. Site condition and strutting details after CBP wall failure.

During the site visit, it was observed that central portion (Gridlines C to H) of CBP wall had collapsed; single inclined struts at Gridlines G and H were observed buckled and disconnected from steel corbels while steel corbels at Gridlines D, E and F mounted at Basement 1 slab were completely sheared off. The unreinforced CBP wall and perimeter CBP wall fell rotationally and leaning towards the excavation face as shown in Figure 16.

From Figure 16, it was sufficiently evident that all the post-installed bolts at struts D, E and F were completely sheared off. Hence, these struts were modelled in FEM back analysis as elasto-plastic anchor element.

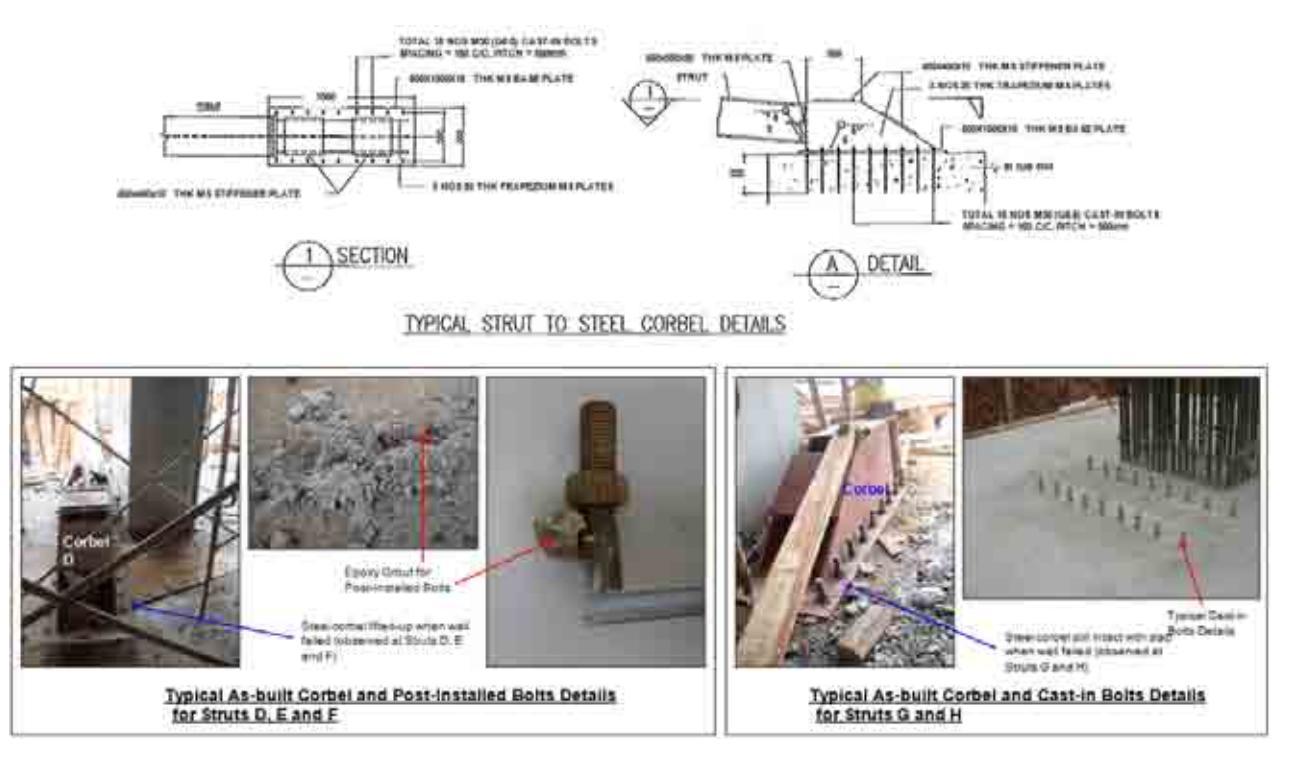
Figure 18. As-built corbel and anchored bolts details

Figure 18 shows post-installed bolts were adopted for steel corbels at Gridlines D, E and F and cast-in bolts were used for steel corbels at Gridlines G and H. The steel corbel was lifted-up with snapped post-installed bolting connection after wall collapse indicating that the steel corbel corbel connections for struts at Gridlines D, E and F are the weakest link of the entire strutting system.

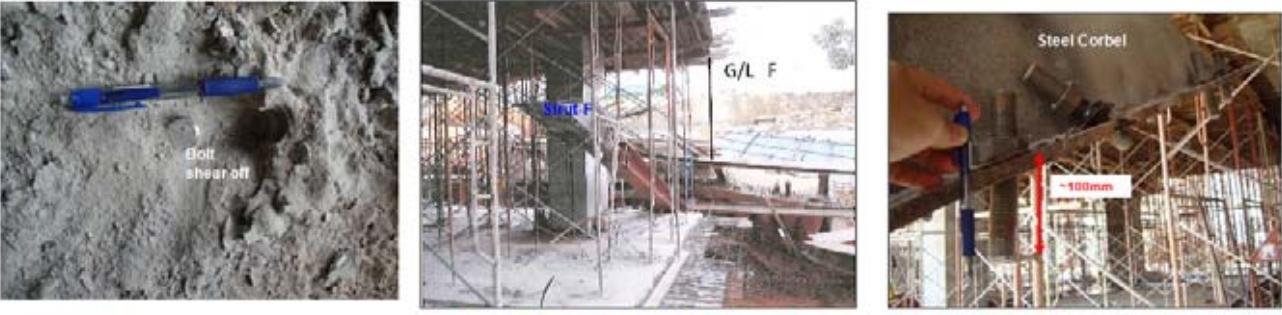
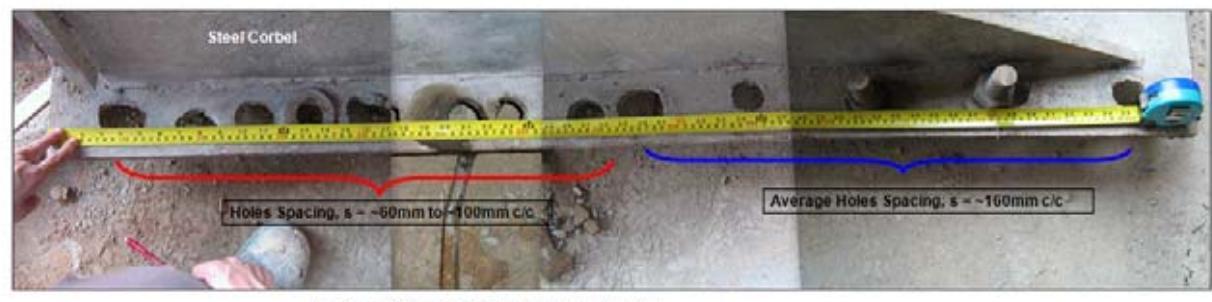
Figure 19. Steel corbel with post-installed bolting connection after wall failure.

Other than that, Figure 19 also shows that the cut holes at steel corbel for Strut F were not complied with the allowable dimension permitted by Table 33 of BS 5950-1:2000. This again would lead to uneven distribution of strut loads onto bolting connection possibly resulting into progressive failure of bolts which may further reduce the overall capacity of the strut.

Bolt shear off

Steel Corbel with Post-installed Bolting Connection was Lifted-up After Wall Failure

Post-installed Bolts After Wall Failure

- c. The strut forces also increased as a result of the increase in lateral wall pressure.
- d. The steel corbel connections at Struts D, E and F, especially the large hole cutting for accommodating the poorly positioned bolts, would have resulted in uneven distribution of shear force from the struts. Hence, the total shear resistance with probable progressive failure of bolts would be lower than the simple summation of the shear resistance of individual bolts (3375kN). With the increasing strut load, the bolts at the steel corbels sheared off and led to total loss of support for the CBP wall.

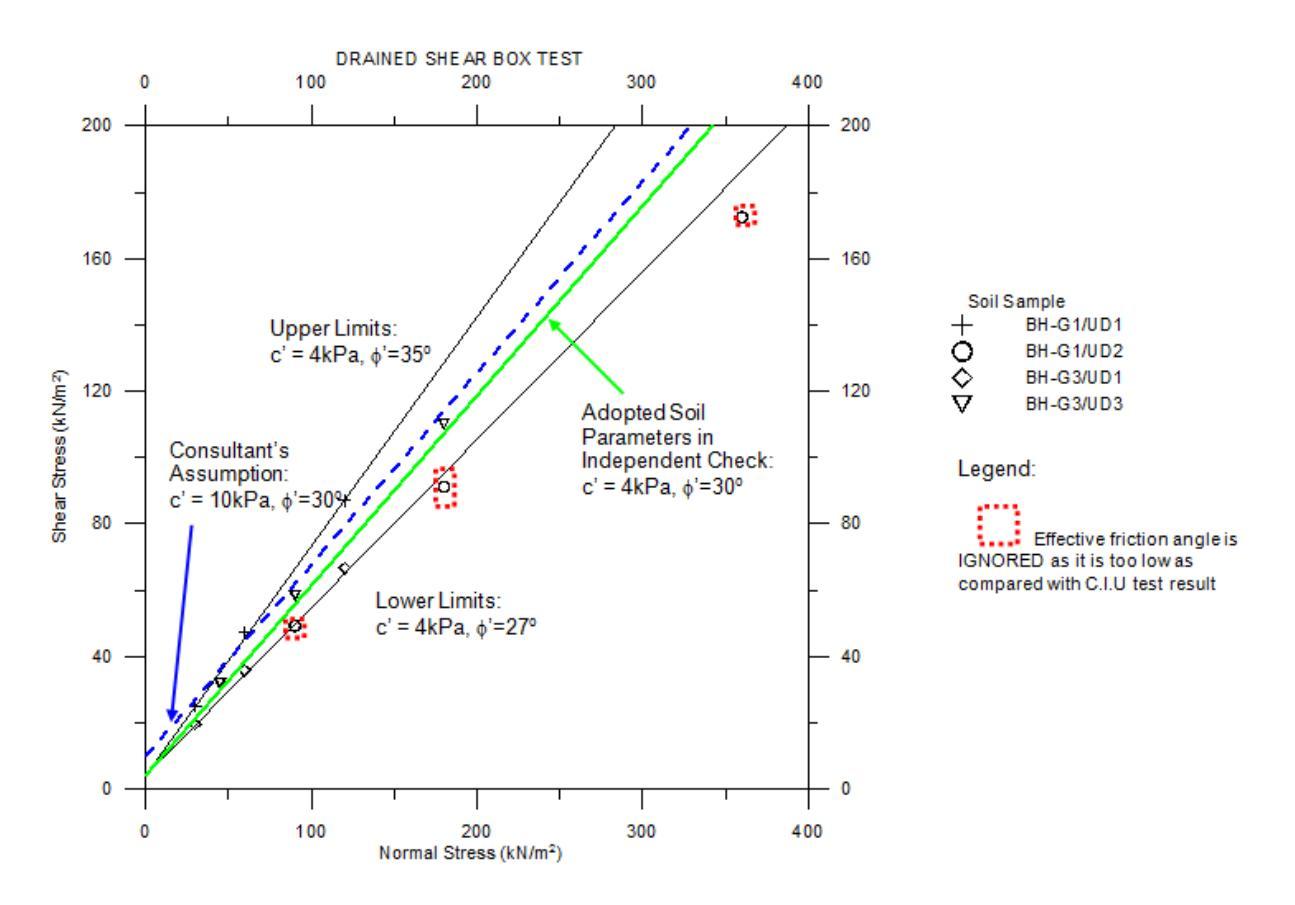
Figure 24. Interpreted shear strength parameters from drained shear box test.

Figure 24 shows upper and lower bound envelopes of shear strength parameters from drained shear box were c' =4kPa and ϕ' = 35° for former while c' =4kPa and ϕ' = 27° for the latter. For this investigation, moderate strength parameters of c' = 4kPa and ϕ' = 30° were selected for the overburden soil layer. Same effective friction angle of 30° was adopted in the consultant's design except for higher apparent cohesion c' value of 10kPa was adopted.

It is evidenced that the adopted high apparent cohesion is not justified from the interpreted strength test results above. The apparent cohesion has significant impact to the assessment of lateral earth pressure. A small increase in the apparent cohesion will reduce significantly the lateral earth pressure. Hence, it would be necessary to be prudent in assessing the cohesion parameter.

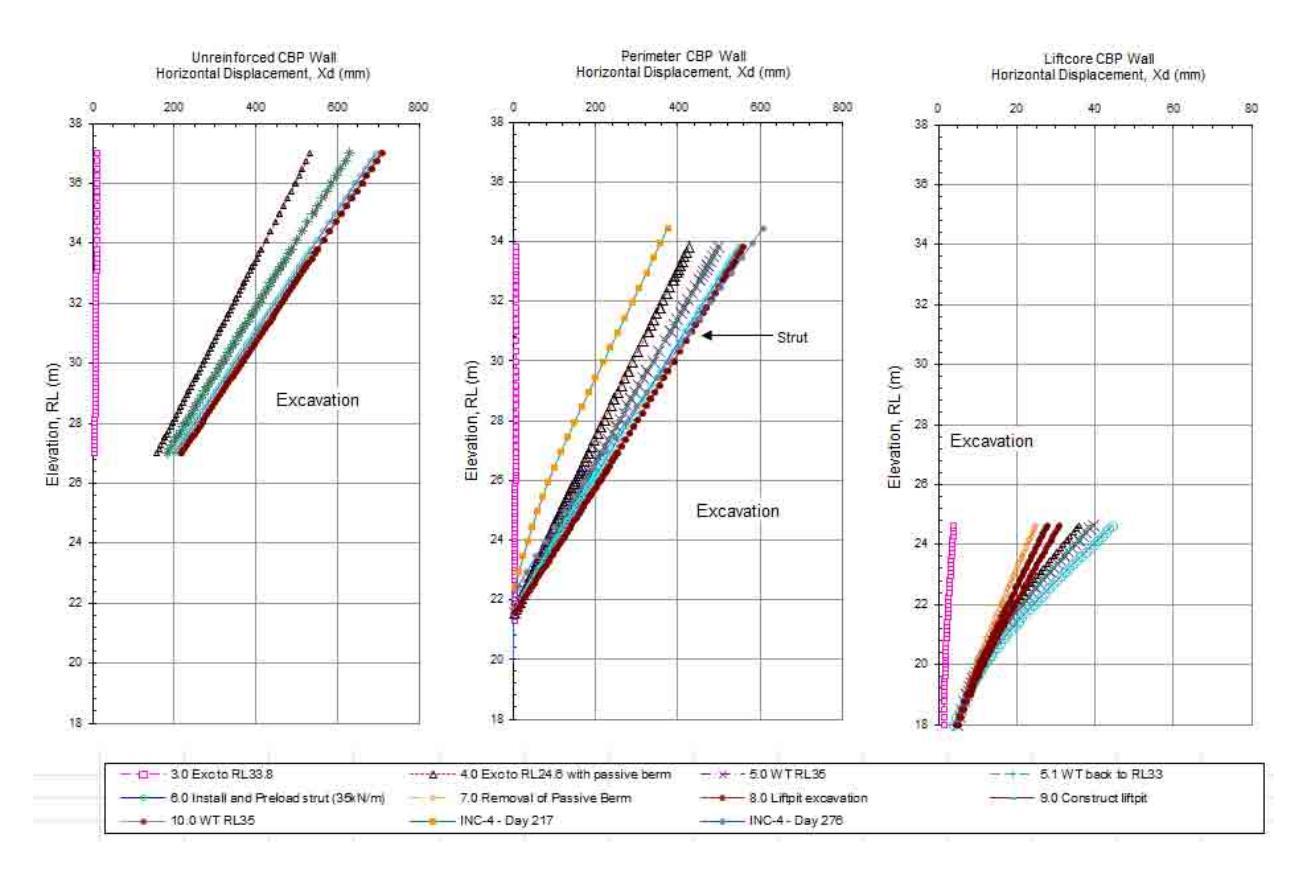
Figure 27. Modelled CBP wall deflections Vs monitoring results for INC-4.

Repetitive water pipe burst incidents at the back lane had contributed to massive movement of CBP wall prior to the CBP wall collapse incident as highlighted in Figure 25. Therefore, water pipe burst incidents happened on Day 206 and Day 227 were taken into consideration in FEM analysis for best fitting the inclinometer readings. Figure 26 and Figure 27 show the FE mesh and predicted CBP wall deflections for back-analysis.
