Common Blind Spots in Ground Investigation, Design, Construction, Performance Monitoring and Feedbacks in Geotechnical Engineering

Ir. Liew Shaw Shong

G&P Geotechnics Sdn Bhd, Kuala Lumpur, Malaysia

Lessons Learnt on Stability of a Piled Retaining Wall in Weak Soils

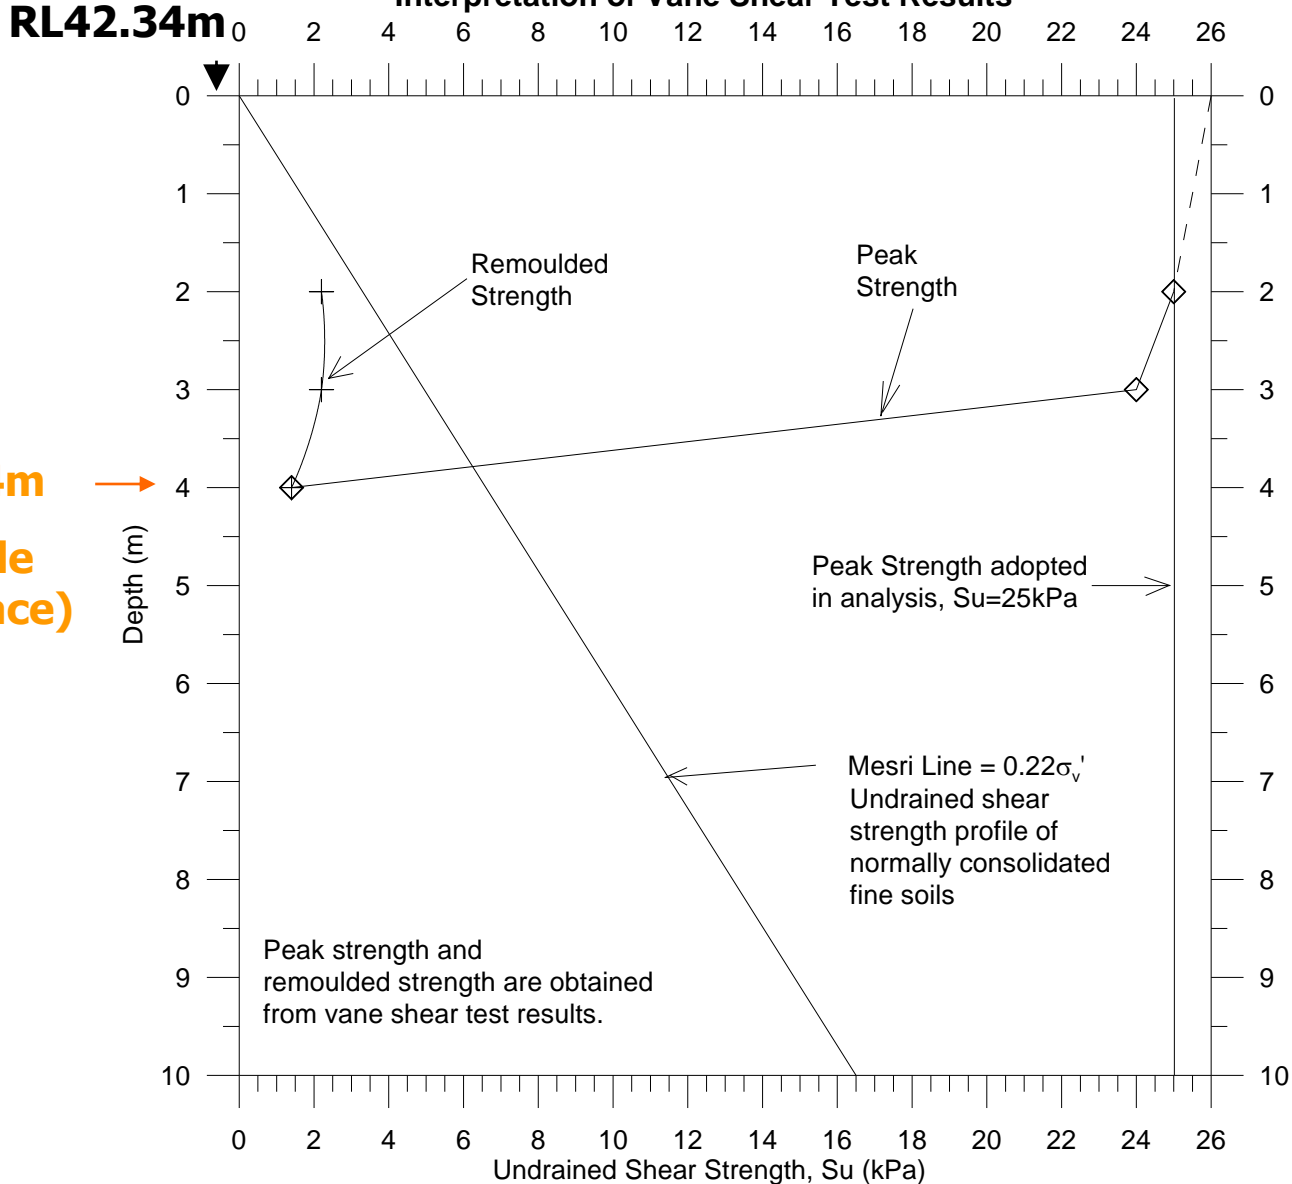
Interpretation of Vane Shear Test Results

RL38.34m
(Possible Slip Surface)

Peak strength and remoulded strength are obtained from vane shear test results.

Peak Strength adopted in analysis, $S_u=25$ kPa

Mesri Line = $0.22\sigma'_v$
Undrained shear strength profile of normally consolidated fine soils

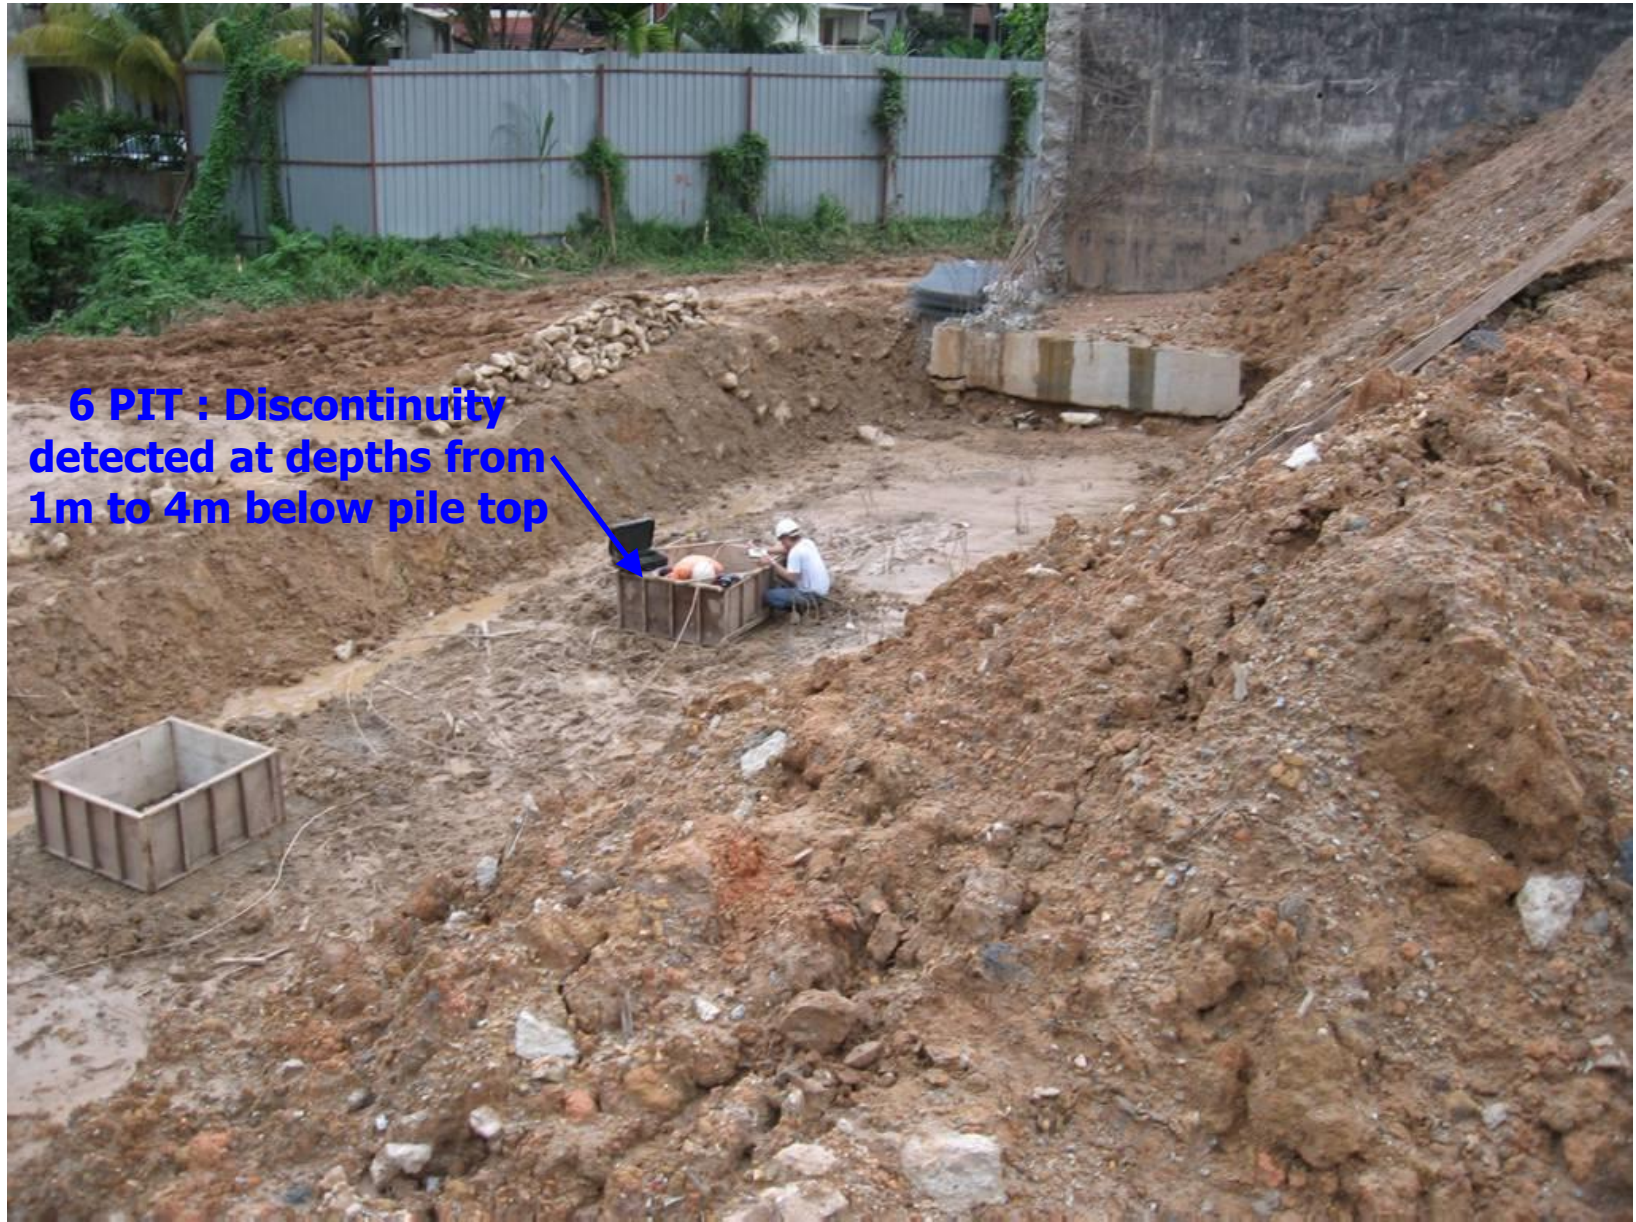
Pile Integrity Testing

**6 PIT : Discontinuity
detected at depths from
1m to 4m below pile top**

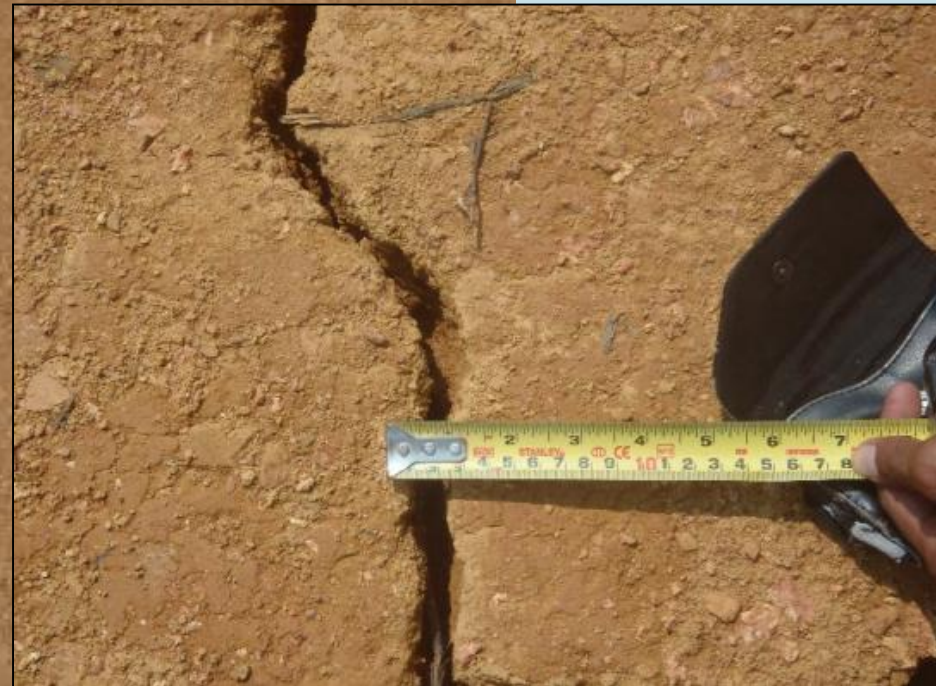
Embankment Distresses

Alligator cracks
observed on site.

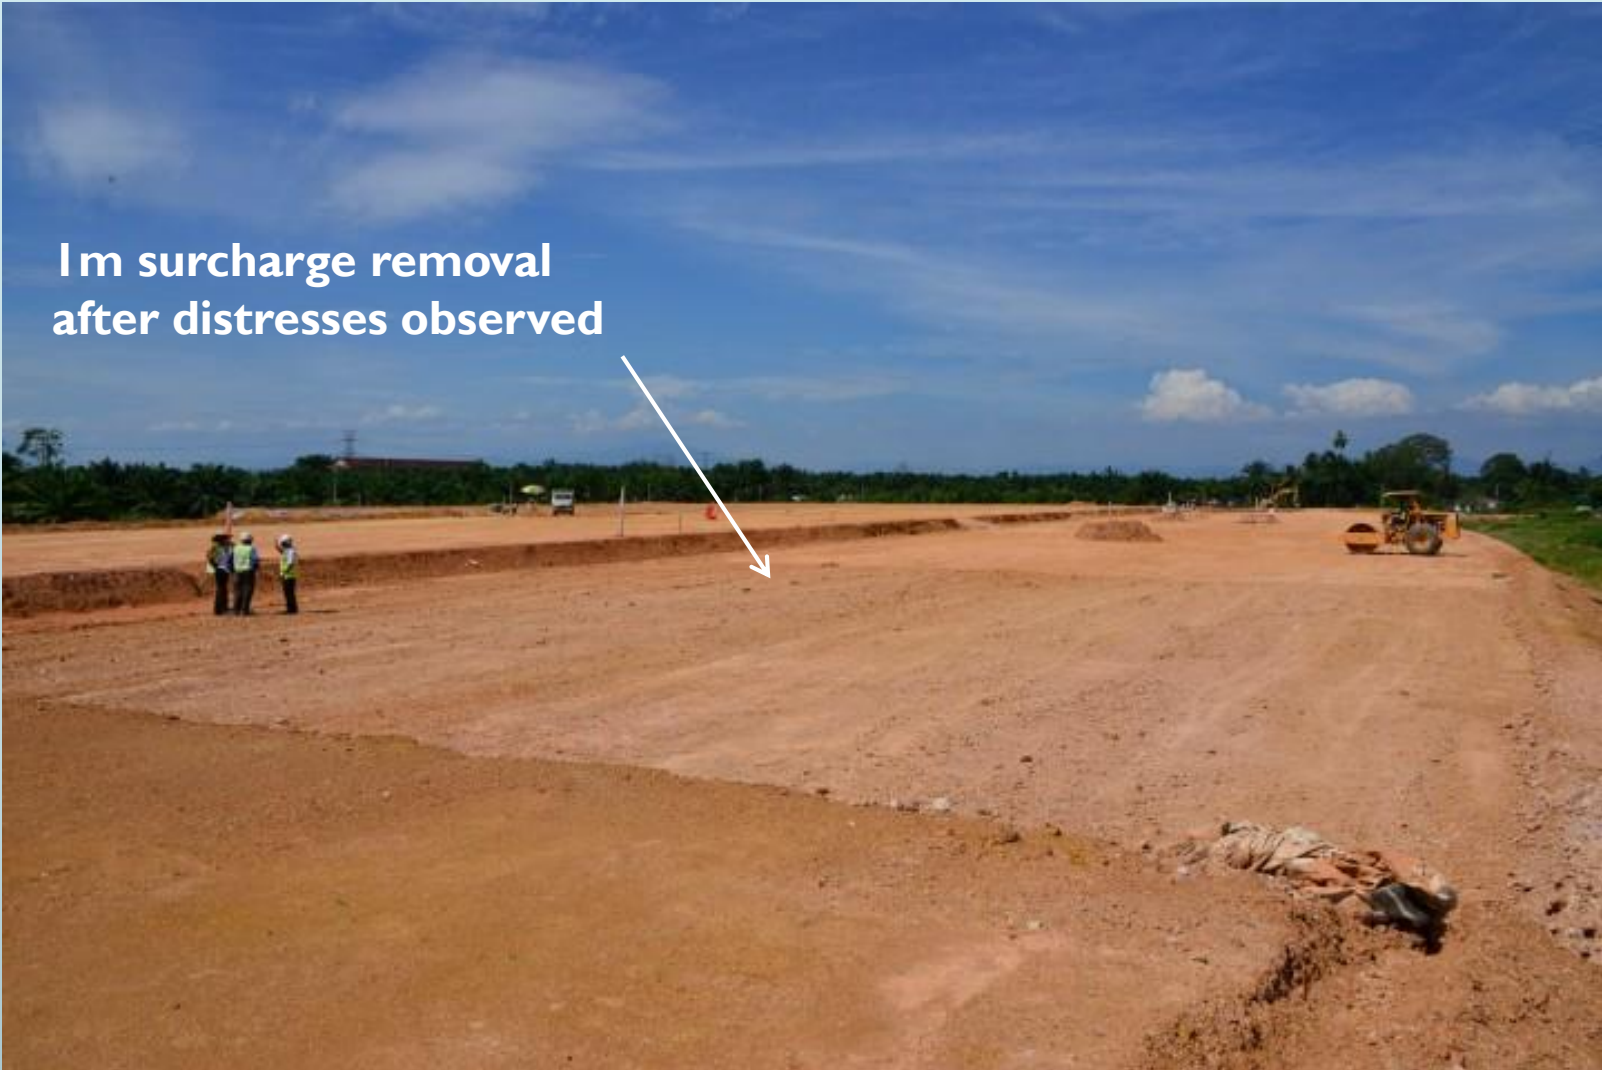
Embankment Distresses

**1 m surcharge removal
after distresses observed**

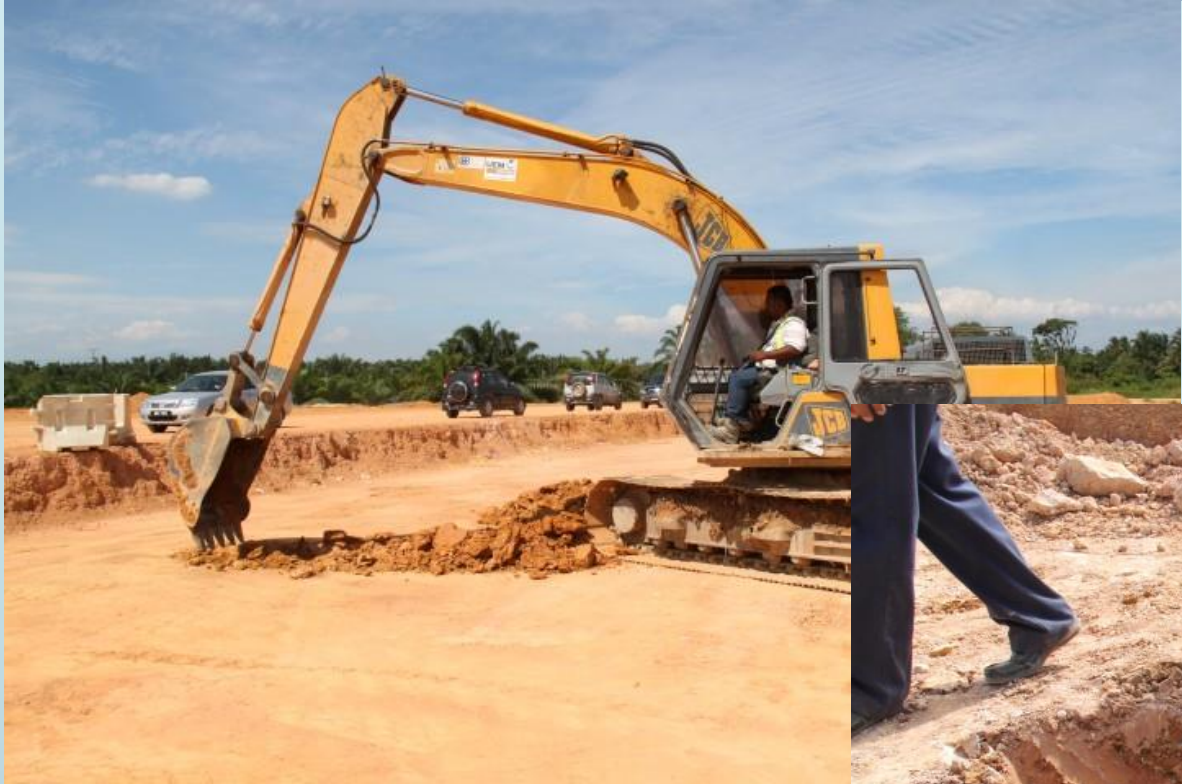
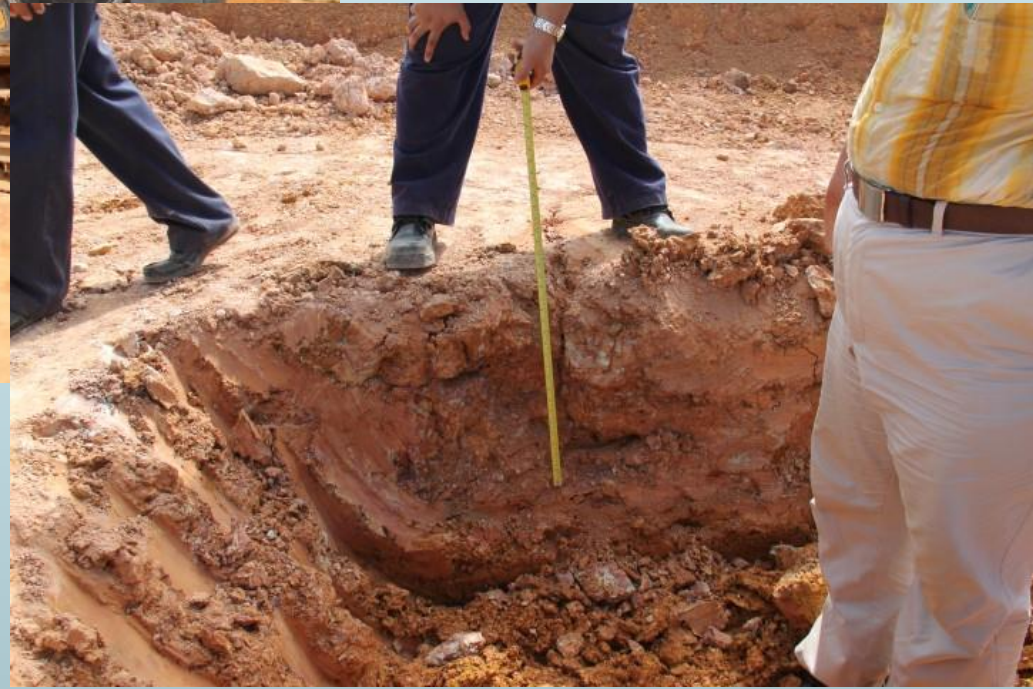
Embankment Distresses

Excavation on cracks found after 1m surcharge removal

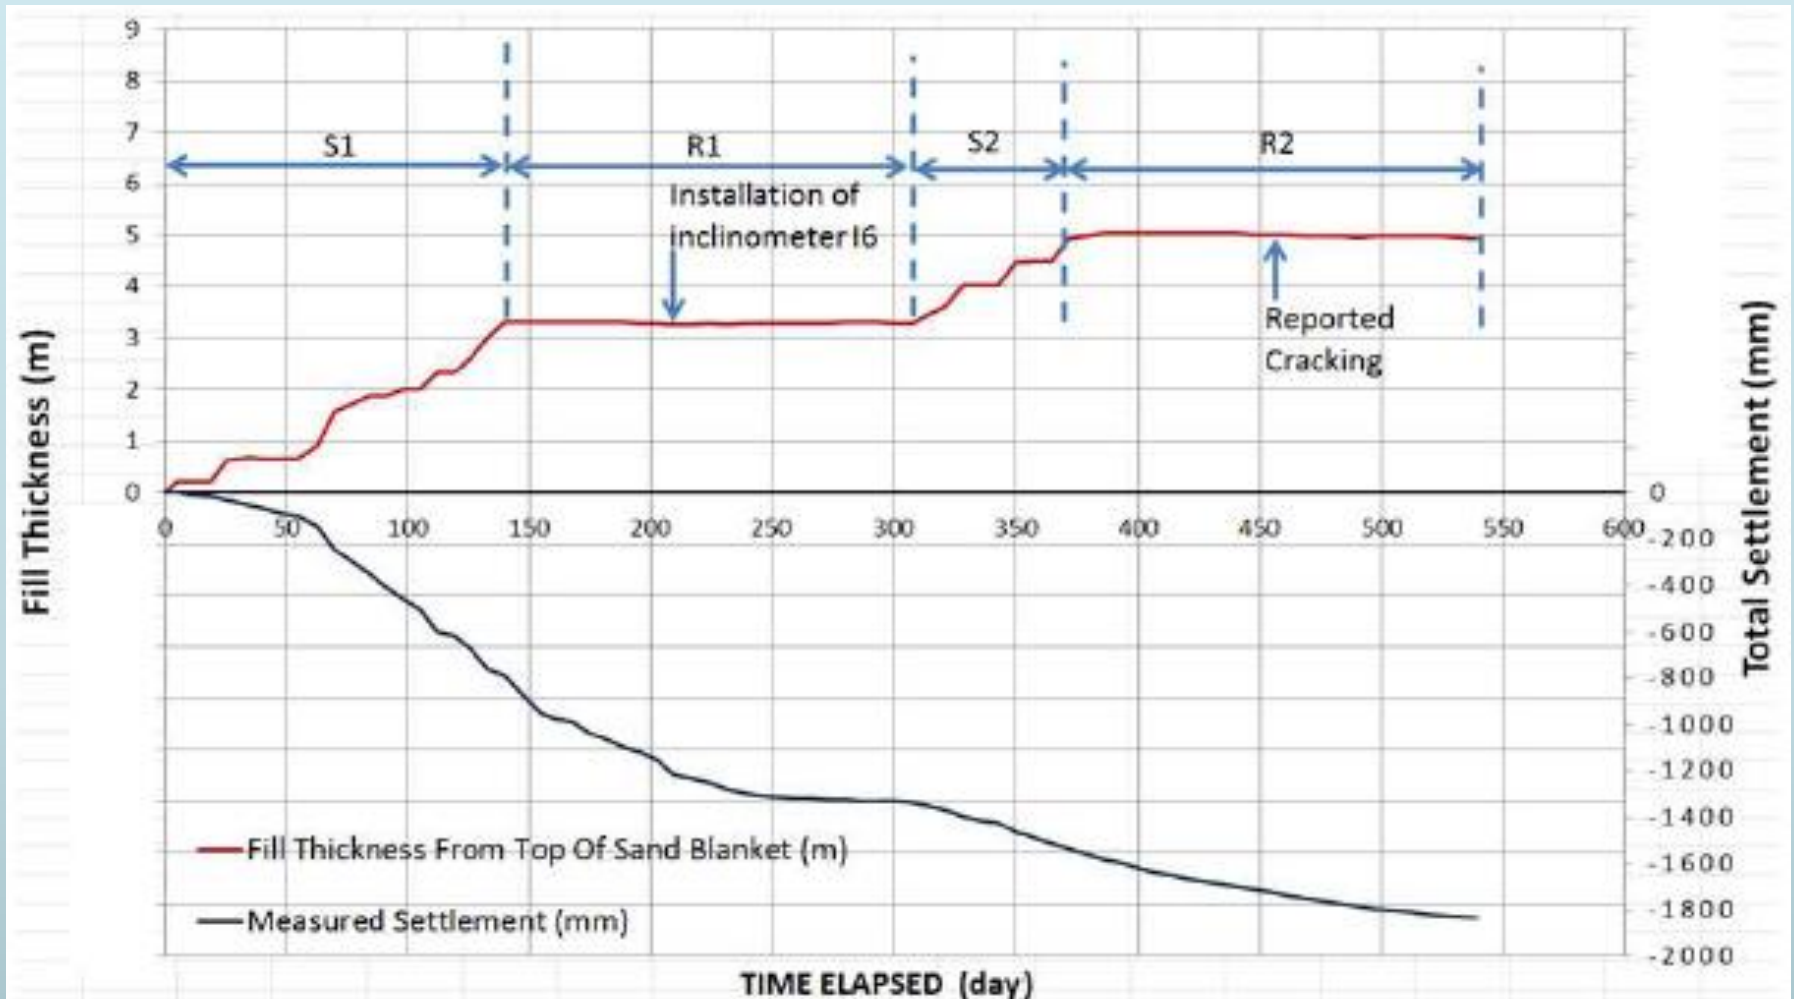
Fill Thickness and Settlement of Embankment with time monitoring by SG580

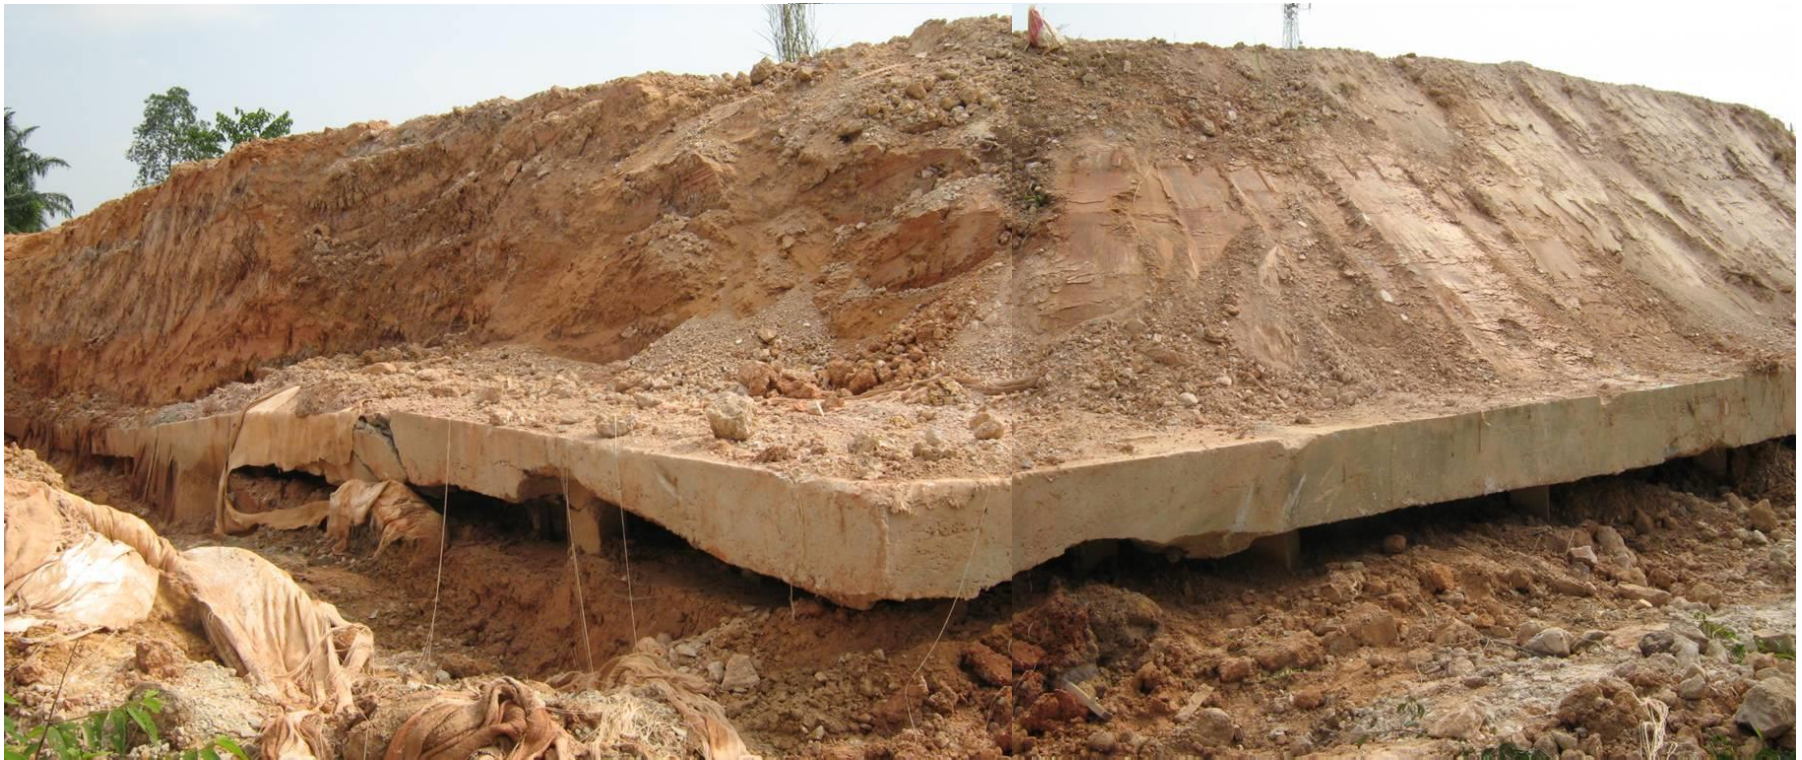
- ▶ Piled Embankment 30m from Abutment B shown structural distress

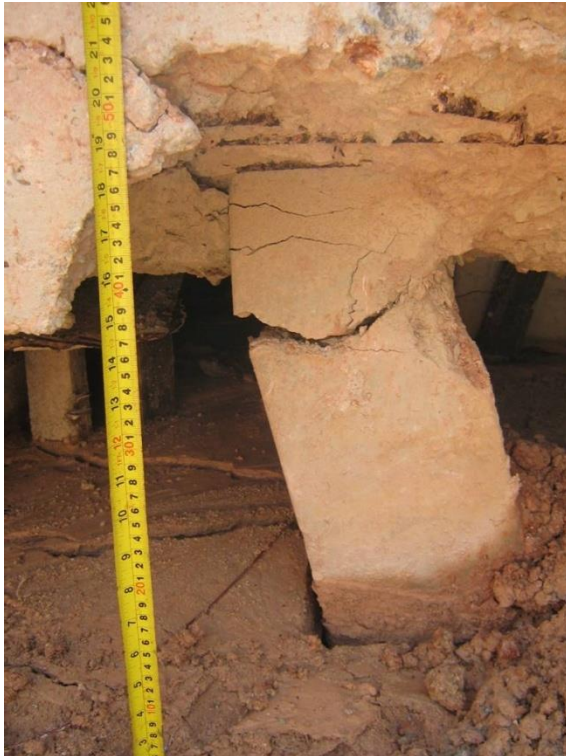
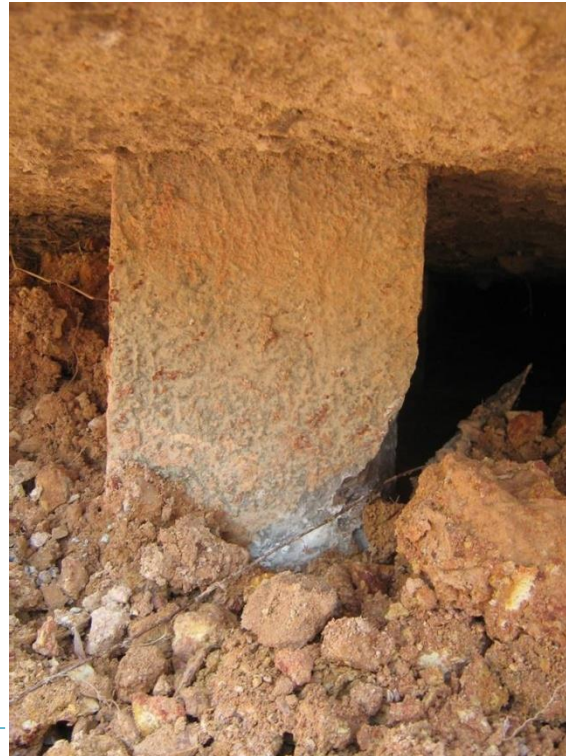
- ▶ Piles of Piled Embankment has shown flexural cracks

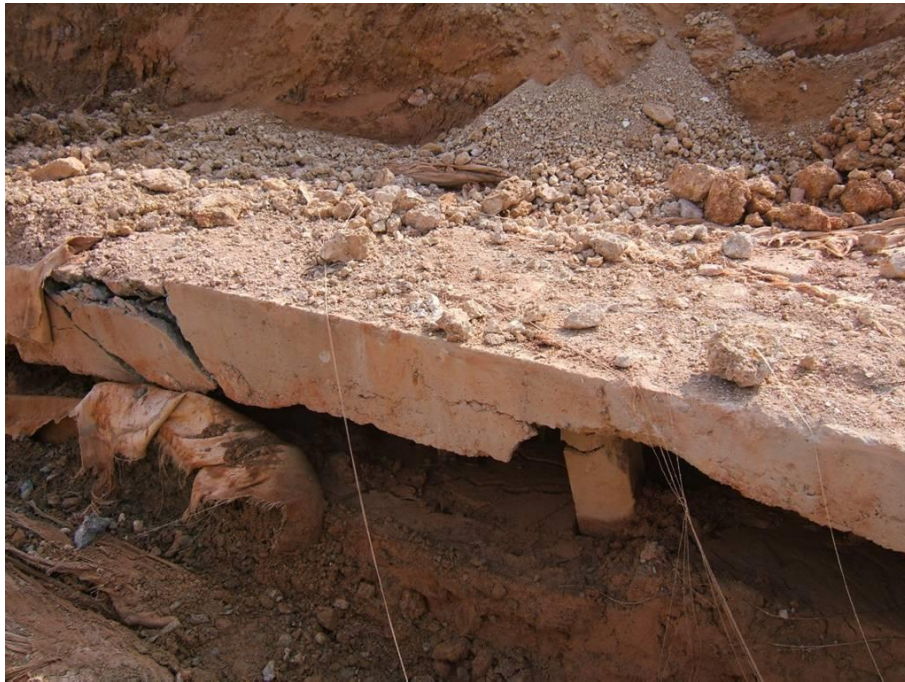
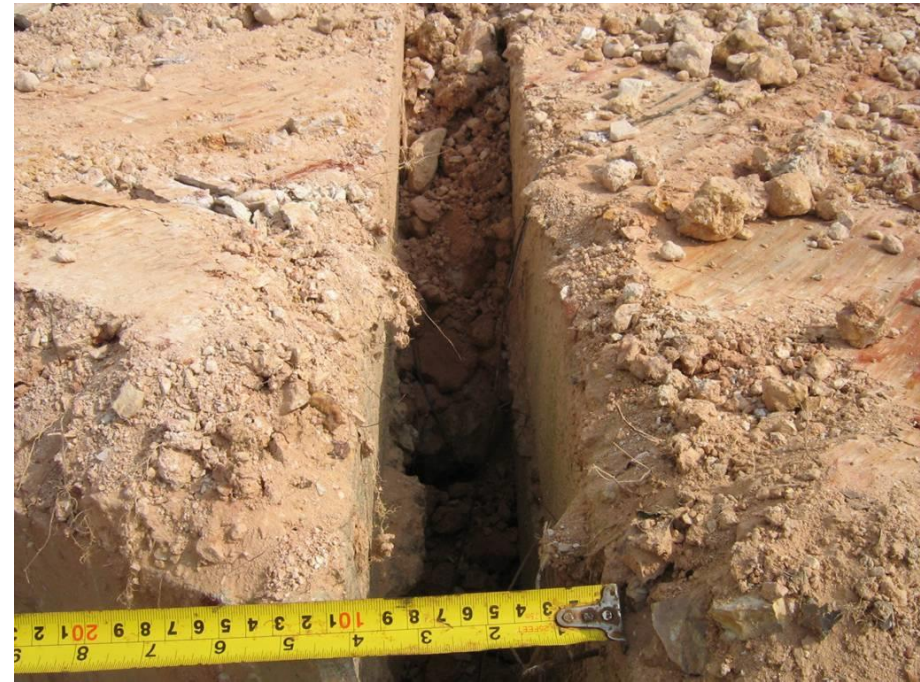
- ▶ Damaged piled embankment slab damaged & 100mm gap at slab joint

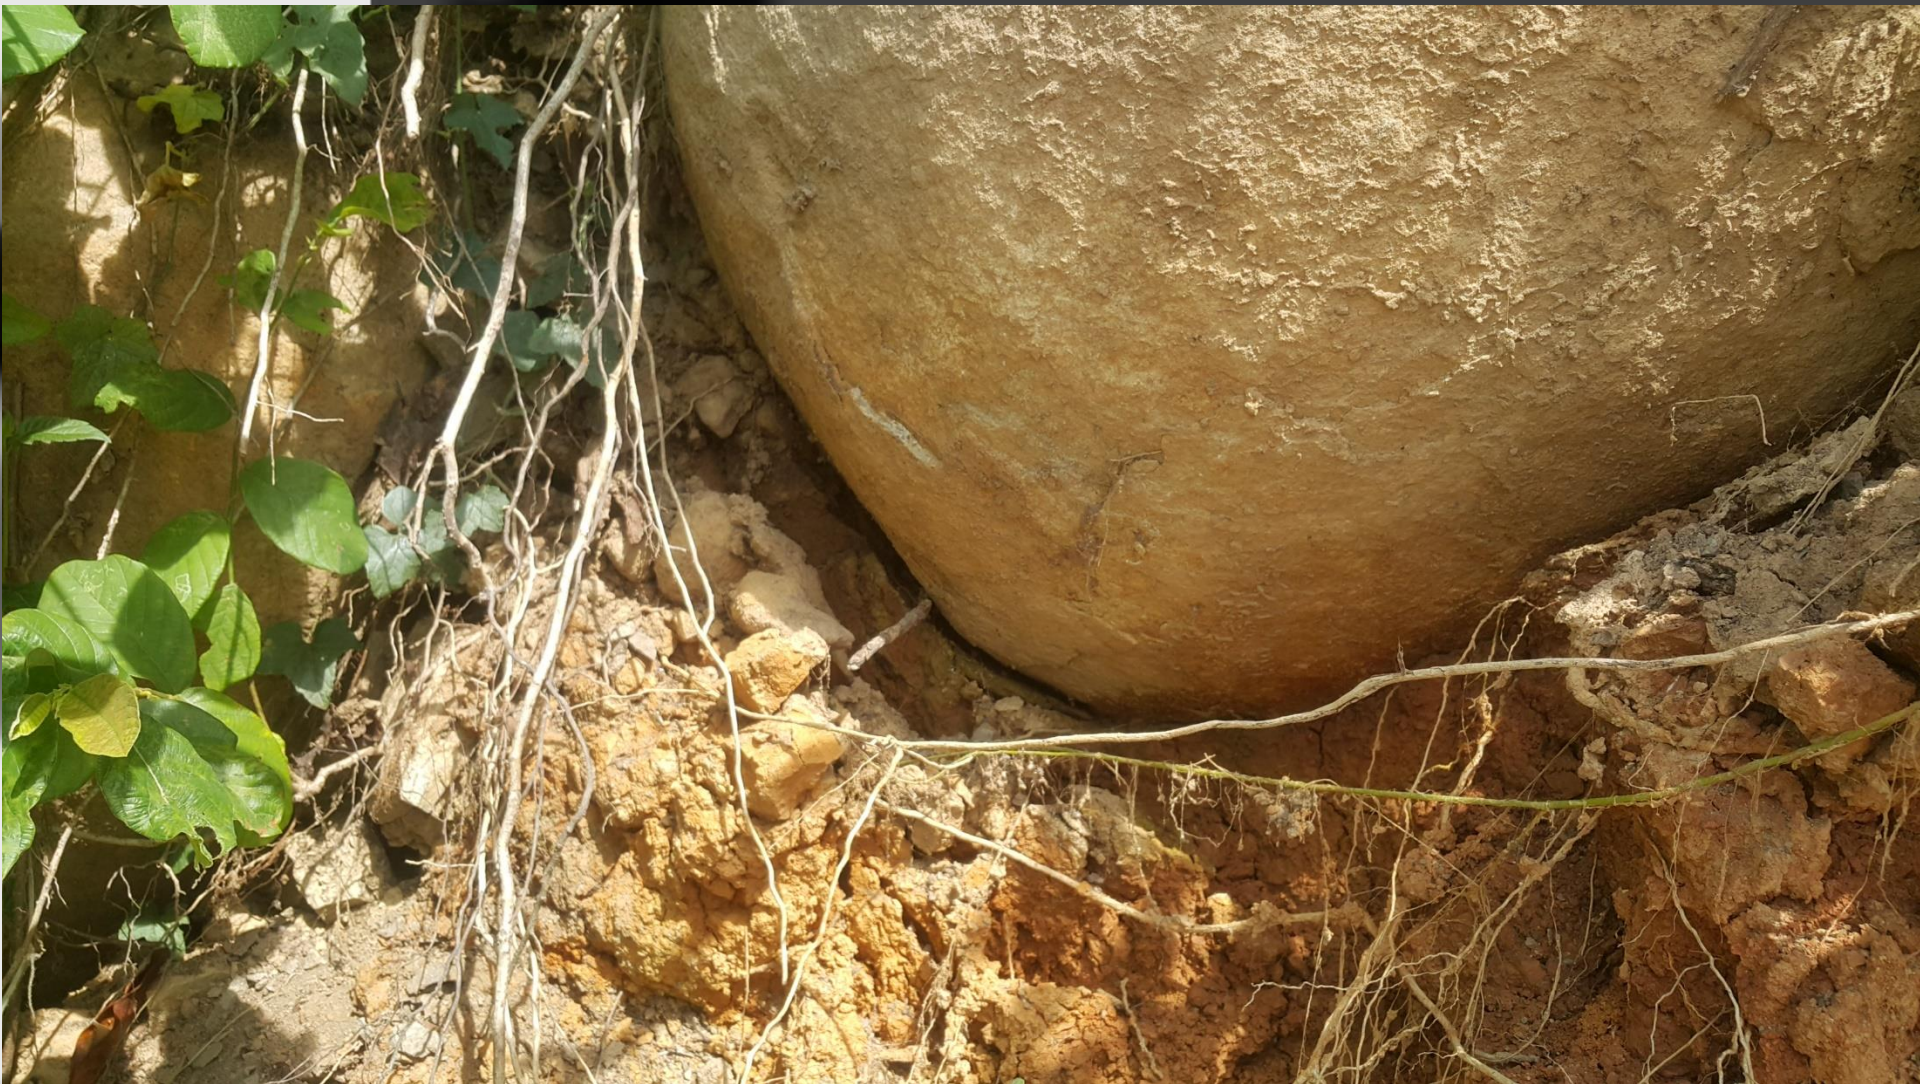
Volumetric Shrinkage of Exposed Soil

- With intention of minimized earthwork cutting forming any platform, soil nailed slope profile is normally steep
- Facing capacity has remarkable effect on Internal Stability of steep soil nailed slope
- Volumetric swelling & shrinkage of soils with moisture variation are realistic observation
- Moisture depletion after covering with shotcrete surface results in volumetric shrinkage of slope soil face leaving air gap with separation of contact with shotcrete
- Mobilisation of face capacity in uncontacted slope surface is unrealistic, thus giving incorrect safety margin of slope stability
