# Investigating and Mitigating Measures to Peat Fire, Sinkholes in Limestone Formation and Boulder Fall

Shaw-Shong Liew, Chee-Leong Low & Shu-Feng Ho  
*G&P Geotechnics Sdn Bhd, Kuala Lumpur*

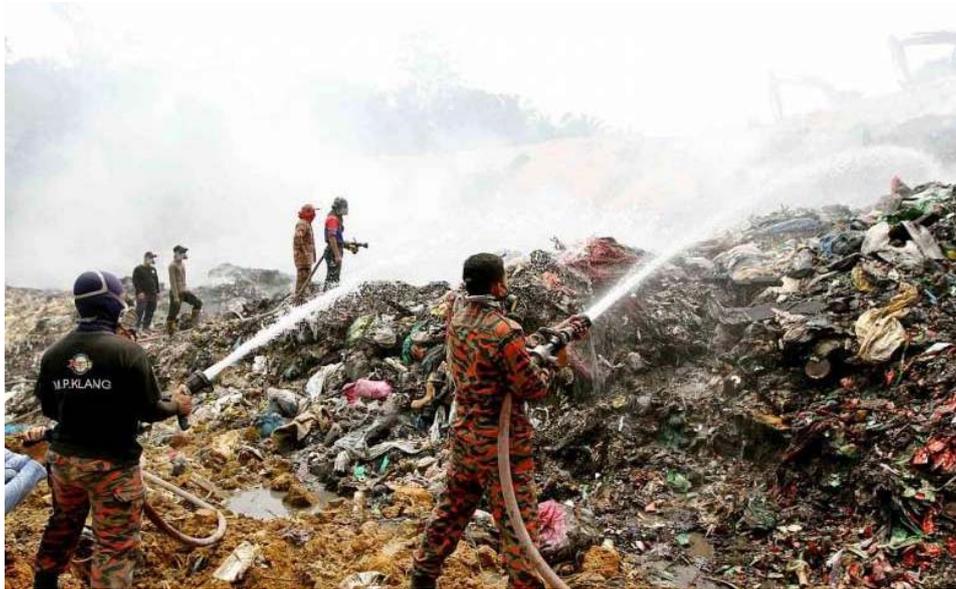
Plate 1: Firefighters putting out blazes at an illegal waste dump in Klang (The Straits Times)

Peat fires characterize with low temperature, spreading slowly across vast areas and flameless like a smoldering coal, which is difficult to be put out when burning underground. This is quite similar to the fire at dump sites, which produce flammable methane from microbial decomposition of organic wastes as shown in Plate 1. Often the trash at certain illegal landfill was burnt by scavengers looking for valuable scrap metal.

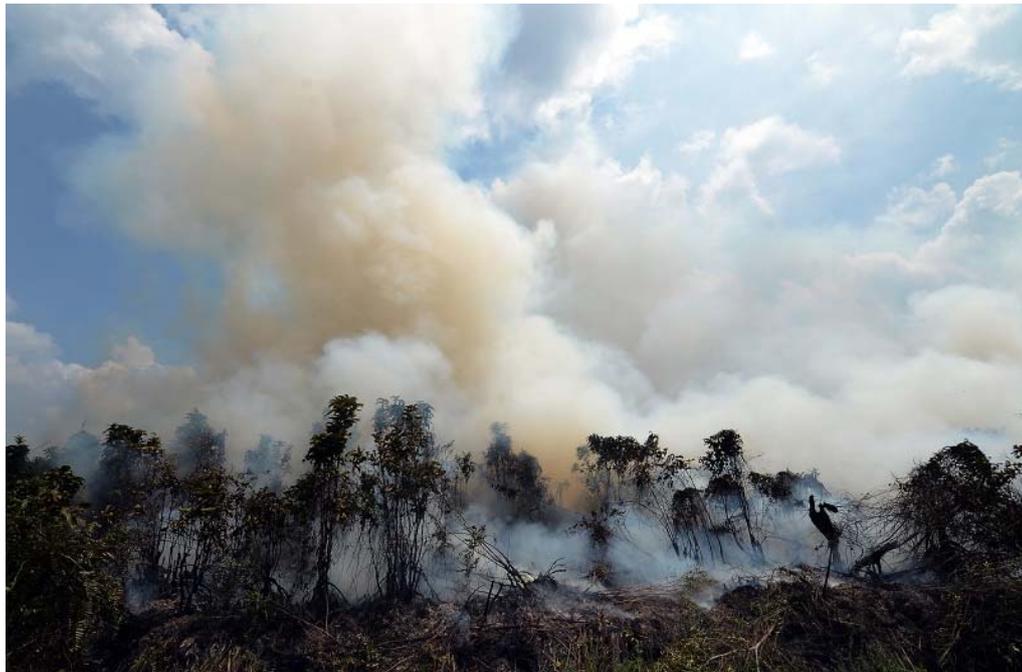
Plate 2: Emission of GHG and toxic gases under action of peat fires at peatland and the consequential bush fires at Sepang, Selangor

- Emission of greenhouse gases (GHG), like carbon dioxide, methane, nitrous oxide (laughing gas) escalating the global warming effect, and some toxic gases, likes carbon monoxide, nitrogen dioxide and nitrogen monoxide. Plate 2 shows the generation of such GHG emission in action of peat fires with consequential bush fires during drought season.

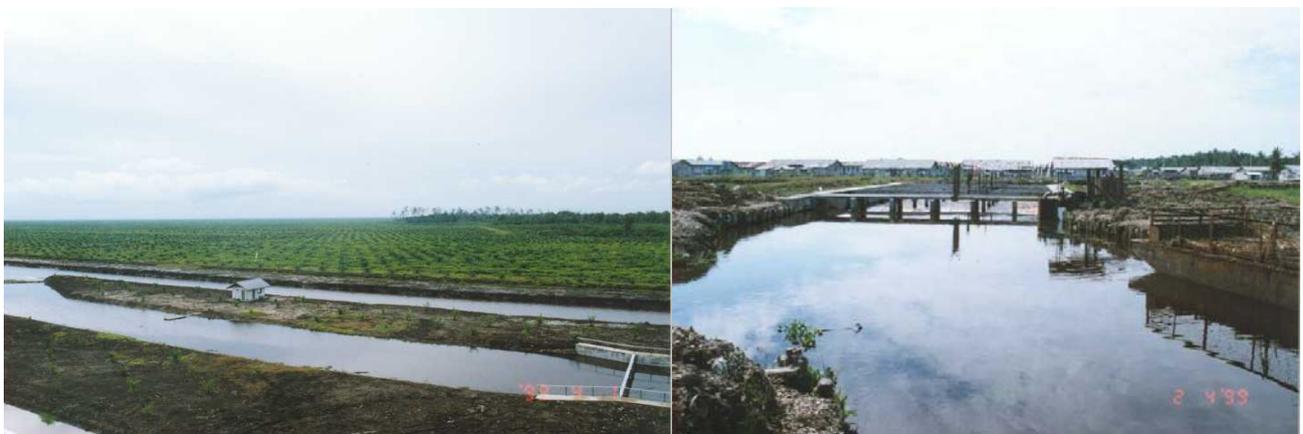
Plate 4: General view of irrigation drainage and transportation network with overflow weir structure at canal system regulating water level at the oil palm plantation estate

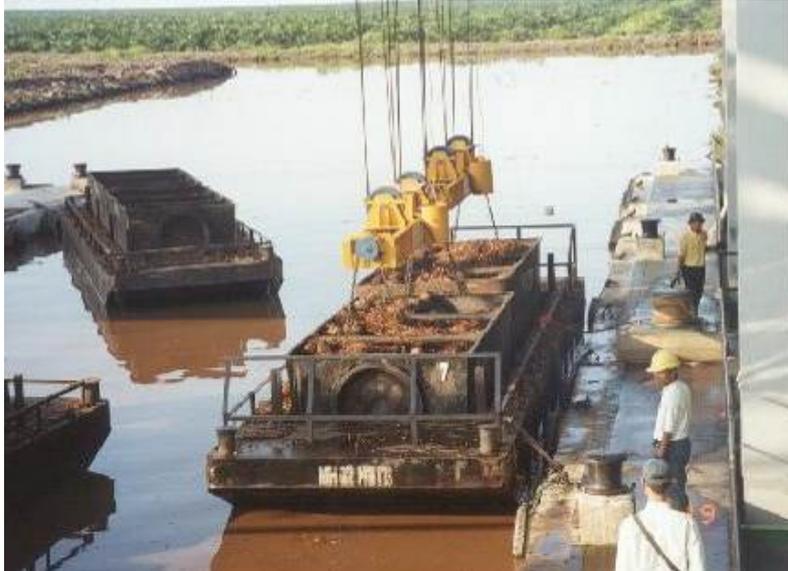
Plate 5: Water transportation channel for fresh bunch fruits (FFB) to processing mill

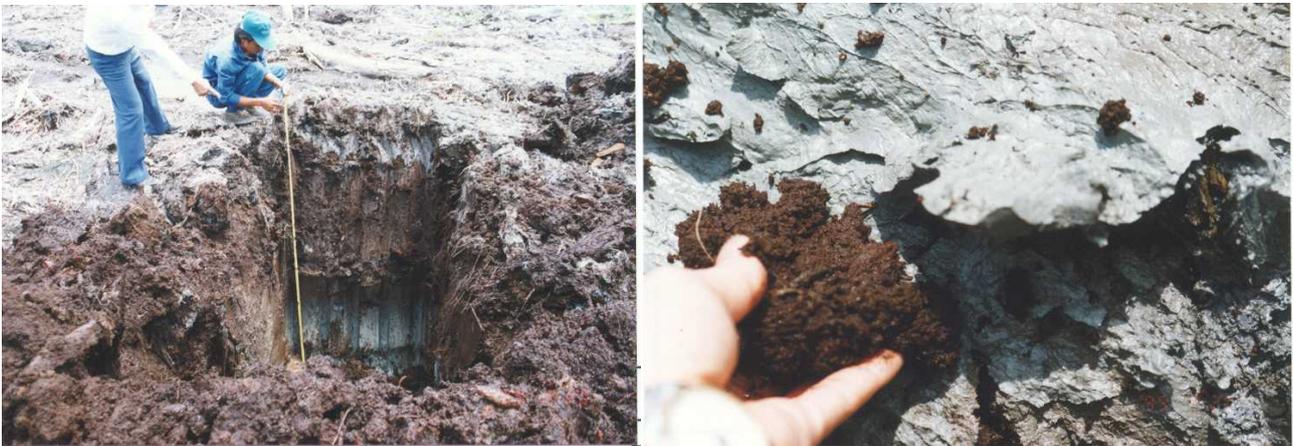
Plate 6: 1.5 to 3m thick clean amorphous peats overlying soft compressible marine clay deposits

The base camp of this project site is located at about 70km away from the eastern coastline, whereby the general surficial deposits are 1.5m to 3m thick clean amorphous peats overlying the soft compressible marine clay deposits as shown in Plate 6. The peats are deposited within the vast flood plain with previously thick shrubs of about 100km wide from the coastline. Generally, the peats are clean without course soil grains or fine soil. It is believed that the decomposed peats with high buoyancy were broken down by the transporting flood storm from its original location, spreading across the vast flood plain and finally deposited at the upmost layer with retention by thick vegetation growth. The high buoyancy of peats has therefore segregate the heavy soil particles from the light weight organic matters, thus leaving the very clean peaty matters deposited at the upmost layer. Some fertilizer producers extract these clean peats with post injection of nutrients, like nitrate, phosphate, etc to provide high value odourless fertilizing products for golf course. With further accelerated decomposition processes of the deposited peats above phreatic level, pore water with very low pH value of about 2.5 to 4 is leached out from the spongy peats resulting in dark brownish highly acidic water to the surface water body. When extensive land clearing was executed for the proposed planting blocks, groundwater table lowering during drought has resulted isolated spots of peat fires around the cleared sites, which were practically impossible to put out. The accelerated decay of the peats releases remarkable amount of methane, which can be ignited rather easily. However, due to common local practice of controlling water table with primary objective to maximise crop yield, the groundwater table was deliberately raised by regulating weirs at every zoning of planting blocks. With capillary fringe above the raised phreatic surface in the peaty soils, it keeps sufficient moisture within the peaty soil, which is equivalent to an artificial sub-terrain flooding, to extinguish the smoldering peat fires. The wetting of peat becomes very effective mitigative solution for peat fire and, also serves as a dual-purpose measure to maximise crop yield.

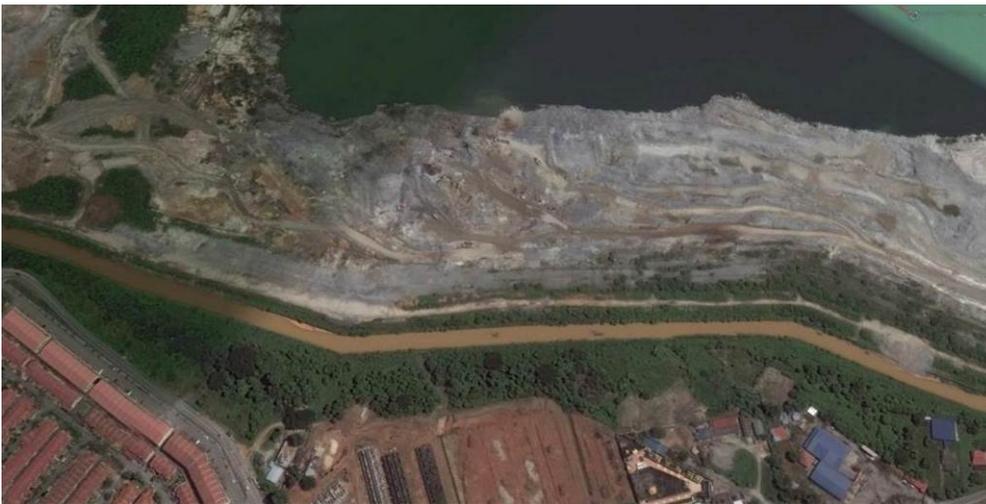
Plate 7: Interface of diverted river between the residential housing development and the quarry site

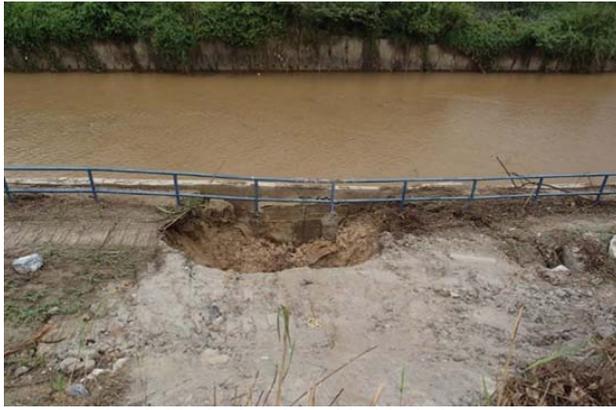
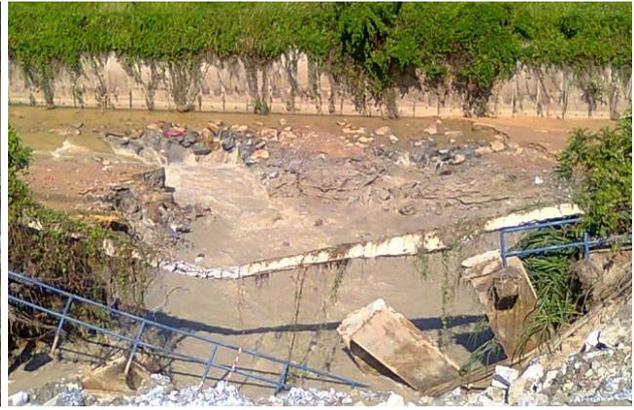
Plate 9: Sinkhole developed behind channelised river section with solution channel connection to quarry benches

The inflow of water into the quarry pit interrupts the quarry operation and, also intercepts river flow downstream. There was an imperative need to plug the channel passage to cease the inflow and convey the upstream river flow to downstream. The quarry team had attempted to dump quarry wastes into the sinkholes appear on ground, but without noticeable success. The conditions were only under controlled after the authors were appointed to carry out the emergency rectification. The recommended action was to dump materials in sequential batches with three different particle gradings of sufficient volume into the sinkholes. The concept is to have the larger blocks of rock fragments to stuck at the narrow channels forming the primary blockage. From the earlier mentioned process on the formation of solution channel, most channels are developed along the joint sets, which are planar by nature. The differential solutioning process and, also the abrasive erosion of solid particles in the seepage flow tends to enlarge the flow passage on the planar joint surface. Water flow will also find the most efficient path under the gravity pull to develop the channel. Nevertheless, the formed

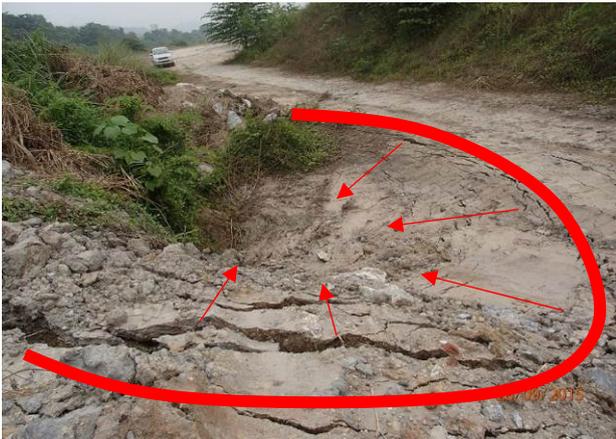
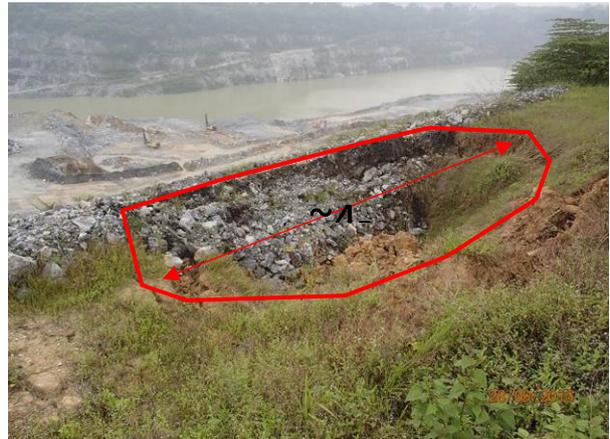
Plate 10: Sinkhole developed in overburden behind the quarry benches

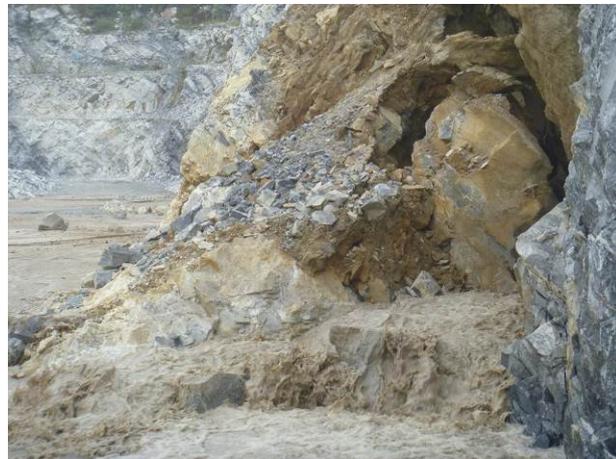
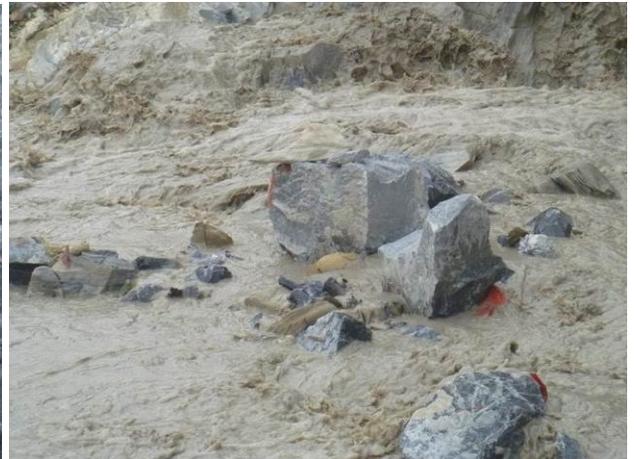
Plate 11: Discharge of solution channel at quarry bench surface and plastic debris from river water

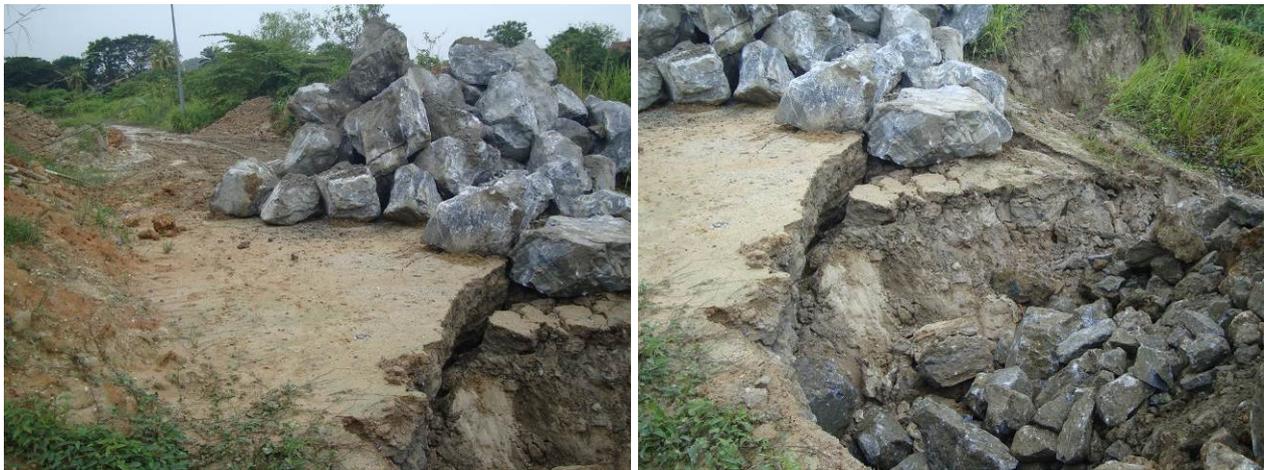
Plate 12: Sequential dumping rock fragments of varying sizes to infill the solution channel for plugging

channels will always be irregular, whereby constricted passage shall exist along the entire channel. As such, so long as there are some larger rock fragments can follow the inflowing water to reach a constricted section and retain there as a primary blockage. The subsequent dumping of medium and smaller size rock fragments will then form the secondary and tertiary blockages to the voids of blocked rock fragments. Generally, the larger rock fragment is half of the sinkhole diameter at the lower portion. The medium and smaller rock fragments are half of the preceding diameter of rock fragment as shown in Plate 12. It is also envisaged that the sequentially dumped rock fragments to travel further reaching the gentler invert profile for deposition and subsequent transported dumps can therefore form a stronger plug upstream until the appeared sinkhole on the ground surface. This is similar to the retention concept in the filter design by using the voids formed in coarser grain matrix structure to retain the smaller grains in the flowing medium. At last, cohesive earth was placed over a filter geotextile over the dumped rock to seal the vertical funnel shaft of the sinkhole. In the actual remedy, water was pumped in the sinkholes to destroy premature arching of the dumped rock fragments at the vertical sinkhole during the dumping. Until the flow discharge ceased at the quarry bench surface, the reinstatement works of the river section and the ground leveling were commenced.

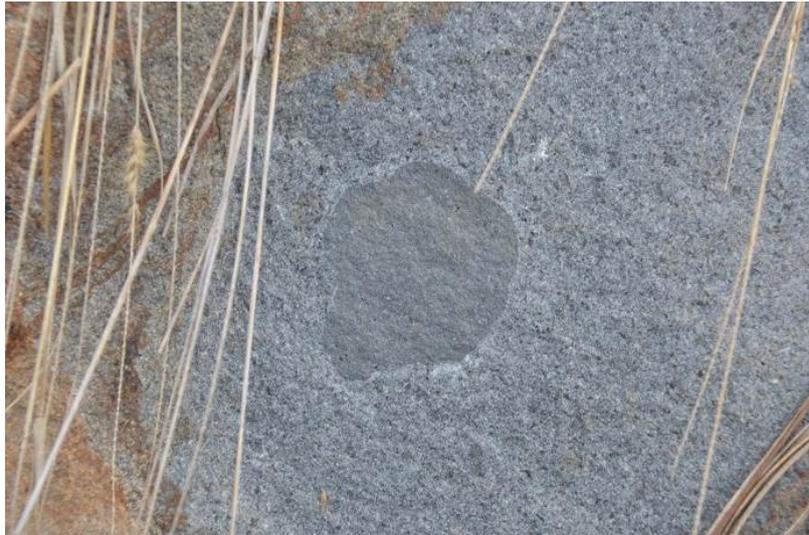
Plate 15: Texture of diorite boulder with inclusions during cooling stage

Hutchinson (2005) gave a very brief, but insightful general geology of the project site. The project site consists of hypersthene diorite forming a line of hills near Tawau area in Sabah, namely Mouth Gemok, Middle Hill and Kukusan Hill. The diorite rocks are grey, medium-grained and only slightly porphyritic, in which the phenocrysts are andesite, hypersthene and clinopyroxene. Hornblende has been pseudomorphed. However, Kukusan Hill pluto is not homogeneous, and contains andesite tuff breccia. Composed of andesite and diorite clasts, euhedral feldspar, altered hornblende and pyroxene in a glass matrix devitrified to a mixture of smectite and zeolites. Plate 15 shows the texture on a fractured surface of diorite within the project site.

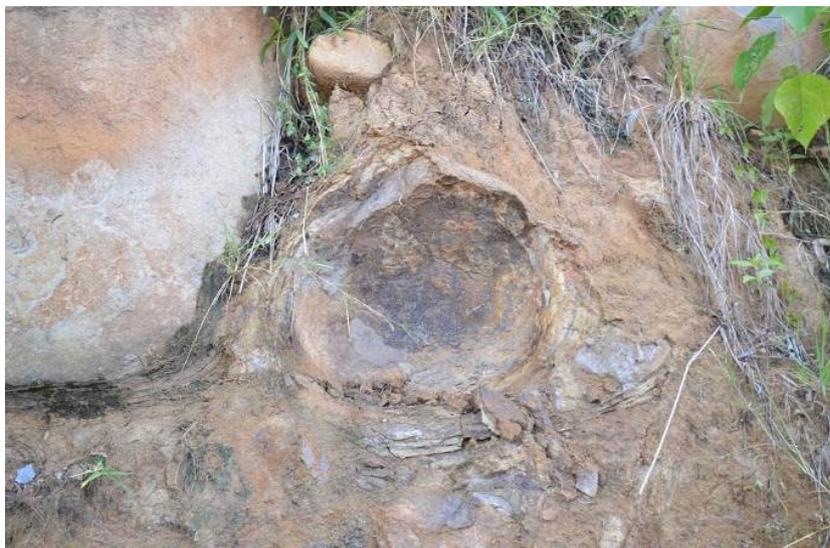
Plate 16: Spheroidal weathering forming core boulders

The deep seated spheroidal weathering processes along the joint discontinuities within the diorite rockmass under the tropical climatic condition have resulted in onion-skin weathering, which is a process of the layers of the rock being peeled off and, also known as exfoliation, thermal expansion and insolation weathering. The outcome of the spheroidal weathering forms many round core boulders as illustrated in Plate 16. Once the core boulders are partially exposed, the embedding weathered saprolite surrounding the core boulder might have relatively higher shrink-swell potential when subject to changes of moisture content due to drying and wetting cycles of climatic condition. The differential movements interacted between the volumetric changes of saprolite and the rigid core boulders can end up with gaps as shown in Plate 17, which might provoke erosion of the embedding saprolite beneath the boulder leaving the upper boulder sitting atop the lower boulder clusters with only few point contacts and largely unsupported at the underside as shown in Plate 18. Such concentrated support condition is highly unstable when the upper boulder starts to move and gain momentum from its potential energy after brittle contact crushing due to overstressing at the point contacts as shown in Plate 19. Despite the average uniaxial compressive strength (UCS) of 244.9MPa was reported by Raj (2004), the stress concentration at the nearly point contact of boulders after erosion of the embedding saprolite may still exceed the intact strength leading to brittle crushing. Once the overall release rate of potential energy from the imposing boulder exceeds the straining energy absorption rate at the contact support system, the progressive brittle crushing at the supporting contact starts with domino effect to allow the boulder gaining momentum to translate and rolling. The boulder movement will only cease when the energy stored for the work done can be fully dissipated by the resistance.

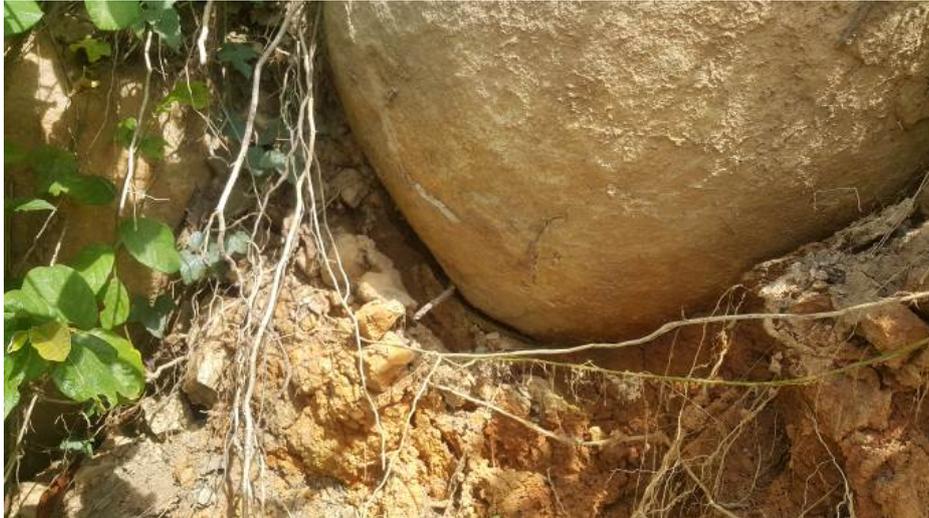
Plate 17: Gap formation at the interface of saprolite and core boulder after drying and wetting cycles

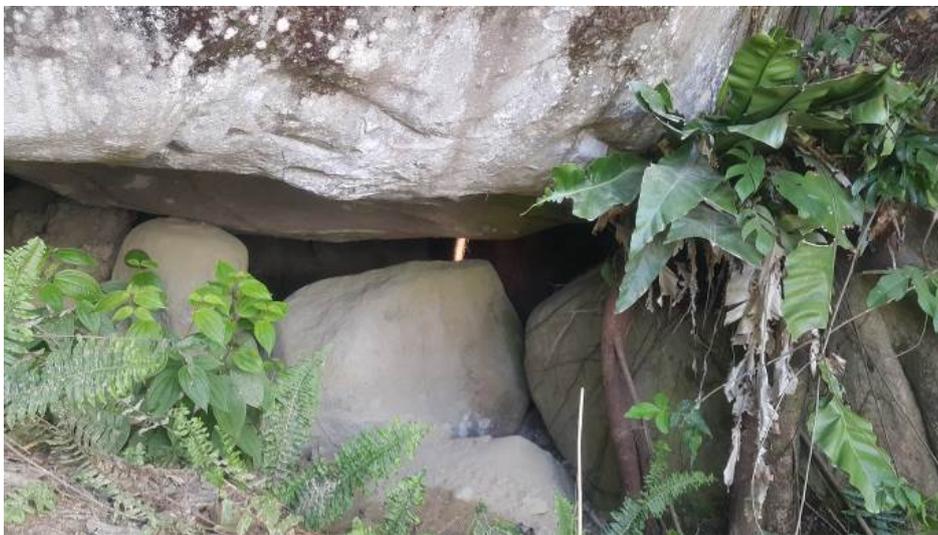
Plate 18: Core boulders supported on few point contacts from lower boulder cluster

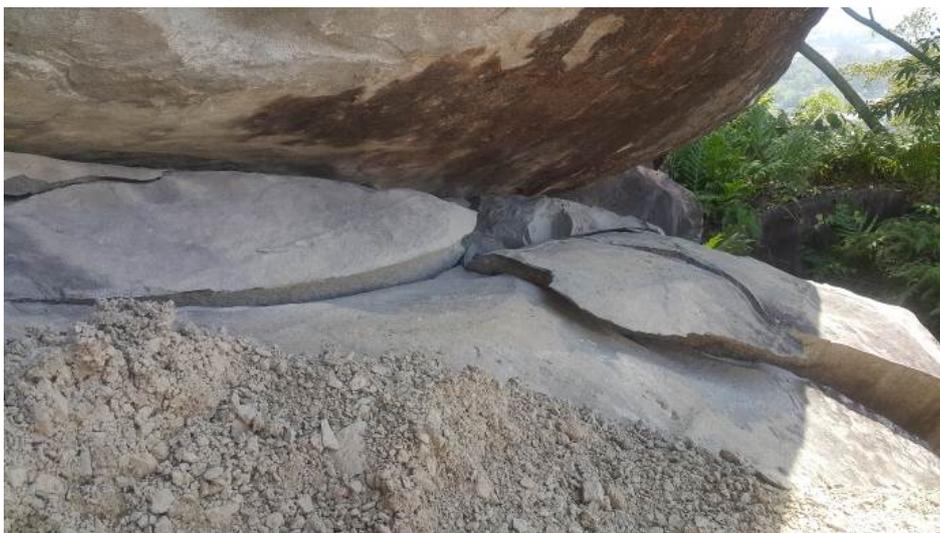
Plate 19: Brittle crushing at concentrated contact of underlying core boulders beneath the gigantic boulder

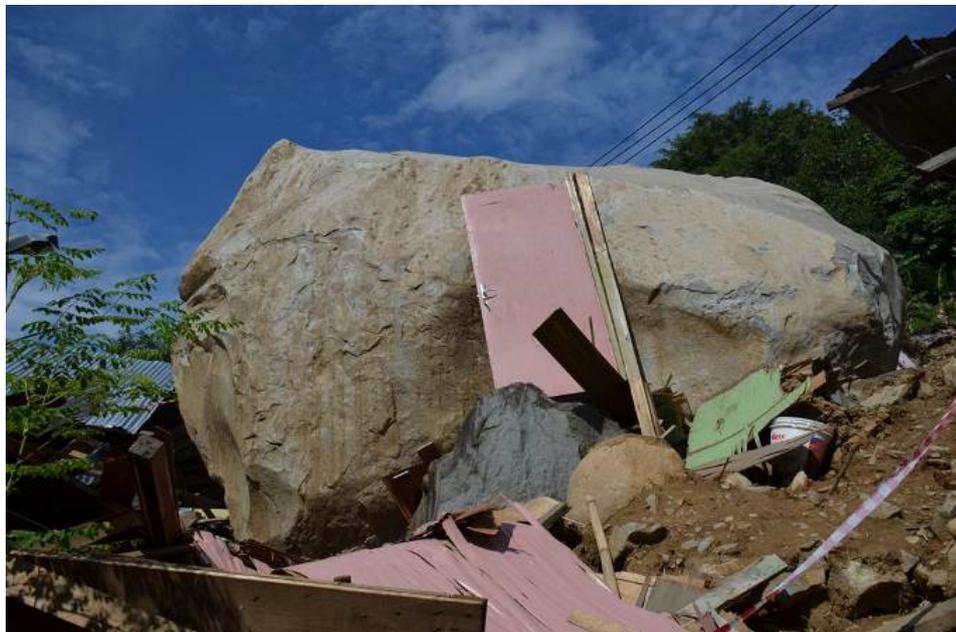
A gigantic sub-rounded diorite boulder weighing about 2,400 tonnes detached from the uphill location rolling downhill descended about 146m in elevation and travelled about 250m horizontally. Along the travelling path, few illegal squatter houses were damaged as shown in Plate 19. From the energy view point, the potential energy used to drive this gigantic boulder is about 3,504 megajoules (973kWh), which is equivalent to about four months electricity consumption of an average household in Malaysia (Nakagami, 2008). The travelling distance of boulders can vary quite substantially depending on the shape of the boulder, hardness and, also the condition of the ground where the boulder traverses through. Some diorite boulders, which is believed from the same diorite hill, are located about 500m away from the centre of the hill top. Hence, the rheology of the ground support to the rolling boulder, shape of the rolling boulder and the hardness of the boulder contacts will play significant role in the travelling distance. It is reasonably postulated that higher rolling or/and translational speed is expected to be higher when the boulder rolls over the smaller underlying boulders cluster deposited within the valley. Higher hardness at the contacts represents lower losses in the impact energy transfer, thus preserves the kinematic energy for continuous movement to a more longer travelling distance. The resistance to decelerate the boulder will be from the rheology of the contact medium along the travelling path, which dissipate the boulder energy by permanently deforming the contact soils and, also damaging the objects blocking the boulder along its movement path.

Plate 19: 2,400 tonnes sub-rounded diorite boulder rolling downhill

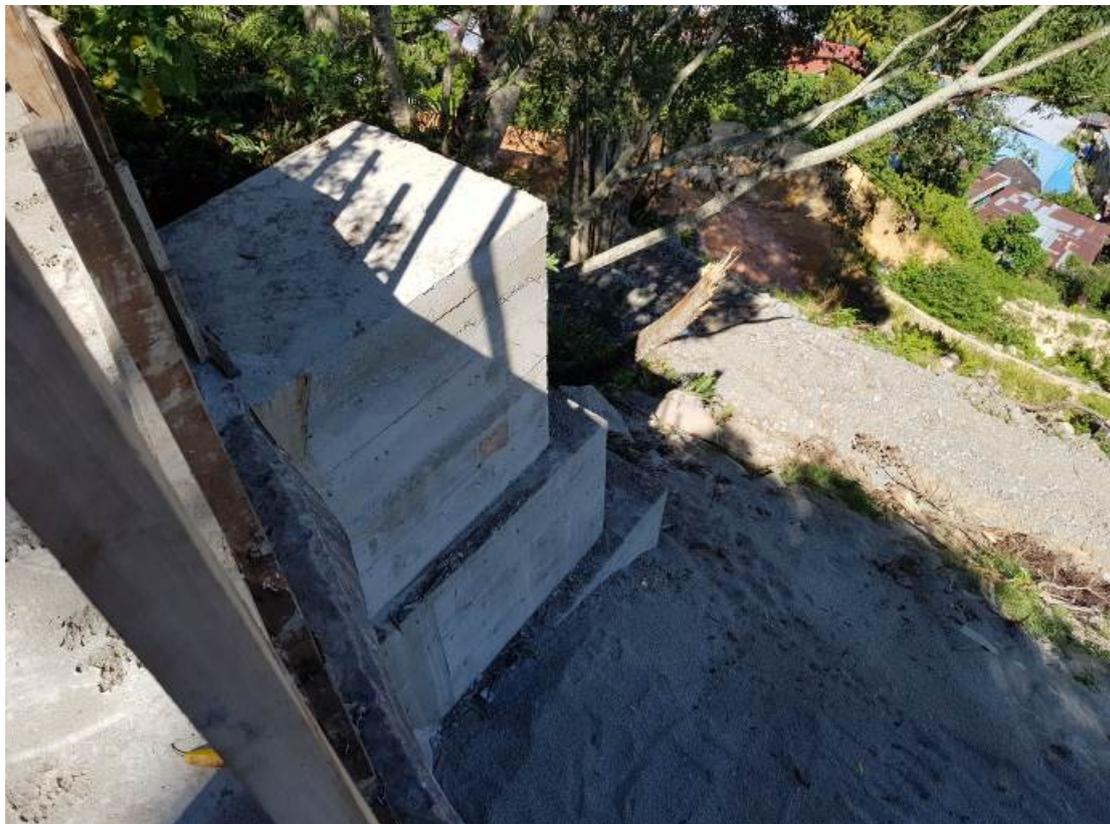
Plate 21: Reinforced concrete buttress abutting to huge diorite boulder

In view of the hazard and threat to the downhill squatter housing, it will be risky trying to breakdown the gigantic boulders at the mid hill along the valley as any action of splitting the marginally stable boulder can result in triggering the movement of the boulders. Hence the mitigative measure is to resort with stabilizing the hazardous boulders in-situ. The approach taken is to solidify the under lying boulder clusters in the valley and integrated with gigantic overlying boulder. The solidification of the smaller round boulders is by injection with highly flowable cement grout slurry first, then cement mortal with chippings bottom up from the valley floor using flexible grout pipe through the voids in between the boulders. Once the grout mortar is up to the boulder cluster top level, then pump mixed concrete will be used to infill the cavity space beneath the gigantic boulder with side forms to contain the concrete. To better integrate the gigantic boulder with the grouted underlying boulder clusters, reinforcement meshes and anchorage dowels into the gigantic boulder are included in the concrete for ductility. Plate 20 shows the schematic diagram of the stabilization measure. As such, the integrated boulder mass will form an overall shape that is not prone to rolling movement. In one case, as the infilling will take time to complete and, also there were signs of brittle crushing at the contacts. It was decided to construct a reinforced concrete buttress to support the marginally stable huge boulder as shown in Plate 21 and then followed by the recommended infilling methods.
