LESSONS LEARNT FROM WORK-SITE INCIDENT AT TANJUNG BUNGAH

Ir. Liew Shaw Shong

REPORT OF THE COMMISSION OF ENQUIRY
INTO THE WORK-SITE INCIDENT
AT TANJUNG BUNGAH
IN THE STATE OF PENANG

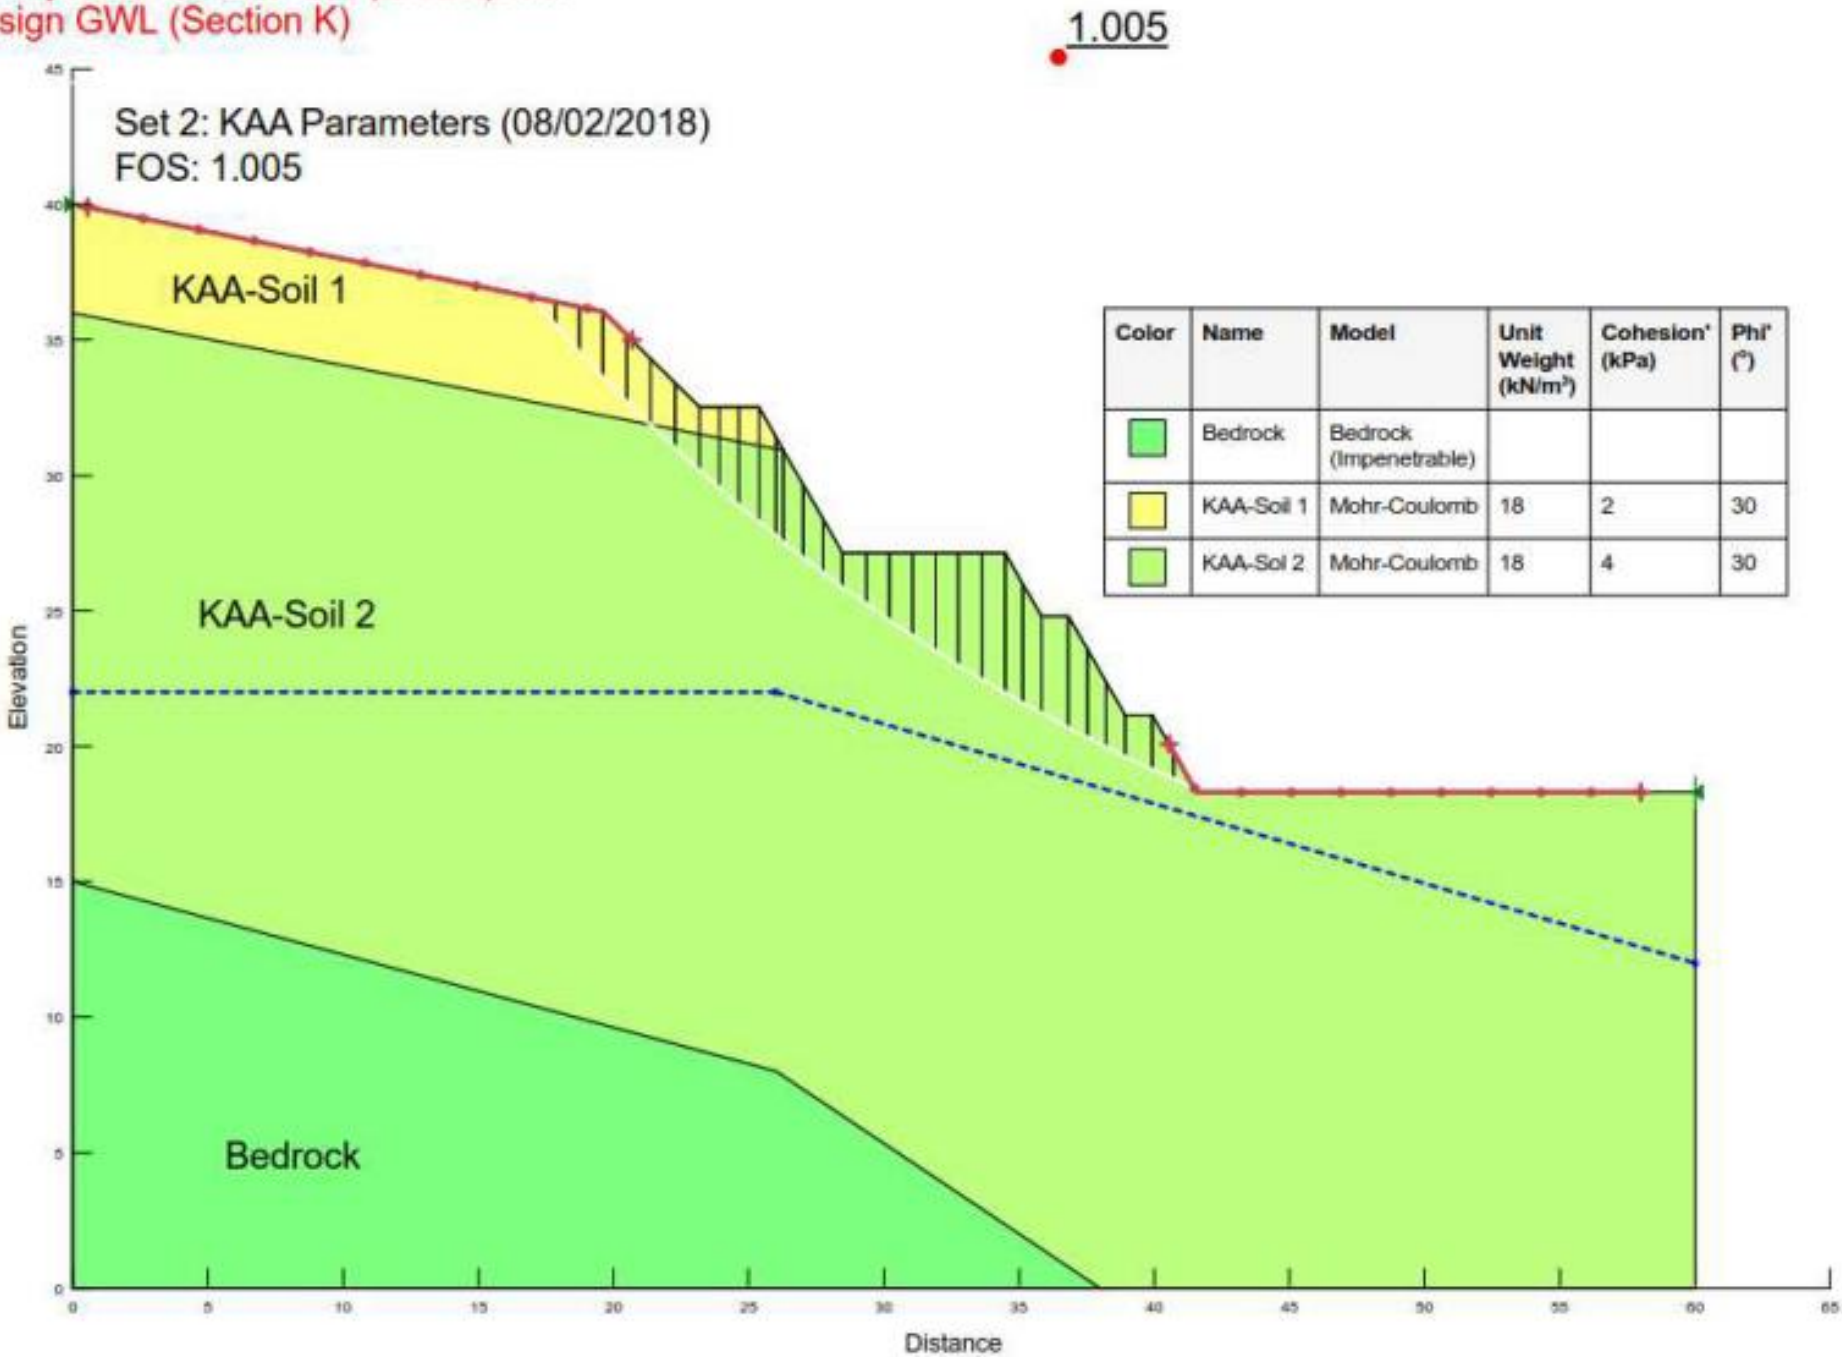
Ir. Khoo K. T. of Perunding KAA Sdn Bhd
Initial design : Inadequate (Global) and unsafe (Local) -> 'blind-folded'
Site incident : 2 minors + 1 major landslips

Set 1b (RL18.3m)
Slope Analysis for Section 9-9 (Global) with
KAA Design GWL (Section K)

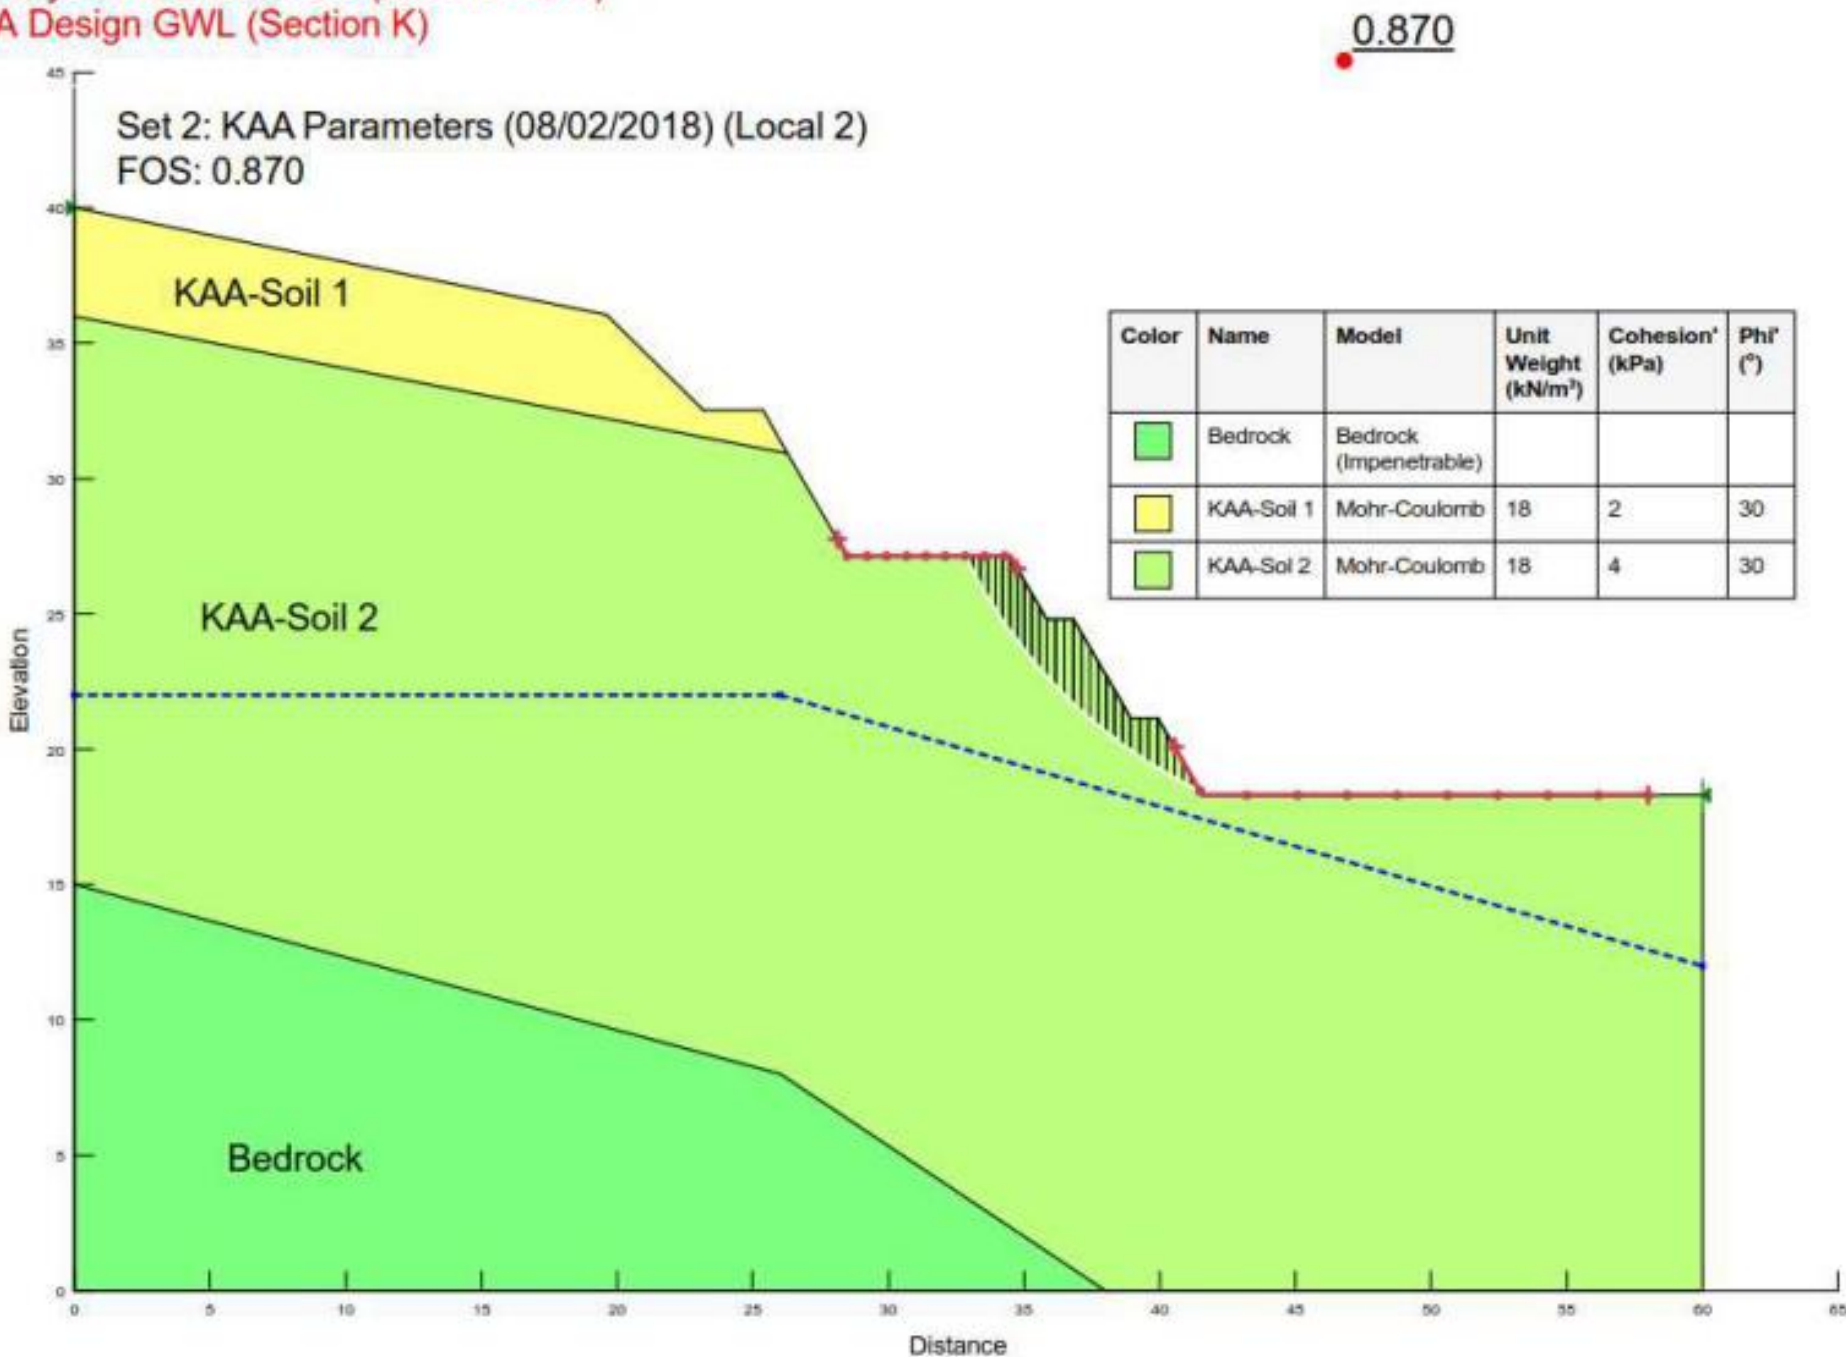
Set 1b (RL18.3m)
Slope Analysis for Section 9-9 (Local-bottom)
with KAA Design GWL (Section K)

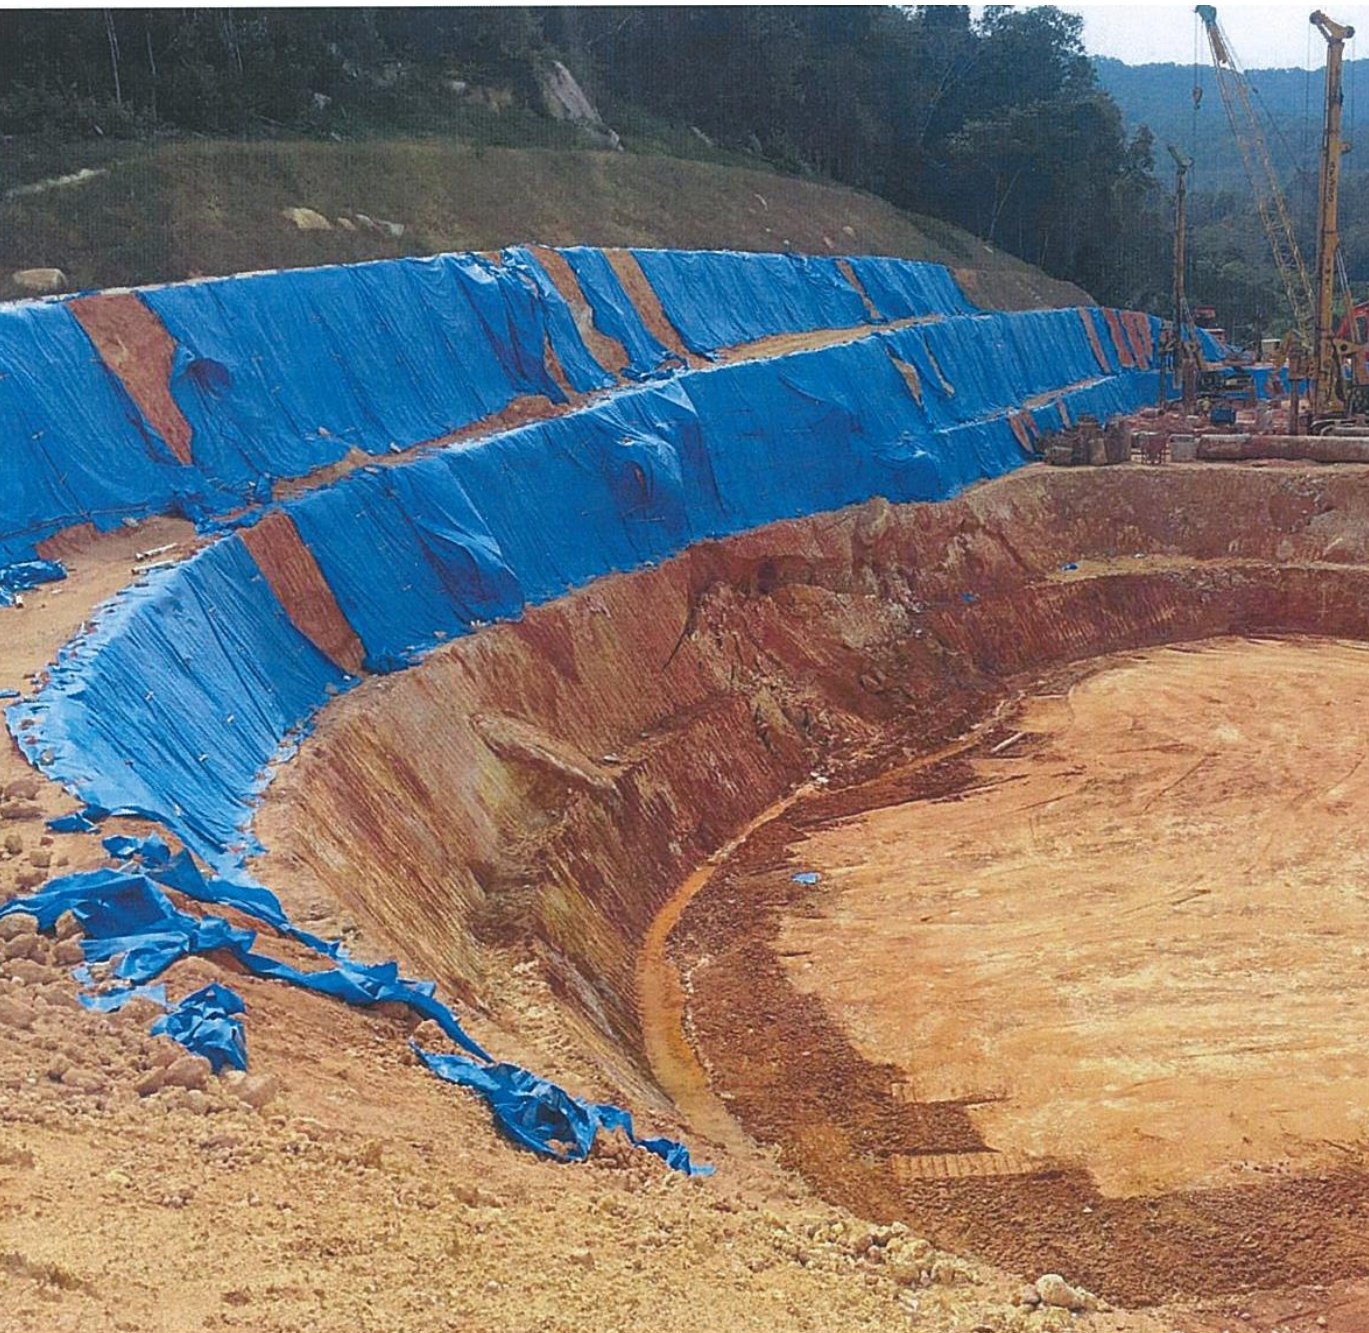
First Slip 8th August 2016 (1st Slip)

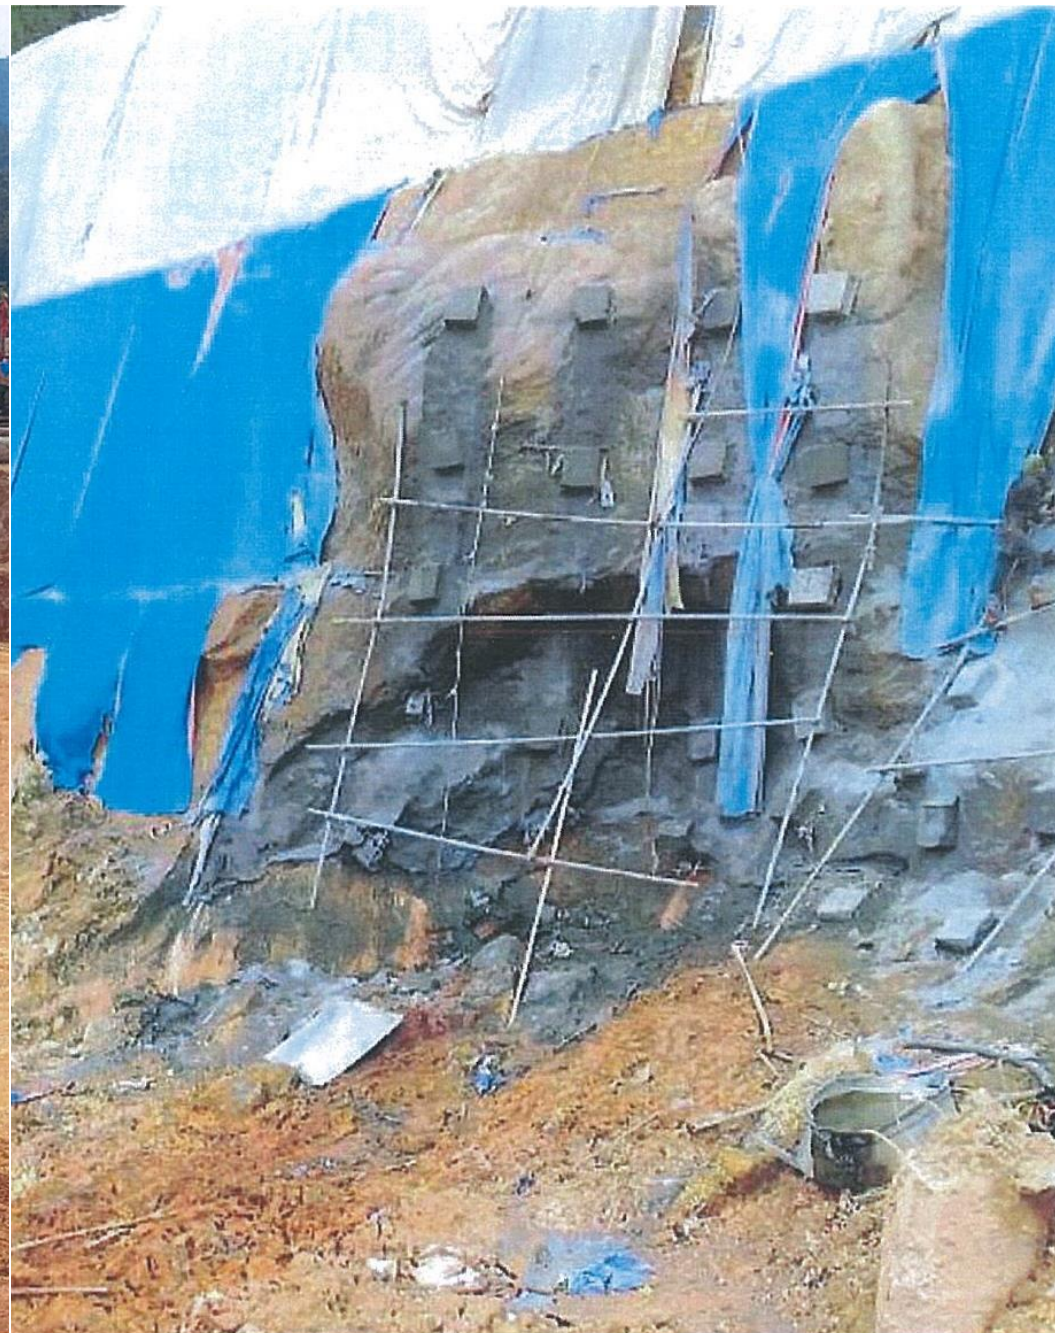
Instability During Soil Nail Installation 5th May 2017- (2nd Slip)

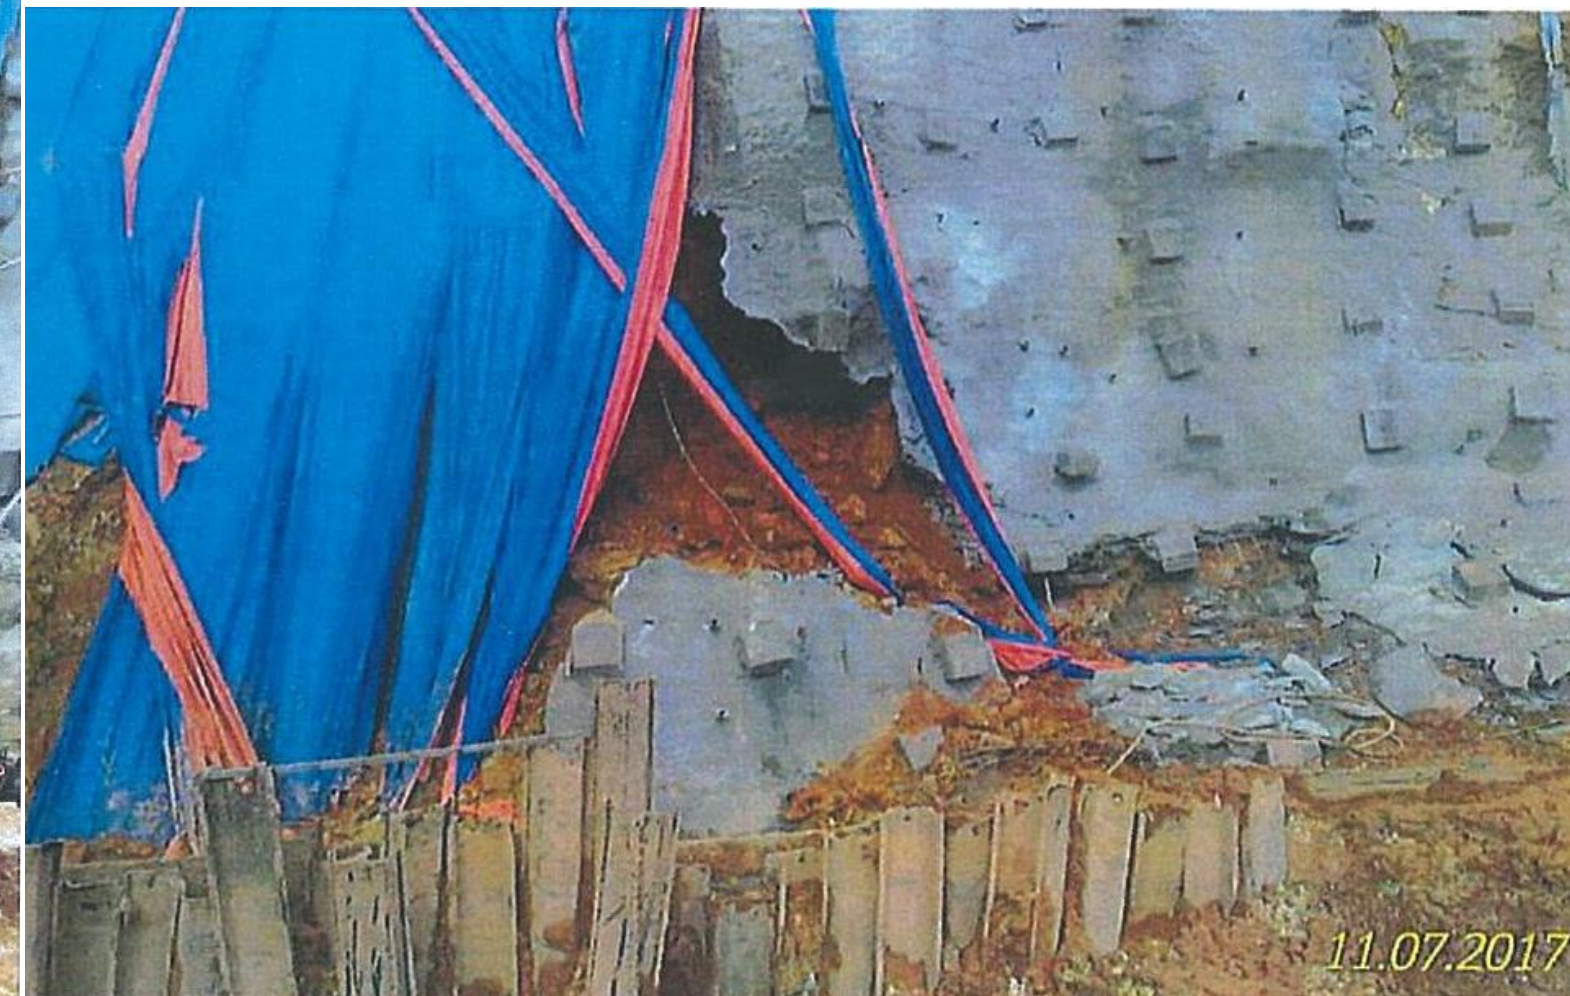
Slope Instability with Damage to Gunite and Soil Nails (3rd Slip) 11 July 2017

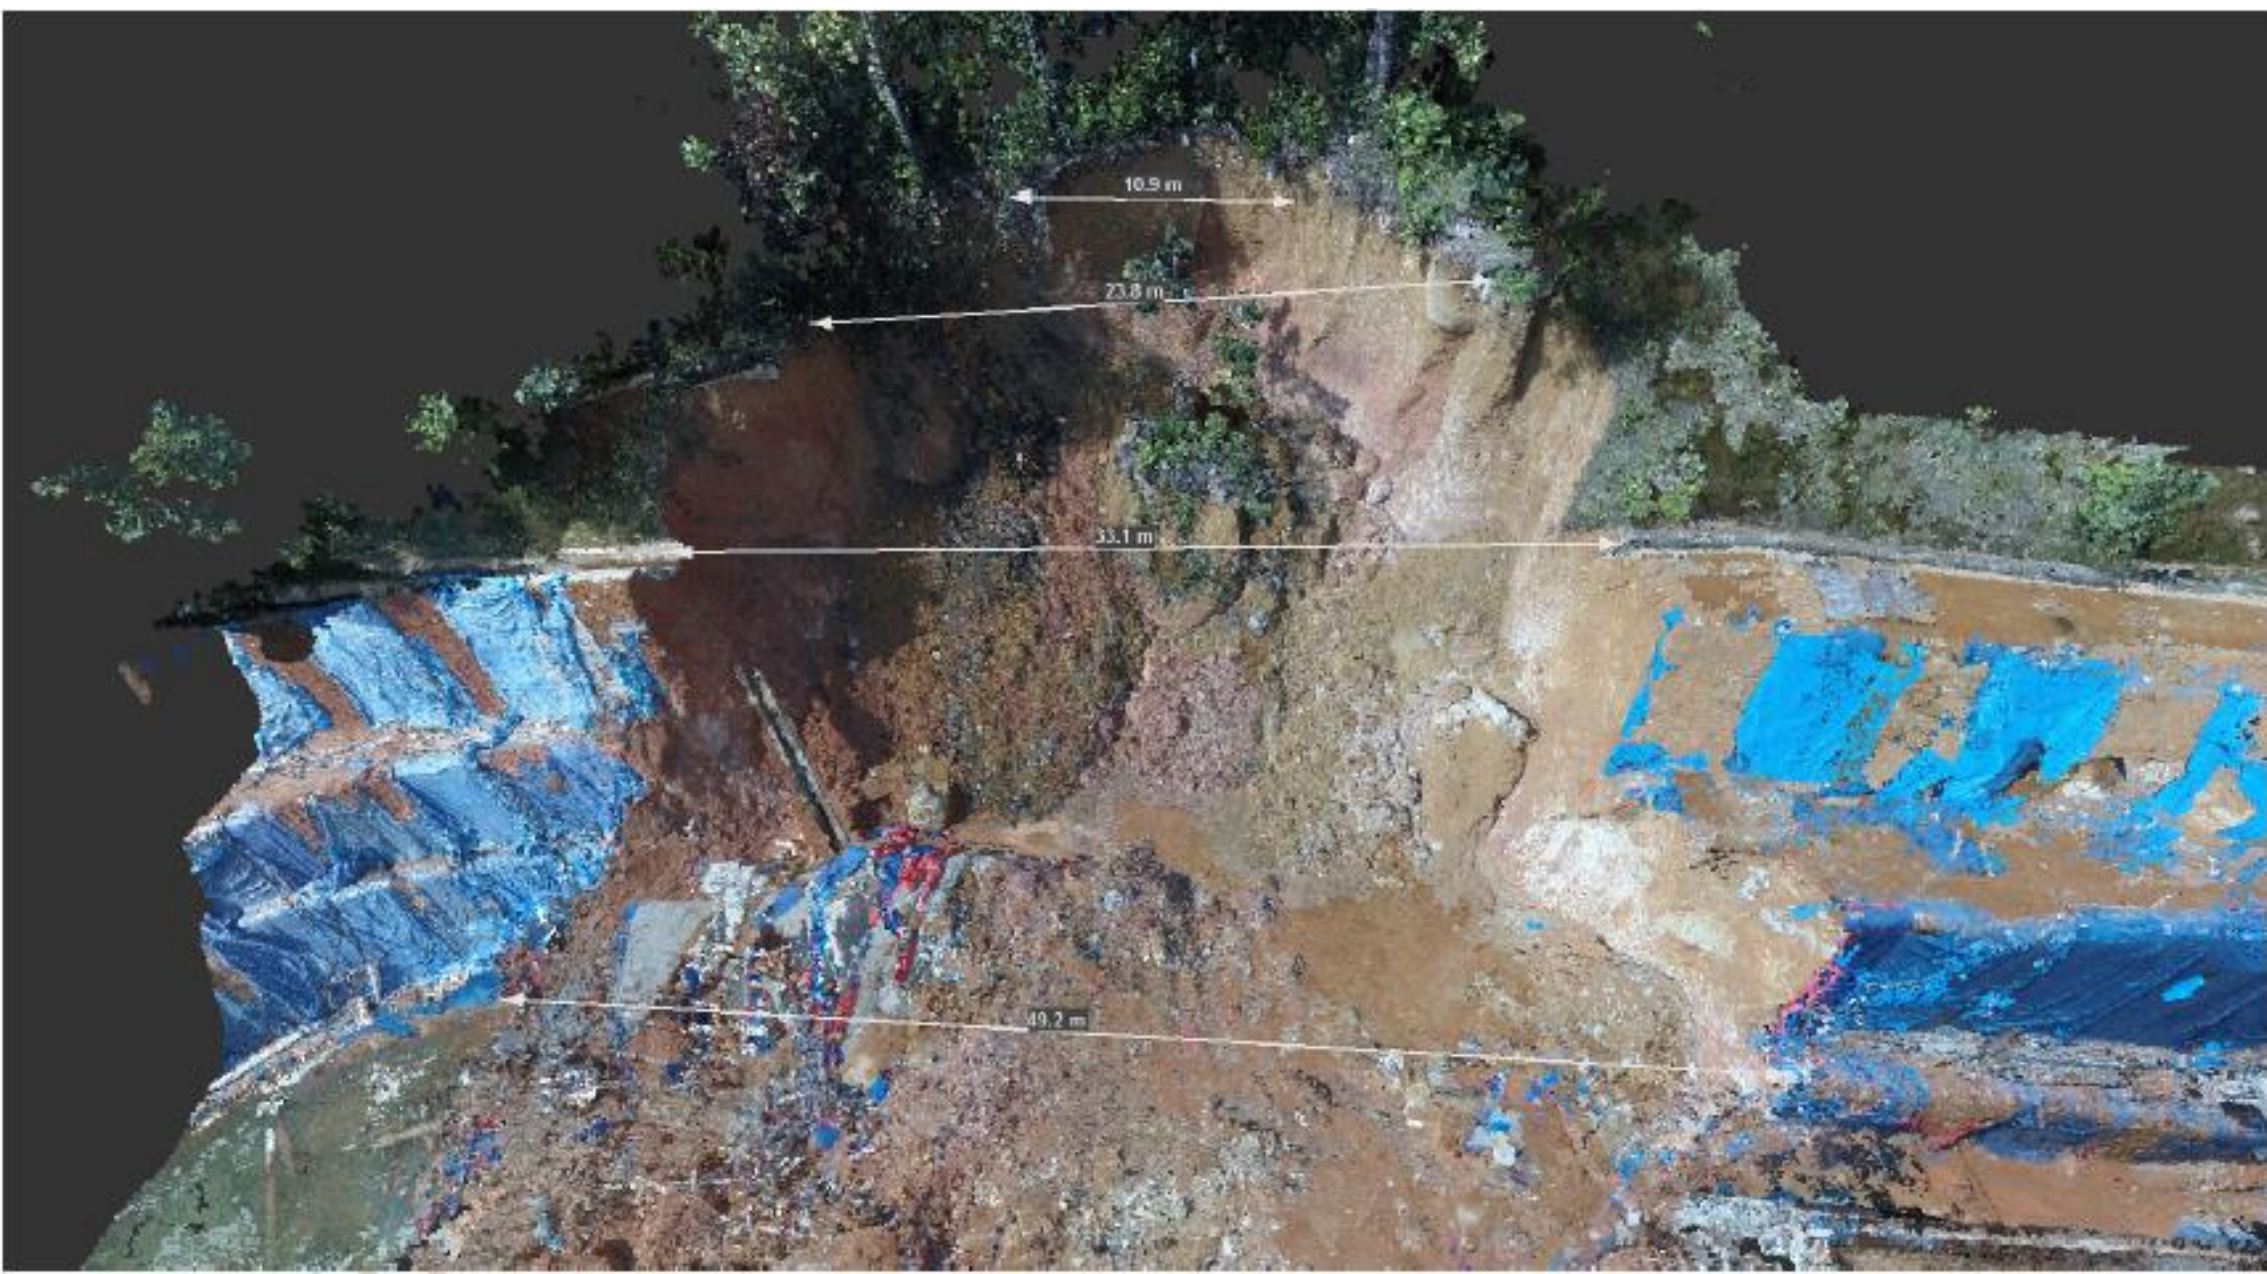
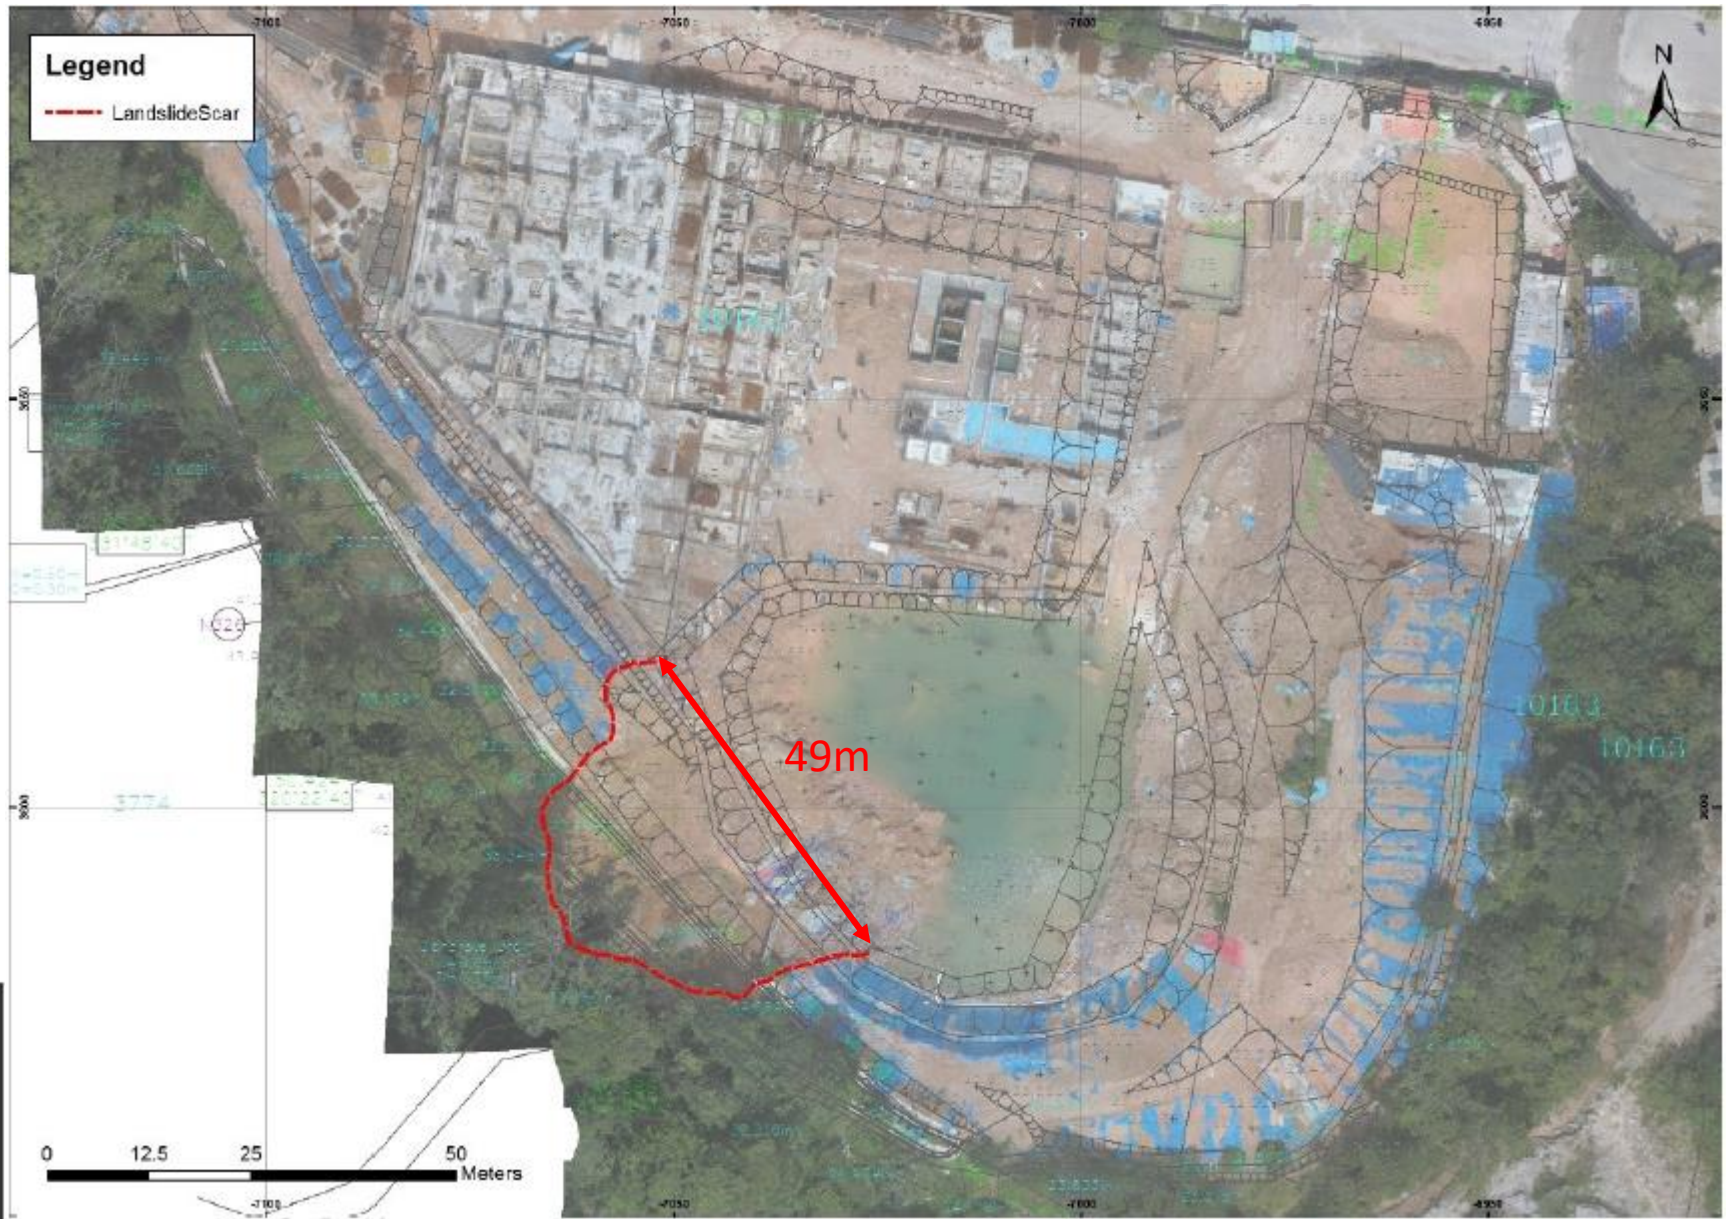
Extract of Photogrammetric Model

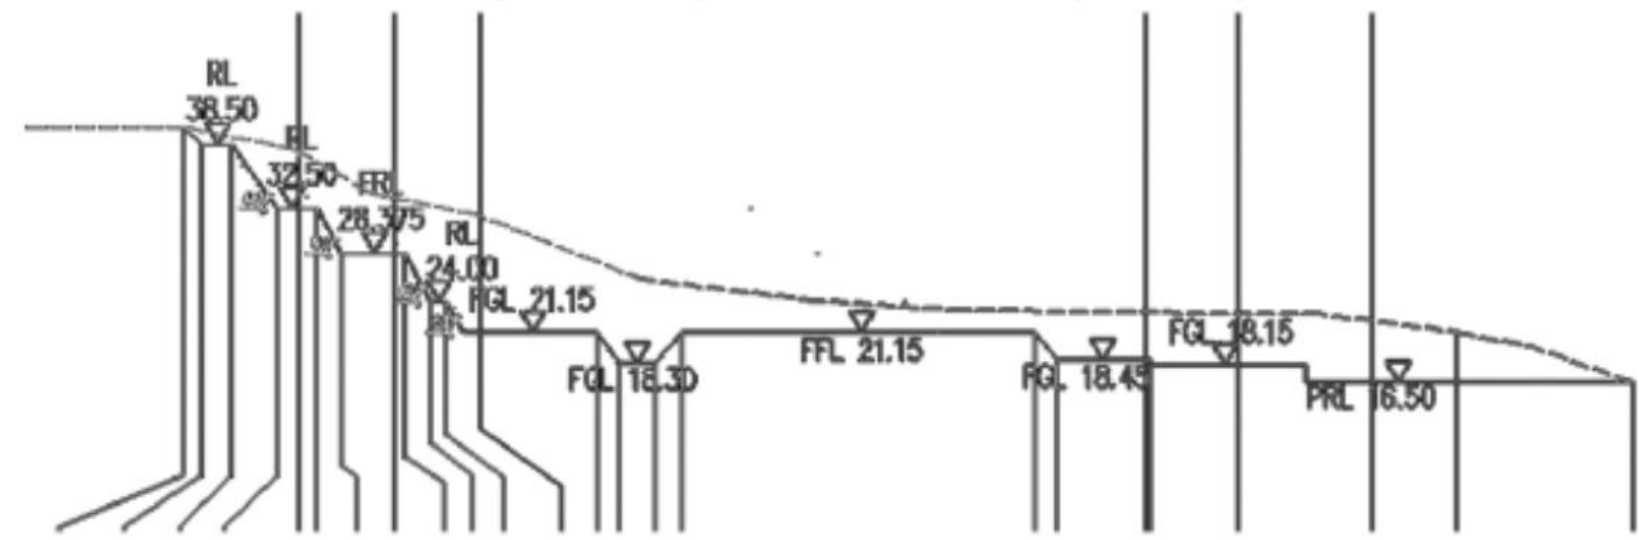
Extract from Site Formation (Earthworks) Contract Document (Section 1)

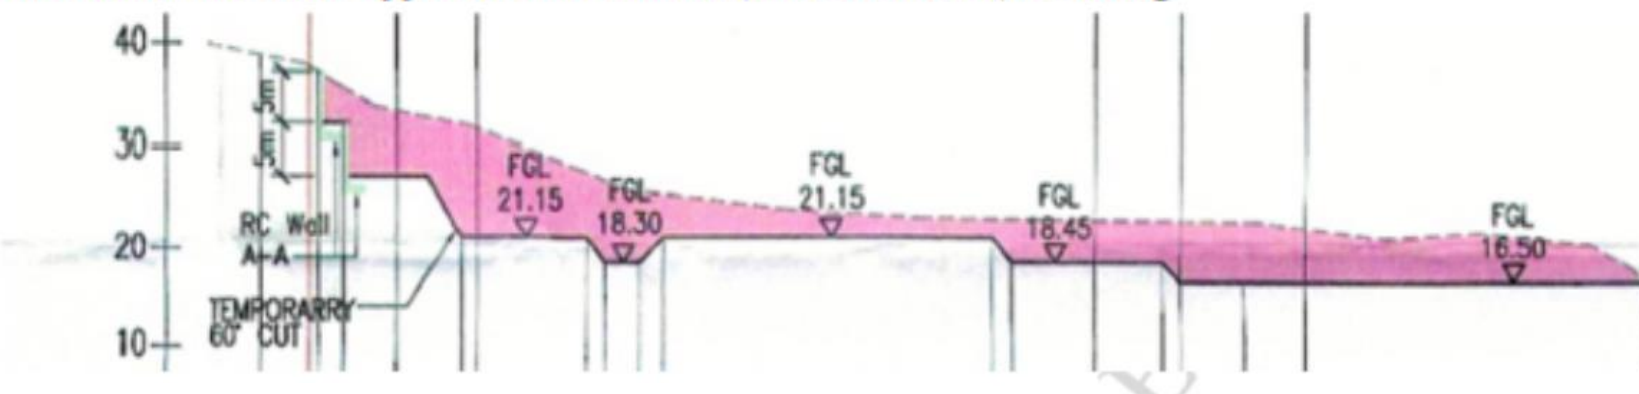
Extract from MBPP Approved Earthworks (Site Formation) Drawing

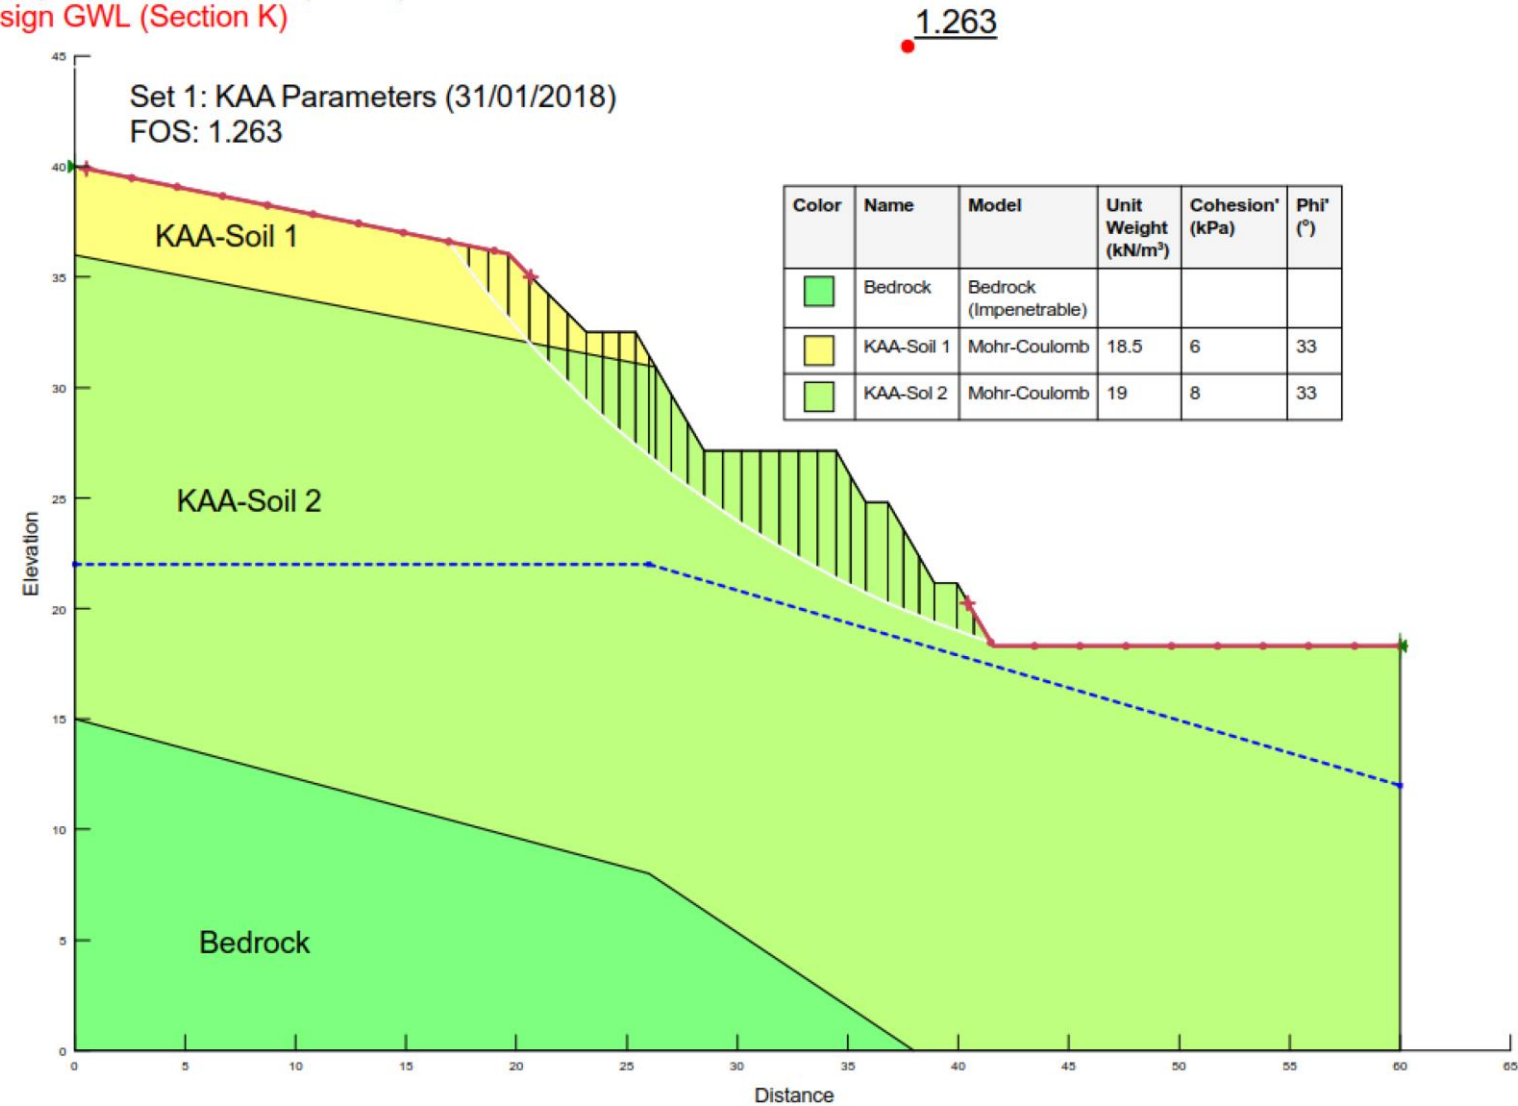
- 1. Overlooked Hillside Guideline - Not applicable for temporary slope?
- 2. Commenced work w/o RE - For 1 year
- 3. Remote control supervision (via messaging apps)
- 4. No calculation for slope cutting
- 5. Further excavation from RL18.3m to RL14.65m w/o calculation.

Set 1a (RL 18.3m)
Slope Analysis for Section 9-9 (Global) with
KAA Design GWL (Section K)

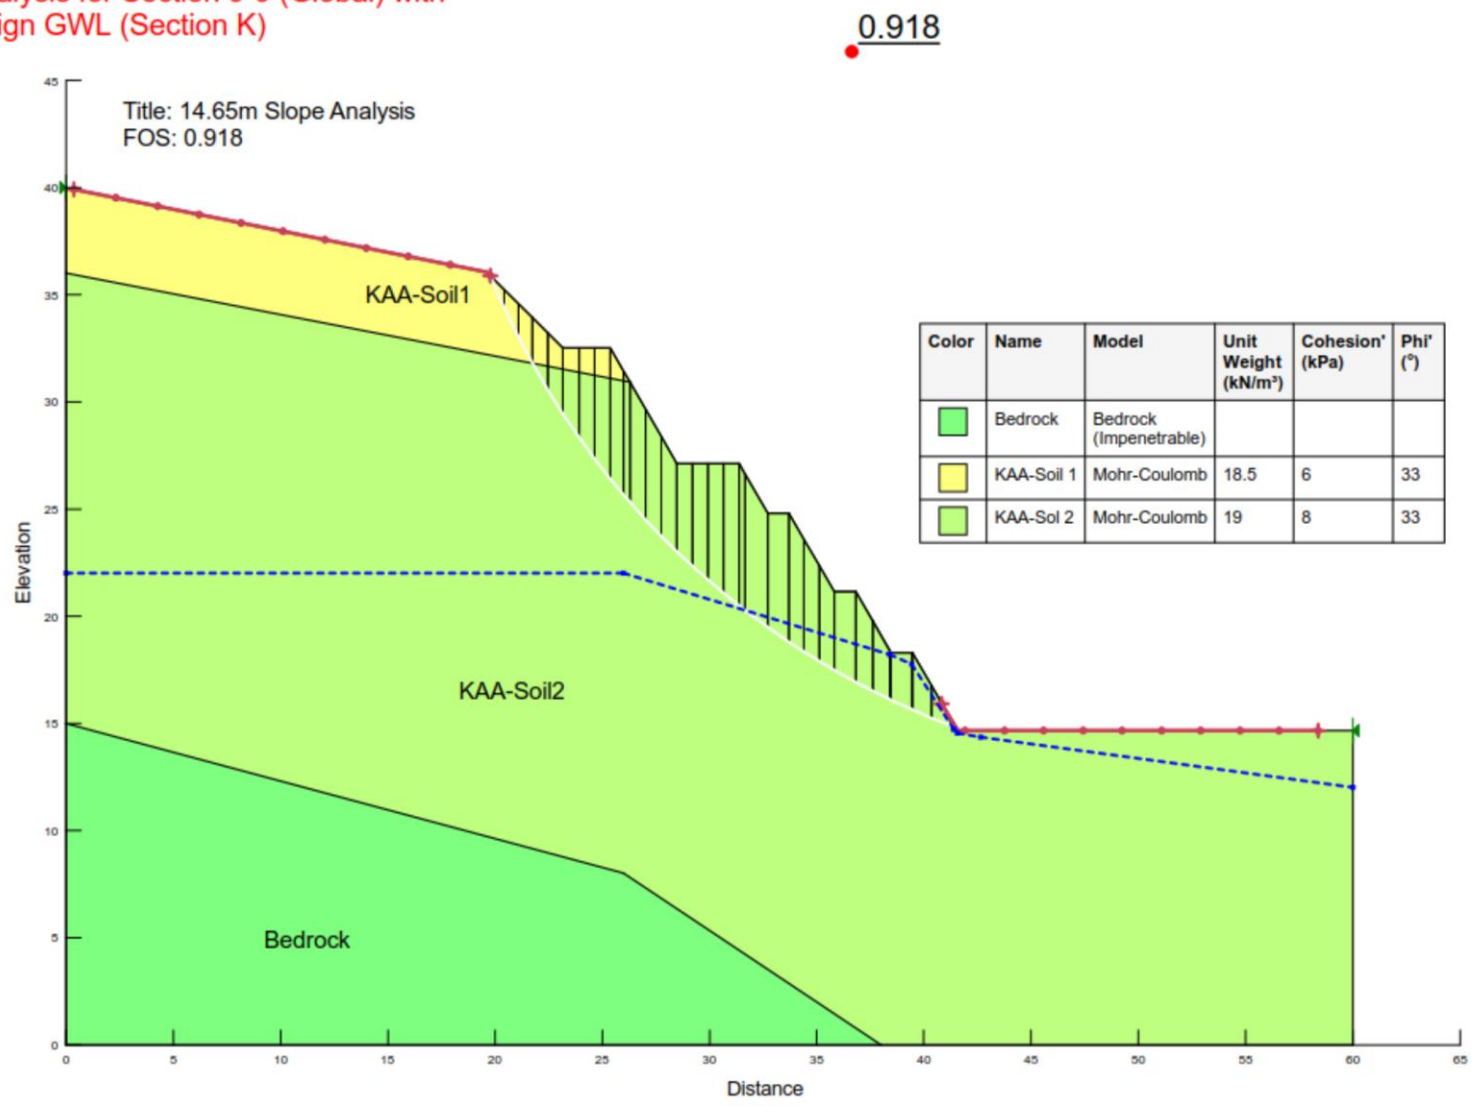
Set 2 (RL 14.65m)
Slope Analysis for Section 9-9 (Global) with
KAA Design GWL (Section K)

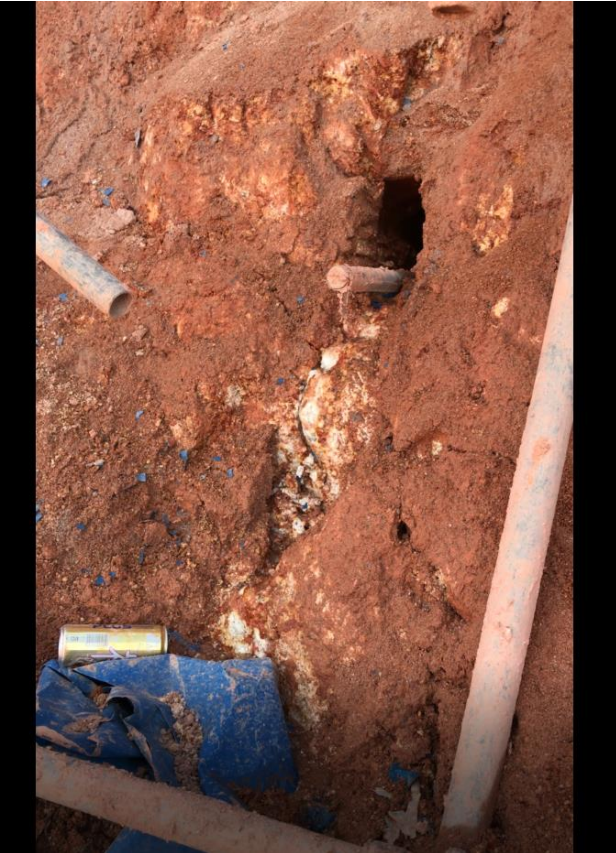
6. Underestimate GW level

Groundwater seeping at RL21m, extracted from Exhibit 53 (Video)
