LESSONS LEARNT FROM WORK-SITE INCIDENT AT TANJUNG BUNGAH

Ir. Liew Shaw Shong

REPORT OF THE COMMISSION OF ENQUIRY
INTO THE WORK-SITE INCIDENT
AT TANJUNG BUNGAH
IN THE STATE OF PENANG

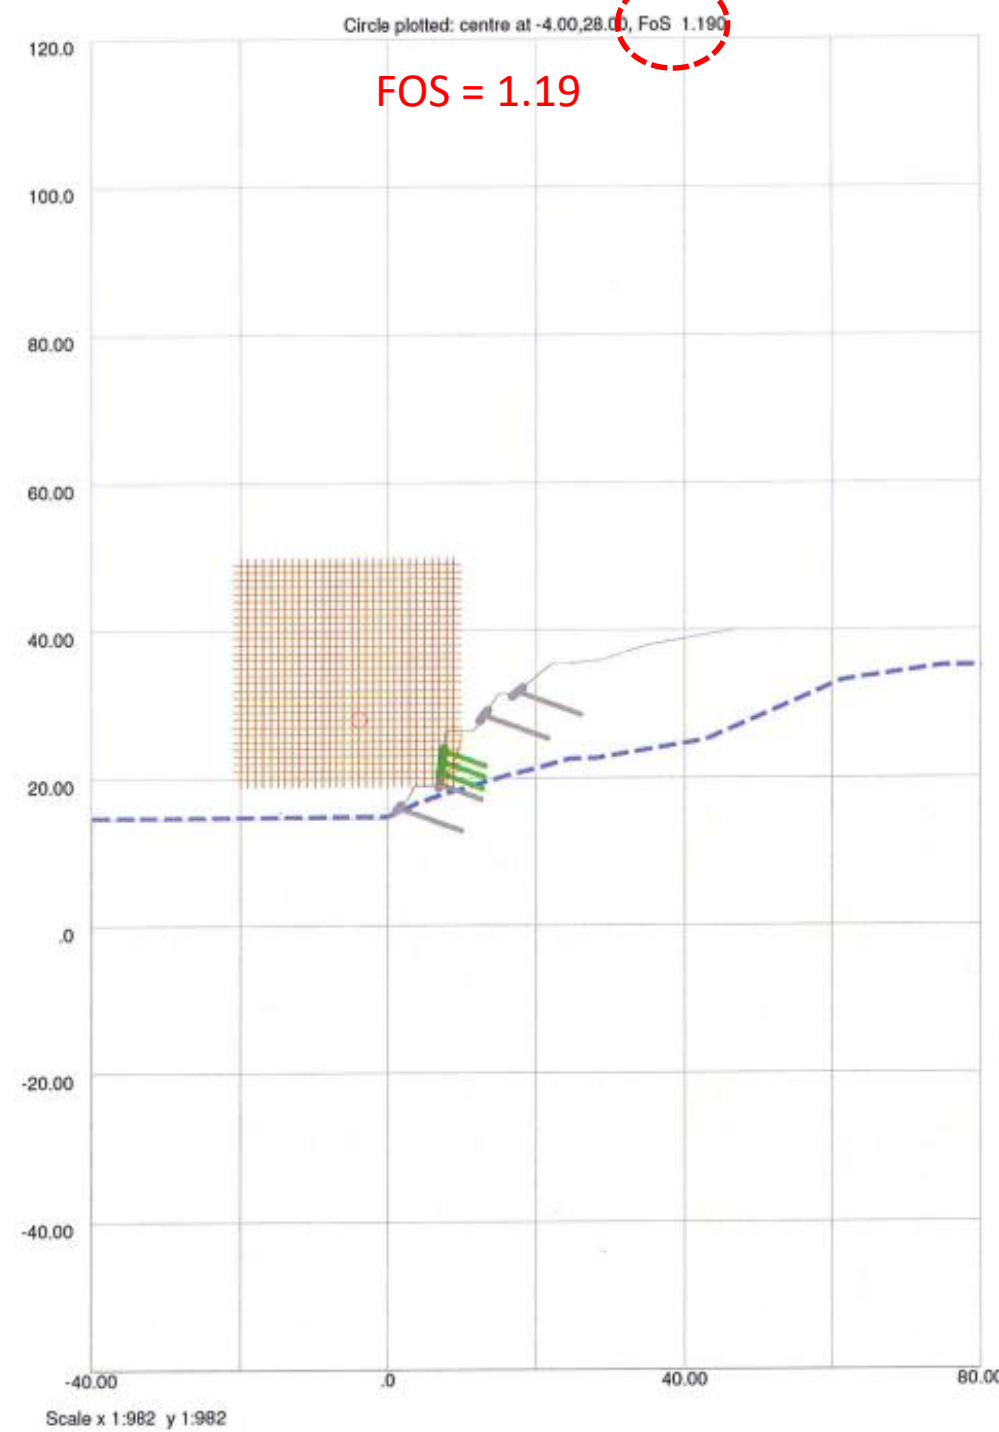
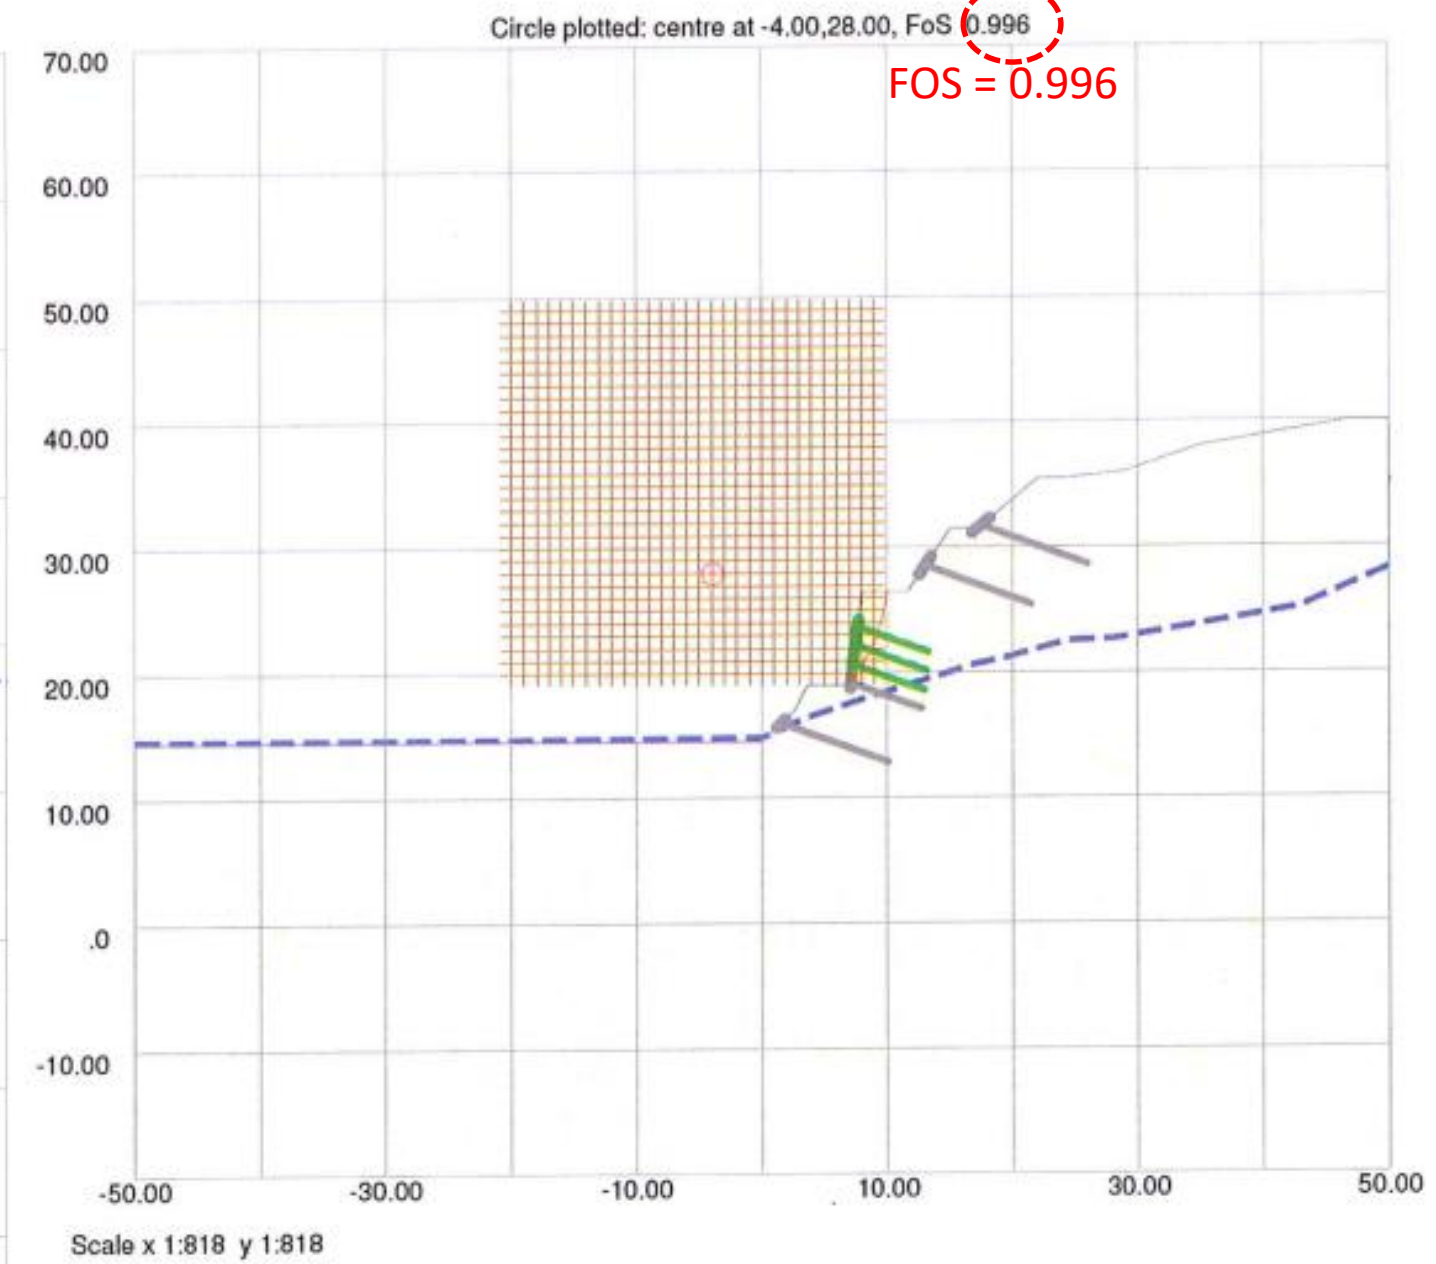
7. No review on design after each landslide!
8. Slow in response to crisis - **Ir Khoo took couple months to look for cheapest slope strengthening work from contractor!**
9. Reduction of 87 soil nail to 49 soil nails w/o calculation!
10. Strengthen slope with adding 6 more nails w/o calculation!

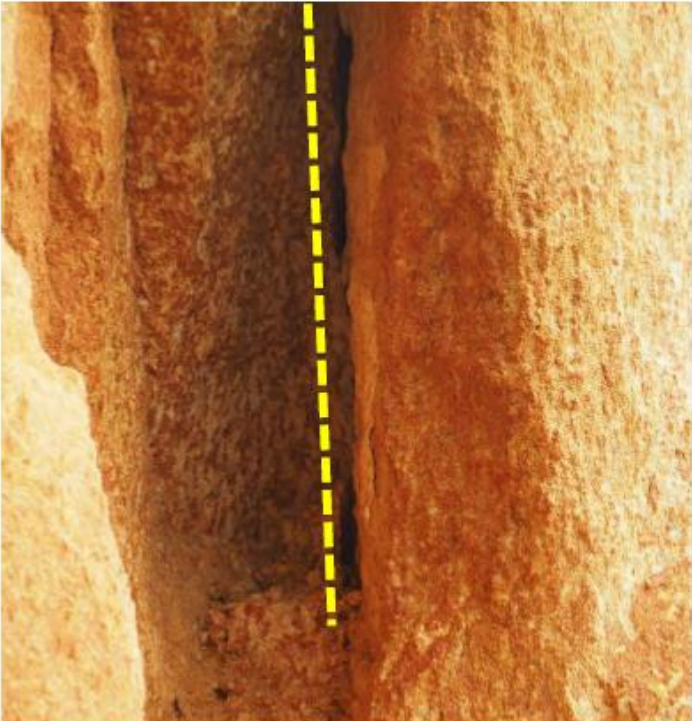
Photo 3: Site observation and field work

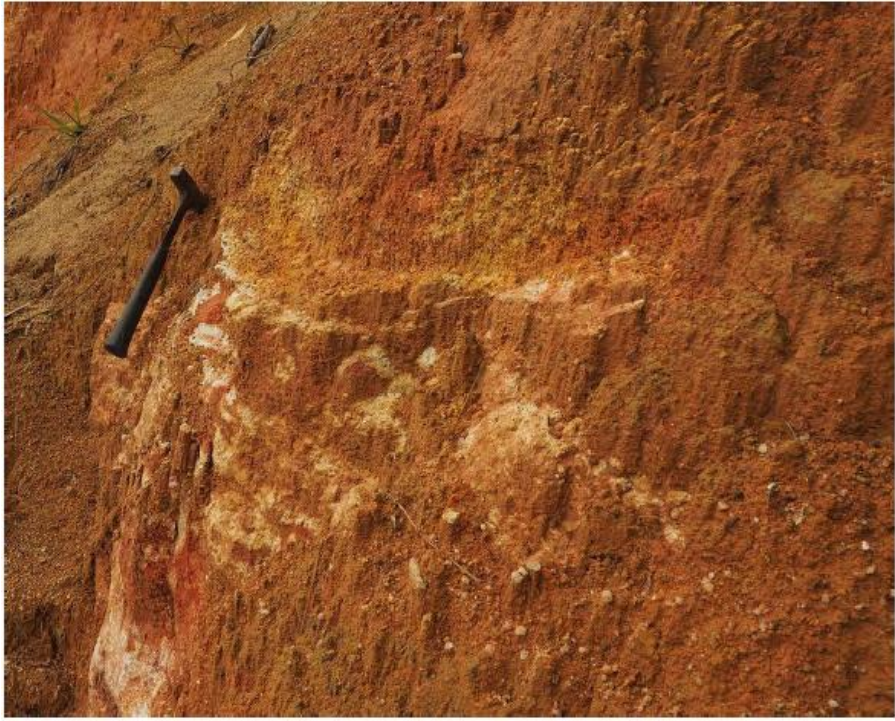
Photo 6: Decomposed feldspar and mica infilling in the relict joint

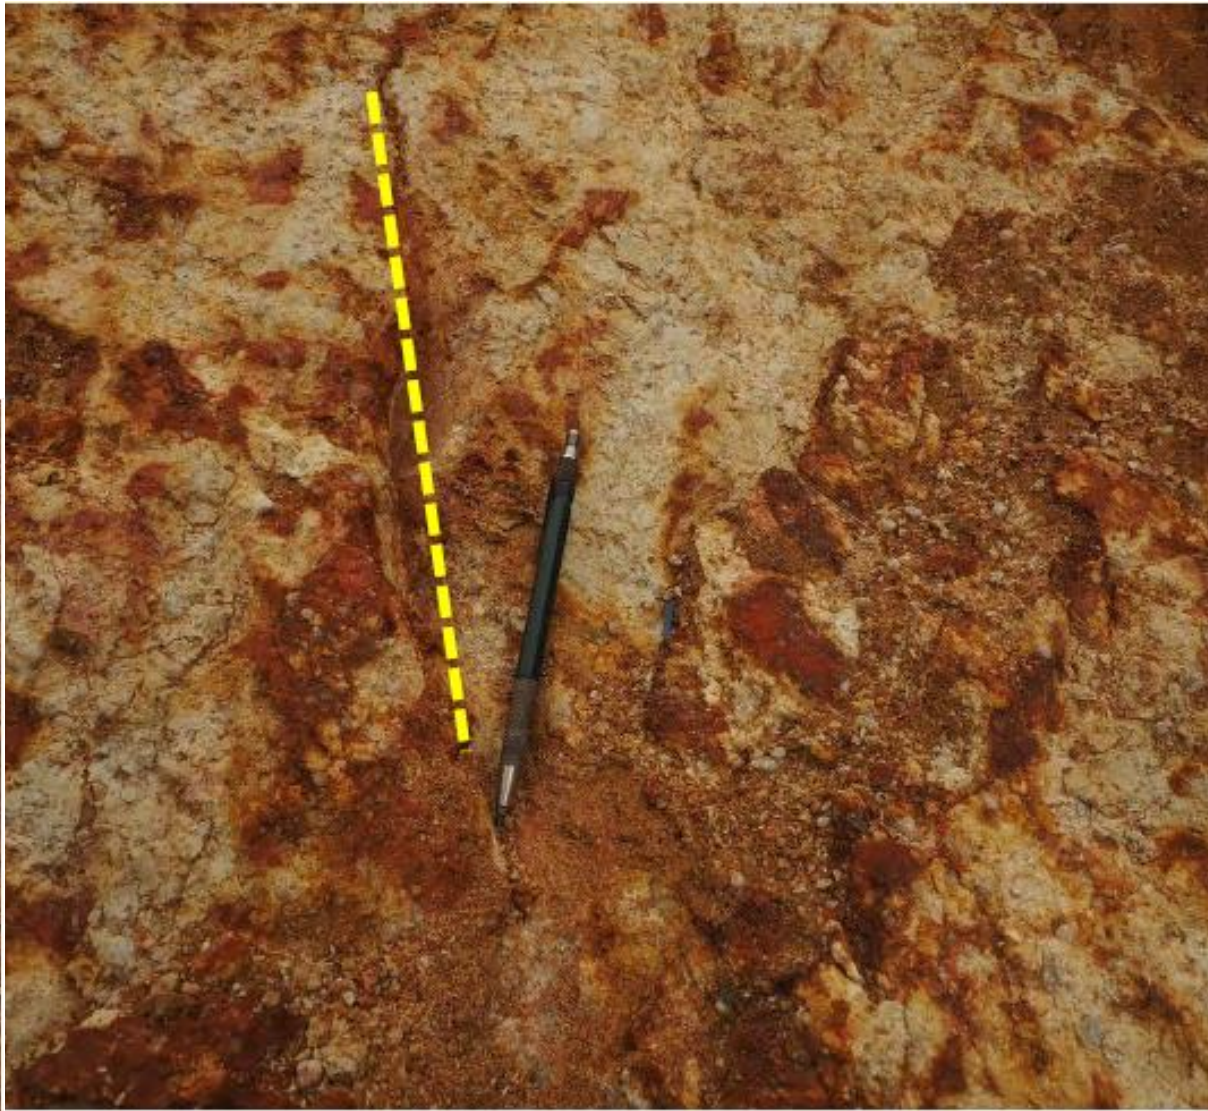
Photo 7: Identified relict joint

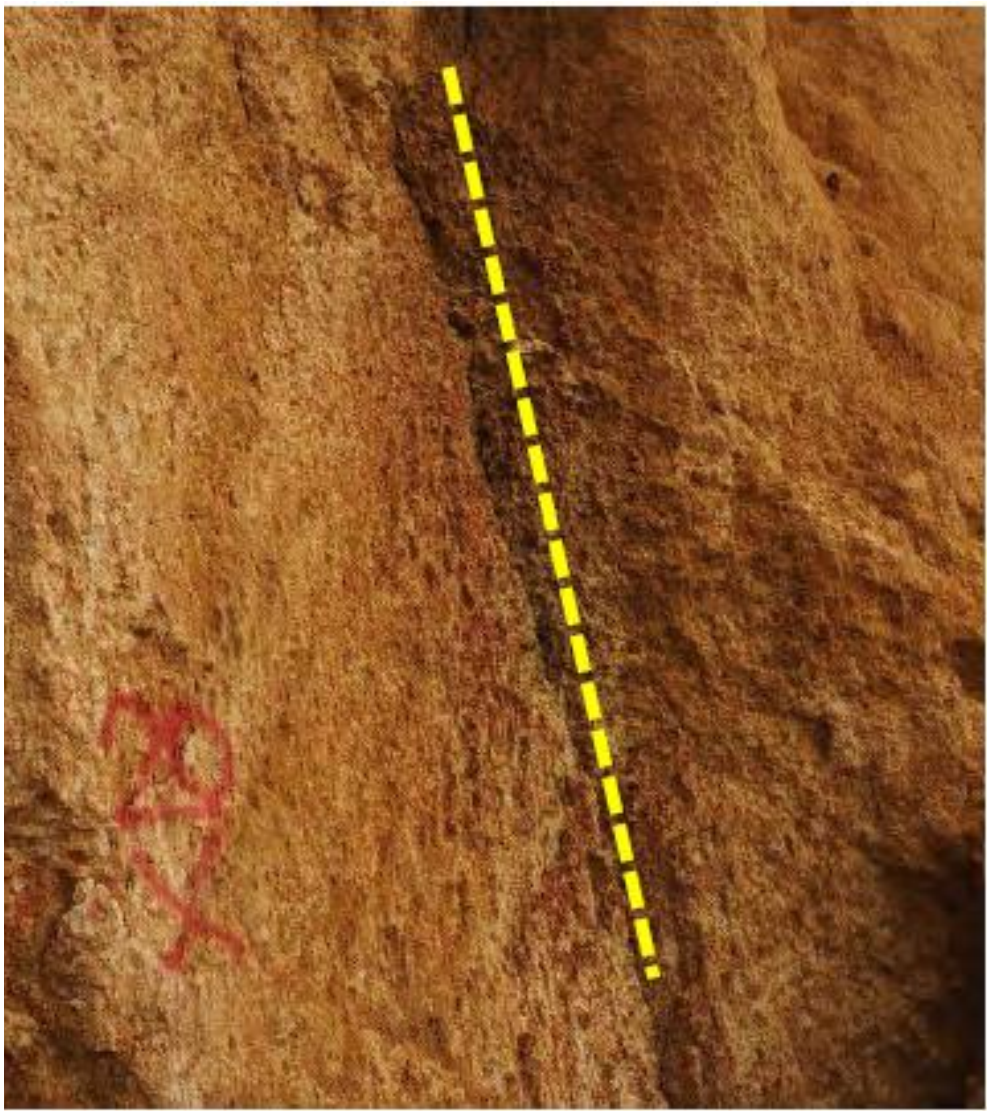
Photo 4: One of the spatial orientation readings of the relict structure

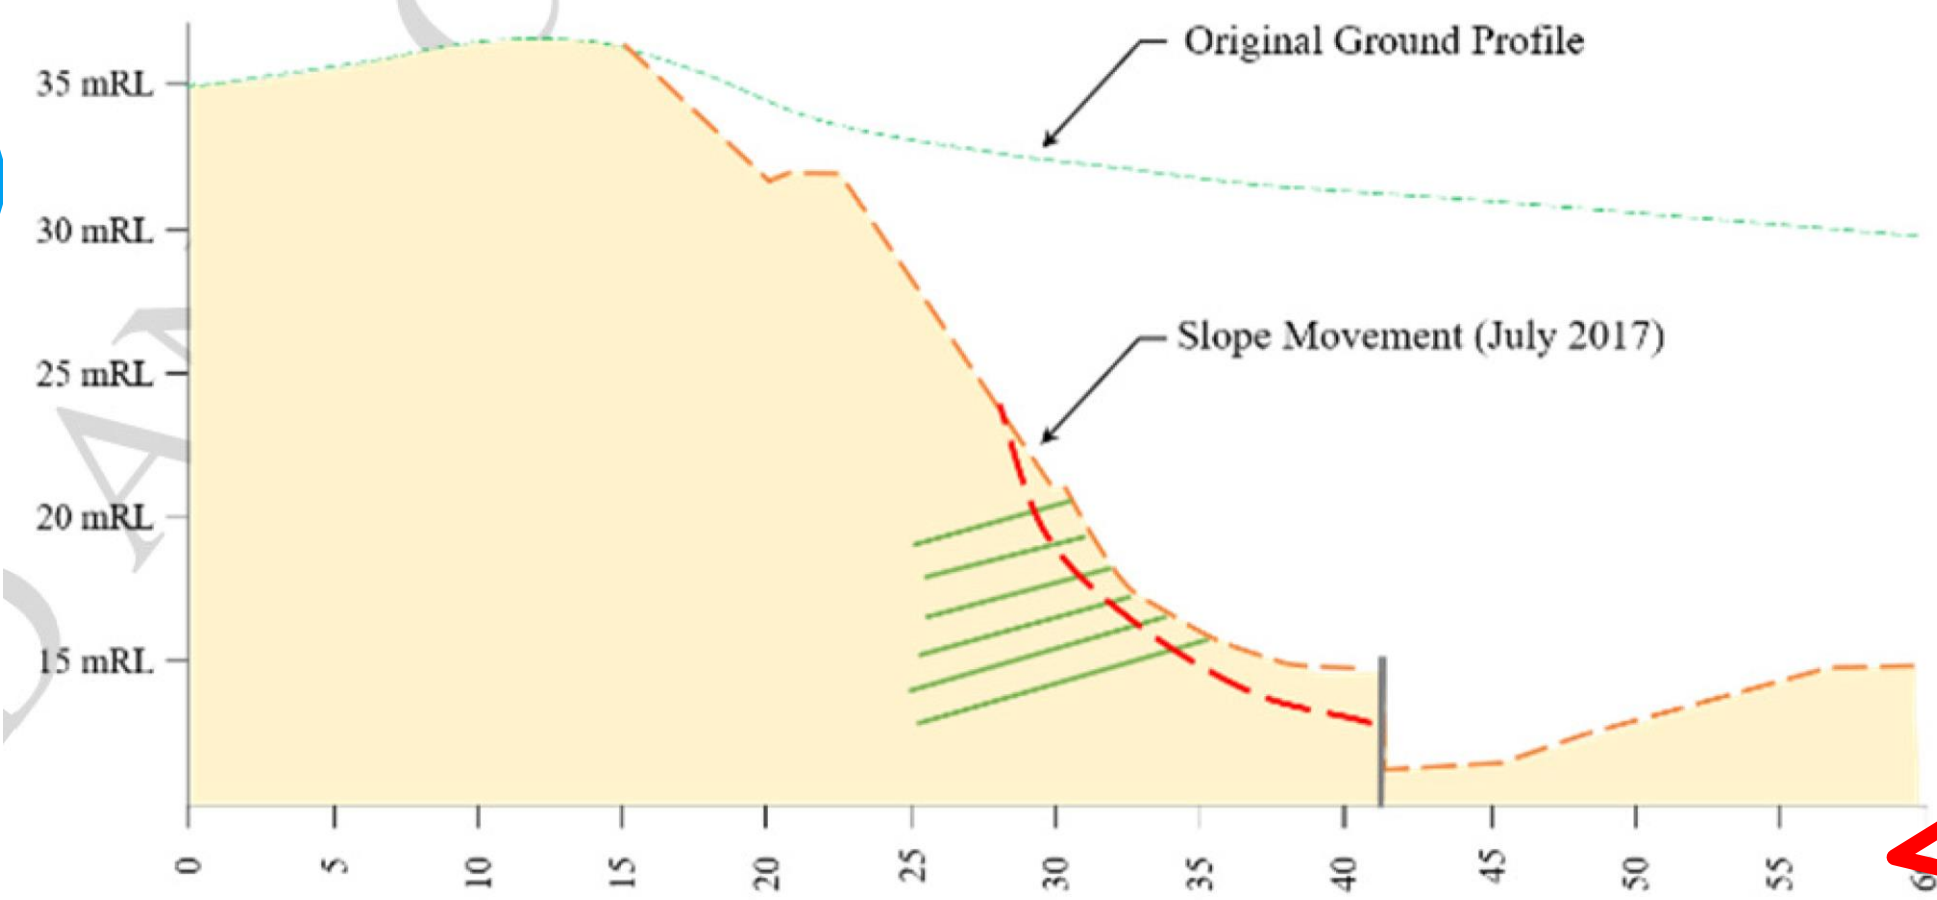
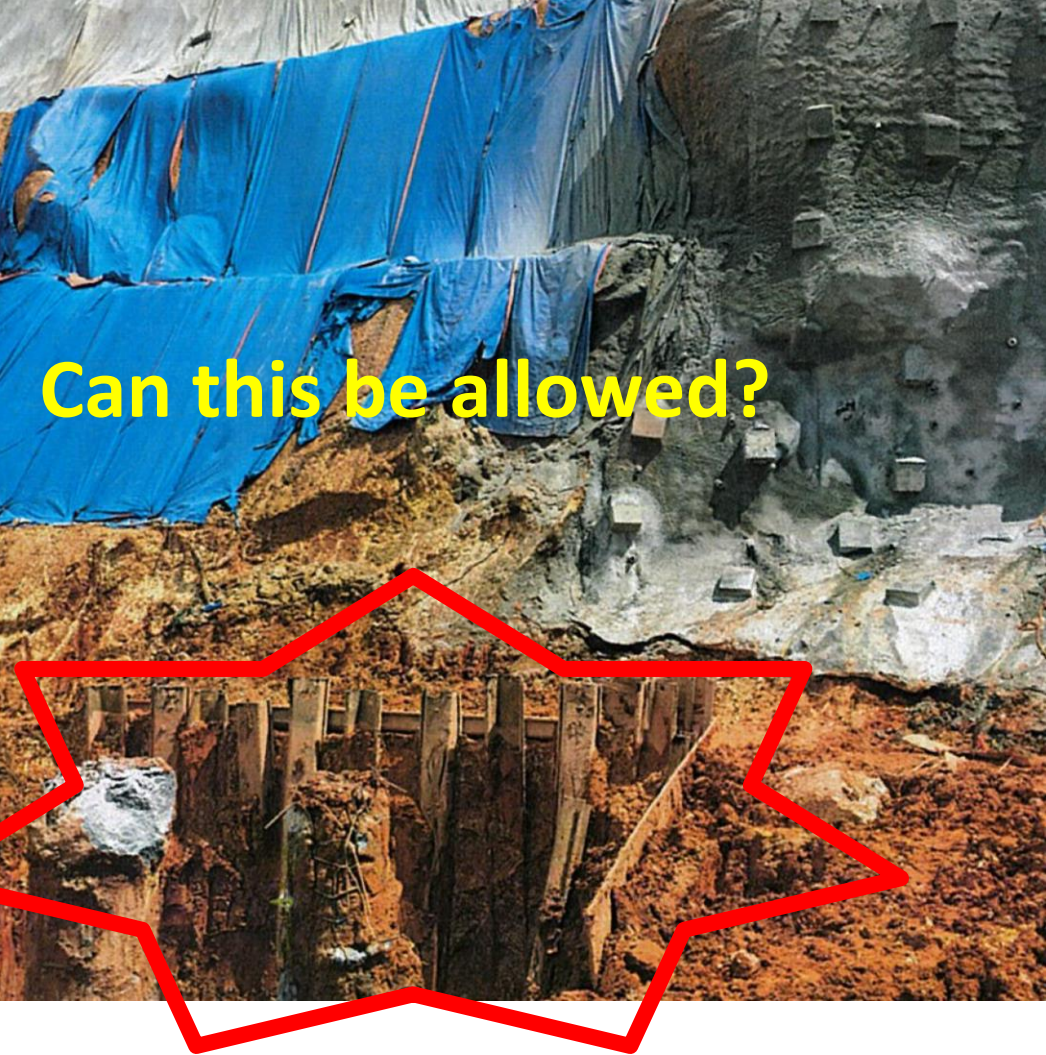
- 1. No shoring for 2.7m pilecap excavation
- 2. Installed sheet piles
- 3. Sheet Pile Displacement and Slope Movement in July 2017
