Four Landslide Investigations in Malaysia

Liew Shaw-Shong, Liong Chee-How & Low Chee-Leong

Gue & Partners Sdn Bhd, Kuala Lumpur, Malaysia.

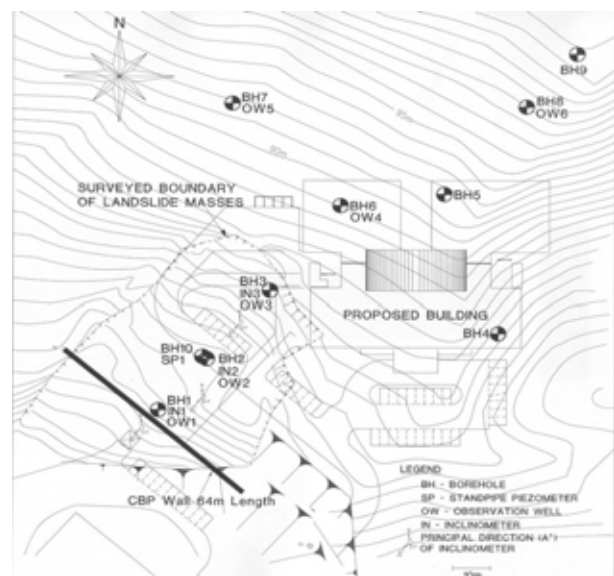
Fig. 1. Borehole and Instrumentation Layout Plan

Subsurface investigation and instrumentation consisting of ten boreholes, three inclinometers, six observation wells and one standpipe piezometer were carried out. The layout of the boreholes and instrumentations is shown in Figure 1. A total of three inclinometers, IN1, IN2 and IN3, three observation wells, OW1, OW2, OW3 and one standpipe piezometer SP1 was installed within the failed mass. The inclinometers were sheared off shortly after the installation. Figure 2 shows the multiple slip surfaces and groundwater level interpreted from the instrumentations.

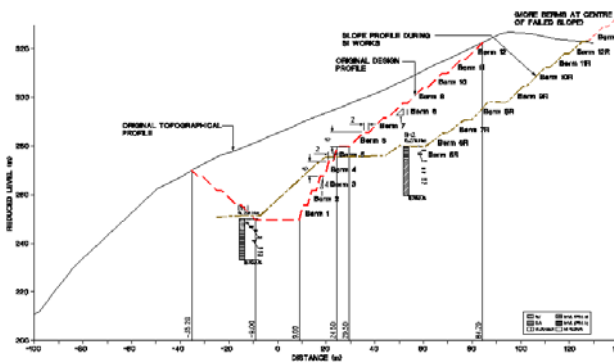
Fig. 3. Original Topography and Design Profiles

The original design of failed slope consists of seven (7) upper berms of 1V:1H cut slope and five (5) lower berms of 4V:1H cut slope with soil nails. A massive slope failure occurred before soil nails were installed at the lowest berm. The slope profiles of original topography and the original design are shown in Figure 3. Figure 4 shows the front view of the failed slope.

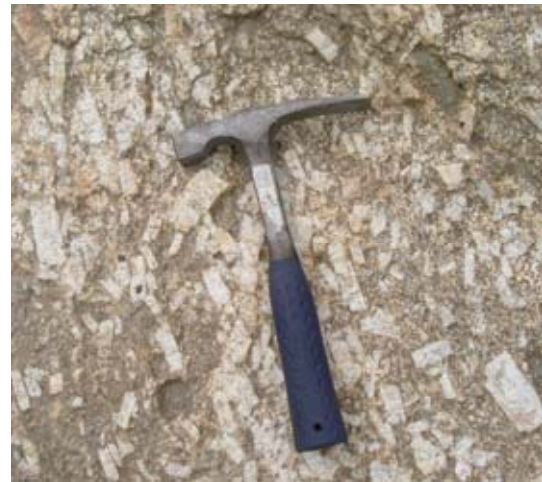
Fig. 9. Feldspar Phenocrysts within Granite

It is interesting to note that complex geological structures and features exist within the region of the site. The site is underlain by granite (Geological Survey Malaysia, 1970). Burton (1970) reported that two sets of fault dominate the structure of the region, which is 323° (northwest-southeast) and 032° (northeast-southwest). Exposed intact granite bedrock was observed at the top of the failed scarp. Prismatic feldspar phenocrysts which are relatively resistant to weathering are found within the granite rock as shown in Figure 9.
