Case Studies of Support of Open Excavations and Distressed Retaining Walls in Malaysia

S. S. Liew

G&P Geotechnics Sdn Bhd, Kuala Lumpur, Malaysia (www.gnpgeo.com.my)

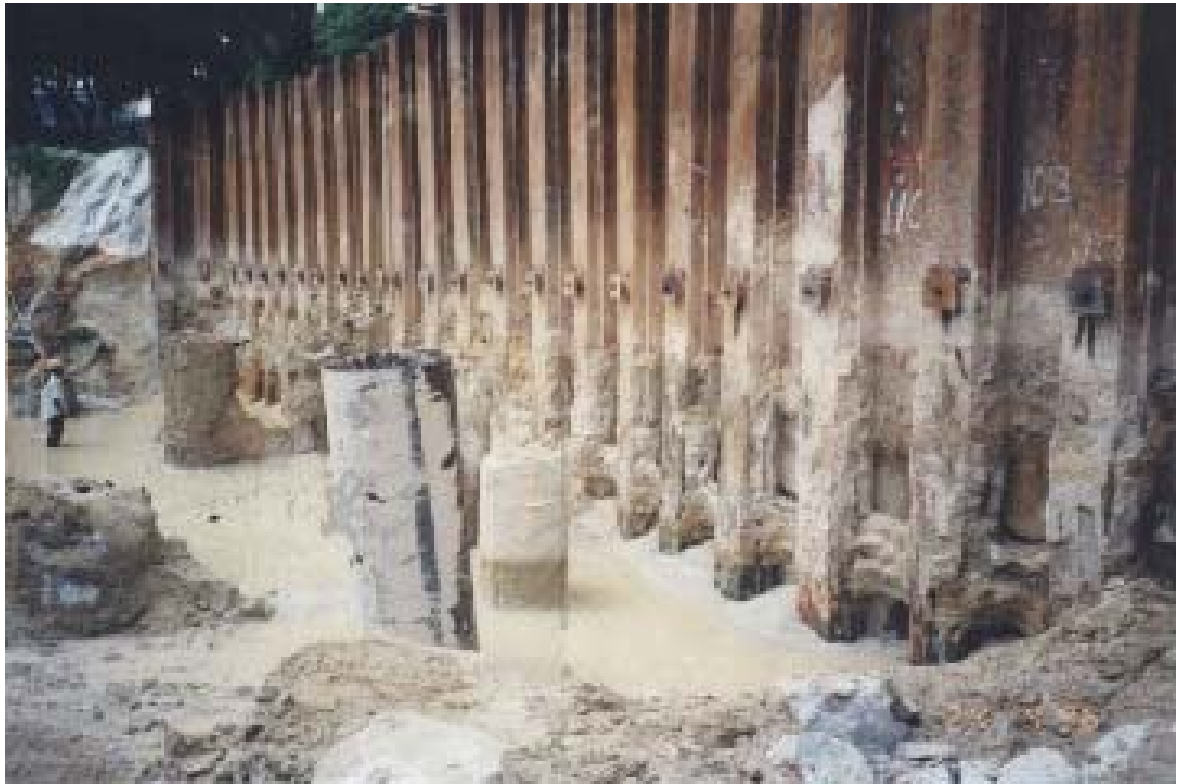
Due to highly unstable hole-stability in the initial ground anchorage construction in the sandy subsoil and occurrence of sink holes on the main road, alternative jacked-in pipe system was proposed to avoid excessive ground disturbance. Three rows of jacked-in pipes were proposed and installed at reduced levels RL+31.0m, RL+28.5m and RL+27.0m respectively. The lateral spacing of the pipes was 1.05m centre-to-centre at the top level and the 0.525m at the two lower levels. Figure 4 shows the installed jacked-in pipes anchorage at the temporary sheet-pile wall.

Fig. 4. View of Retaining Wall with Jacked-in pipe Anchorage.

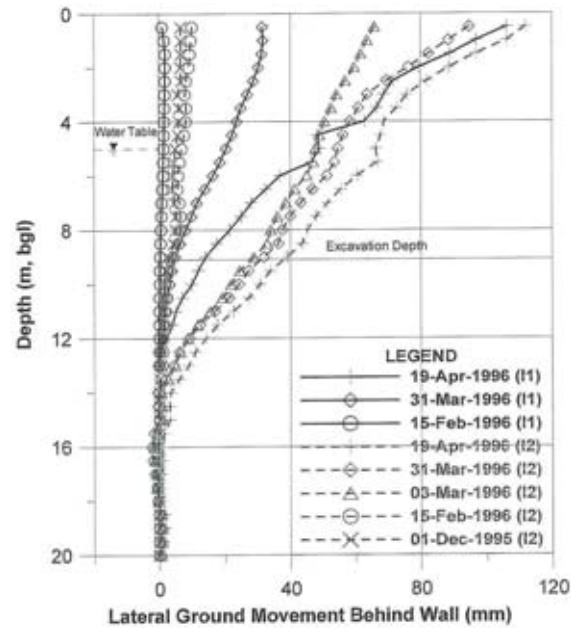
Two inclinometers, namely I1 and I2, were installed in the retained soil immediate behind the sheet-pile wall to measure the performance of the retaining system. Inclinometer I1 was installed with 1m embedment into the shallow limestone at about 12m below the ground level whereas Inclinometer I2 was also embedded 1m into the deeper bedrock at about 19m below ground level. The lateral ground movements recorded by the two working inclinometers are shown in Figure 5. The maximum lateral ground movements at the end of excavation are in the range of 106mm to 110mm, which is corresponding to approximately 1.2% of the retaining height. The maximum lateral movements occurred at the top of retained ground. The lateral deflection profile of the retained soil tends to indicate that the wall almost performed like a cantilever wall.

Fig. 5. Wall Deflection Profile of Retaining Wall with Jack-in pipe Anchorage.

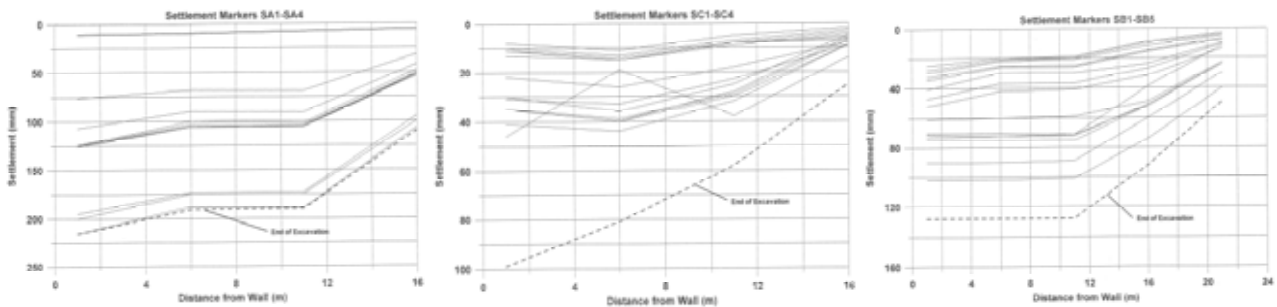
The settlement profiles of the three (3) sets of settlement markers are shown in Figure 6. The maximum settlement is about 218mm, which is located at Marker SA1. This could be attributed to the excessive washing-out of subsoil material during trial installation of the two conventional ground anchors according to the compliance design. In general, the magnitude of settlements behind the wall at the end of excavation is in the range of 125mm at the wall and tapers off after about 20m to 25m away from the wall, which is about 2.2 to 2.8 times of excavation depth. The settlement profiles fall near to the Zone I in the settlement chart by Peck (1969), which is for sand and soft to hard soil with average workmanship. The ground settlement-to-wall deflection ratio ranges from 0.95 (Settlement Markers SB and Inclinometer I2) to 2 (Settlement Markers SA and Inclinometer I1).

Fig. 6. Settlement Profiles for Markers SA1-SA4, SB1-SB5 and SC1-SC4.

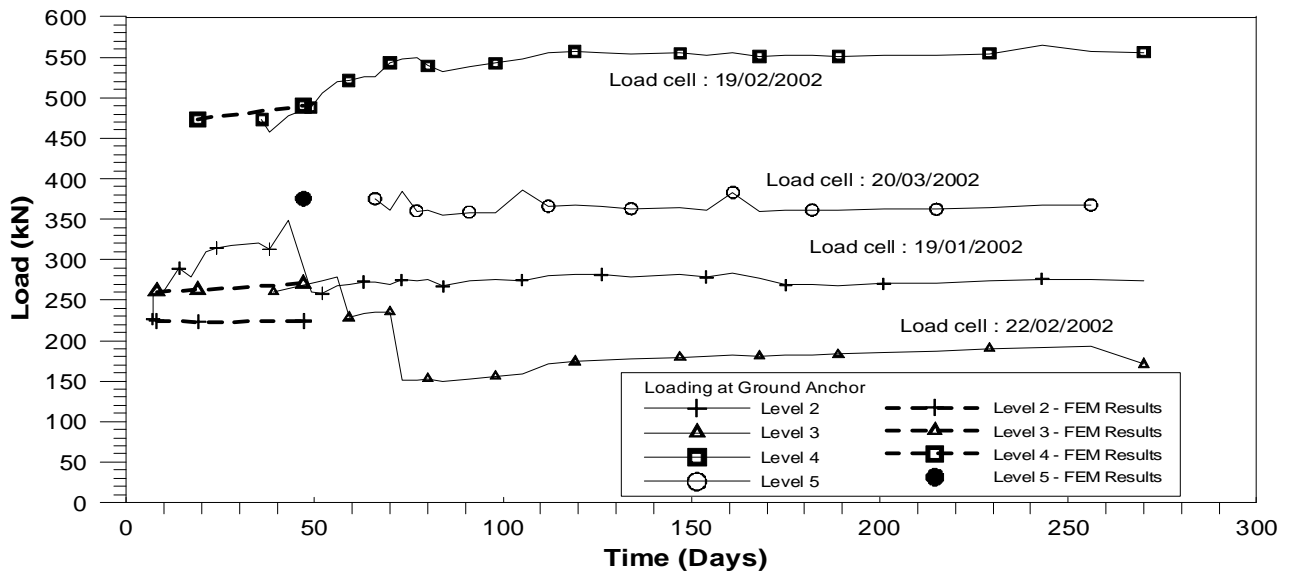
As for the prestressed ground anchor, designated prestressing loads have been applied to the respective ground anchors during lock-off. However, some ground anchors have shown reduction of prestress as in Figure 13, which could be due to creeping of the relatively short fixed anchor length and potential relaxation of prestress as a result of vertical movement of CBP piles under high vertical load component from the prestressed ground anchor.

Fig. 13. Prestressed Ground Anchor Load with Time.

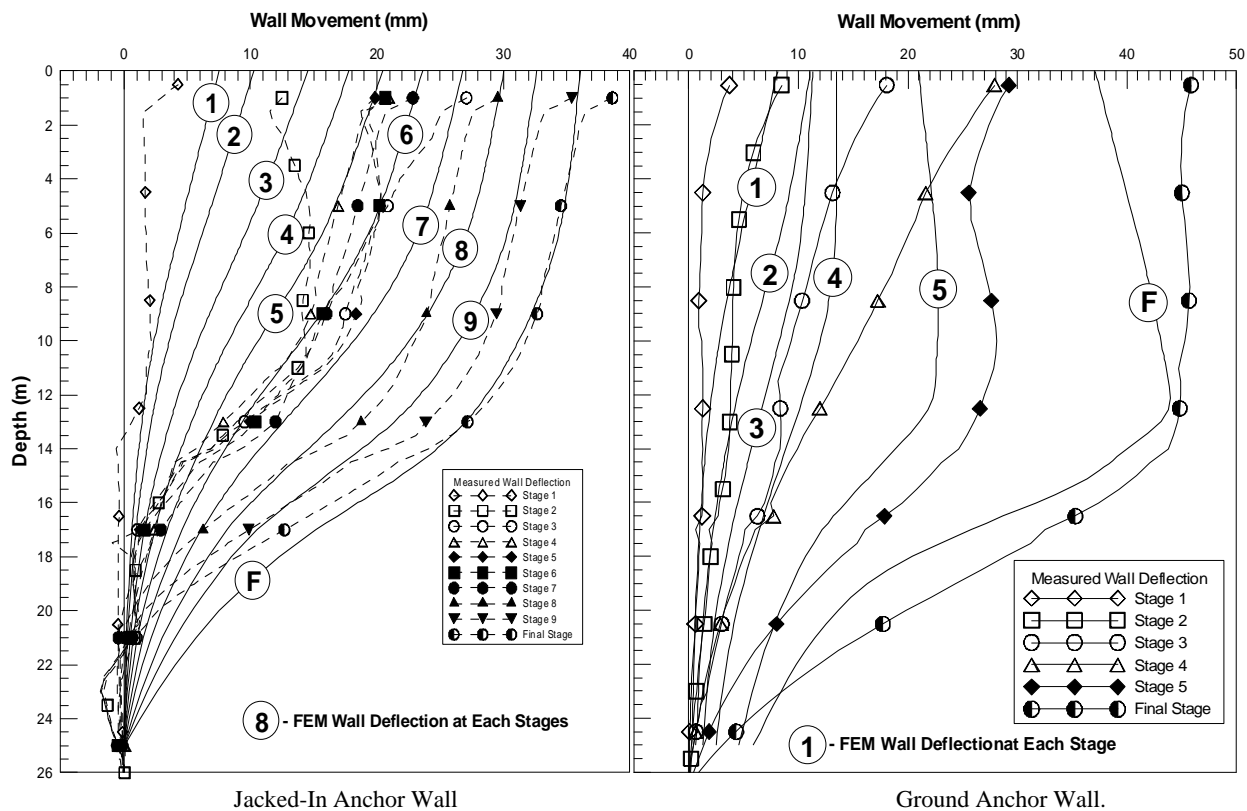
The wall movements at both the jacked-in anchors and prestressed ground anchor walls have been monitored using the inclinometers installed inside the CBP wall. Figure 14 shows the monitored wall movements during various excavation stages at both walls. The jacked anchor wall has moved about 35mm at the final excavation with relatively fixed toe embedment, whereas the prestressed ground anchor wall has moved about 46mm with the wall toe rotated, which implies the overall wall movement could be more and the more passive resistance at the wall embedment has been remarkably mobilised to maintain overall wall stability. The wall deflection-to-excavation depth ratio is about 0.21% and more than 0.27% for jacked-in anchor and ground anchor respectively.

Fig. 14. Wall Movements at Jacked-In Anchor Wall and Ground Anchor Wall.

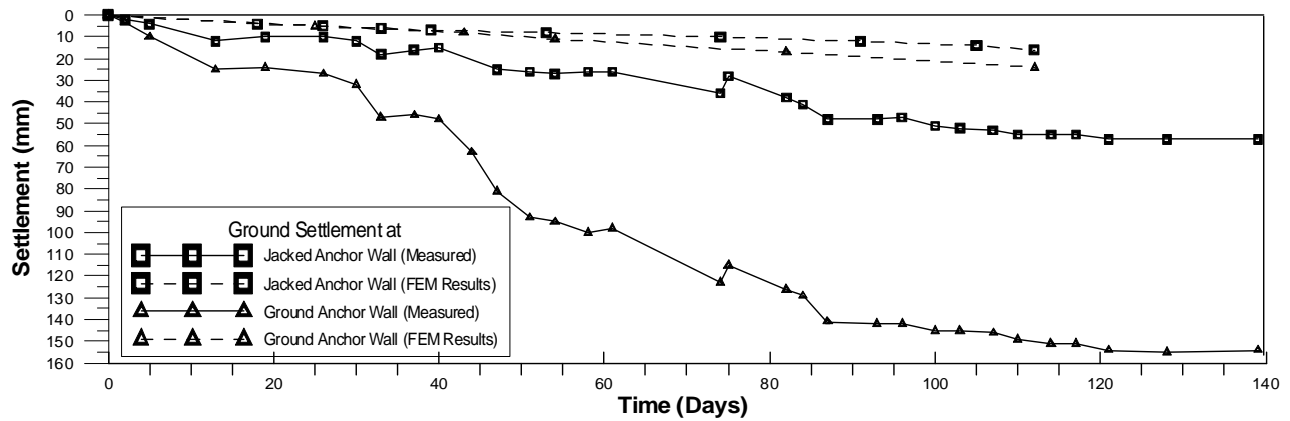
The ground settlement behind the CBP wall at various construction stages is shown in Figure 15. The ground settlement results indicate the performance of jacked anchor support system is far better than the prestressed ground anchor system. Generally, the ground settlement-to-wall movement ratio for jacked-in anchor wall and ground anchor wall is 1.57 and 3.37 respectively.

Fig. 15. Ground Settlement behind the CBP Wall.

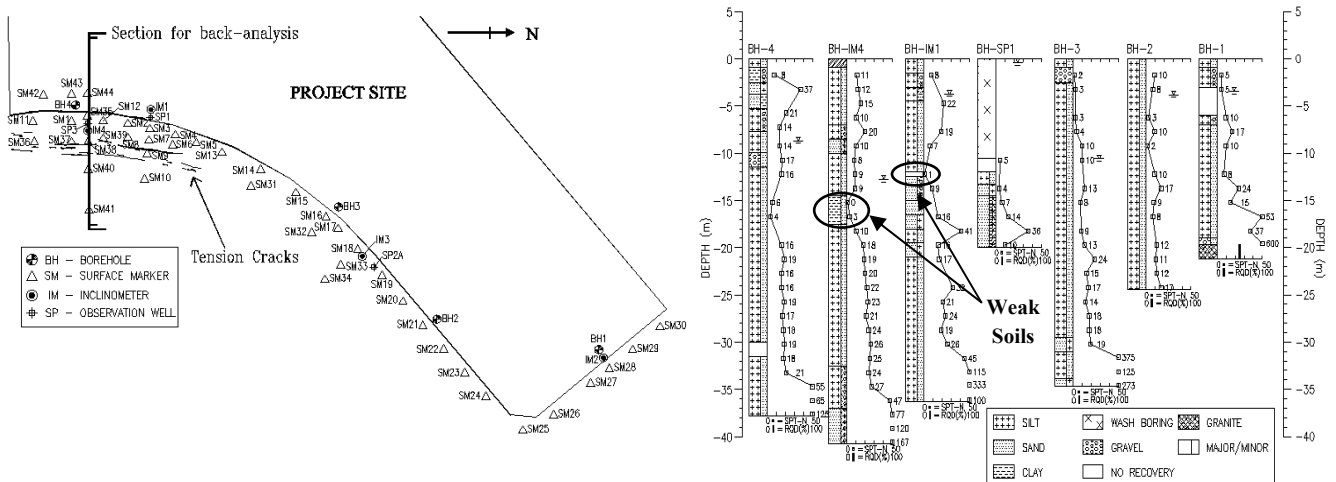
Subsurface investigation (SI) was carried out to establish the subsurface conditions for the geotechnical investigation and remedial design. Figure 22 shows the layout of SI works, instrumentation and the interpreted boreholes logging. The fills material mainly consists of sandy silt with SPT-N values generally ranging from 0 to 20. A layer of soft material was detected at the depth of 12m to 15m below the ground surface in two boreholes (BH-IM1 and BH-IM4) within the distressed soil mass, which was overlying the natural valley in the pre-development topographical condition. The existence of this soft compressible material was further confirmed during an additional subsurface investigation when excessive lateral movements were detected in the subsequent staged excavation.

Groundwater levels were fluctuating and exhibiting seasonal storm responses throughout the construction period. The topographical features of a previous natural valley suggest that collection and concentration of underground seepage may have occurred within the previous valley. This is particularly evident in the soggy and saturated conditions of excavated materials immediately above the valley. Significant seepage was also observed at the previous valley area during excavation.

Fig. 22. Subsurface investigation and instrumentation layout and Borehole Logging Profile.

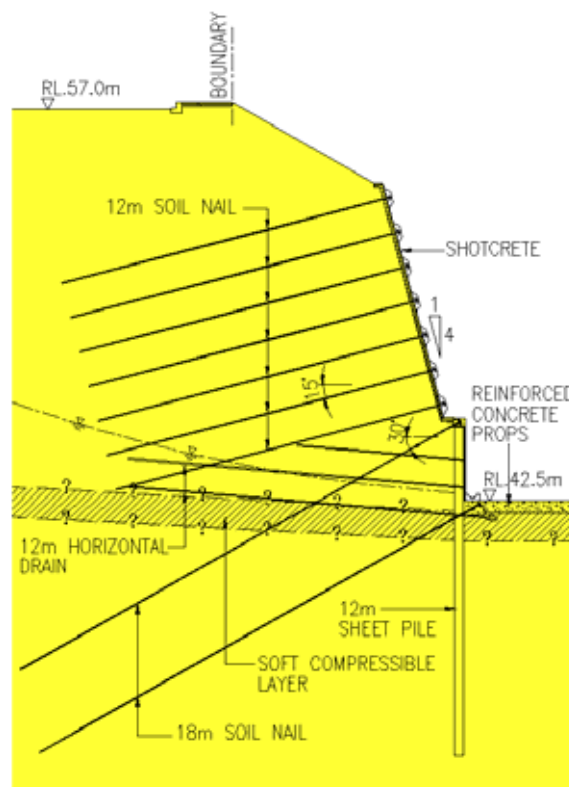
Fig. 23. Cross-section of stabilisation work in the valley area.

At the valley area where excessive creep movement was observed, 12m long FSP IIIA sheet pile walls with two rows of 18m long soil nail anchorages and permanent reinforced concrete props against the basement structure were used to supplement the passive resistance of the excavation in addition to the soil nailed slope on top. The cross-section of stabilisation work at the valley area is shown in Figure 23. Strength reduction method in finite element (FE) analysis was used to assess the original safety factor and the improvement after the proposed stabilisation work at this critical section.

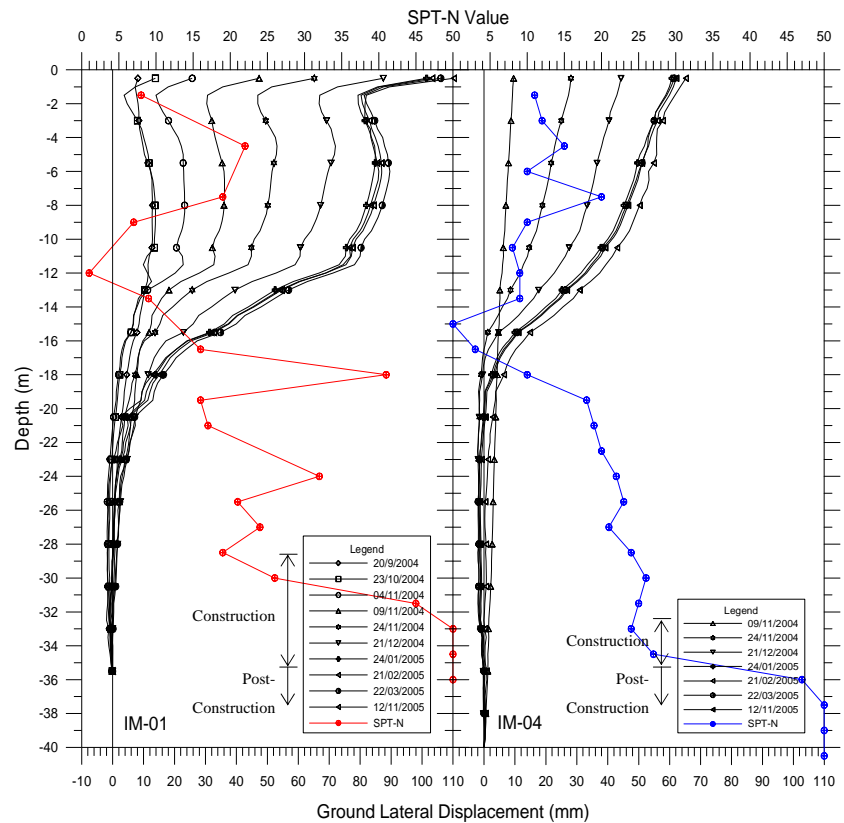
Figure 26 shows the monitored soil nailed slope movements during various stages of excavation. While the cumulative ground settlements behind the soil nailed slope are shown in Figure 27. Groundwater levels had generally been monitored from the installed observation wells throughout the construction period. Figure 28 shows the measured groundwater levels over time.

From the monitoring results, the ground lateral displacement and settlement had stabilised with no appreciable further deformations after the completion of slope stabilisation works. In addition, the groundwater was observed achieving steady state equilibrium even after reaching the final excavation.

Fig. 26. Measured ground lateral displacements.

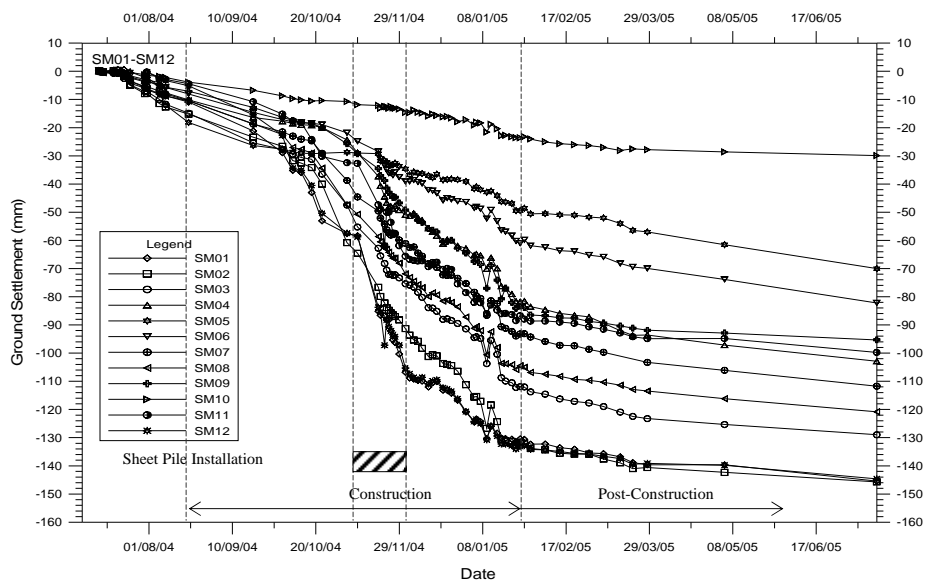
Fig. 27. Measured ground settlements.

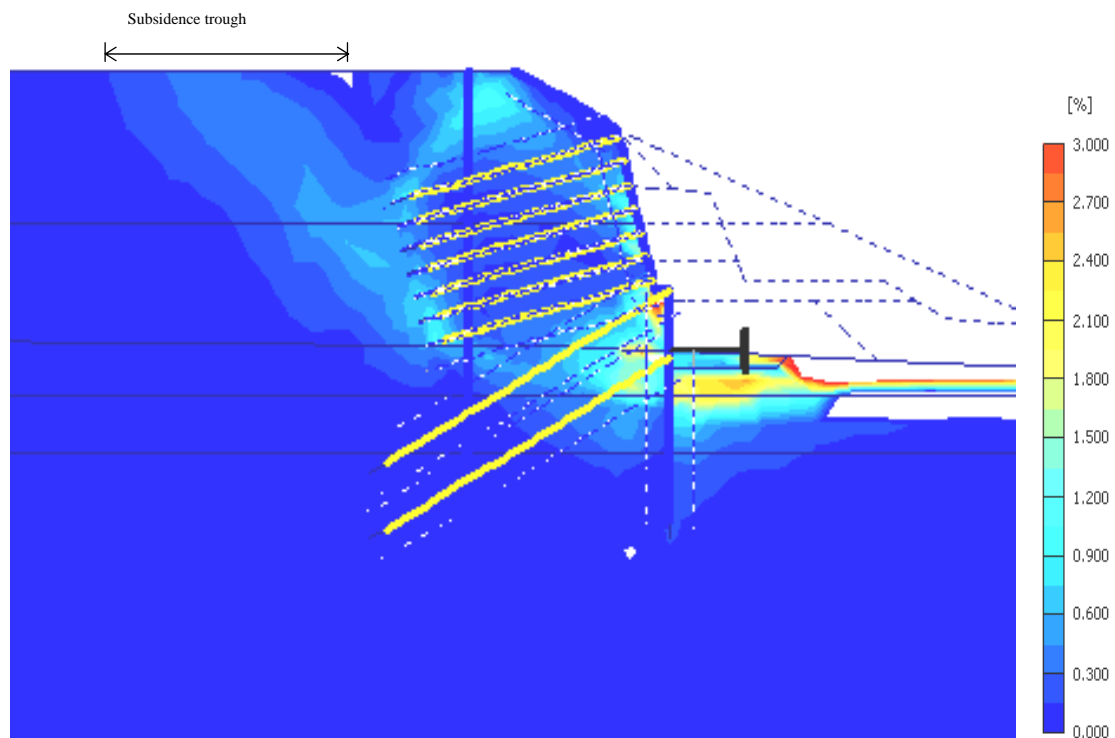
Subsidence troughs developed on the retained ground surface has been observed from the FE back-analysis results (see Figure 29). The results show that surface subsidence is generally expected at a distance of 8m from the excavated face, which tallies extremely well with the site conditions as demonstrated in Fig. 30. The location of the trough is just immediately behind the end of the soil nail where a relatively large shear strain is developed along the potential slip surface behind the reinforced soil mass. This is fairly close to the formation of an active wedge in the retaining wall design. Two major tension cracks signify the extent of the developed active wedge behind the reinforced slope mass.

Fig. 29. Shear strain of soil mass within the soil nail reinforcing system.

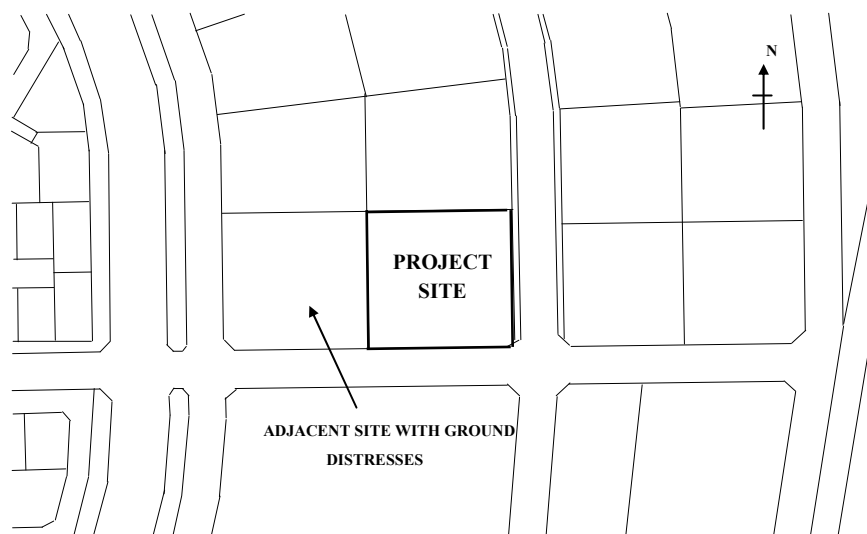
Fig. 31. Site location.

This case history involved construction of a two-storey basement in an urban area. The scope of investigation was to evaluate the conditions of a distressed temporary shoring structure, investigate the probable causes and subsequently to propose remedial options. Figure 31 shows the location of the project site and the adjacent land lot which had been affected due to ground distresses.

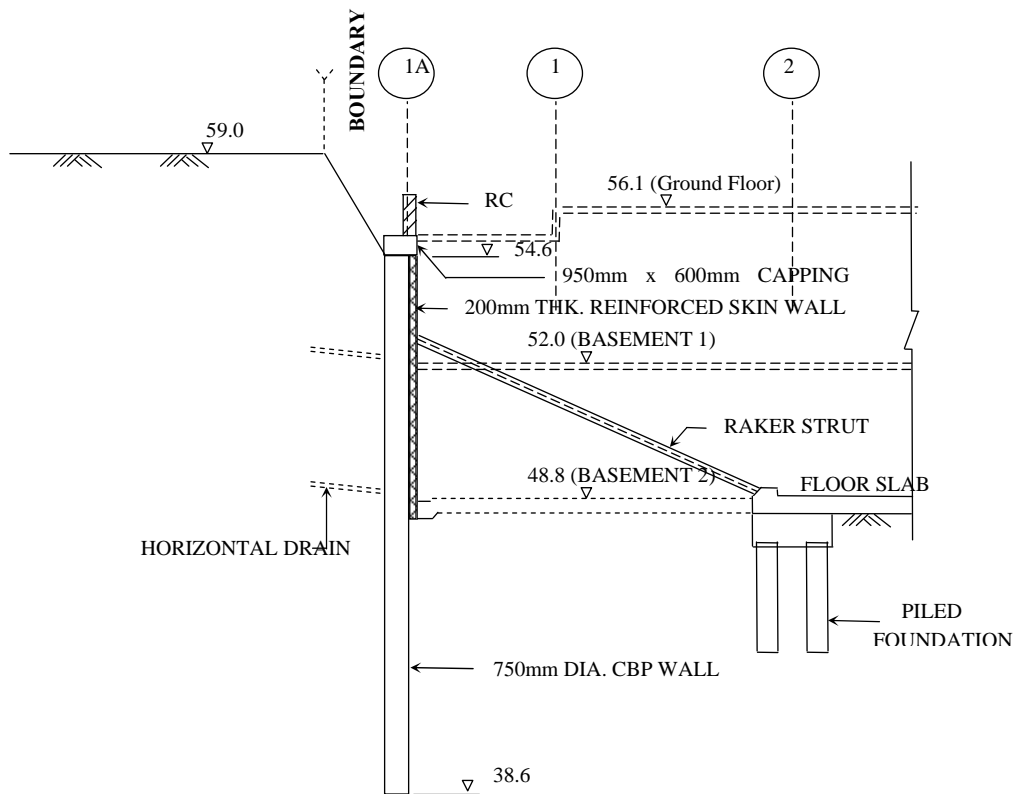
Fig. 32. Cross-section of the proposed alternative retaining walls.

Temporary shoring structure consisting of contiguous bored pile (CBP) wall propped by raking struts against lower basement slab was proposed by the contractor to provide peripheral soil support for the 10.5m deep excavation at western boundary. The designed CBP wall is of 16m long 750mm diameter bored pile with cut off level at RL 54.6m. In order to facilitate the CBP installation, 12m long temporary steel sheet piles (type FSP IIIA) were driven from RL 59.0m at about 0.7m offset away from boundary to provide sufficient working platform and as the temporary shoring support for the exposed 4.4m temporary excavation (from RL 59.0m to RL 54.6m). Figure 32 shows the details and cross-section of the proposed alternative temporary shoring system and permanent retaining wall.

From the site observation, deviation of CBP wall was likely caused by the over-excavation of the temporary passive berm with localized pile cap excavation in front of the wall without installation of the planned raking strut. The incidence had affected the adjacent property lot with considerable ground distresses and also structurally damages the CBP wall.

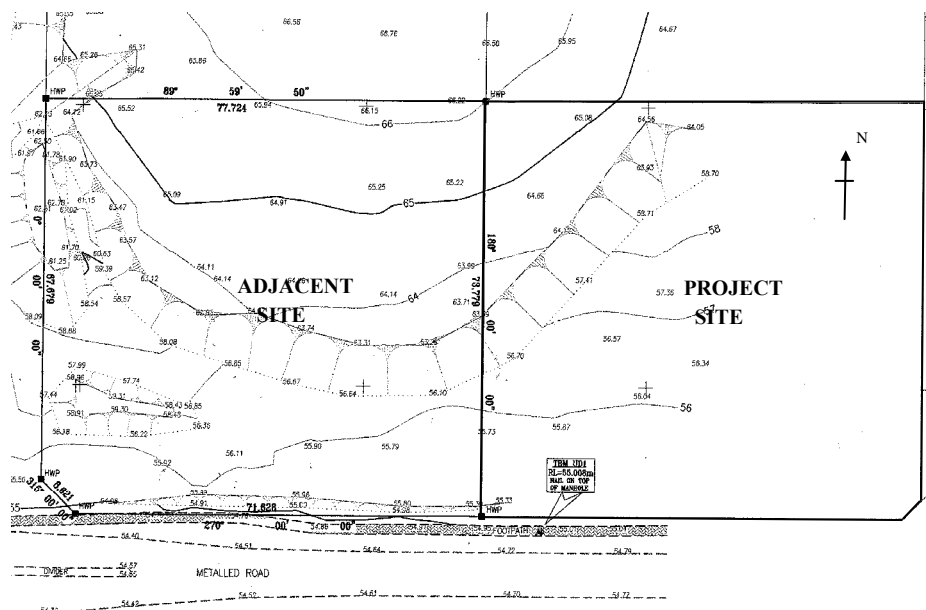
Fig. 33. Topographical survey plan of adjacent lot (subject to disturbance before the finished level).

Based on the topographical survey plan of adjacent lot, which was believed to be the condition before the earthworks, part of the proposed site (i.e. at north-western side) is of sloping terrain from approximately RL 65m to RL 56m. There is a 6m high cut slope existed within this sloping ground as indicated in Figure 33.

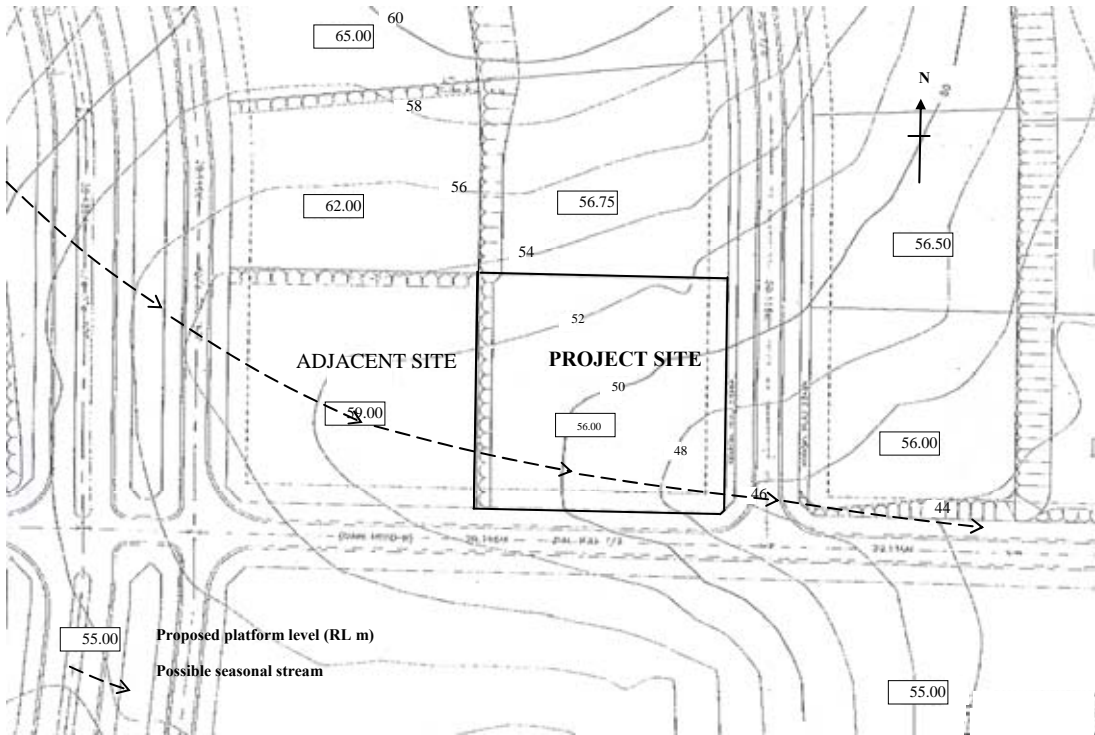
Fig. 34. Regional major earthworks layout with contour lines.

Based on the pre-development topographical condition as shown in Figure 34, the contour lines for both the adjacent lot and the proposed site range from RL 54m to RL 47m. As such, it is evidenced that earthworks had previously been carried out at these areas to raise the building platform level to RL 59.0m and RL 56.0m for the adjacent lot and the proposed site respectively. Both of

the sites are on filled platforms. Particularly, the distressed area was primarily located at the valley where thicker fill was placed. High potential of saturation of fill due to perched groundwater seepage after filling in the previous valley terrain can be expected if subsurface drainage is not provided.

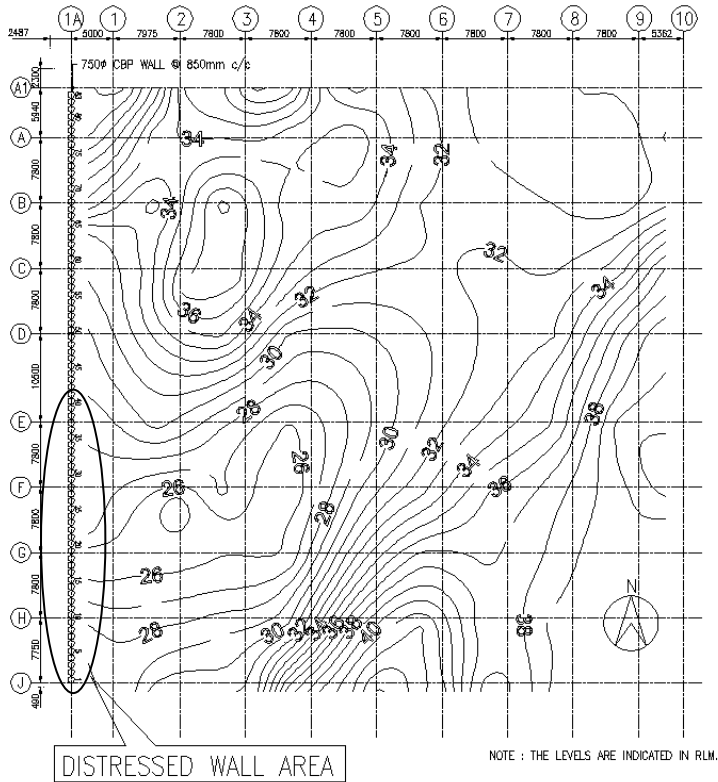
Fig. 35. Interpreted contour of hard stratum from piling information.

In addition to the topographical map, assessment on the piling information was carried out to reveal the soil consistency profile within the site as shown in Figure 35. It was found that the distressed ground and retaining wall areas correspond well with the expected thicker fill and deeper weathering profile at the valley area as discussed.

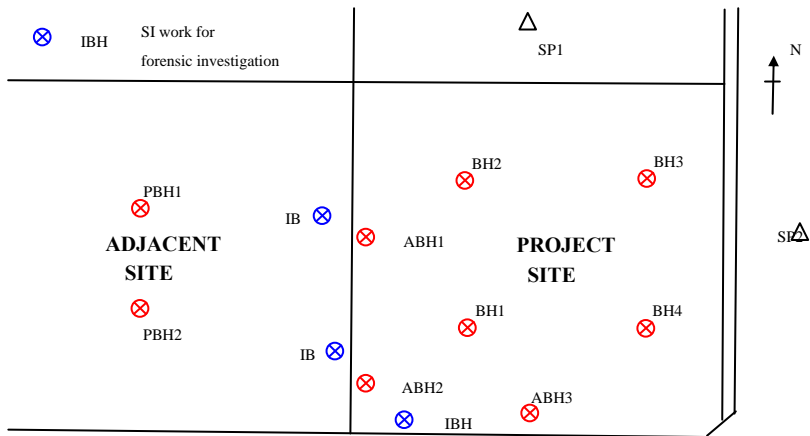
Fig. 39. Subsurface investigation layout.

Before the wall and ground distresses, two stages of subsurface investigation (SI) works were carried out at the proposed site. The second stage SI works is the additional SI conducted at the perimeter western boundary for the alternative basement wall design by the contractor. At that time, no much attention was given in identifying the weak deposits between the original ground and the platform backfill. The SI layout is shown in Figure 39.

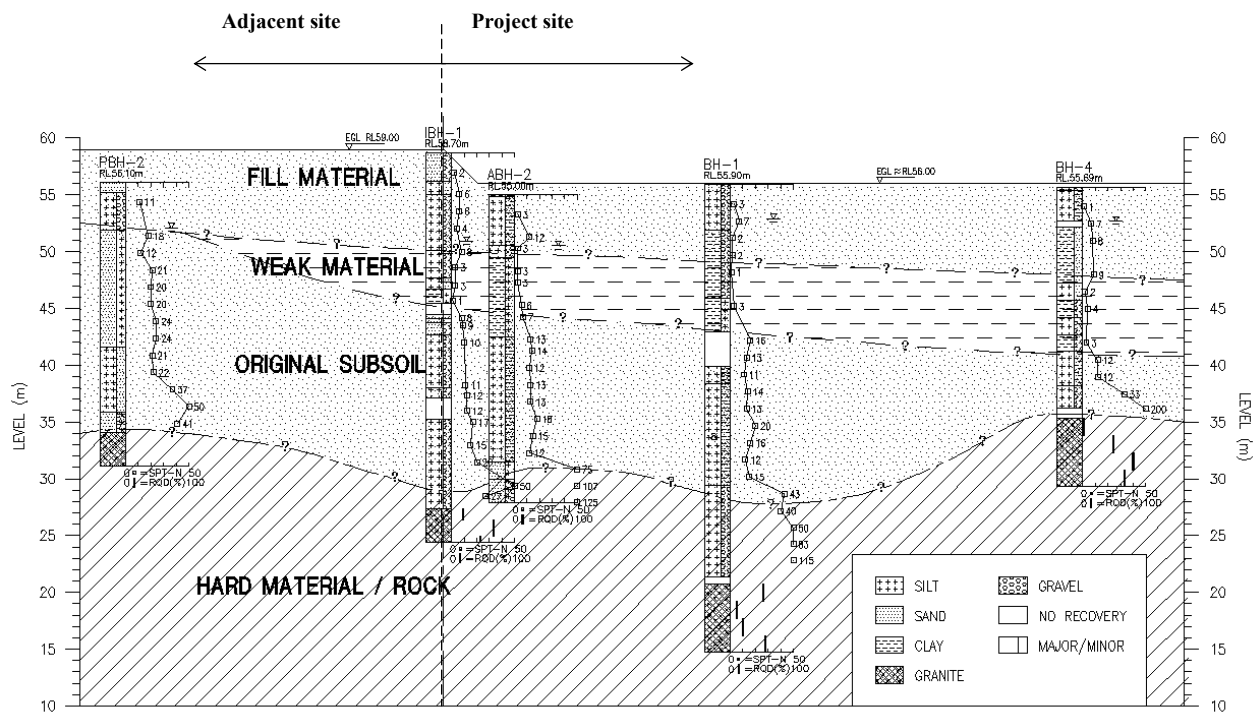
Fig. 40. Typical cross-section of subsurface profiles at the distressed wall area.

After the incidence, additional three boreholes were sunk within the distressed wall area to investigate the subsurface profile and to install instruments for construction monitoring. In particular, a layer of 6-9m thick of very soft to soft sandy/silty clay (SPT-N <= 4) was encountered from RL 52m to RL 43m as detected in the few boreholes near to the distressed wall area. Generally, SPT-N values of the subsoil range from 3 to 6 at the top 13m of the subsoil and gradually increase with depth thereafter. This implies that the top layer of subsoil is most probably of fill material underlain by the soft deposits in the valley. A typical cross-section of subsurface profiles at the distressed wall area is shown in Figure 40. The groundwater levels recorded in the boreholes and observation wells were generally higher at the western side and lower towards the eastern side of the project site, which tallies with the flow path of the valley during pre-development condition.

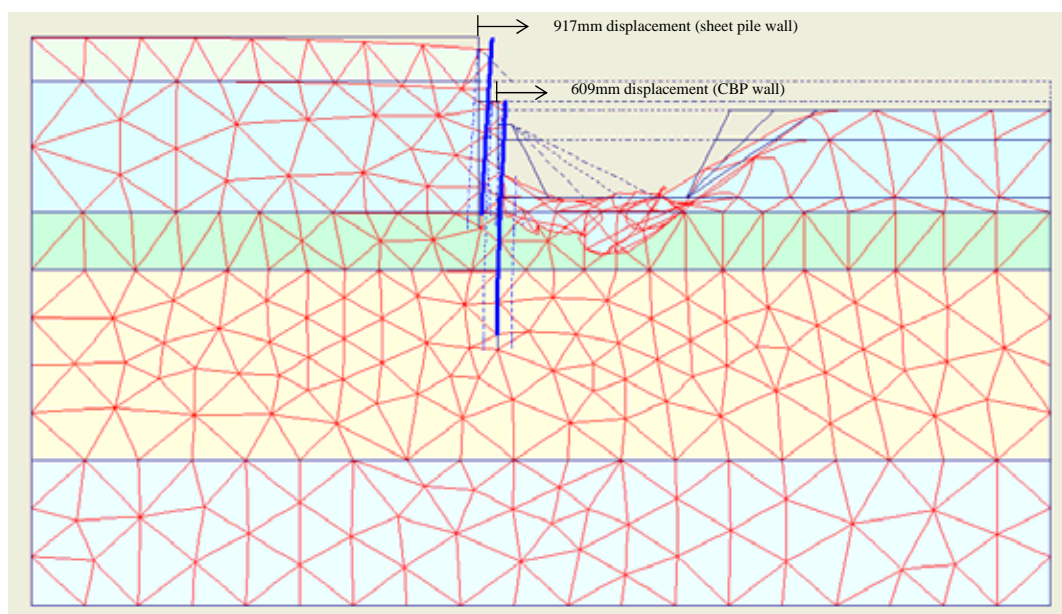
Fig. 41. Results of finite element analysis.

In order to confirm the probable causes of ground distresses and wall movement, Finite Element (FE) analysis using computer software “PLAXIS” was performed independently based on the subsurface profile as shown in Figure 41. The construction sequences of excavation were simulated in the FE analysis.

At one analysis stage where over-excavation in front of the wall was carried out, the analysis results revealed that the retained earth platform displaced excessively in the horizontal and vertical (settlement) directions with the temporary sheet pile retaining wall moving forward. As part of the lateral resistance to the temporary retaining walls by the passive berm was removed before installation of raking strut, over-excavation of this berm had reduced the lateral resistance to the sheet pile wall and subsequently mobilises the resulting strength of the retaining walls from serviceability state condition towards the ultimate limit state condition. The excessively displaced temporary sheet pile wall had induced additional lateral force to the installed contiguous bored piles (CBP) walls. The high induced flexural stress unavoidably damaged the CBP pile and led to excessive ground distresses. The results of FE analyses (see Figure 41) reasonably well agreed with the measured wall movements and ground deformations (e.g. tension cracks, settlement and depression).

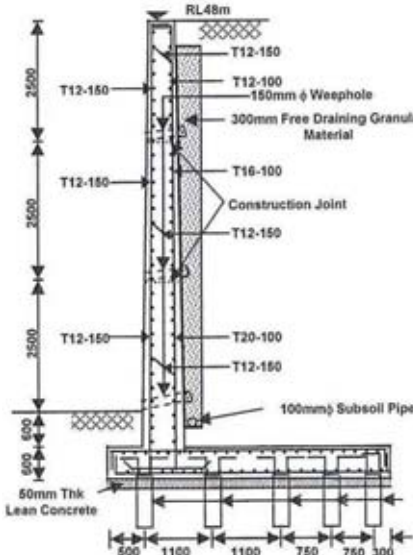
Fig. 44. Typical Section of Piled Reinforced Concrete Retaining Wall

A section through the distressed RC retaining wall is shown in Figure 44. The RC retaining wall was supported on five rows of driven vertical precast 200mm RC piles at 2m longitudinal spacing. The vertical compressive working load of the 200mm RC square piles is 450kN. High strain dynamic pile test was previously carried out on seven of the piles. The pile driving records of the test piles indicated that the piles were driven to end-bearing condition and the installed lengths ranged from about 4.5m to 11.7m. The mobilised pile capacity in the six tested piles had achieved a minimum factor of safety of 2.0 and one pile with a

marginally lower factor of safety of 1.8. The test cube results for the wall construction show that the concrete cubes had achieved the designed strength of 30MPa.

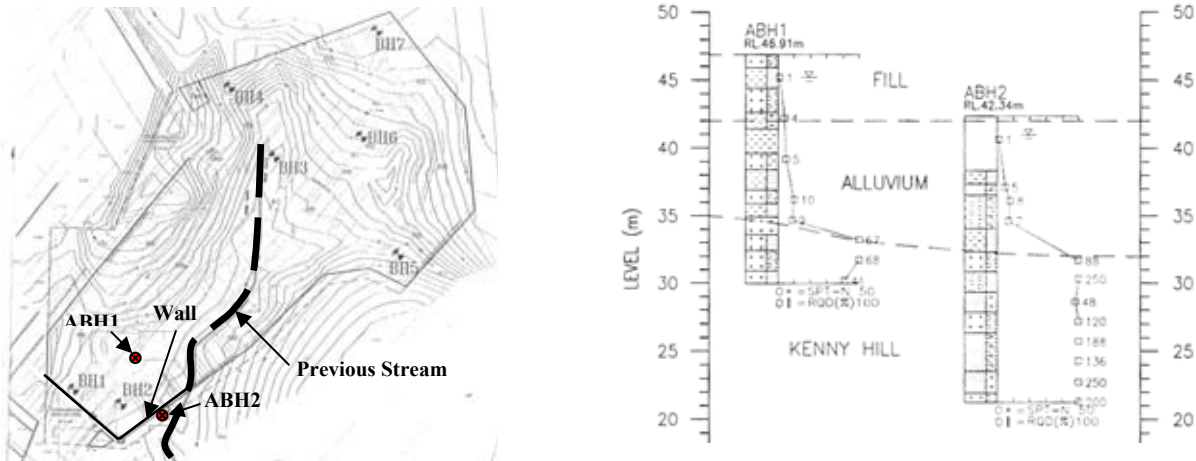
Fig. 46. Site Topography and Subsoil Profile

The layout of two previous subsurface investigation (SI) works carried out for the project. The first one consisted of seven boreholes for the entire project site is shown in Figure 46. The second SI works consisted of three boreholes and 25 Mackintosh Probes carried out along the retaining wall alignment. Only basic laboratory tests, such as soil classification had been performed in both SI works. There was no strength testing carried out in either SI.

Additional SI work, consisting of two boreholes (ABH series in Figure 46), vane shear tests, ten Mackintosh Probes and laboratory testing, was proposed to investigate the shear strength parameters and to reconfirm the subsoil profile. The SI layout plan and borehole profiles are shown in Figure 46. Borehole ABH-1 was carried out about 14m behind the RC retaining wall indicating higher percentage of silt and clay while borehole ABH-2 was carried out near the toe of the RC retaining wall showing high percentage of sand and gravel. Both boreholes ABH-1 and ABH-2 encountered hard material at RL34m and RL32m respectively. The borelog profile of ABH-1 shows the top 5m of fill above RL42m with low SPT-N values. From RL42m down to RL35m for borehole ABH-1 and RL32m for borehole ABH-2, the subsoil materials are considered likely to be alluvial deposits.

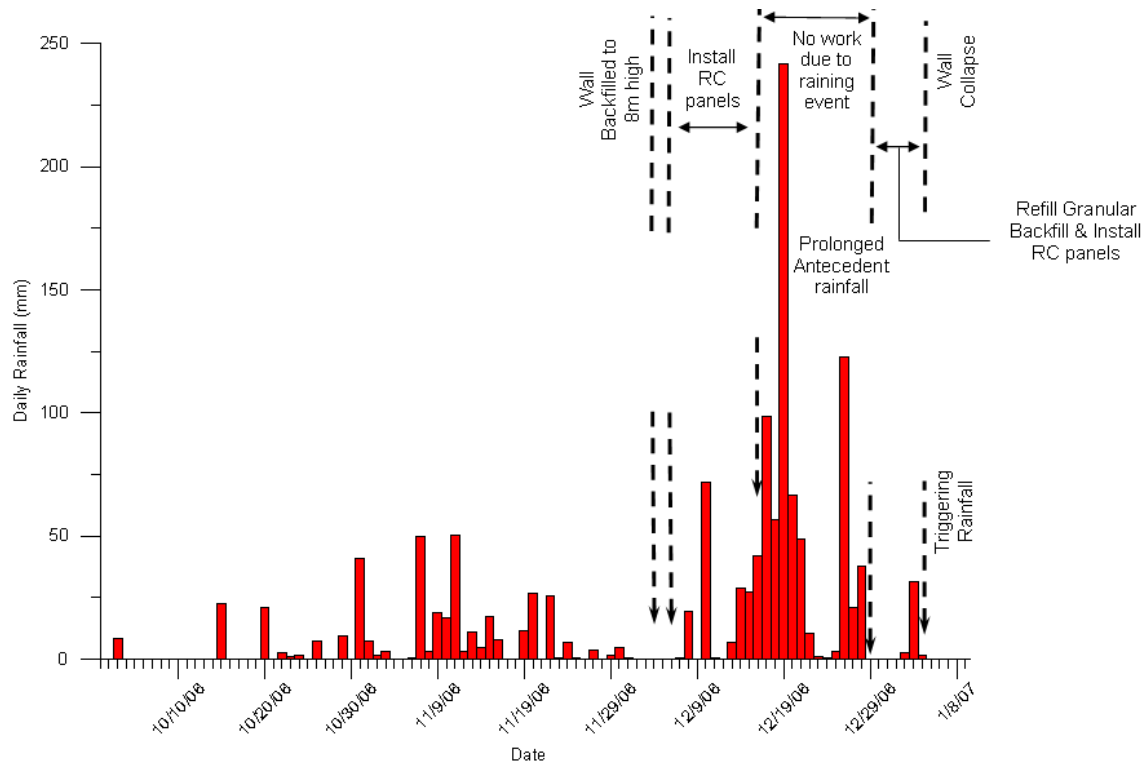
Fig. 52. Daily Rainfall Chart

Figure 52 shows the meteorological daily rainfall data of nearby rain gauge station from October 2006 to 9th January 2007 provided by Malaysian Meteorological Department (MMD). Another rain gauge station of the Department of Irrigation & Drainage (DID), Malaysia is corresponding well to MMD station enhancing the fact that the rainfall event during this period is a large scale regional rainfall event rather than a localised climatic phenomenon. Prolonged rainfall with extremely high intensity was observed at the above two stations from mid to the end of December 2006.

Average Recurrence Interval (ARI) with respect to various precipitation periods was calculated for the rainfall events before the RS wall collapsed. The basis of the ARI calculation has been made to an established Rainfall Intensity-Duration-Curve.

Based on the analysis results, most of the calculated ARI with respective precipitation periods are more than 200 years, which have been far exceeding in normal design life of a local drainage system of development in urban area. The ARI of a temporary drainage of a site is normally the same as the expected construction period with some extra for allowance.

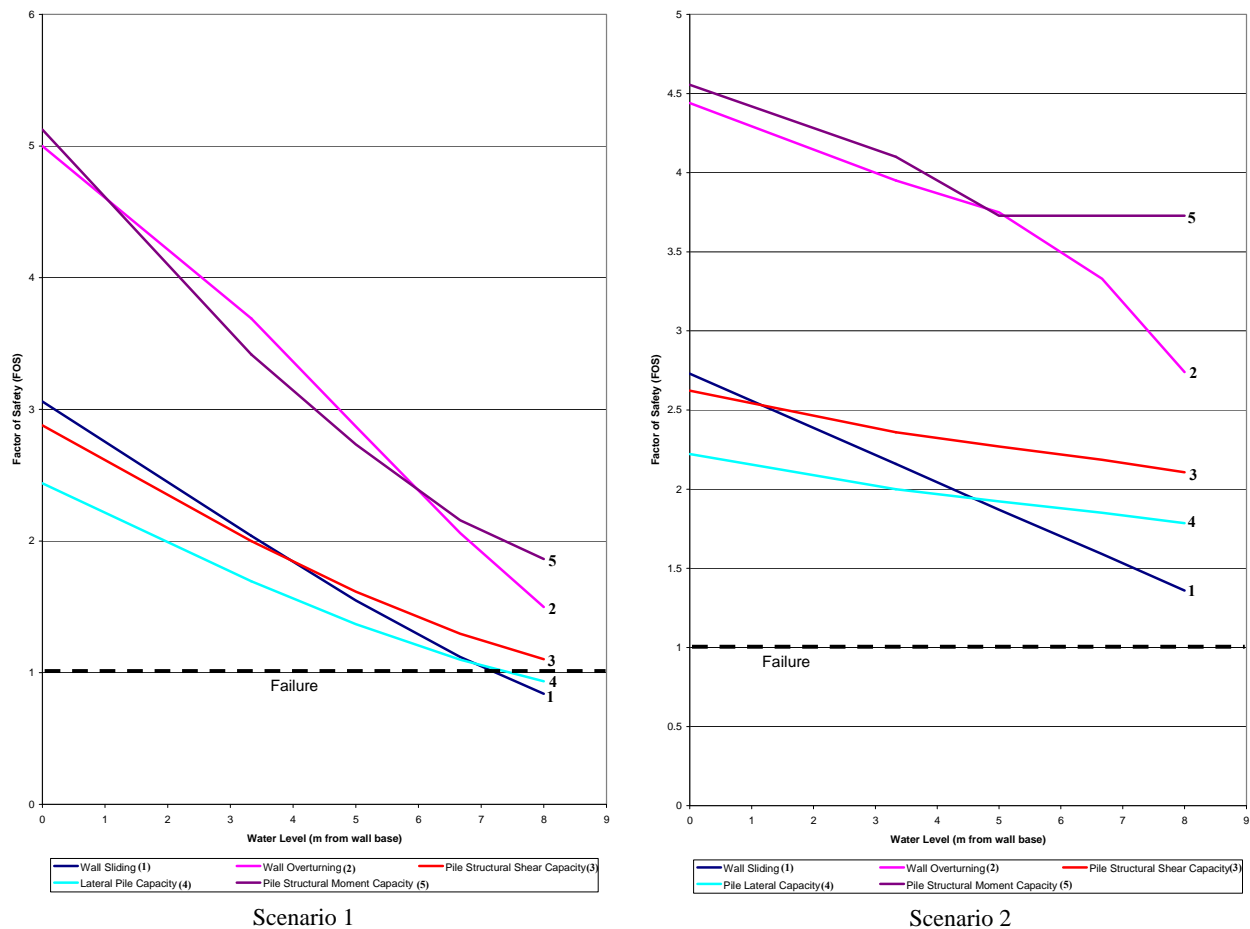
Fig. 53. Safety Factors of Geotechnical Resistance and Achieved Load Factor against Structural Resistance of Wall Elements

Results of the analyses for the two scenarios are summarised in Figure 53. Generally, Scenario 1 is the governing case.

The external stability of the reinforced soil block with respect to various water levels behind the wall was checked. As shown in Figure 53, the factor of safety against wall sliding above the piled slab reduces to 1.0 when the water level is at about 7.2m above the wall base in Scenario 1.

Global stability of the RS wall was also checked with respect of different water levels. For more representative modeling, the self weight of RS wall was ignored in the analyses, as the wall is both supported vertically and laterally by piles. The pile resistance against lateral loading was considered in the stability analyses. The results show that the factor of safety is still higher than 1.0 when the water level is about 8m above the wall base.
