How to improve the Safety of Temporary Works in Construction

Presented by:
Ir. Tan Yean Chin
President of IEM
Secretary General of FEIAP

13 Jan 2017

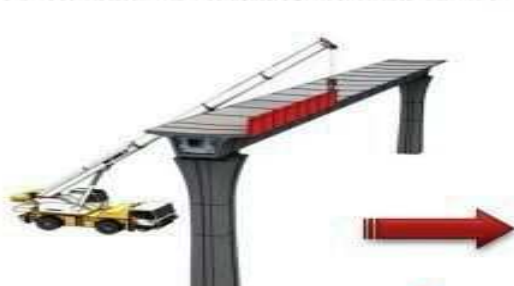
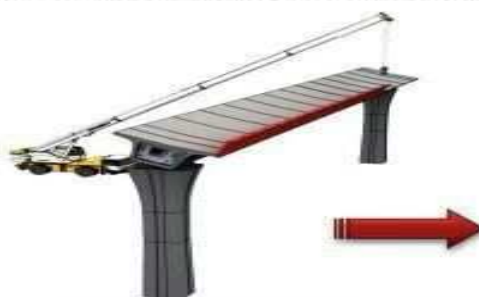
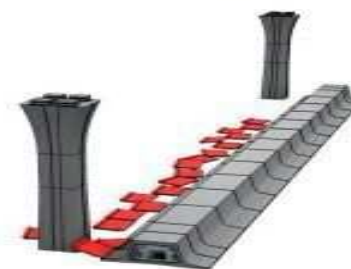
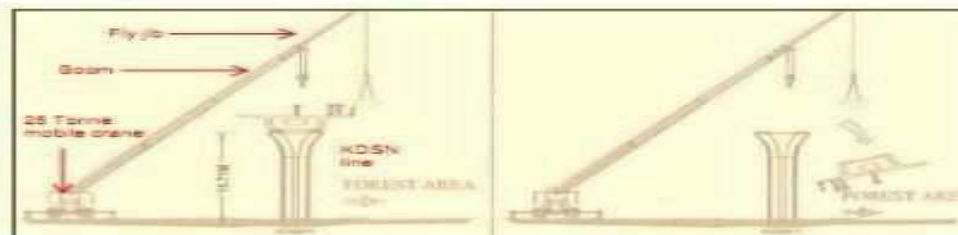
27.6.2014

A SINGLE TRACK VIADUCT DECK UNDER CONSTRUCTION TOPPLED AND LANDED ON GROUND.

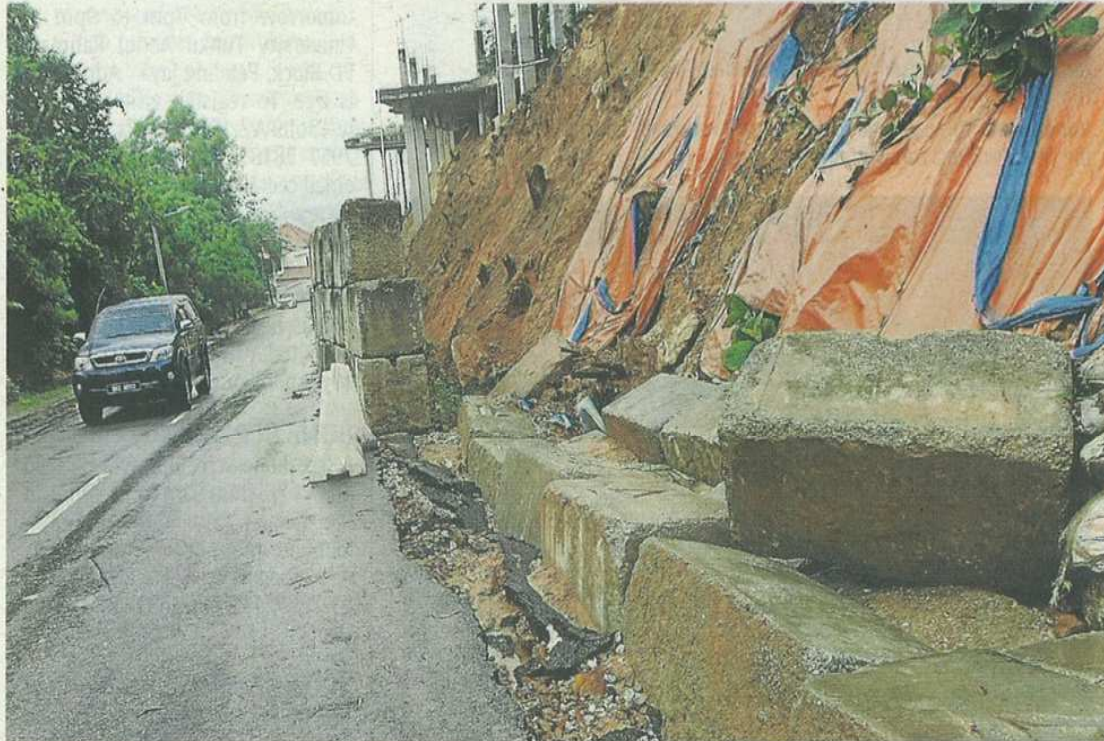
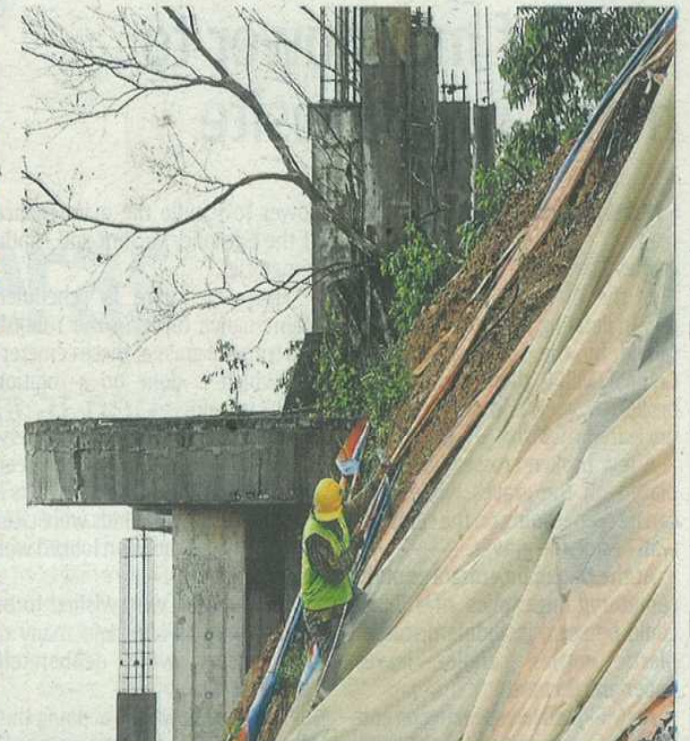
For safety of residents: MBPJ has embarked on hill strengthening works in Jalan 5/64. The project should be completed within eight months.

A landslide on May 5 in Jalan 5/64 uprooted trees, damaged several cars and cut off access to the area.

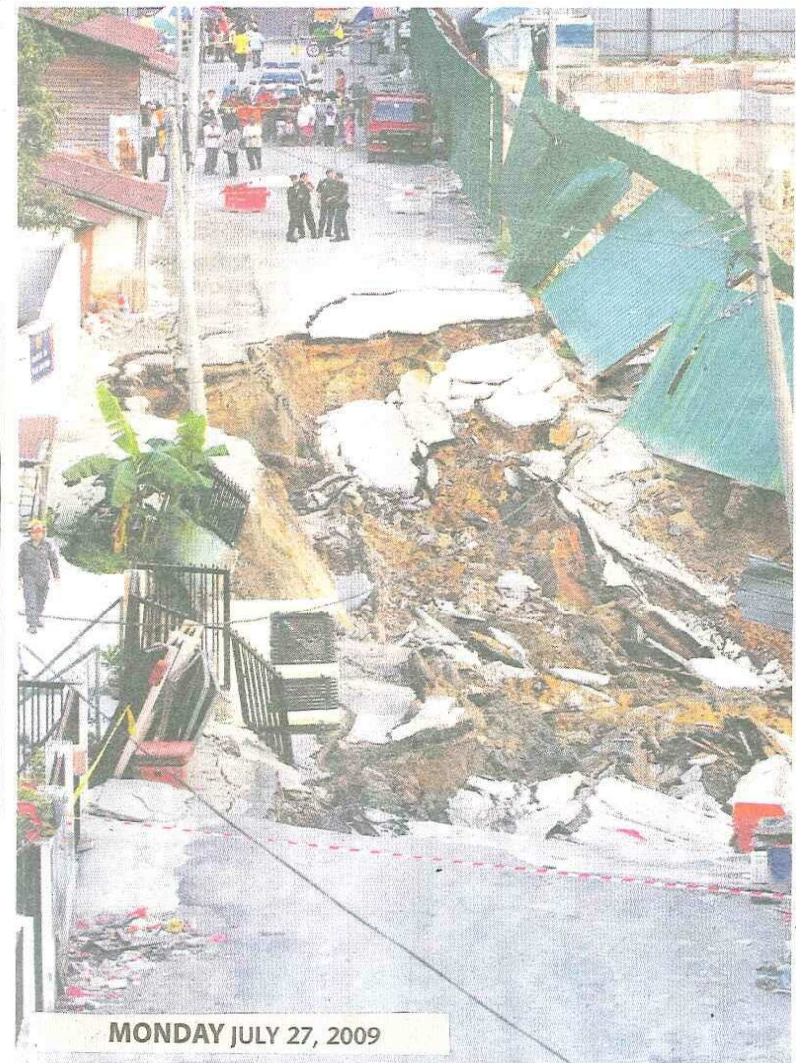
MONDAY JULY 27, 2009

Part of Lorong Gelugor, near Jalan San Peng in Kuala Lumpur, caved in on Saturday forcing the evacuation of residents of 22 units of Public Works Department and City Hall quarters. None of the houses collapsed, although cracks appeared in some of them. Evacuees have been put up at a nearby hotel.

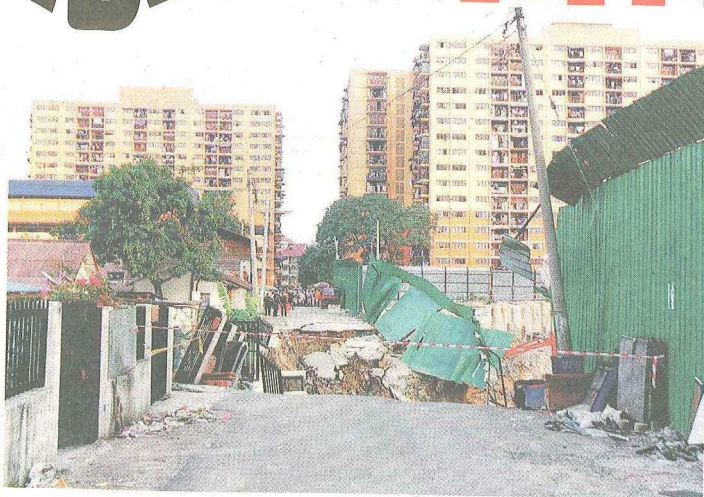
一線之危 当局封锁地陷的主要地方，以免有好奇的公众趋前查看而发生意外。

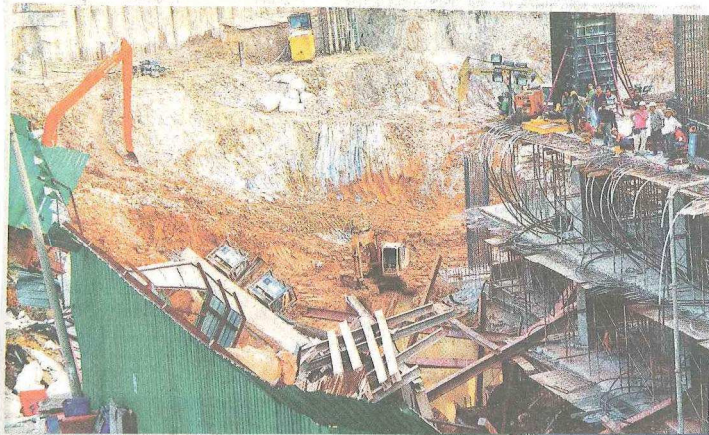
满目疮痍

地陷现场满目疮痍，所幸没有造成人命伤亡。

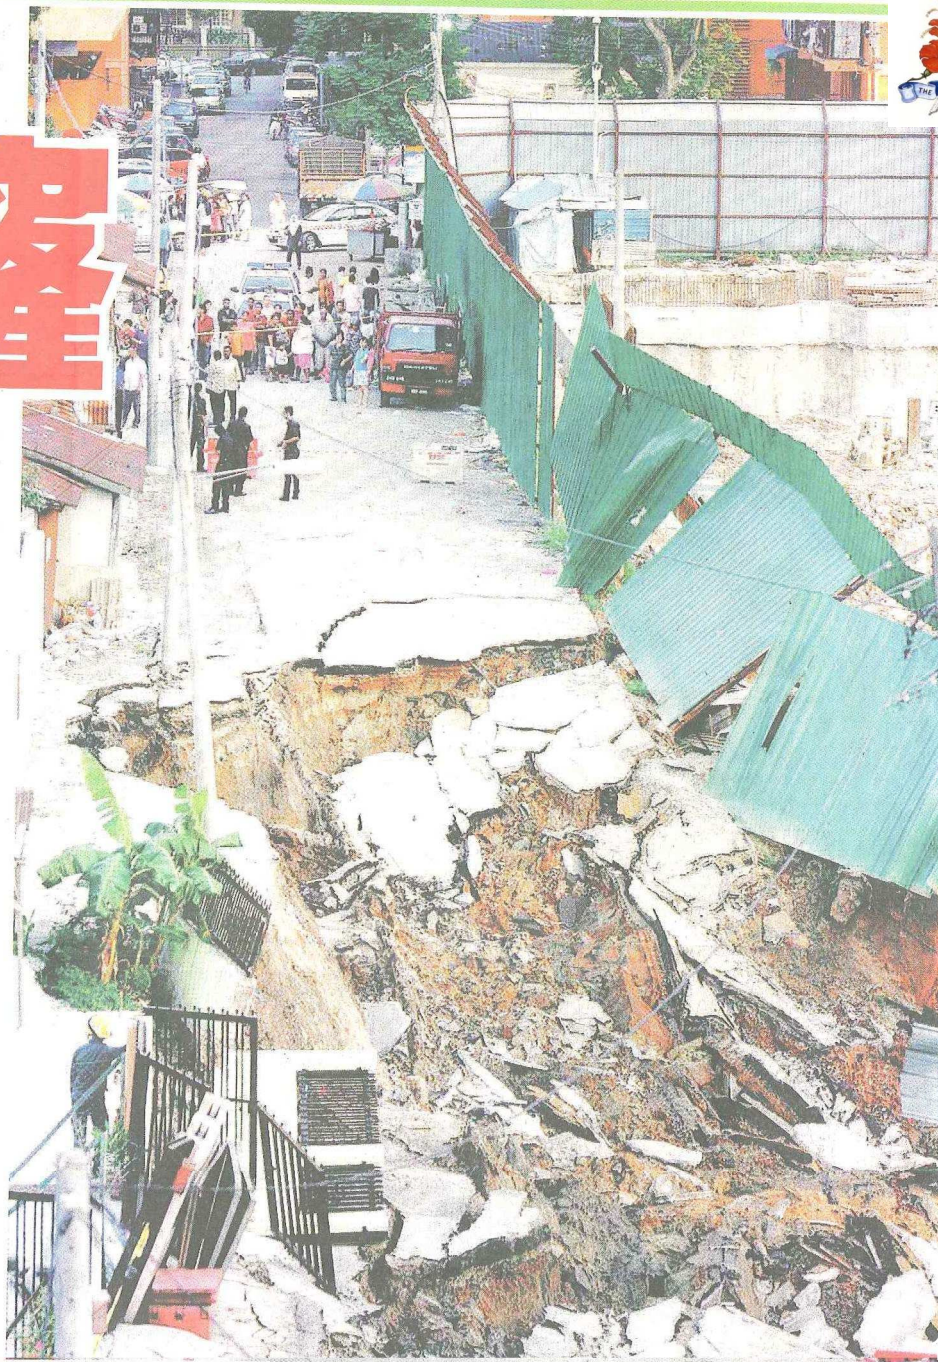
觸目驚人

地陷的地方部分路段坍塌，让人触目惊心。

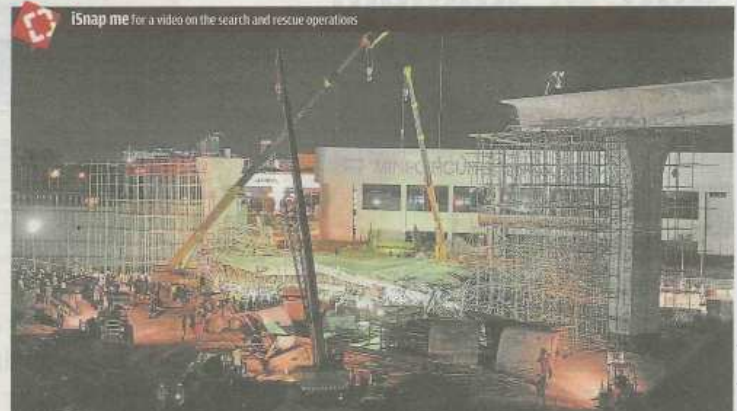
Bridge ramp collapses

Just three months from its official opening, tragedy hit the second Penang bridge when a section of a ramp linking it to an expressway collapsed. It is feared that four people may have been killed.

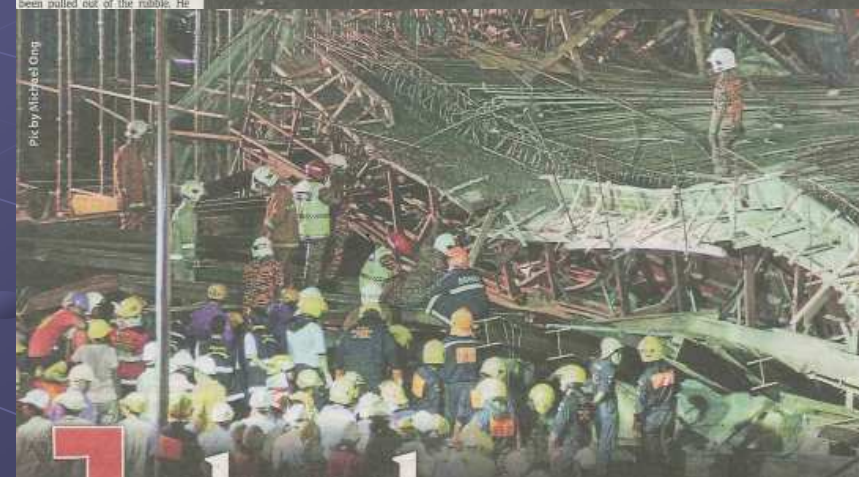
1 dead, 3 injured

SECOND BRIDGE HORROR: Ramp under construction in Batu Maung, Penang, collapsed at 7.15pm yesterday

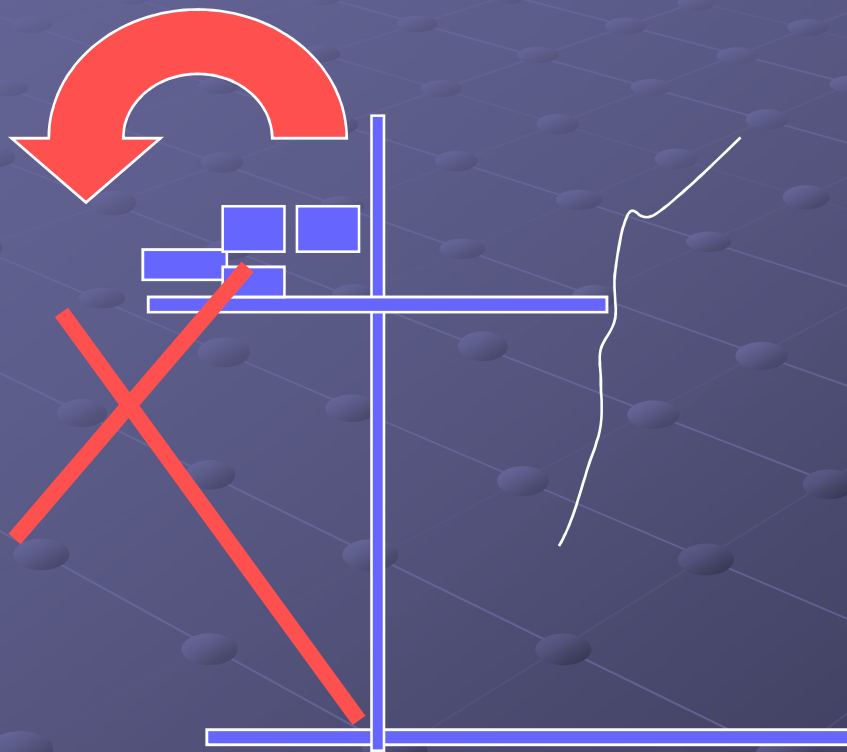
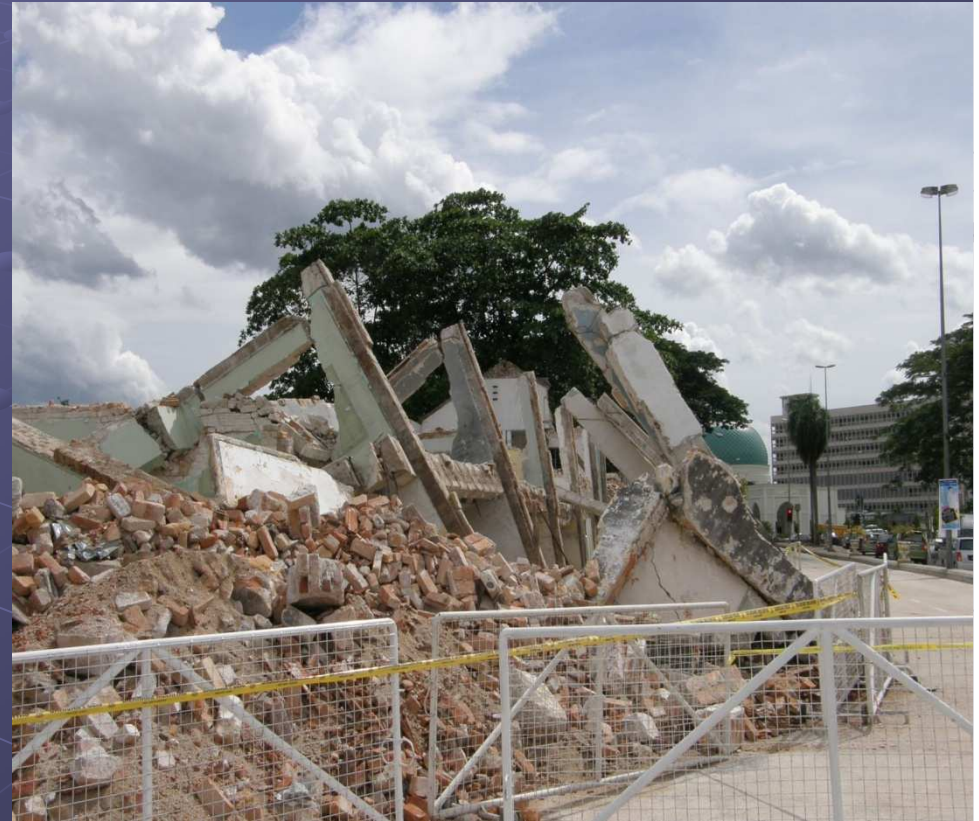
Ipoh shophouse – cantelever collapse

Ipoh shophouse demolition mishap causing 2 deaths of passing by motorists - 2009

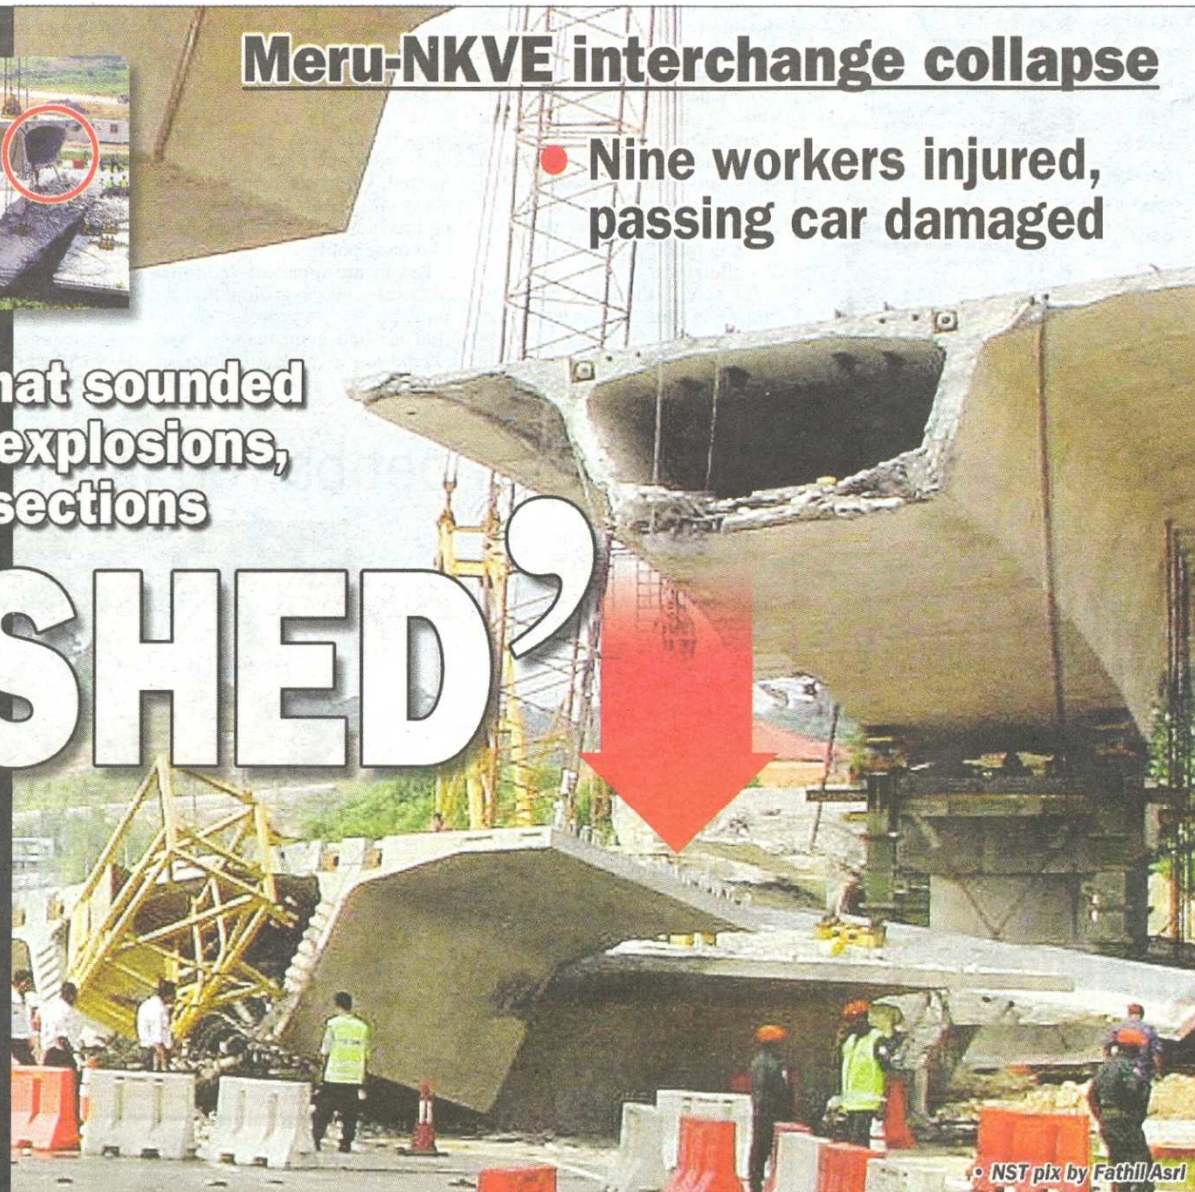
The collapse at 1.40pm today injured nine foreign construction workers working on top of the section, which fell five metres to the ground. The flyover is part of a 7.5-km interchange

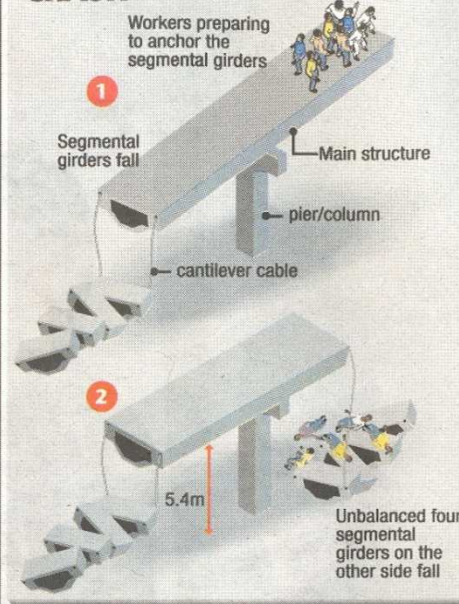
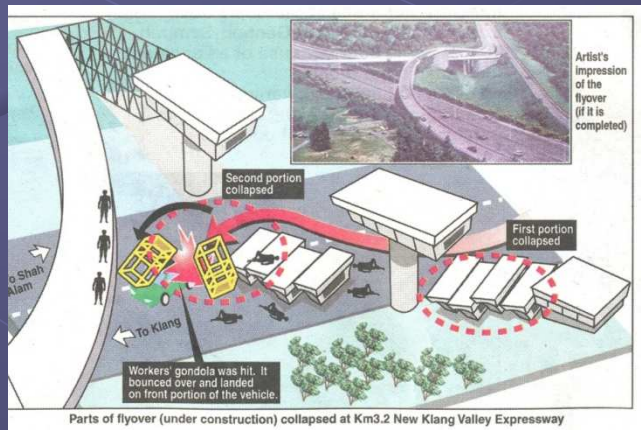
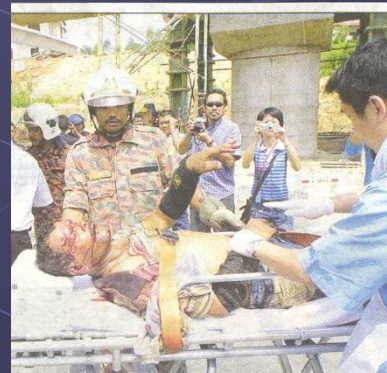
MERU-NKVE INTERCHANGE CRASH

MANGLED WRECK: A section of the collapsed flyover and the gondola of the NKVE-Jalan Meru Link flyover

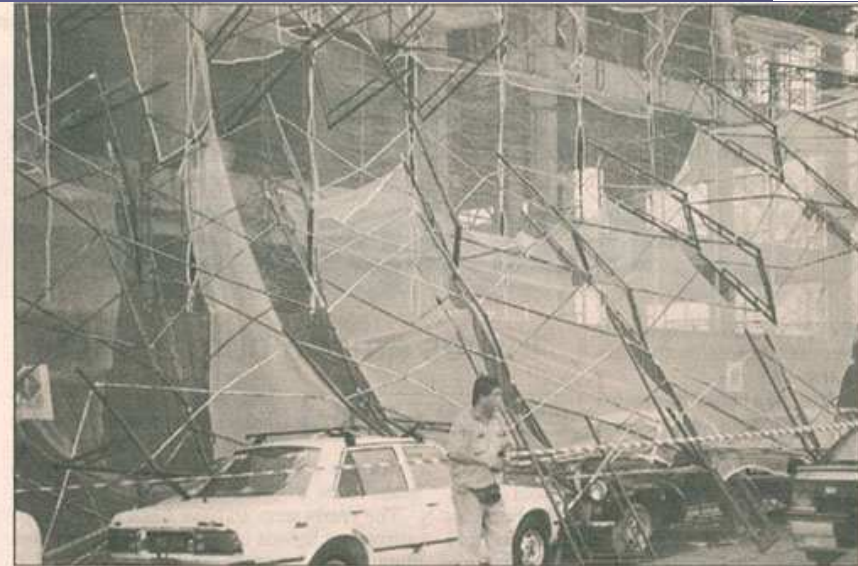
"There was a strong wind and we saw the 20-metre-high metal scaffolding fall," said the MPSJ officer.

tion - before hitting the power cables, causing an explosion. It also damaged three cars parked nearby.
