**10th International Conference on Piling and Deep Foundations, Amsterdam, The Netherlands
May 31 - June 2, 2006**

Design and Construction of Soil Nail Strengthening Work over Uncontrolled Fill for a 14.5m Deep Excavation

Liew, S. S. and Khoo, C. M.
Gue & Partners Sdn Bhd, Malaysia

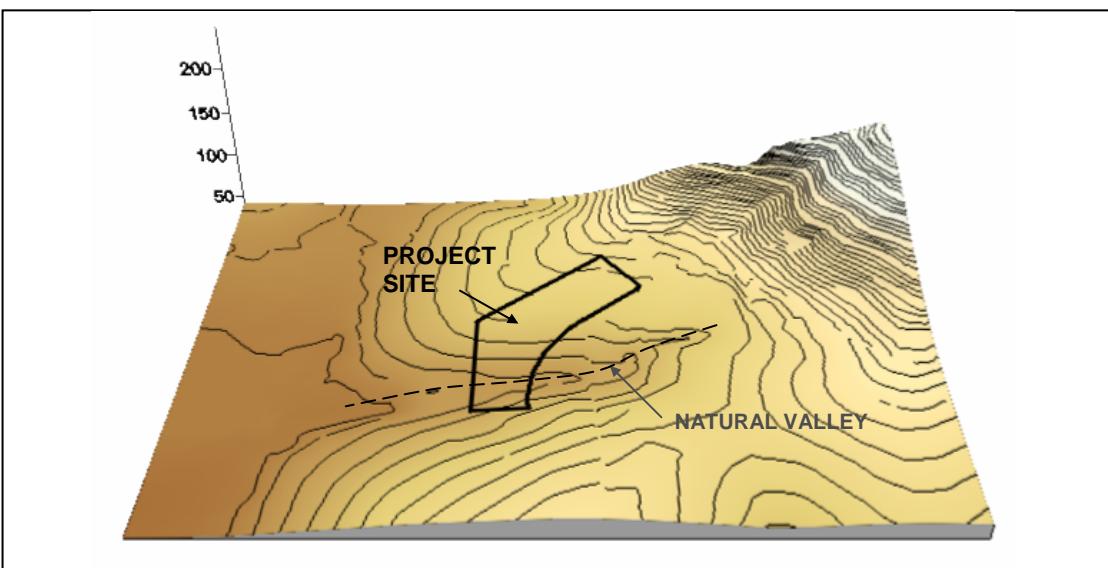
Figure 5: 3-Dimensional original ground contour

The desk study of the investigation revealed that the distressed area was formerly a natural valley with natural stream flowing from the hilly terrain on the east. Figure 5 shows the three dimensional original ground contour at the development site. The adjacent commercial development had subsequently leveled a wide building platform with uncontrolled fill slopes as thick as 15m, some even overlying the originally deposited soft compressible material within the lower part of the valley. The existence of soft compressible material beneath the filled slope was further confirmed during the additional subsurface investigation when excessive lateral movements were detected in the subsequent staged excavation.

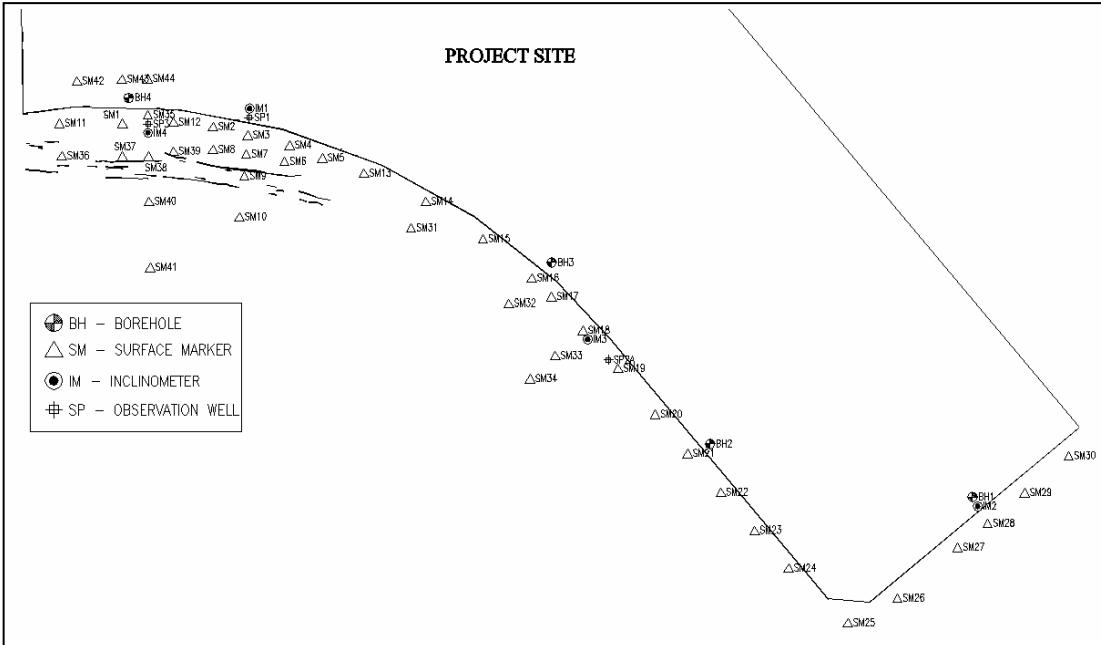
Figure 6: Subsurface investigation and instrumentation layout

Subsurface investigation and instrumentation programme consisting of four boreholes, four inclinometers, three observation wells and forty-four (44) surface markers were planned and implemented to investigate the probable causes, to propose remedial measures of the slope strengthening work and to monitor performance of remedial work during the excavation stage. The layout of the boreholes and instrumentations is shown in Figure 6.

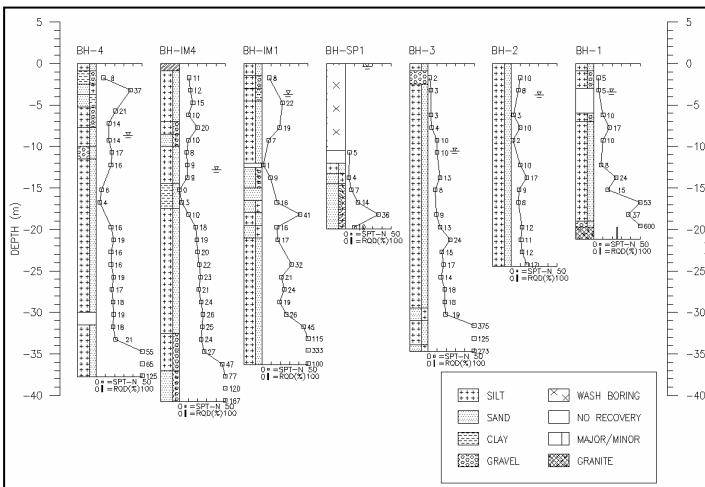
Figure 7: Borehole profiles

Figure 7 shows the interpreted subsoil profiles of the boreholes. The SPT-N values of overburden fill material generally range from 0 to 20 (Figure 8). A layer of soft material of about 2m thick was detected at depth of 12m to 15m below the ground surface in the two

boreholes (BH-IM1 and BH-IM4) within the distressed soil mass, which was overlying the natural valley in the pre-development topographical condition. Generally, the fill material and the underlying subsoil have similar soil consistency with plastic limit (PL) of 30 and liquid limit (LL) from 40 to 60. However, the soft material is of intermediate to high plasticity clayey material with PL of 15 and LL from 40 to 60. The effective shear strength parameters of $c' = 5\text{kPa}$ and $\phi' = 32^\circ$ and undrained shear strength (c_u) of 40kPa were interpreted for the fill material and soft material respectively for geotechnical design of remedial work. Slightly higher undrained shear strength than remolded strength of penetrating vane shear tests was finally adopted for the soft material after noticeable creep movement in this material has been recorded in the inclinometers and substantiated by the back analyses. Peak strength and the remolded strength of penetrating vane shear tests are 65kPa to 80kPa and 36kPa respectively.

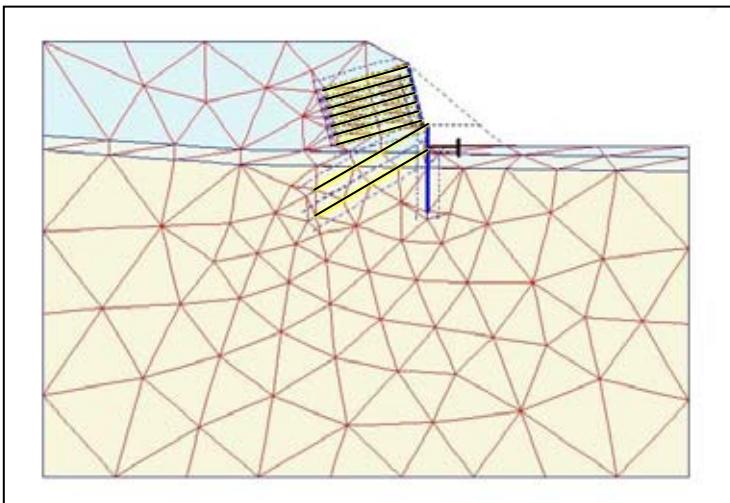
Figure 10: Plane strain FE analysis (Plaxis V8.2)

Due to urgency of the remedial design, back analyses based on the profile of the excavated soil mass at the time of distress were carried out to obtain the necessary soil strength parameters. The shear strength parameters were subsequently verified with the laboratory tests, such as consolidated isotropically undrained (C.I.U.) triaxial tests and multiple reversals direct shear box tests. The soil nail strengthening design was carried out generally in accordance to the design standard by Federal Highway Administration (1998). Slope stability analyses using both classical limit equilibrium method and strength reduction method in finite element (FE) analysis were used to assess the original safety factor and the improvement after strengthening. The FE analyses were performed using "Plaxis" (Brinkgreve, 2002), a finite element method computer program under plain strain condition (Figure 10).
