LESSONS LEARNED FROM TWO INVESTIGATION CASES OF GROUND DISTRESSES DUE TO DEEP EXCAVATION IN FILLED GROUND

Shaw-Shong, Liew
G&P Geotechnics Sdn Bhd
Kuala Lumpur, Malaysia

Chee-Min, Khoo
G&P Geotechnics Sdn Bhd
Kuala Lumpur, Malaysia

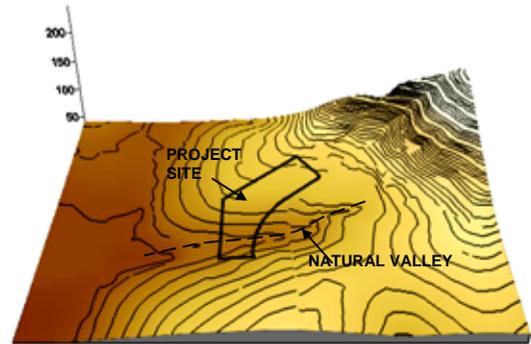
Fig. 5. Three-dimensional original ground contour.

Information obtained from the detailed site investigation revealed that the slope above the lowest proposed basement level mainly comprised of massive uncontrolled fill. At one location where ground distresses were observed in the initial stage of steep open excavation, a previous natural valley with underground stream was later discovered originating from the north-eastern hilly terrain as illustrated in Fig. 5. The adjacent commercial development had subsequently levelled a wide building platform with uncontrolled fill as thick as 15m primarily made up of loose sandy silt overlaying a thin (about 2m thick) deposited soft compressible material at the valley area.

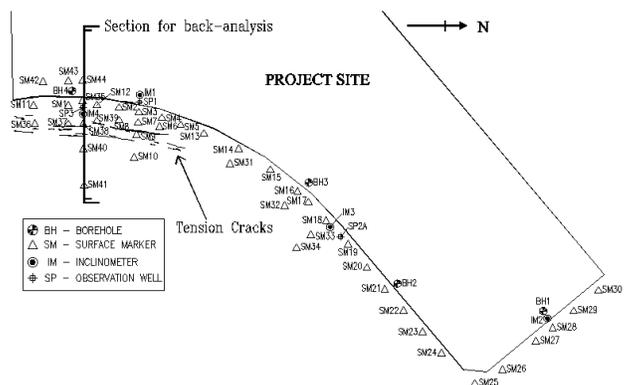
Fig. 6. Subsurface investigation and instrumentation layout.

Subsurface investigation (SI) was carried out to establish the subsurface conditions for the geotechnical investigation and remedial design. The SI layout is presented in Fig. 6 together with the instrumentation layout. Figure 7 shows the interpreted boreholes logging. The fills material mainly consists of sandy silt with SPT-N values generally ranging from 0 to 20. A layer of soft material was detected at the depth of 12m to 15m below the ground surface in two boreholes (BH-IM1 and BH-IM4) within the distressed soil mass, which was overlying the natural valley in the pre-development topographical condition. The existence of this soft compressible material was further confirmed during an additional subsurface investigation when excessive lateral movements were detected in the subsequent staged excavation.

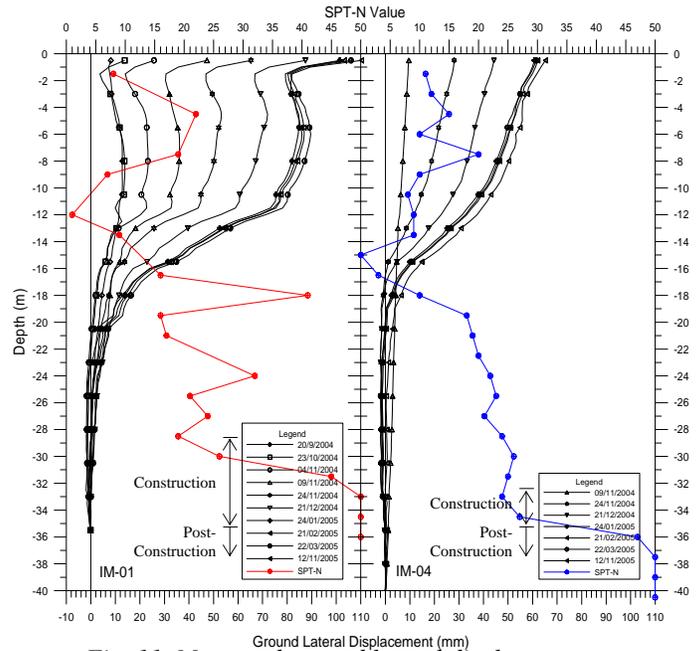
Fig. 11. Measured ground lateral displacements.

Figure 11 shows the monitored soil nailed slope movements during various stages of excavation. While the cumulative ground settlements behind the soil nailed slope are shown in Fig. 12. Groundwater levels had generally been monitored from the installed observation wells throughout the construction period. Figure 13 shows the measured groundwater levels over time.

From the monitoring results, the ground lateral displacement and settlement had stabilised with no appreciable further deformations after the completion of slope stabilisation works. In addition, the groundwater was observed achieving steady state equilibrium even after reaching the final excavation.

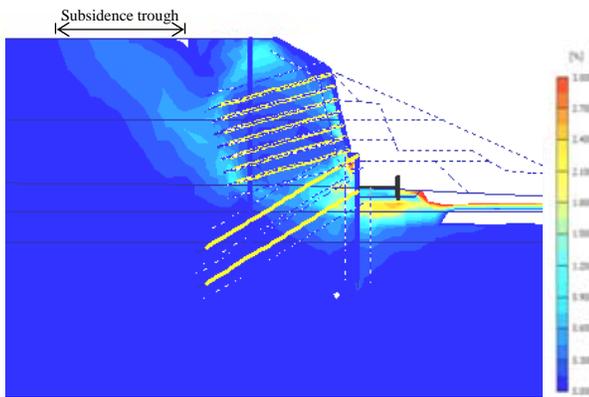
Fig. 14. Shear strain of soil mass within the soil nail reinforcing system.

Subsidence troughs developed on the retained ground surface has been observed from the FE back-analysis results (see Fig. 14). The results show that surface subsidence is generally expected at a distance of 8m from the excavated face, which tallies extremely well with the site conditions as demonstrated in Fig. 15. The location of the trough is just immediately behind the end of the soil nail where a relatively large shear strain is developed along the potential slip surface behind the reinforced soil mass. This is fairly close to the formation of an active wedge in the retaining wall design. Two major tension cracks signify the extent of the developed active wedge behind the reinforced slope mass.

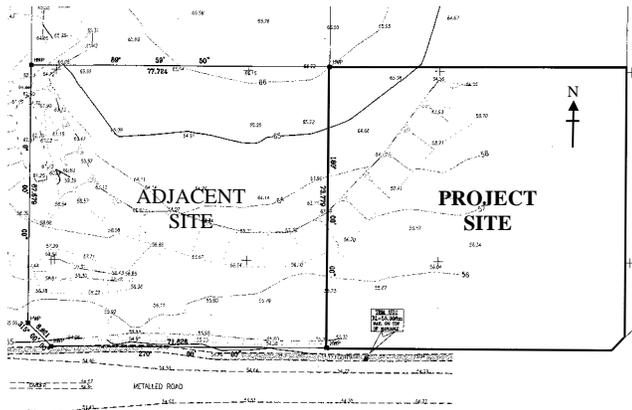
Fig. 18. Topographical survey plan of adjacent lot (subject to disturbance before the finished level).

Based on the topographical survey plan of adjacent lot, which was believed to be the condition before the earthworks, part of the proposed site (i.e. at north-western side) is of sloping terrain from approximately RL 65m to RL 56m. There is a 6m high cut slope existed within this sloping ground as indicated in Fig. 18.

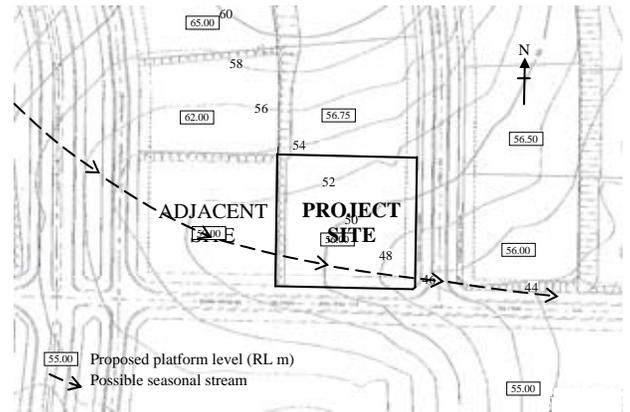
Fig. 19. Regional major earthworks layout with contour lines.

Based on the original topographical of the pre-development condition as shown in Fig. 19, the contour lines for both the adjacent lot and the proposed site range from RL 54m to RL 47m. As such, it is evidenced that earthworks had previously been carried out at these areas to raise the building platform level to RL 59.0m and RL 56.0m for the adjacent lot and the proposed site respectively. Both of the sites are on filled platforms. Particularly, the distressed area was located at the valley where thicker fill was placed. High potential of saturation of fill due to perched groundwater seepage after filling in the previous valley terrain can be expected if subsurface drainage is not provided.

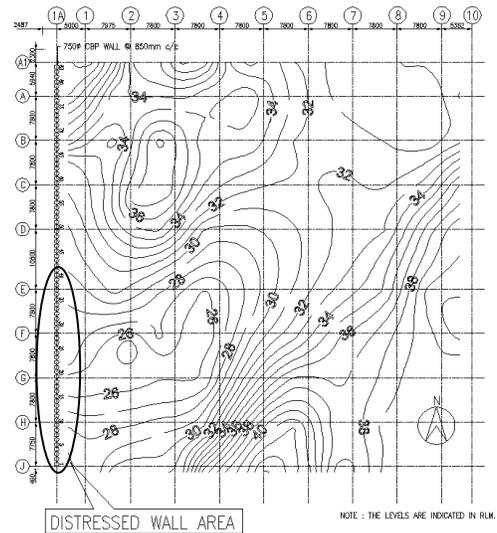
Fig. 20. Interpreted contour of hard stratum from piling information.

In addition to the topographical map, assessment on the piling information was carried out to reveal the soil consistency profile within the site as shown in Fig. 20. It was found that the distressed ground and retaining wall areas correspond well with the expected thicker fill and deeper weathering profile at the valley area as discussed.

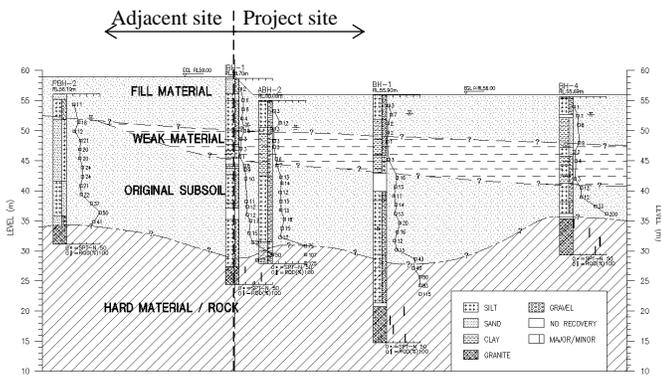
Fig. 25. Typical cross-section of subsurface profiles at the distressed wall area.

After the incidence, additional three boreholes were sunk within the distressed wall area to investigate the subsurface profile and to install instruments for construction monitoring. In particular, a layer of 6-9m thick of very soft to soft sandy/silty clay (SPT-N <= 4) was encountered from RL 52m to RL 43m as detected in the few boreholes near to the distressed wall area. Generally, SPT-N values of the subsoil range from 3 to 6 at the top 13m of the subsoil and gradually increase with depth thereafter. This implies that the top layer of subsoil is most probably of fill material underlain by the

soft deposits in the valley. A typical cross-section of subsurface profiles at the distressed wall area is shown in Fig. 25.
