Failure Investigation of Crib Wall, Piled Reinforced Concrete Wall And Geosynthetic Reinforced Soil Wall

Liew Shaw-Shong¹, Lee Peir-Tien² and Lim Fang-Liang³

¹Director, G&P Geotechnics Sdn Bhd, Kuala Lumpur, Malaysia

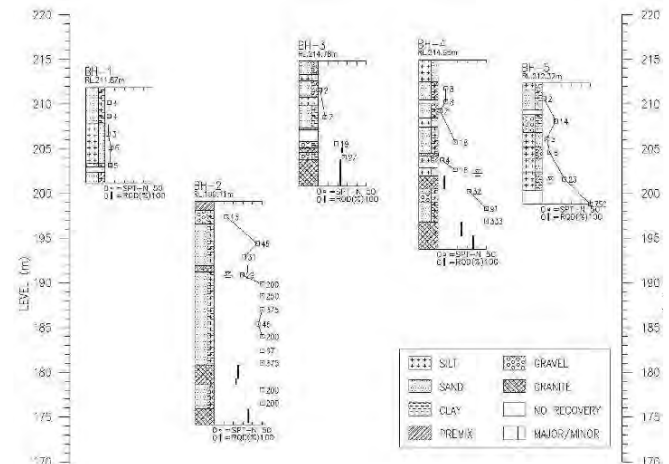
Figure 3 Subsoil Profile

Based on the Geological Map of Selangor, Sheet 94 Kuala Lumpur published by the Geological Survey Department, the site is underlain by Granite formation. Generally, the subsoil strata below the wall backfill consist of a layer of weathered residual soils with primarily silty SAND and sandy SILT overlying the granite bedrock

as shown in Figure 3. Whilst the backfilled material with average SPT-N values of 5 was found on top of the residual soils.

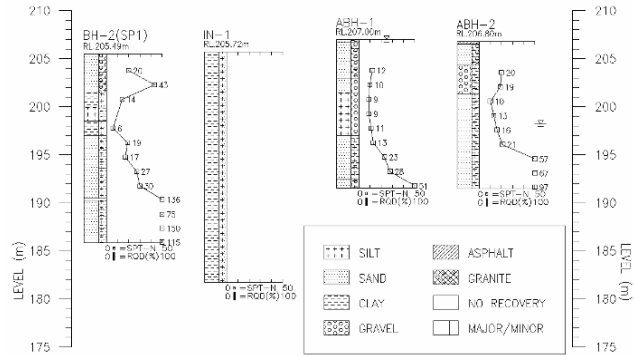
Figure 9 Borehole Profile

Similar to Case History 1, the site is overlain by Granite formation. The subsoil generally consists of silty SAND. The subsoil profiles and soil conditions of the project site are summarised in Figure 9.
