Failure Investigation of Piled Reinforcement Soil Wall & Excessive Movements of Piled Embankment at Soft Ground, Malaysia

ABSTRACT: This paper presents two case histories covering a collapsed piled supported reinforced soil wall at weak deposits under extreme weather condition and another case of excessive movement of piled road embankment approaches affecting the bridge abutments. The first case history demonstrates an ultimate limit state condition under the most unfavorable meteorological events of which the failure was expected and justified from the design review, whereas the second case shows the problem of the consolidation settlement of working platform resulting free standing condition of the embankment piles with high lateral loading from the non-pile supported approach earth embankment of lower height. Both cases involve the reaching of ultimate lateral pile resistance of the supported structure. Sequence of events established from investigation evidences leading to the failure are illustrated in the paper and remedial solutions are also presented.

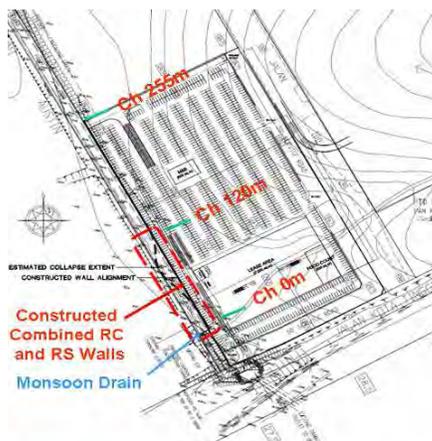
Figure 1 Layout plan of the RS wall

The project site is located within a new residential and commercial mixed development at the southern region of Peninsular Malaysia. The collapsed structure is a combined 2m high reinforced concrete (RC) wall sitting atop a 8m high reinforced soil (RS) wall supported on 400mm thick RC slab and six rows of $\phi 300$ mm driven prestressed spun concrete piles at weak thick alluvium deposits overlying a more competent very hard residual soils. The 255m long combined wall was constructed as the building platform at RL29m for a commercial complex in which there is a 3.5m deep and 6.5m wide monsoon drain in front of the wall. The soffit of 400mm thick RC slab is at about RL18.6m, whereas the invert of monsoon drain varies from RL16.5m to RL 17.5m towards upstream. Figures 1 and 2 show the layout plan of the project site and cross section of the combined wall respectively.

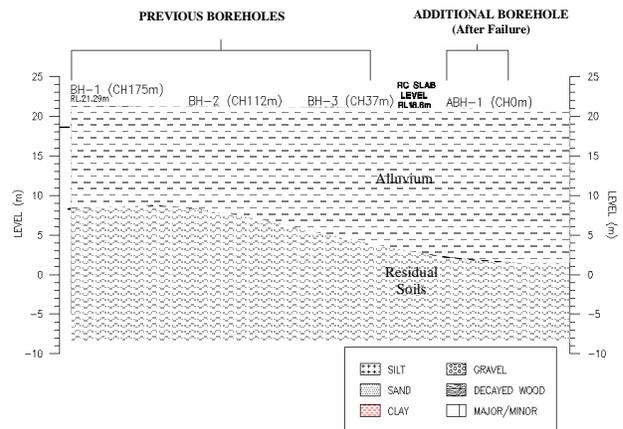
Figure 3 Subsoil conditions of the site

Generally, fill consisting of medium stiff to stiff clayey SILT and clayey SAND (N=6 to 10) was found at the top 4 to 5m below the initial platform at RL20m. Subsequently, very soft to soft CLAY material (Su=40kPa) of about 4m thick was detected overlying a stiff to very stiff sandy SILT (N=10 to 30) of about 10m thick. The groundwater level fluctuated between RL14.0m and RL18.0m. The subsail profile and soil conditions of the project site are summarised in Figure 3.

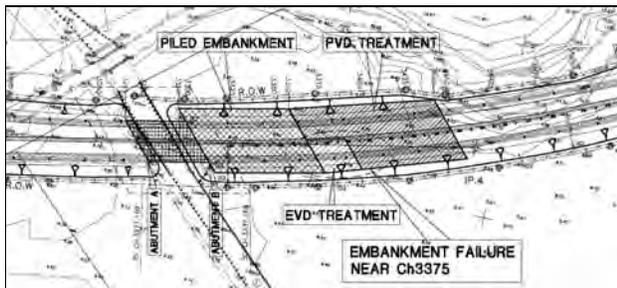
Figure 8 Layout of distressed bridge abutments and embankment

Figure 8 shows the layout of distressed piled embankment and the embankment on two ground treatment techniques near Ch 3375.

- First failure occurred at the PVD treated area immediately next to the piled approached embankment after the embankment fill was completed 6 days later.
- Subsequently, development of tension cracks leading to sudden collapse of embankment fill was reported at the EVD treated area and the adjoining piled embankment after reaching 5m fill height.
- Thereafter, spalling of concrete and gap opening at the bridge deck near Abutment B were observed.
- After the failure of EVD embankment and piled embankment, most electrometric rubber bearings at Abutments A and B suffered observable shearing deformation as shown in Figure 9.
- From the bridge bearing distortion at abutments and piers, it was confirmed that there was clockwise rotation on plan and
