Investigation of Soil Nailed Slope Distress at Fill Ground & Remedial Solutions

ABSTRACT: This paper presents a case history of a distressed 6m to 10m high soil nailed slope formed for basement excavation at fill ground over a natural valley. Above the soil nailed slope, there is an existing 8m to 11m high reinforced soil wall, located 23m away from the soil nailed slope. During the early stage of excavation for soil nailing works, distresses like ground surface cracking and settlement were observed. Perched groundwater at the natural valley during the heavy monsoon season posed further difficulties to the drilling works and induced instability in the steep excavated face of the fill materials. As such, a well planned instrumentation programme was implemented to monitor the construction safety of the on-going soil nailing works. Remedial solution using permanent steel sheet pile wall with two rows of soil nail anchorages is presented in this paper. The performance of the remedial works through instrumentation results and design verification tests of nailing are presented to illustrate their effectiveness and satisfactory performance even with the adverse rainfall event.

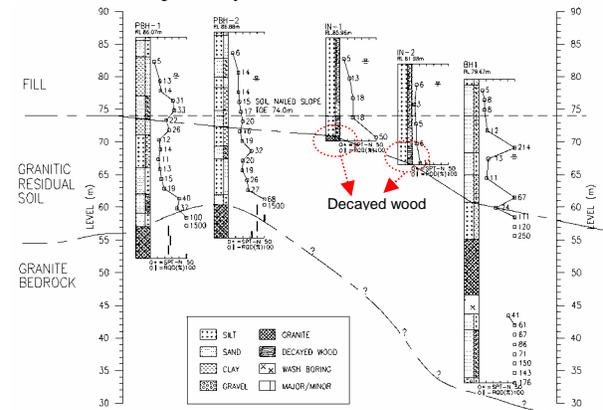
Figure 4 Boreholes profiles

Information obtained from the nearest exploratory boreholes to the soil nailed slope area revealed that the subsoids mainly consist of clayey SAND and sandy SILT with SPT-N values ranging from 5 to 33 (denoted by PBH1, PBH2 and BH1 in Figure 4). A hard layer can be found at about 13m below the soil nailed slope toe. The shear strength parameters obtained from the undisturbed samples at the granite residual soil revealed that the average values of c' and ϕ' are 5kPa and 31° respectively.

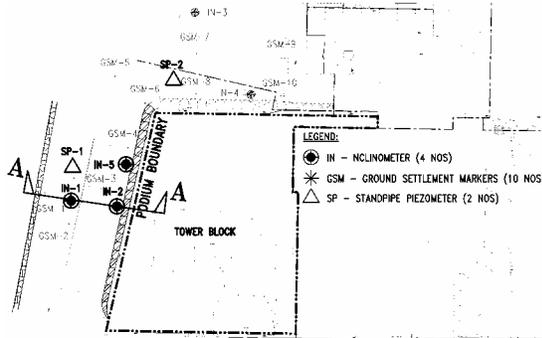
Figure 5 Instrumentation layout

Prior to the construction of the soil nailed slope, two inclinometers (namely IN-1 and IN-2) were installed to monitor the nailed slope performance as a precautionary measure during the construction period. The inclinometer monitoring was carried out on fortnightly basis. At the same time, ten numbers of ground

settlement markers were also installed to monitor the ground settlement as shown in Figure 5. An additional inclinometer (IN-5) was installed after the nailed slope suffered distressing. Undisturbed samples were collected during the installation of IN-5 and two numbers of multiple-reverse direct shear box tests were performed on the reconstituted soil samples. The interpreted residual shear strength of the retained soils was approximately $c' = 0$ kPa and $\phi' = 18^\circ$, which were used for remedial design.

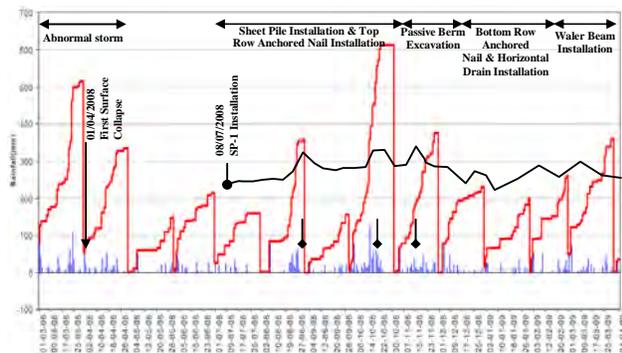
Figure 6 Hyetograph for Kuala Lumpur Rain Gauge Station

Two observational wells (SP-1 and SP-2) were installed in July 2008 to measure groundwater level on a weekly basis during the period of unexpected prolonged rain storm between March and April 2008 (Figure 6). Monitoring results of SP-1 (Figure 7) located at slope crest showed that groundwater levels changed erratically indicating rain storms during the construction of soil nailed slope especially between August and December 2008. Surface runoff filled up the tension cracks and created perched groundwater. The excavated bare slope was susceptible to shallow surface collapse after saturated by water.
