Two Case Studies of Collapsed Temporary Excavation using Contiguous Bored Pile Wall

Liew, Shaw-Shong & Loh, Yee-Eng G&P Geotechnics Sdn Bhd, Kuala Lumpur

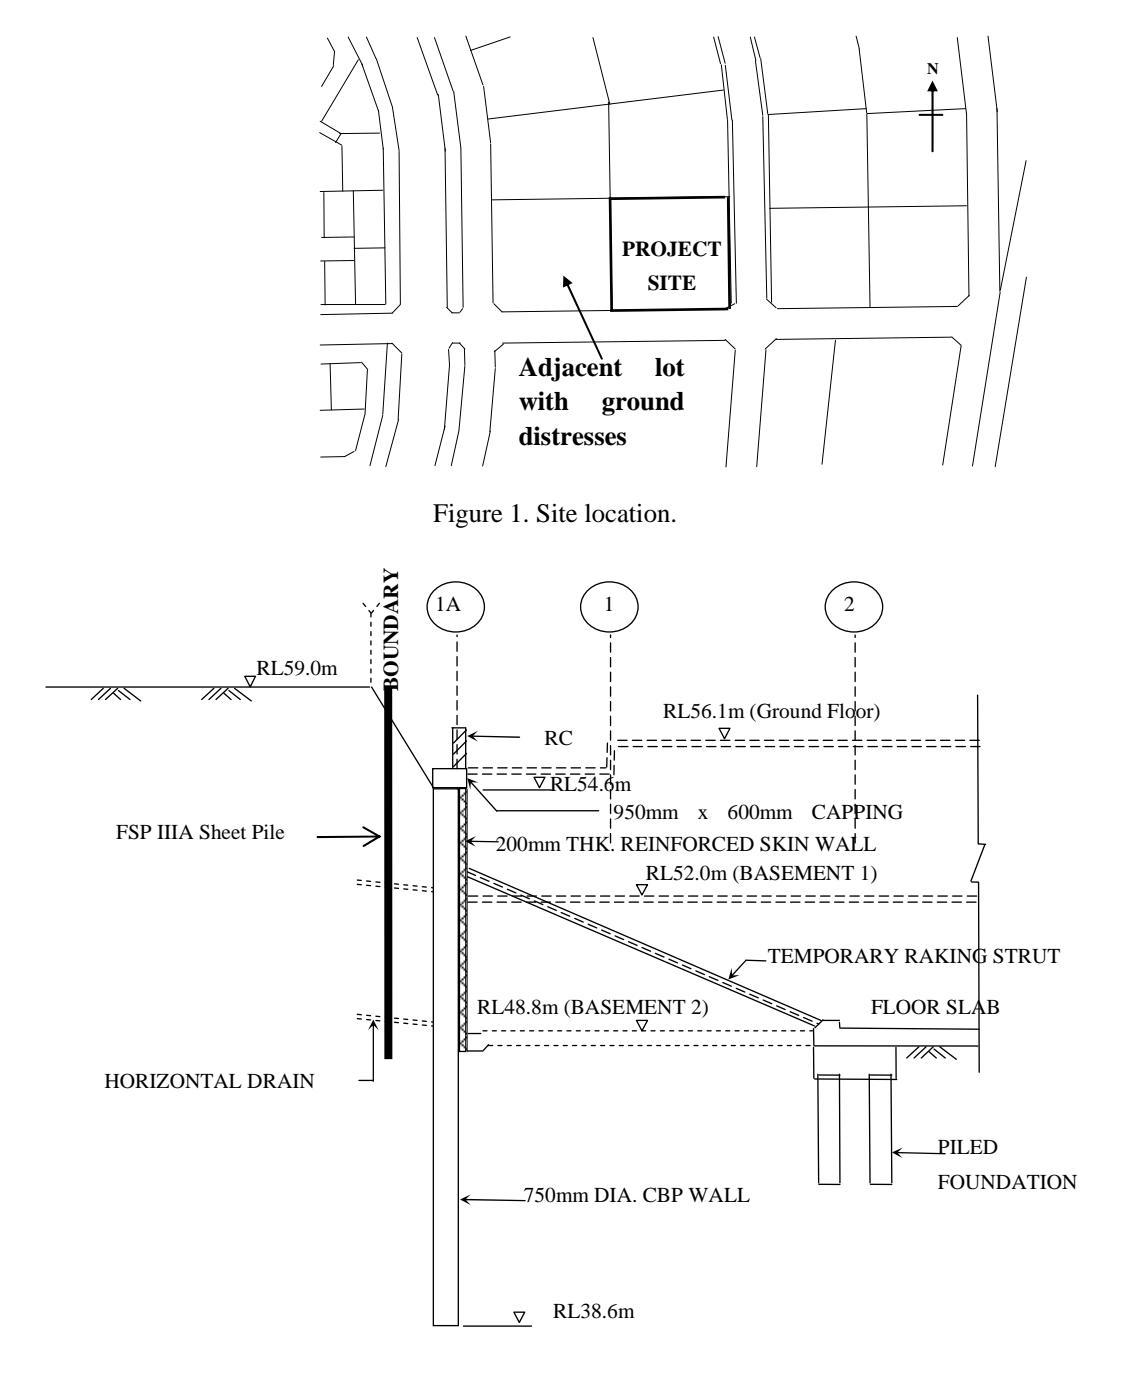
Figure 2. Cross-section of the proposed alternative retaining walls.

12m long temporary steel sheet piles (type FSP IIIA) were installed at retained ground at RL59.0m with about 0.7m offset from project site boundary to provide sufficient working platform and as the temporary shoring support for the exposed 4.4m temporary excavation (from RL59.0m to RL54.6m). Figure 2 shows the details and cross-section of the proposed alternative temporary shoring system and permanent retaining wall.

After completion of CBP wall installation, excavation was continued from RL54.6m to RL52.0m. Ground distresses at the adjacent retained platform in the forms of ground subsidence, tension cracks and excessive deviation of the CBP wall were observed. From the site observation, deviation of CBP wall was likely caused by the over-excavation of the temporary passive berm with localized deep pile cap excavation in front of the wall without timely installation of the planned raking strut. The incidence had affected the adjacent property lot with considerable ground distresses and also resulted in structural damages to the CBP wall.

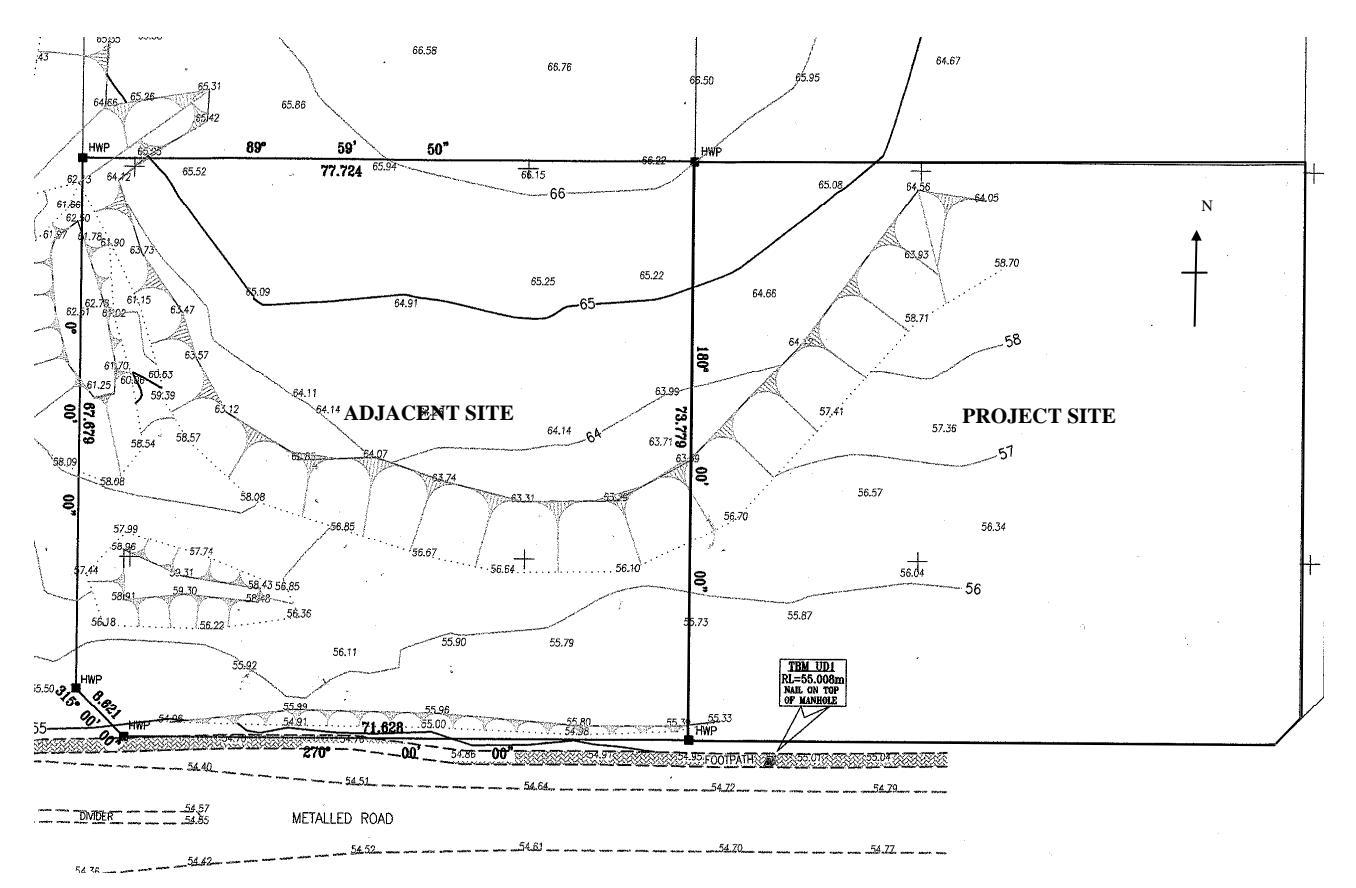
Figure 3. Topographical survey plan of adjacent lot (subjected to disturbance before reaching the finished level).

From the earthworks as-built drawings, the ground level before excavation was relatively flat with levels ranging from RL54.8m to RL56.5m and a steep soil slope (1V:1H) of about 3m high sloping from adjacent lot (at RL 59.0m) towards the proposed site. Based on the topographical survey plan of adjacent lot, which was believed to be the condition before the earthworks, part of the proposed site (i.e. at north-western side) is of sloping terrain from approximately RL65m to RL56m. There was a 6m high cut slope existed within this sloping ground as indicated in Figure 3.

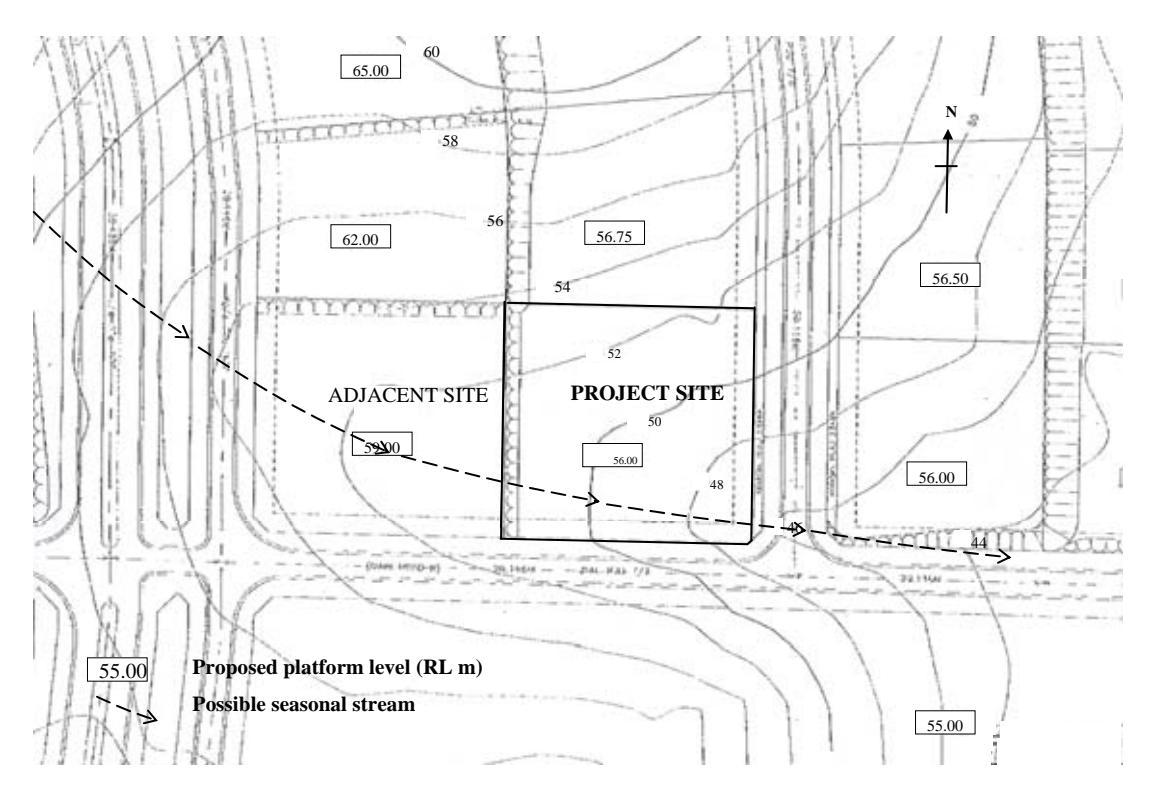
Figure 4. Contours of original ground and subsequently proposed earthwork levels.

Based on the pre-development topographical condition as shown in Figure 4, the contour lines for both the adjacent lot and the project site range from RL54m to RL47m. As such, it was evidenced that earthworks had previously been carried out at these areas to raise the building platform level to RL 59.0m and RL 56.0m for the adjacent lot and the project site respectively. Both of the sites are on filled platforms. Particularly, the distressed area was primarily located at the valley where thicker fill was placed. High potential of saturation of fill due to perched groundwater seepage after filling in the previous valley terrain can be expected if subsurface drainage is not provided. In addition to the topographical map, assessment on the piling information was carried out to reveal the soil consistency profile within the site as shown in Figure 5. It was found that the distressed ground and retaining wall areas correspond well with the expected thicker fill and deeper weathering profile at the valley area.

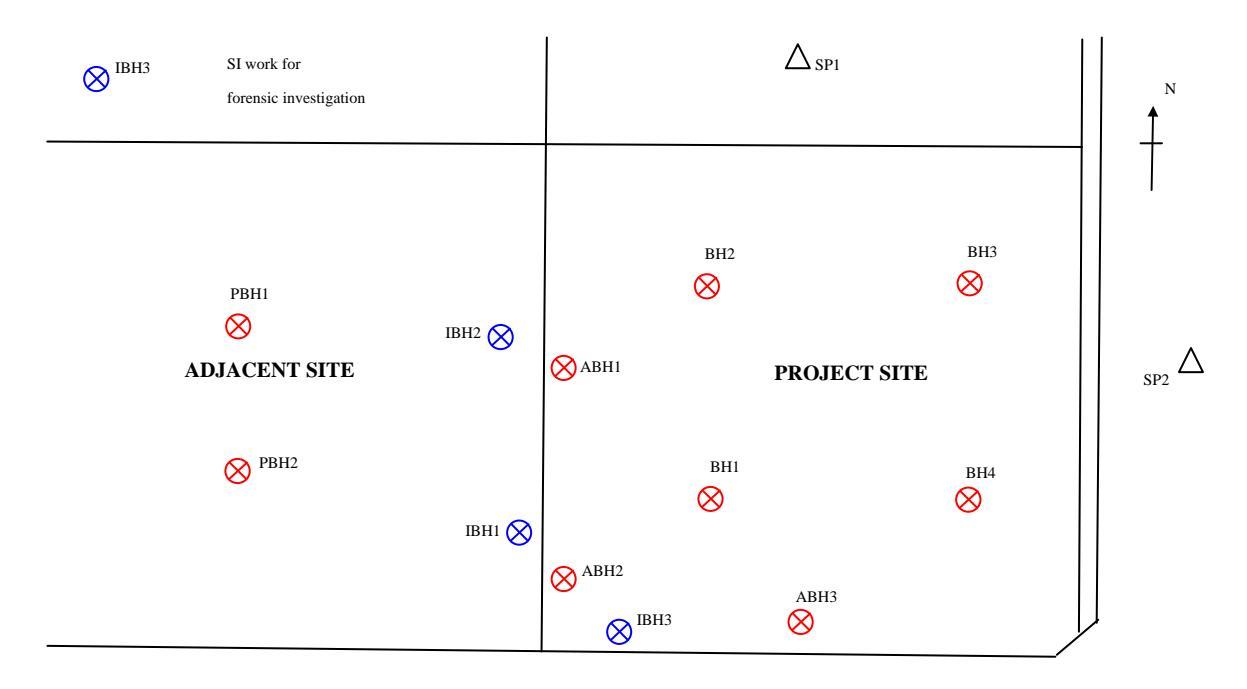
Figure 9. Layout of subsurface investigation boreholes.

Before the wall and ground distresses, two stages of subsurface investigation (SI) works were carried out at the proposed site. The second stage SI works is the additional SI conducted at the perimeter western boundary for the alternative basement wall design by the contractor. At that time, no much attention was given in identifying the weak deposits between the original ground and the platform backfill. The SI layout is shown in Figure 9.

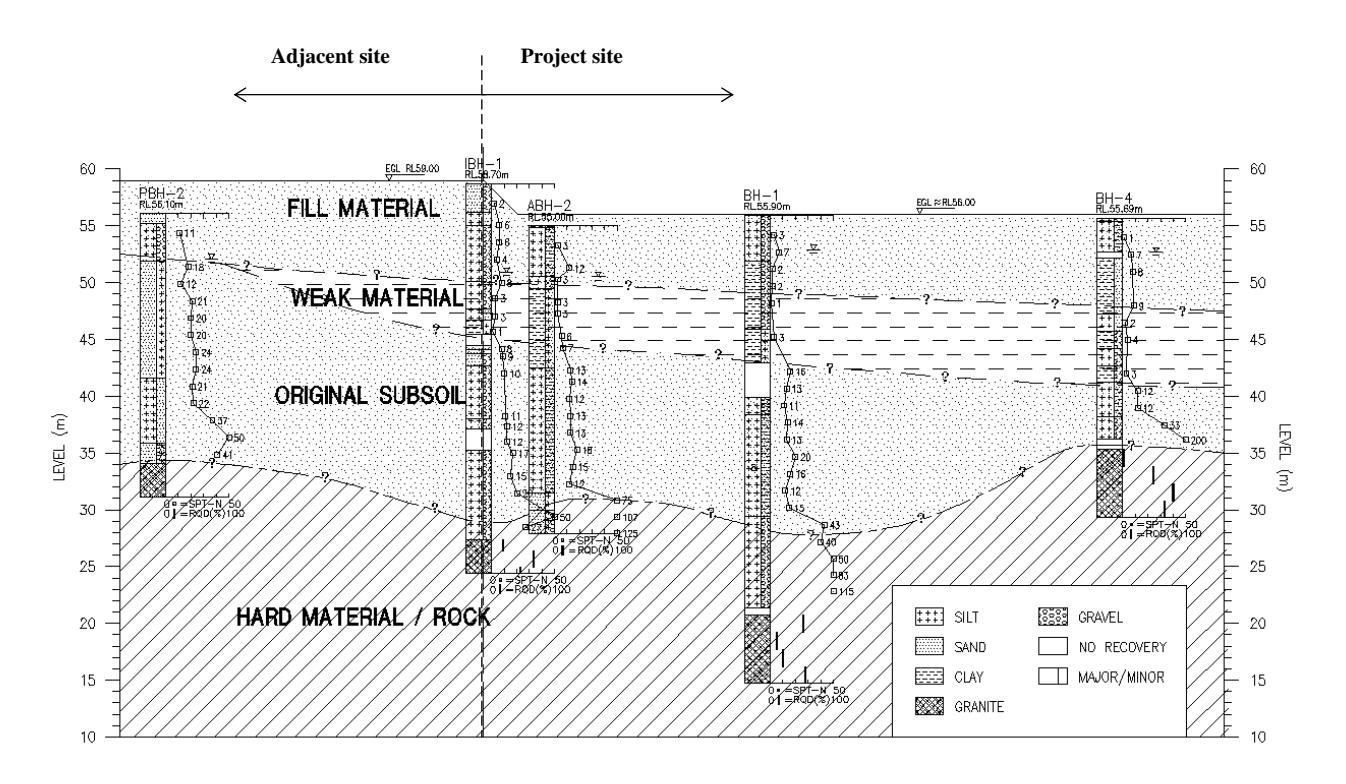
Figure 10. Interpreted subsurface profiles at the distressed wall area.

After the incidence, additional three boreholes were sunk within the distressed wall area to investigate the subsurface profile and to install instruments for substructure construction monitoring. In particular, a layer of 6-9m thick of very soft to soft sandy/silty clay (SPT-N \leq 4) was encountered between RL52m and RL43m as detected in the few boreholes near to the distressed wall area.

Generally, SPT-N values of the subsoil range from 3 to 6 at the top 13m of the subsoil and gradually increase with depth thereafter. This implies that the top layer of subsoil is most probably of fill material underlain by the soft deposits in the valley. An interpreted cross-section of subsurface profile at the distressed wall area is shown in Figure 10. The groundwater levels recorded in the boreholes and observation wells were generally higher at the western side and lower towards the eastern side of the project site, which tallies with the suspected flow path in the valley during predevelopment condition.

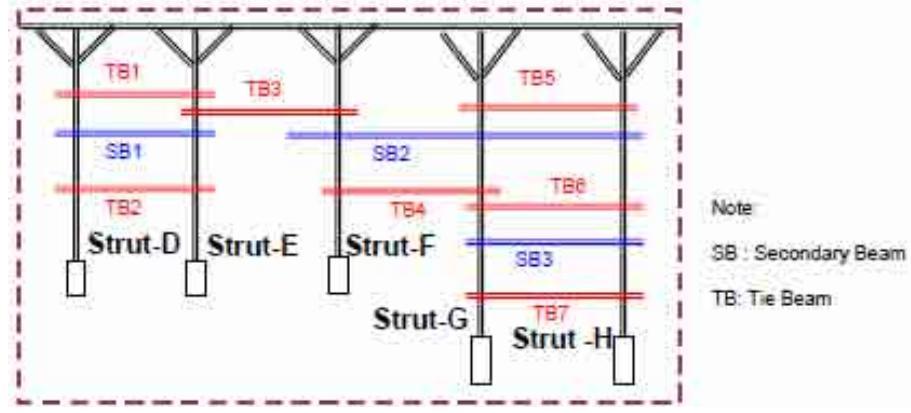
Figure 17. As-built strutting layout.

Based on the photographs taken before the wall failure and information provided by the contractor, the as-built strutting layout was re-constructed and presented in Figure 17. Figure 17 shows that horizontal tie beams were installed to provide lateral restraint for single inclined strut but no bracing system was provided to properly transfer and balance the restraint force. The lateral restraint system provided by horizontal tie-beam was incomplete in accordance with BS5950-1:2000 where Clause 4.7.1.2 in the BS5950-1:2000 states that a restraint should be connected to an appropriate triangulated bracing system for the overall internal stability of the strutting system.

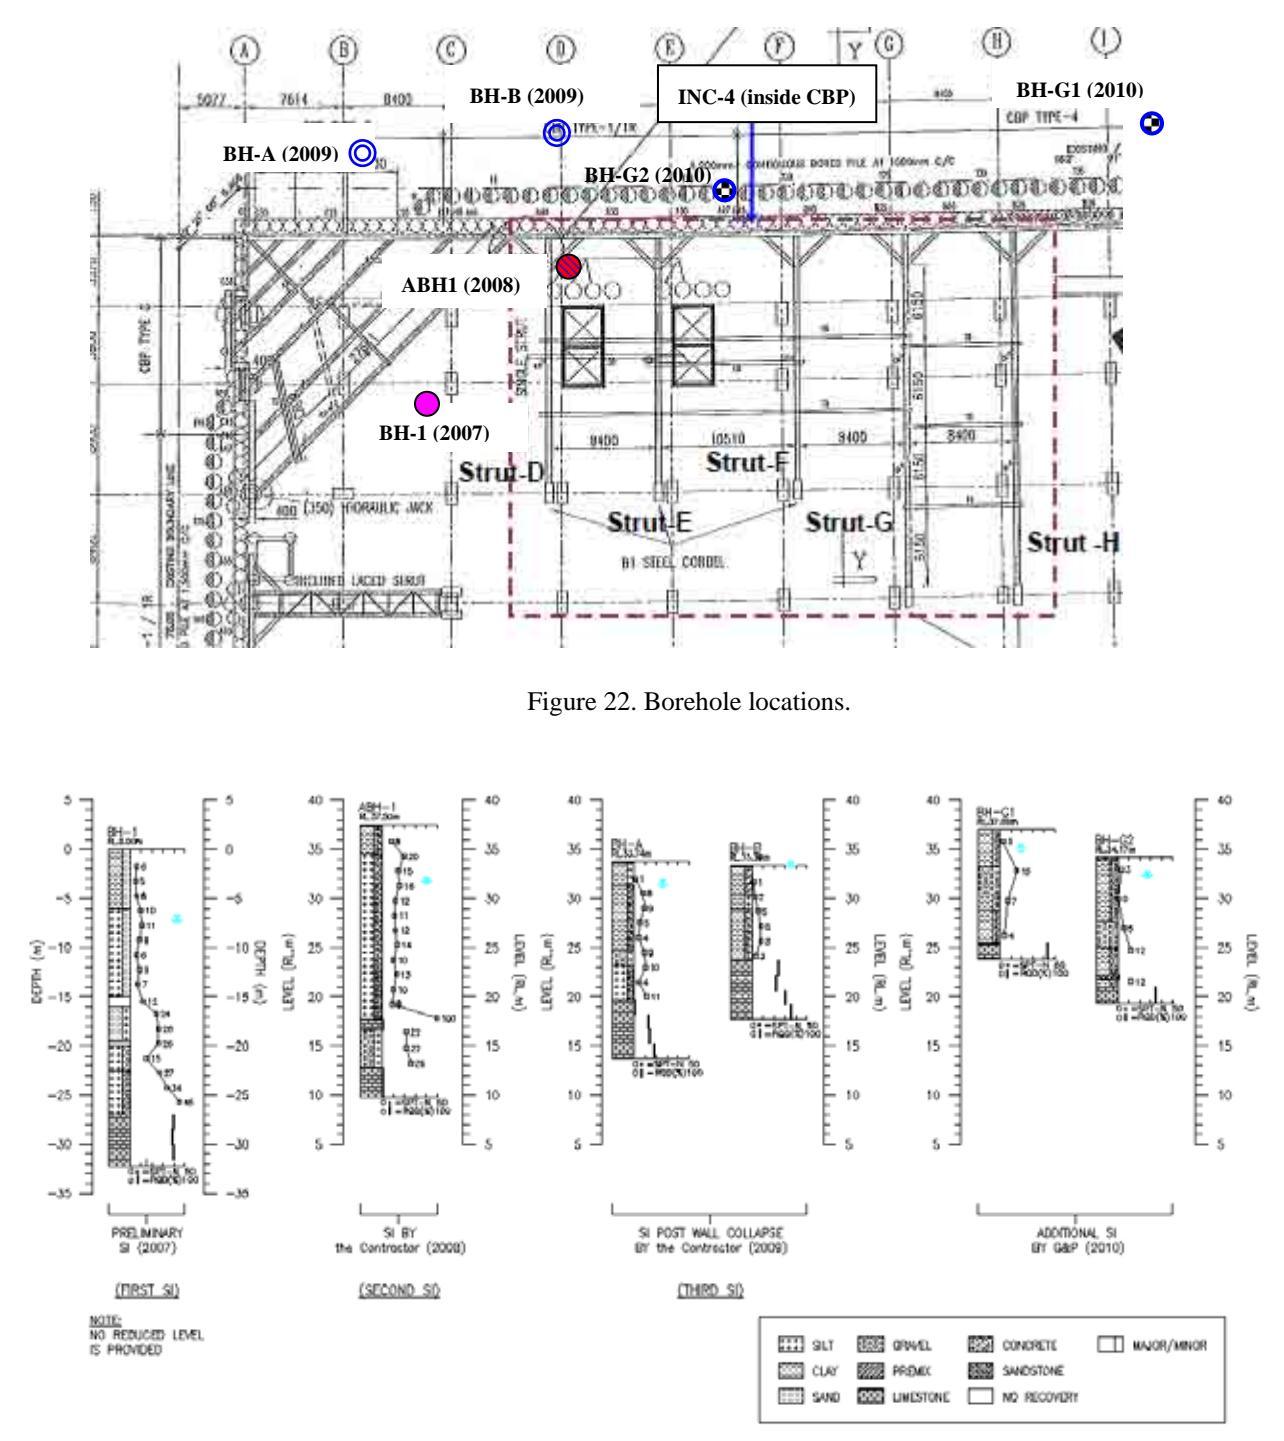
Figure 23. Subsoil profiles.

Locations and subsoil profiles for the relevant boreholes located near the collapsed CBP wall are shown in Figure 22 and Figure 23.

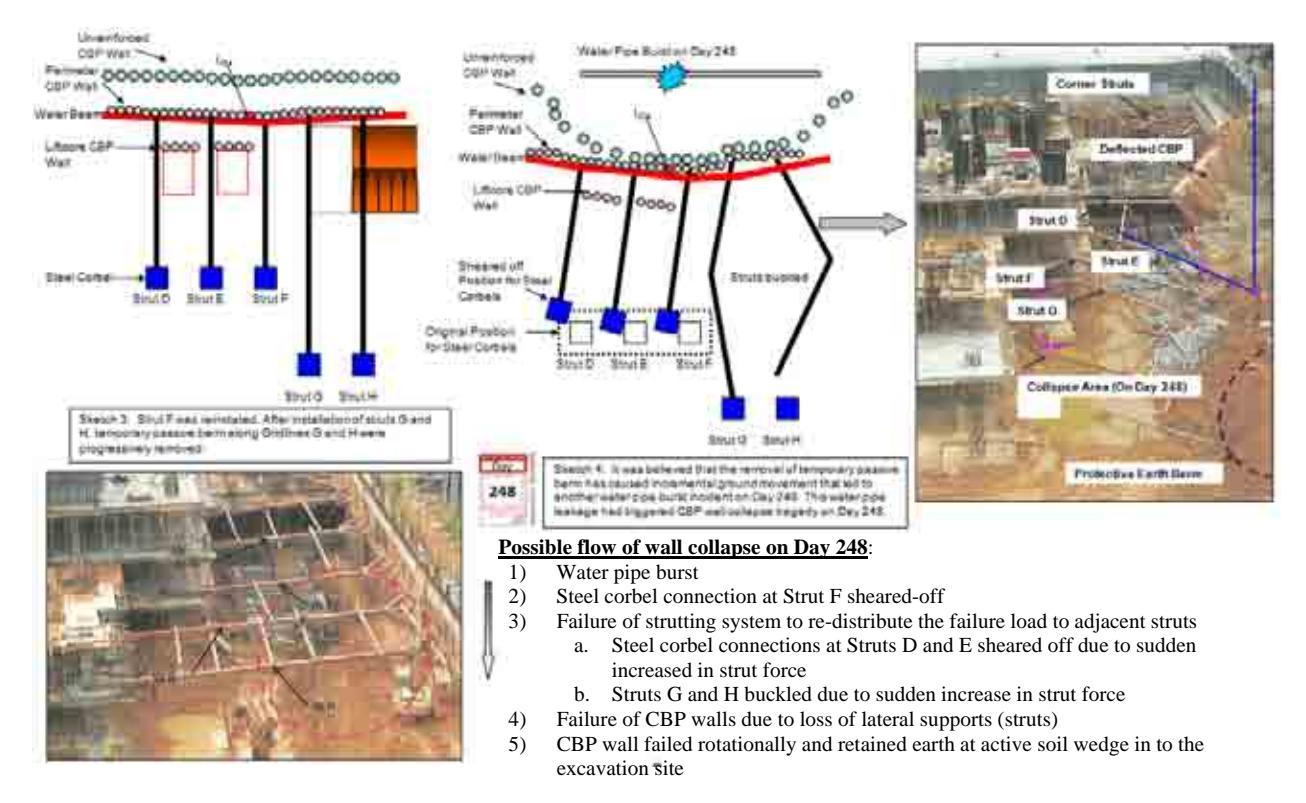
Figure 29. Flow of important events related to CBP wall collapse (Part 2 of 2).

- e. It is likely that Struts E and F had given way first and affected the Struts D (bolts at steel corbel of Struts D, E and F were sheared off) and the other two longer Struts G and H (Struts G and F buckled and dislodged from the corbels).

Figure 28 and Figure 29 illustrate the important chronological events related to the CBP wall collapse.
