Investigation of Creeping Slope Movements of a Suspected Colluvium Deposit

ABSTRACT: This paper describes a case study with an initial failure incident of a pile supported retaining wall of a development whereby the investigation reveals the presence of colluvial deposits at the hill along a river valley floor. The approach of the investigation starting from desktop study, site reconnaissance, borehole exploration, laboratory and field testing, field instrumentation is presented to show the importance and proper investigative procedures of these interlinks of evidence. Clear evidence from visual observation on the presence of matrix of round cobbles, pebbles and unsorted angular gravels confirms high possibility of colluvium from deposition of earlier river alluvium with continuous cutting by a river system. One of the important aspects of the observed slope creeping movement relates to the perched hydrogeological regime of the region, which was likely be evidenced as a triggering factor of the on-going creep movement of the inherent marginally unstable colluvial deposits. The inclinometer profiles also show the extent of unstable colluvial mass over the identified slip surface.

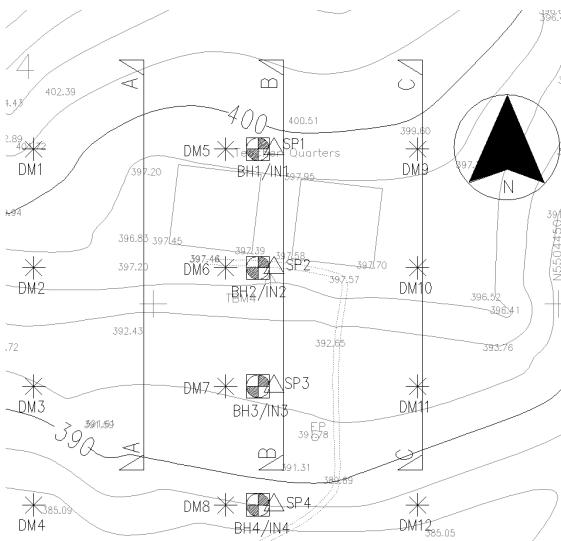
Figure 10 Subsurface Investigation Layout Plan

Figure 10 shows the layout for the additional SI which consists of four (4) additional boreholes, four (4) inclinometers and four (4) groundwater standpipes with cross-sections for illustration of subsoil profiles. The interpreted subsoil profiles are illustrated in Figures 11 to 13.

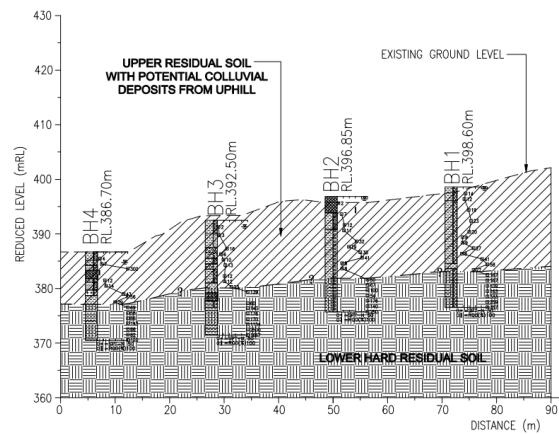
Figure 11 Interpreted Subsoil Profile (Section A-A')

Generally, the subsoil stratum of the site consists of a layer of 9m to 15m thick clayey colluvial / alluvial deposits with some boulders, gravels and small stones overlying the hard residual soil.
