Massive Creep Movements of Post-Glacial Deposits in Kundasang Areas

S. S. LIEW & S. S. GUE
Gue & Partners Sdn. Bhd., Malaysia

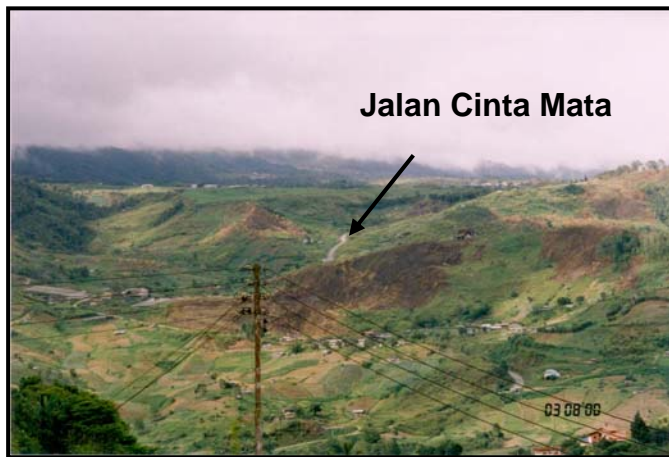
Photo 1: Overall Site Terrain

The overall site terrain is generally undulating in nature as shown in Photo 1.

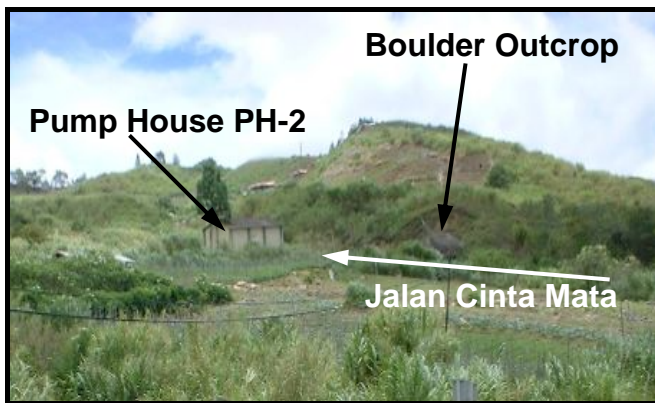
Photo 3: Overview of Jalan Cinta Mata Entrance

There is an abandoned pump houses (PH-2) at the left hand side after turning into the Jalan Cinta Mata and another pump house (PH-3) at the right hand side near the end of the affected chainage of the road. Photo 3 shows the location of the pump house (PH-2). This pump house is built for the Mesilau Mini Hydro project as part of the irrigation scheme, which provides irrigation for horticulture in the Kundasang areas.

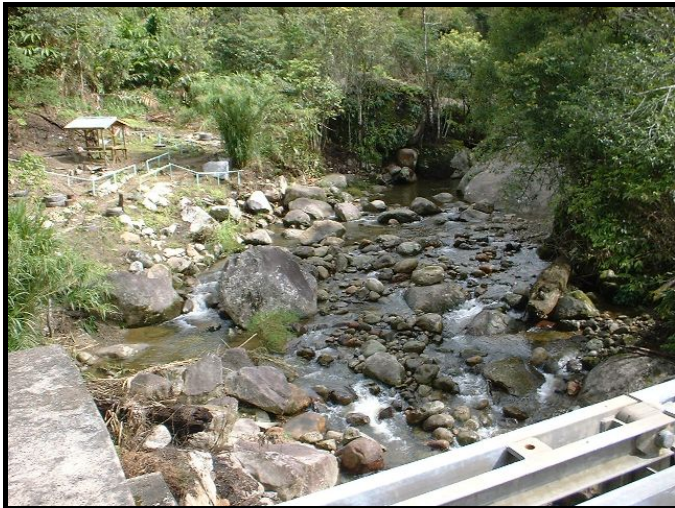
Photo 9: Outcrop at Sg. Mesilau

A geological walk-around at the studied area has confirmed the geological formation and aforementioned geological conditions. Photos 9 and 10 show the Pinosuk Gravels outcrops at the Sg. West Mesilau and the adjacent cut slope along the road respectively. Photo 11 shows the granitic boulders on the Desa Cattle Farm.

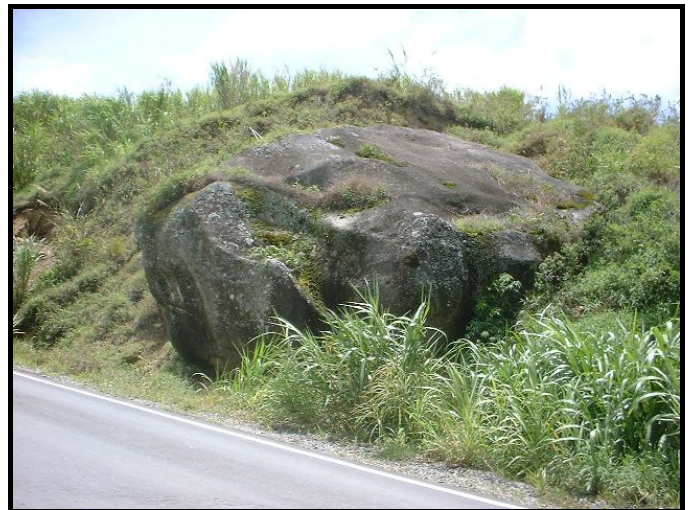
Photo 12: Granitic Boulder at Lower Plateau

5. Numbers of large granitic boulders were observed at the surrounding of the area. Photo 12 shows the gigantic granite boulder on the opposite side of the borehole, BH-6. This provides good evidence on the historical transportation of the glacial till derived from the Mt. Kinabalu. The walk-around by our geological expert on 22 September 2001 looking for the geological features on the outcrop and the exposure at the river has confirmed that the site is within the Pinosuk Gravels. An outcrop consisting of red shale, which is believed to be the remnants of the lower Trusmadi Formation, was observed in borehole BH-5 and the adjacent boulder outcrop.

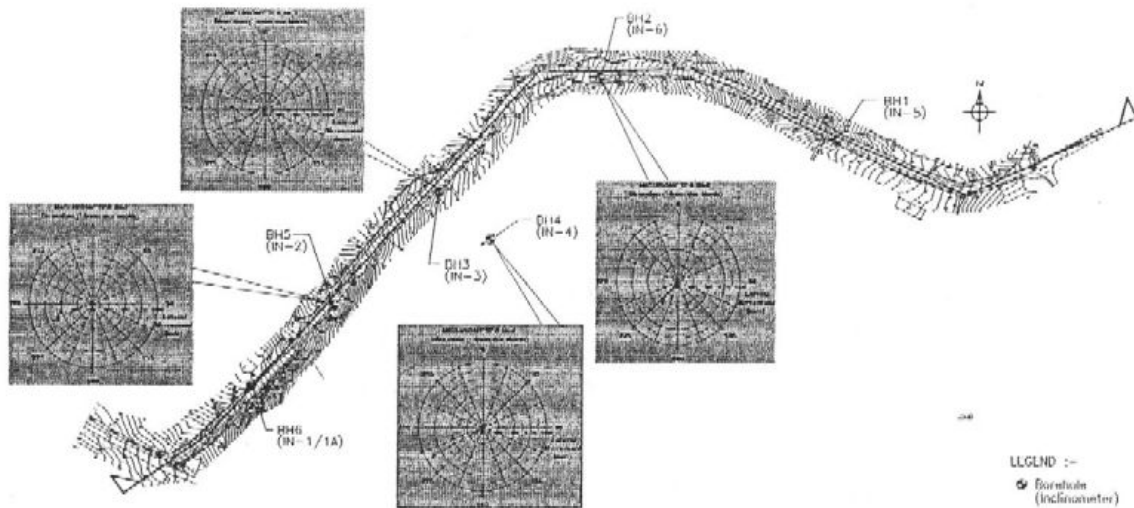
Figure 5: Layout of SI Boreholes and Instrumentation

There was a subsurface investigation (SI) programme consisting of 6 exploratory boreholes with inclinometers installed in every borehole. An additional borehole was sunk to reinstall the inclinometer (IN-1A) for replacing the inclinometer IN1, which has been sheared off during the monitoring period. Beside the boreholes, standpipe piezometers were installed to the depth of 10m for groundwater monitoring. The SI and instrumentation layouts are shown in Figure 5.

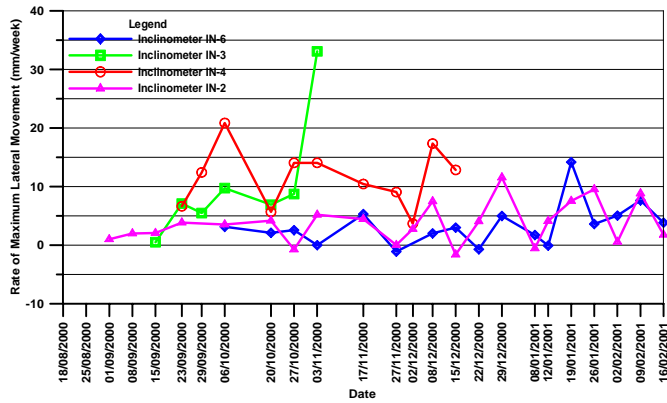
Figure 7: Rate of Maximum Lateral Movement

The interpreted borelog profile and the groundwater conditions are shown in Figure 6. From the inclinometer results, it is observed that distinct shear planes can be identified, particularly at inclinometers, IN-2, IN-3, IN-4 and IN-6. The direction of lateral movement of these inclinometers is in the narrow range between 225° and 250°. The maximum lateral movement is 140mm, which is in Inclinometer IN-4. The rates of maximum lateral ground movements in these inclinometers are generally in the range of 2mm/week to 14mm/week with few exceptional cases of maximum up to 21mm/week as shown in Figure 7. Whereas, inclinometers IN-1, IN-1A and IN-5 show lateral movement profile of a buckling casing and indicate that there is some compression within the subsoil at these inclinometers.

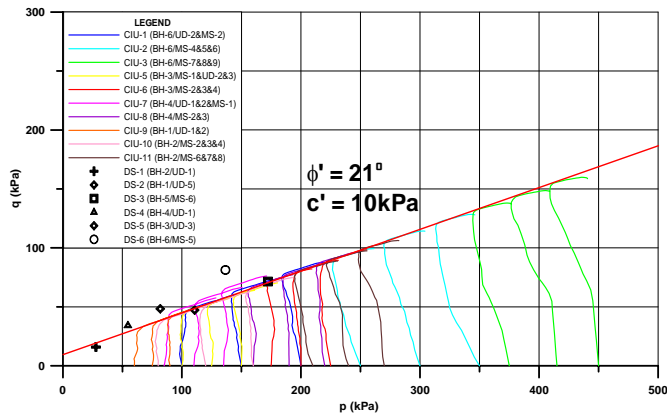
Figure 8: C.I.U. Tests & Direct Shear Box Tests

From the interpreted consolidated isotropically undrained (C.I.U) triaxial test results, the effective shear strength of the subsoils with vertical effective stress level ranging from 50kPa to 450kPa indicates : $\phi' = 21^\circ$ and $c' = 10\text{kPa}$, as shown Figure 7. The soil samples recovered from the boreholes are generally Silty Clay with sedimentary clast and occasionally Sandy Silt at the upper layer.

Six undisturbed soil samples near to the identified slip plane have been selected, reconstituted and tested in direct shear box to indicate the shear strength of the fine content of the soil mixtures. The test specimens were prepared from the soil particles passing through the 425 μm sieve with the adjusted moisture content. The normal effective stresses on these specimens were applied based on the corresponding vertical in-situ effective stresses. The interpreted soil strength from direct shear box tests is fairly near to the CIU strength with two data points having slightly higher values. This is also shown in Figure 8.

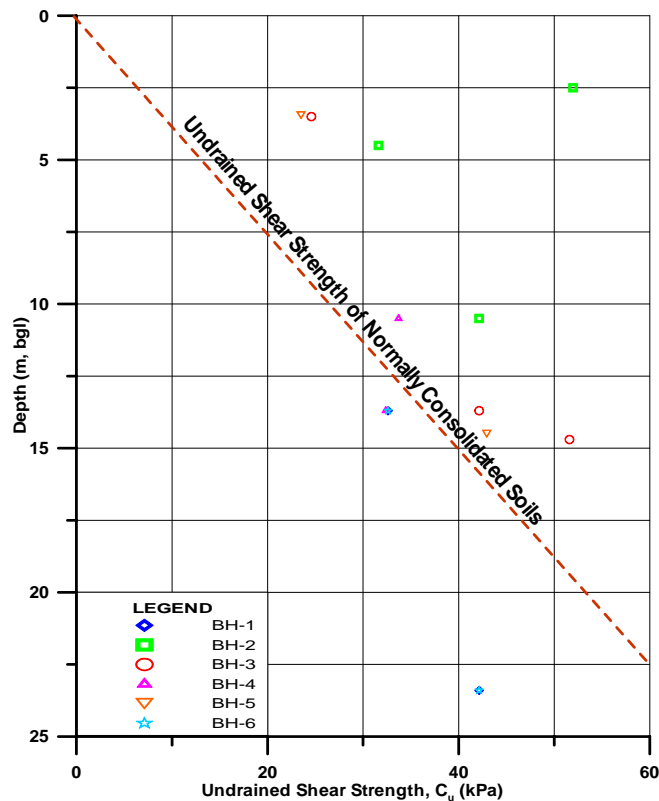
Figure 9: Undrained Shear Strength Tests

1. The natural water content in the subsoil of the moving soil mass is lower than the plastic limit of the subsoil. The natural water content of the soil samples is in the range from 7% to 13%.
2. The bulk density of the subsoil is generally in the range between 21 to 23kN/m³, except for sample, MS-6 in borehole, BH-5, which has the bulk density of 23.69kN/m³.
3. The undrained shear strengths of most undisturbed samples are considerably low as shown in Figure 9, which are
