Geotechnical Investigation and Monitoring Results of a Landslide Failure at Southern Peninsular Malaysia (Part 1: Investigating Causes of Failure)

A proposed building was constructed on a cut platform. After cutting of a two-berm slope (gradient 1V:1.5H) for the building platform, the cut slope collapsed following a heavy downpour. On top of the failed cut slope, there was another proposed structure yet to be constructed. A comprehensive geotechnical investigation was carried out to investigate the causes of the failure and to propose remedial measures.

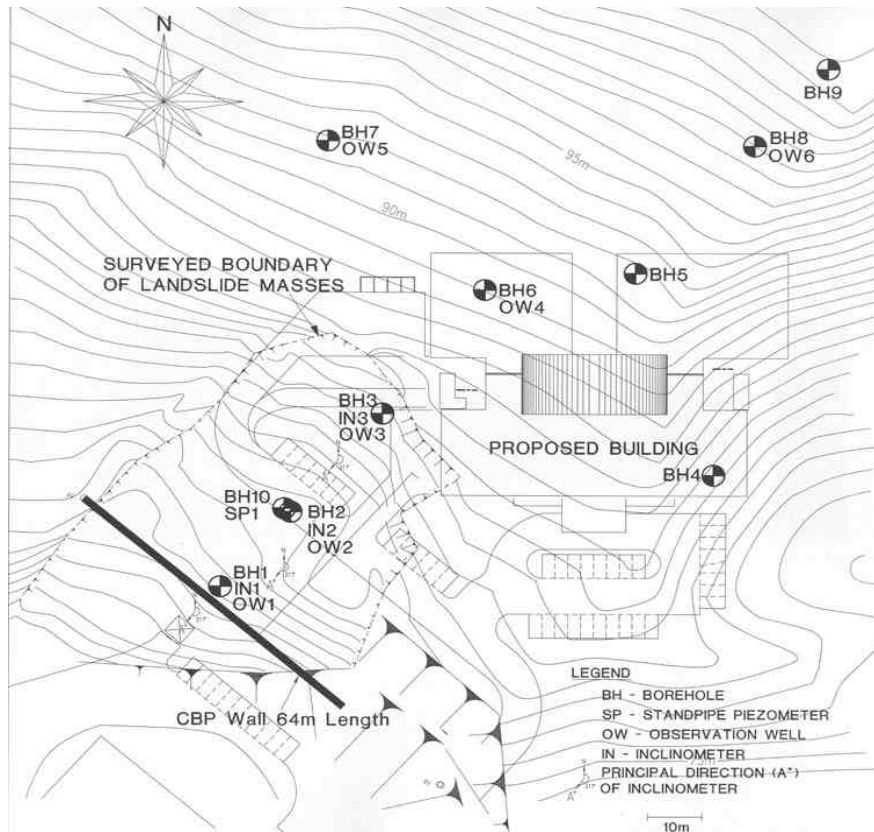
Figure 5 Layout of Borehole and Instrumentation Plan

Subsurface investigation and instrumentation programmes consisting of ten boreholes, three inclinometers, six observation wells and one standpipe piezometer were planned and implemented to investigate the causes of failure, to propose remedial measures and for geotechnical design of the upper proposed building. The layout of the boreholes and instrumentations is shown in Figure 5. Three boreholes, namely BH-1, BH-2 and BH-3, were

sunk within the failed mass. Upon completion of boring operation and sample collection, inclinometers, IN-1, IN-2 and IN-3 were installed in the boreholes. Apart from the inclinometers, three observation wells, OW-1, OW-2 and OW-3 were also installed at 1m away from boreholes BH-1, BH-2 and BH-3 respectively. Liew & Gue (2001) have presented a similar investigation for post glacial deposit in East Malaysia, in which the inclinometers have successfully determined the creep movements and slip surface. Figure 6 shows the interpreted subsoil profiles. The overburden material is generally weak, with SPT-N ranging from 0 to 15.

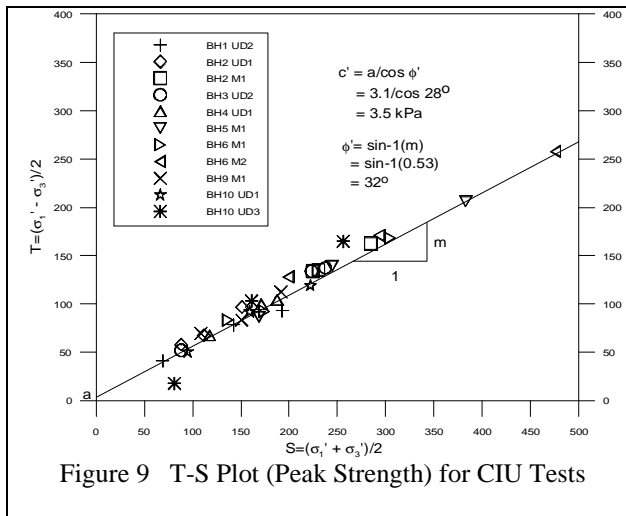
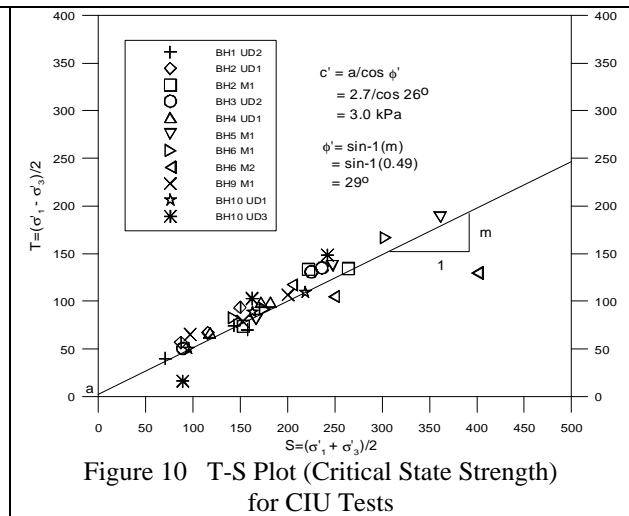
Eleven (11) numbers of C.I.U. tests were carried out on the thin wall and Mazier samples. Figures 9 and 10 show both the T-S plot for the interpreted peak strength ($c' = 3.5$ kPa and

$\phi' = 32^\circ$) and critical state strength ($c' = 3.0$ kPa and $\phi' = 29^\circ$). As shown in the graphs, the C.I.U. results are fairly consistent.

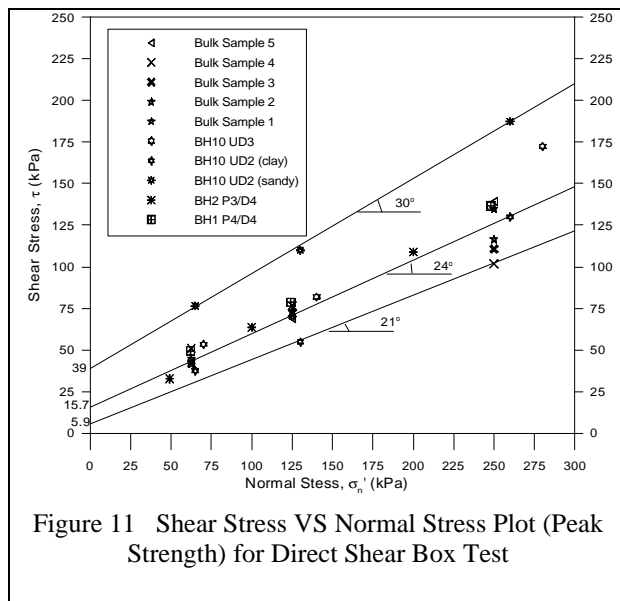
Figure 11 Shear Stress VS Normal Stress Plot (Peak Strength) for Direct Shear Box Test

Figure 11 shows the upper bound of the peak strength of : $c' = 39.0$ kPa, $\phi' = 30^\circ$ while the lower bound value of : $c' = 5.9$ kPa, $\phi' = 21^\circ$. The average shear strength obtained is : $c' = 15.7$ kPa, $\phi' = 24^\circ$.

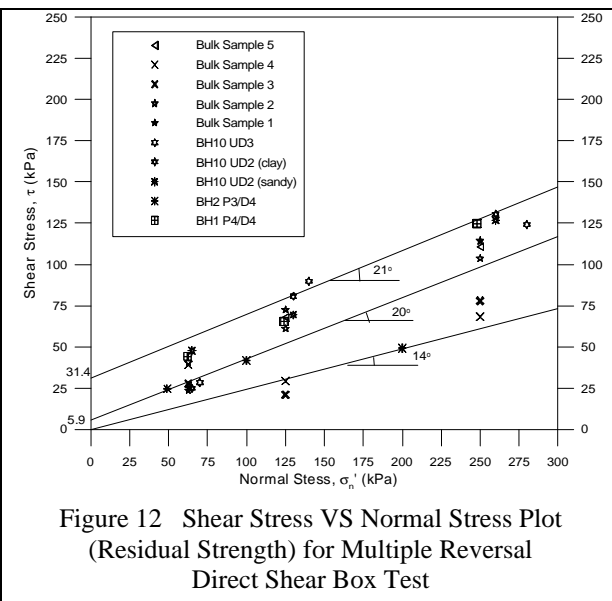
Figure 12 Shear Stress VS Normal Stress Plot (Residual Strength) for Multiple Reversal Direct Shear Box Test

Figure 12 shows the upper bound of the residual strength of : $c' = 31.4$ kPa, $\phi' = 21^\circ$ while the lower bound value of : $c' = 0$ kPa, $\phi' = 14^\circ$. The average shear strength obtained is : $c' = 5.9$ kPa, $\phi' = 20^\circ$. The scatter of interpreted residual strength is rather large and could be largely due to inconsistency in generating the smooth shearing surface in this particular soil type during the reversal shearing process. A continuous large strain shearing in one direction, like ring shear test, could have produced a more consistent residual strength.
