Slope Failures in Tropical Residual Soils

Presented by:
Ir. Dr. Gue See Sew
21 April 2005

- Creep Movement of Slopes, Sabah.
- Cut Slope Failure in Skudai, Johor.
- Cut Slope Failure at Gua Musang, Kelantan.
- Cut Slope Failure at Kuala Lumpur.
- Filled Slope Failure at Salak Tinggi.

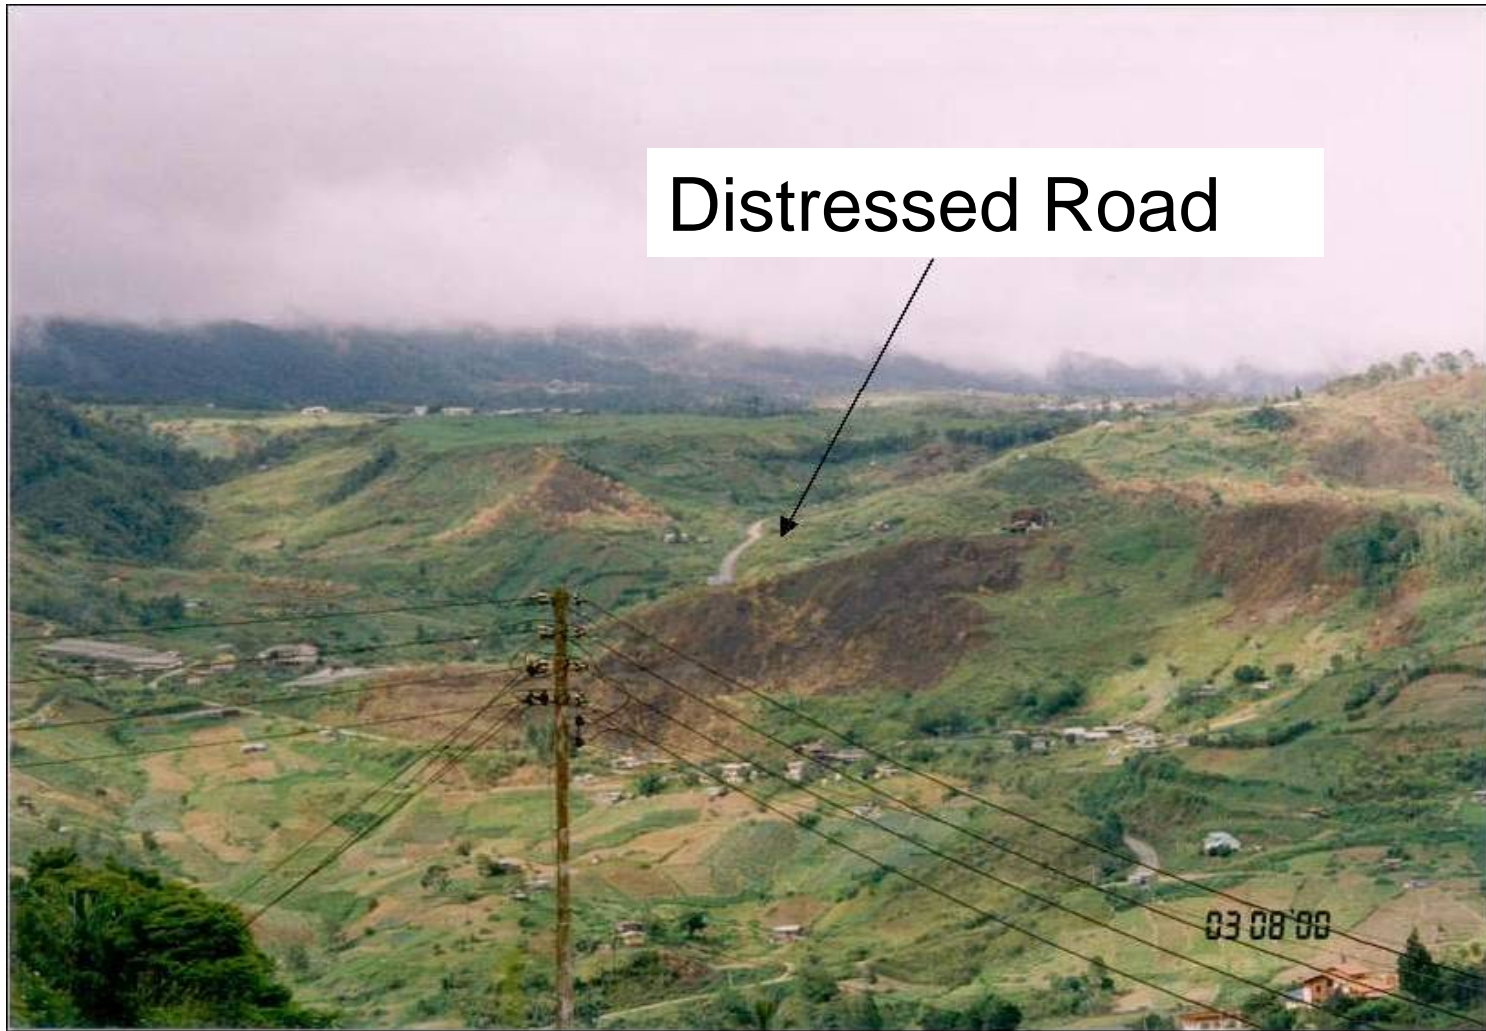
Creep Movement of Slope, Sabah

- Damage of road pavement and drains.
- Tension cracks, settlement and lateral movement.
- Investigation of root causes.

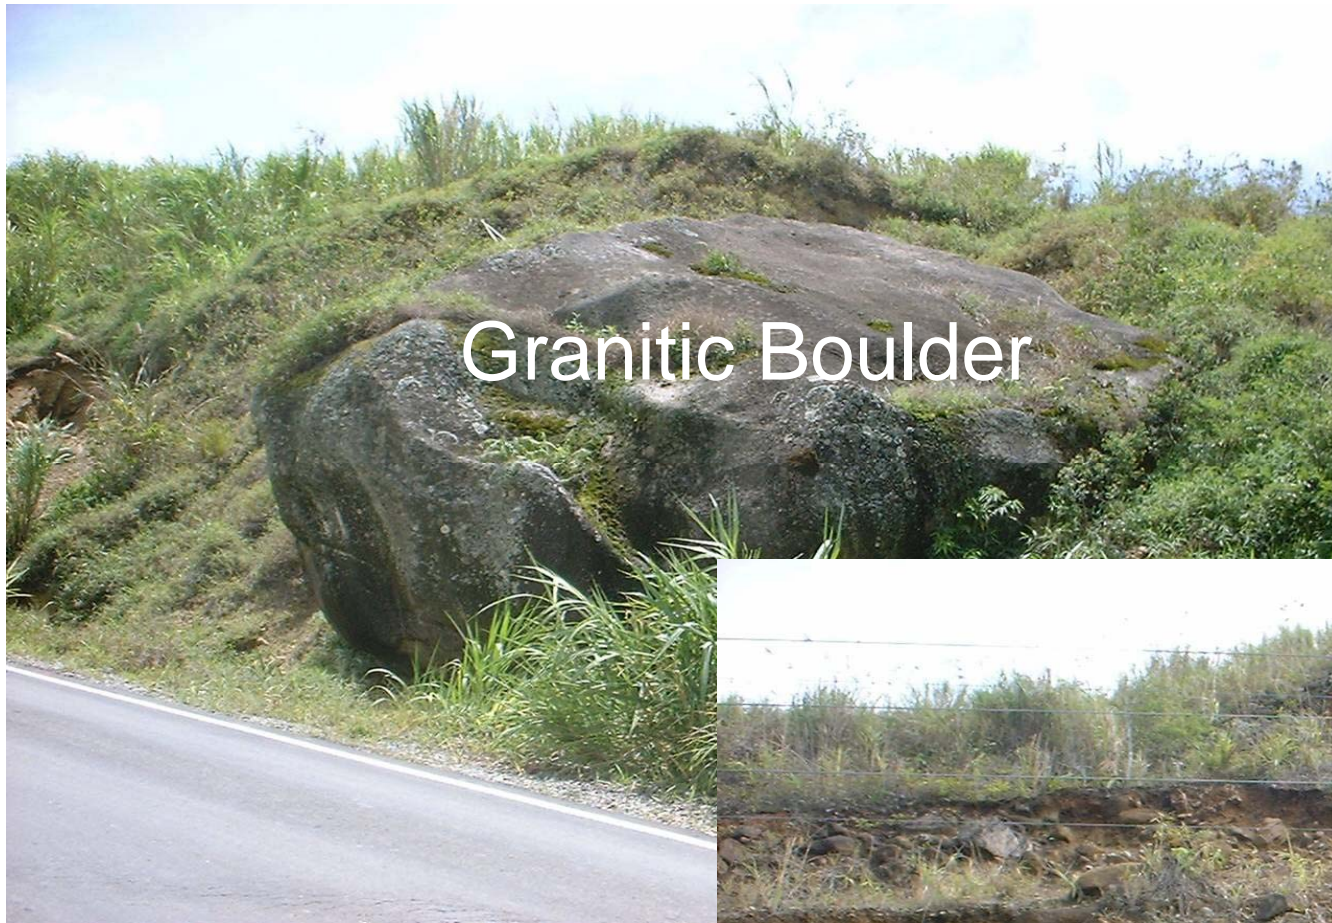
Granitic Boulder

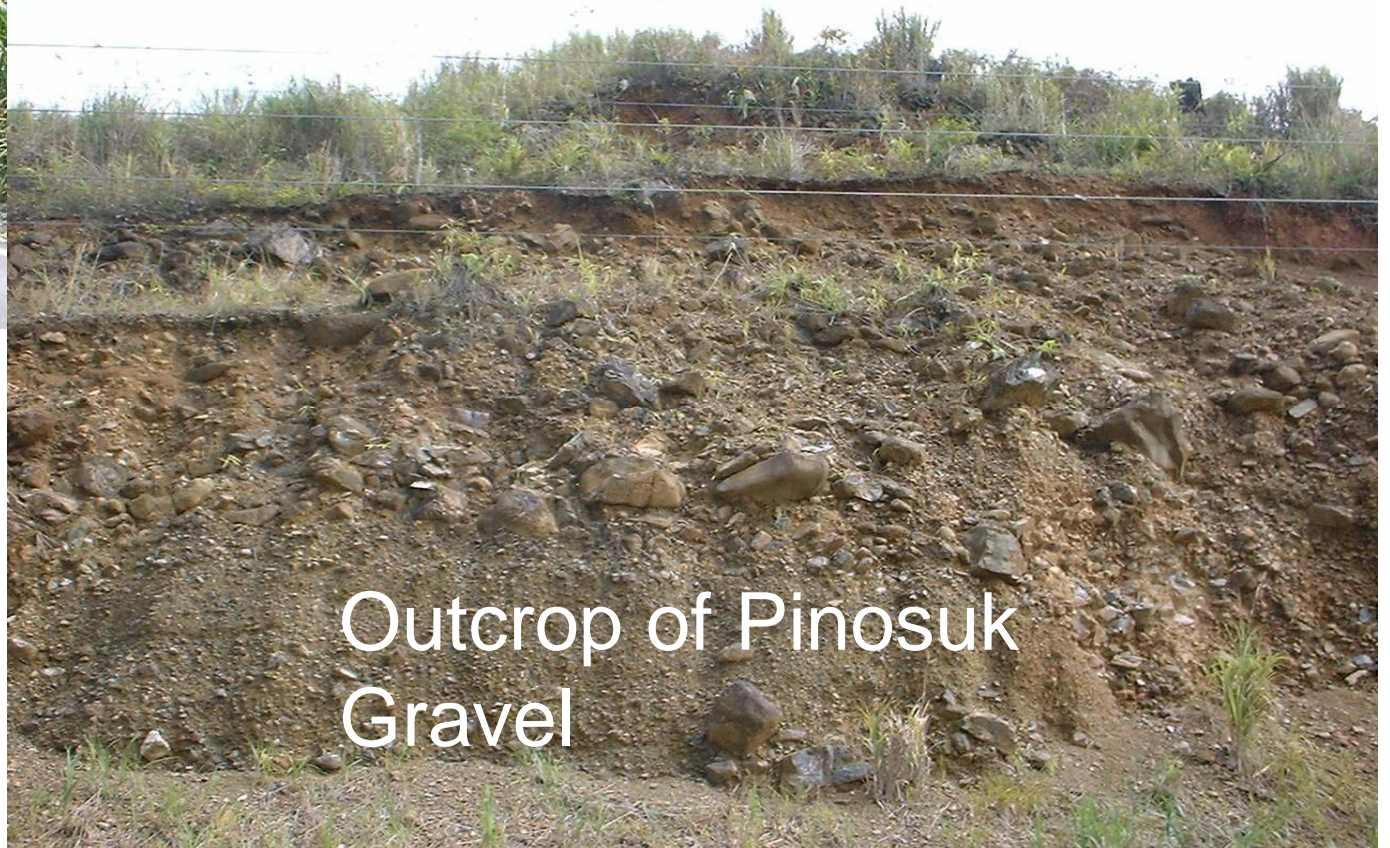
Outcrop of Pinosuk
Gravel

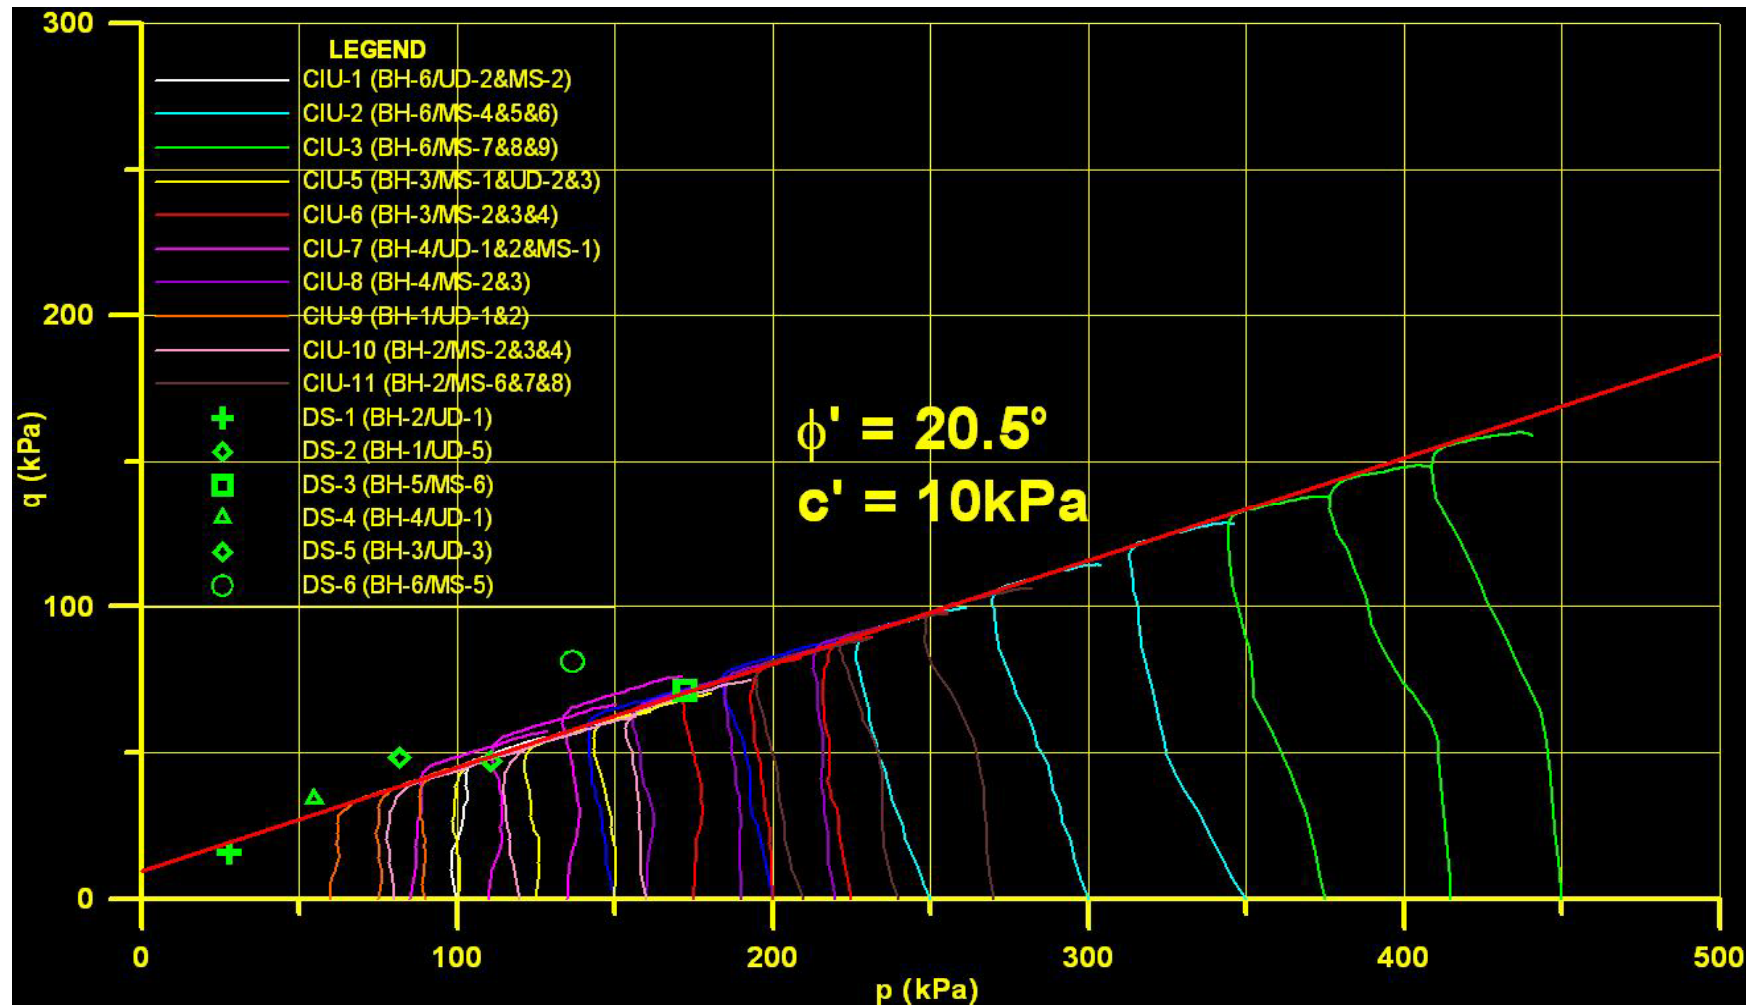
Shear Strength Test Results

- Six Boreholes & Inclinometers
- Six Piezometers (GWT : 1.5~2.5m)
- C.I.U. Tests & Direct Shear Box Tests ($\phi' = 21^\circ$, $c' = 10\text{kPa}$).
- Others Properties : $w_n = 7\%$ to 13% , $\gamma_{\text{bulk}} = 21 \sim 23.7\text{kN/m}^3$
- Normally Consolidated

- Interpreted laboratory shear strength parameters are too high to cause instability.
- Back-analysis shear strength parameters:
 $\phi' = 13^\circ \sim 16^\circ$, $c' = 0 \sim 5 \text{ kPa}$

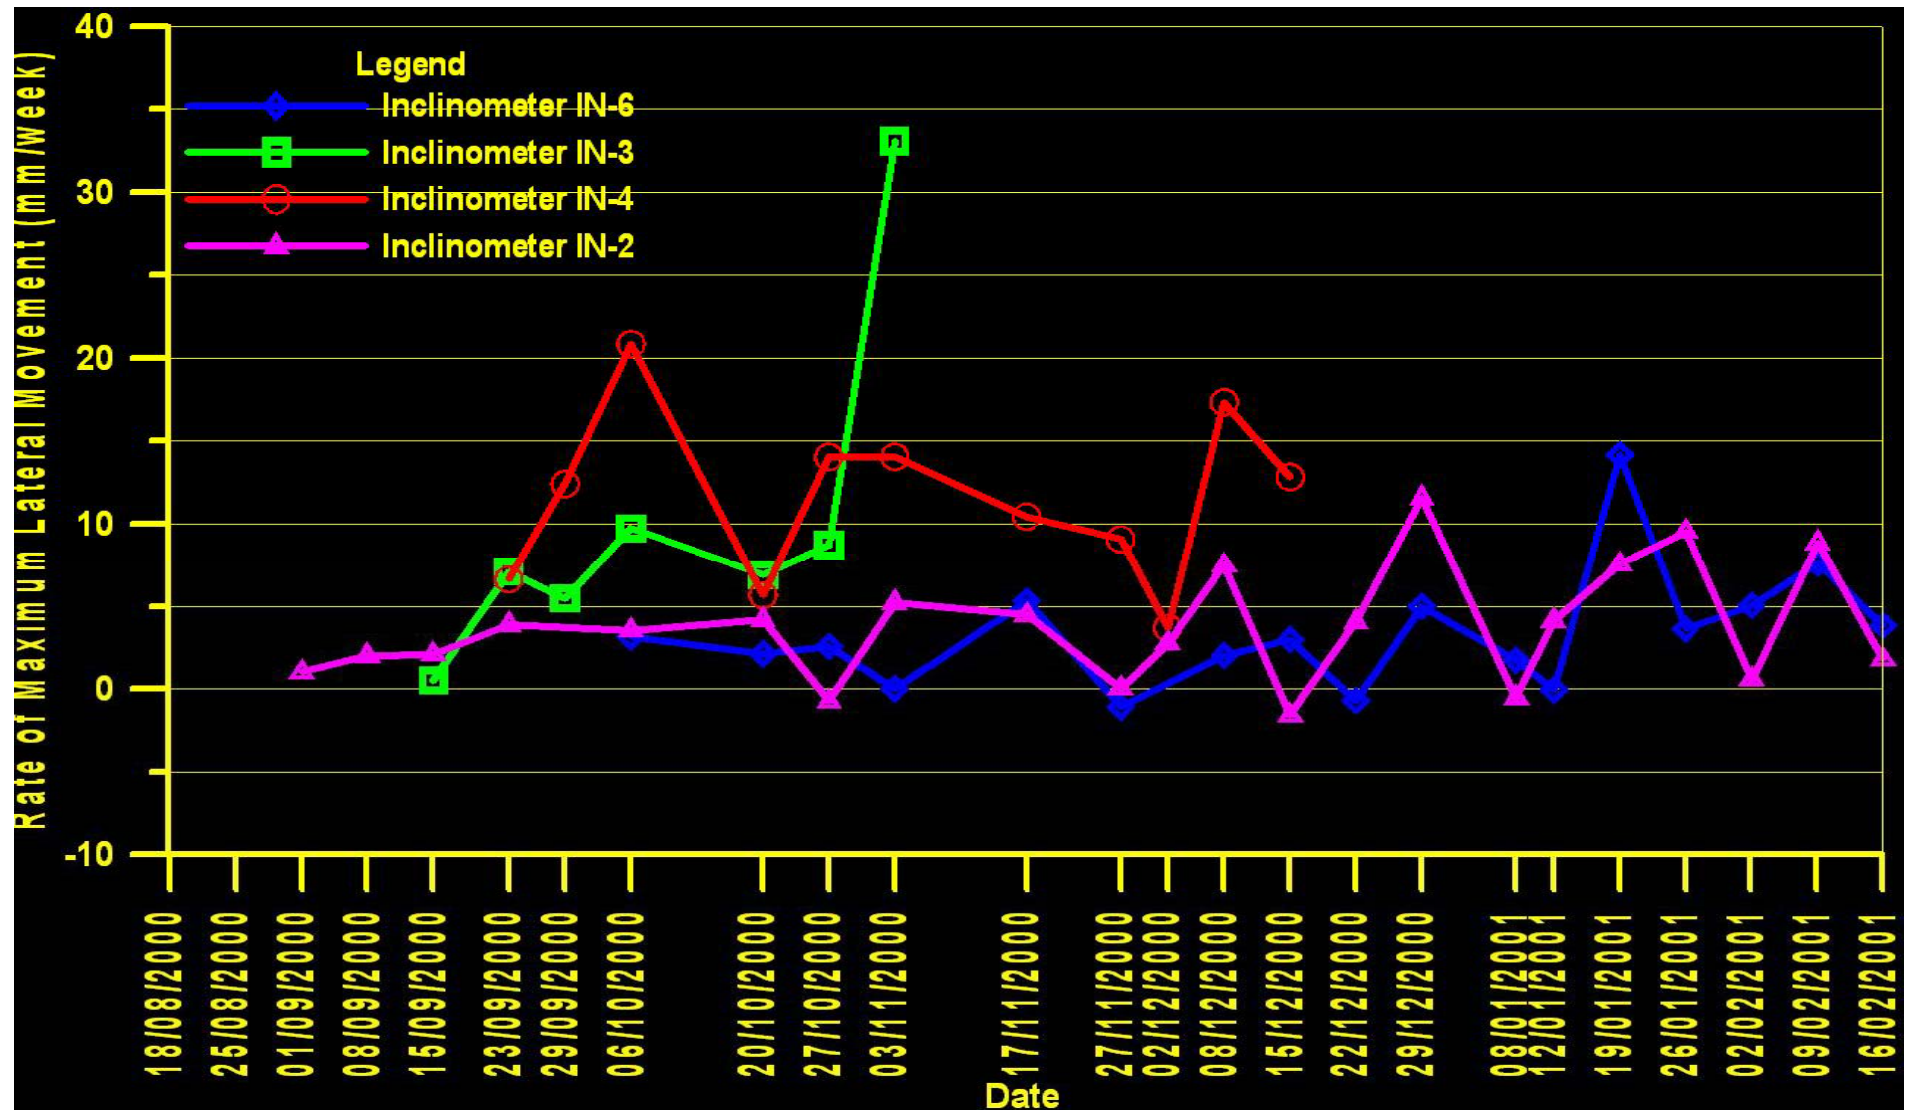
Inclinometer Movement Rate

- Inclinometers detected slip surface.
- Lateral Movement:
- Direction : $225^{\circ} \sim 250^{\circ}$
- Max. Movement : 140mm (IN-4)
- Rate of Movement : 2~14mm/week
(Max. 21mm/week)

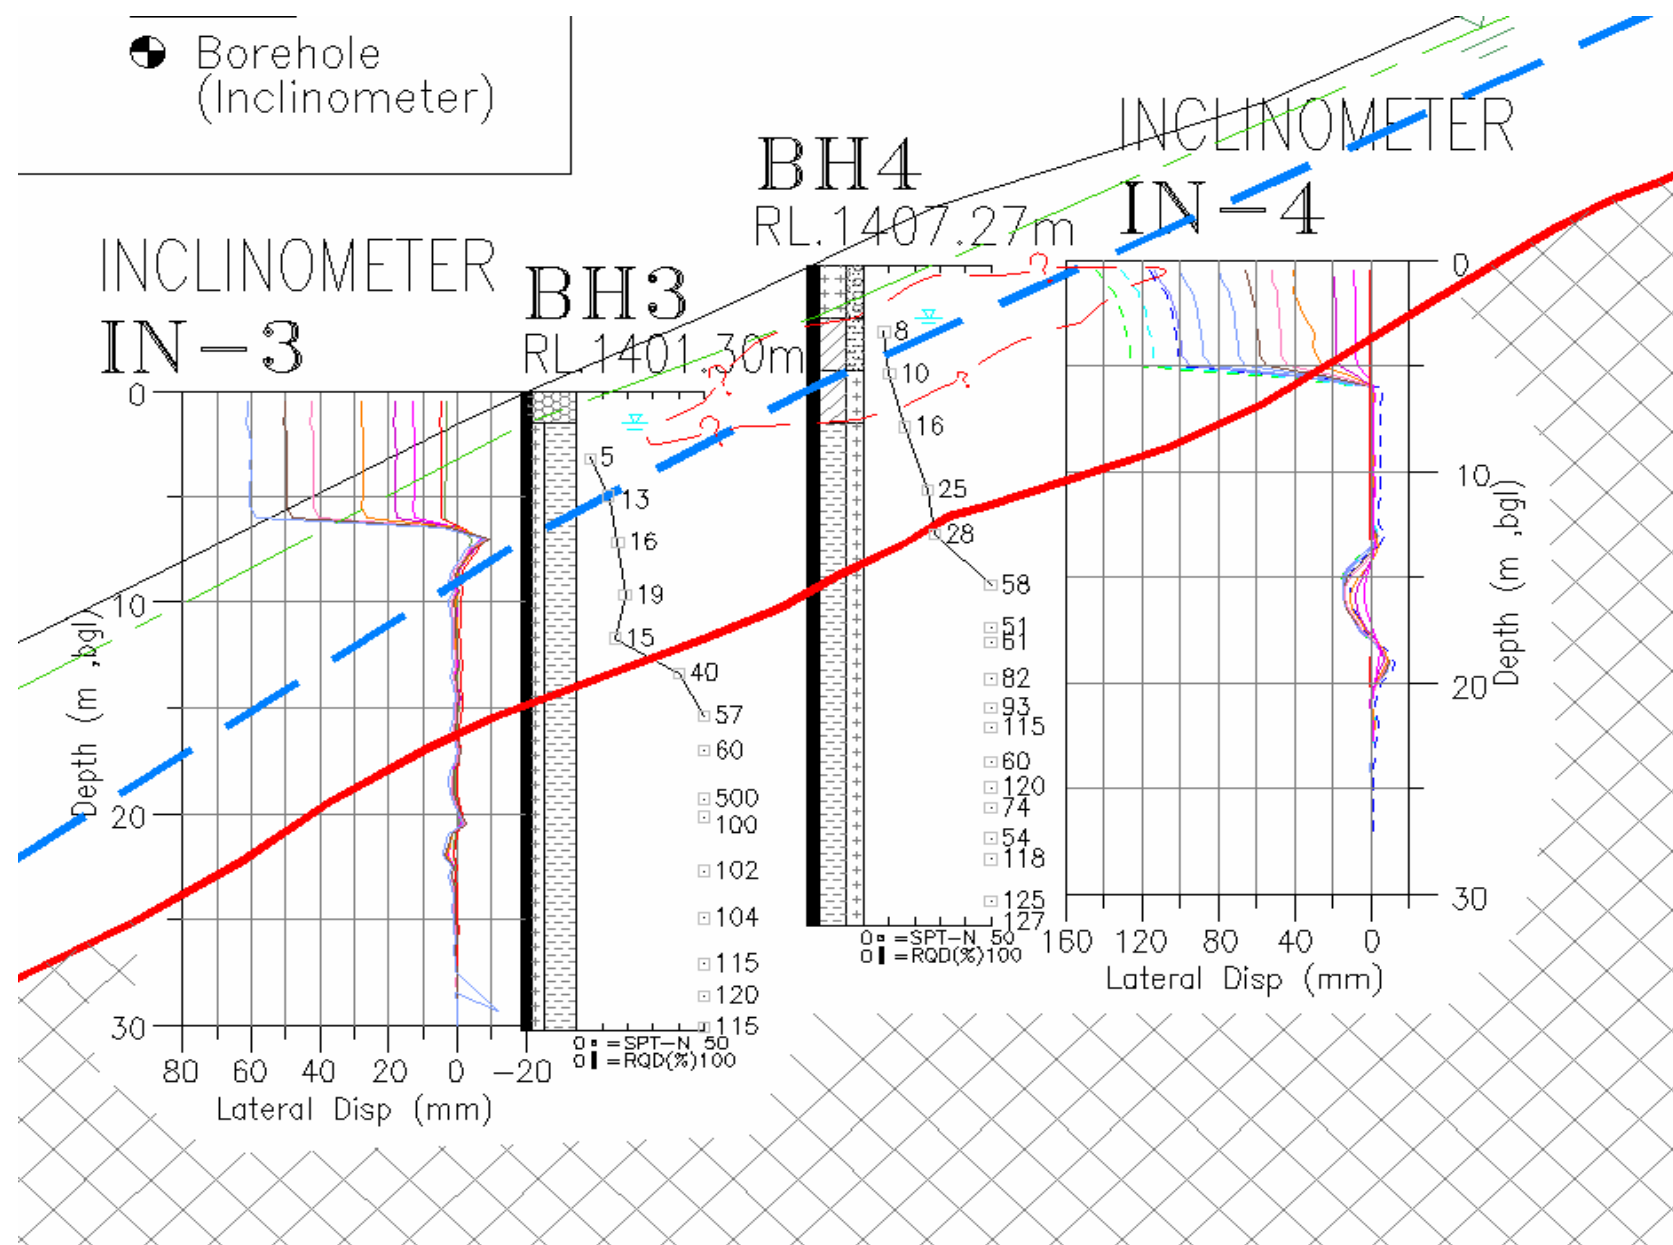
Borehole
 (Inclinometer)

- Slip Surface : 6m (higher ground) to 15m (lower ground).
- Movement Direction: almost parallel to road alignment, towards river.
- Back-analysed shear strength < Interpreted laboratory test results.

- Carry out continuous sampling at shear plane to collect samples for testing.
- Carry out ring shear test or multiple reversal direct shear box test to determine residual strength.

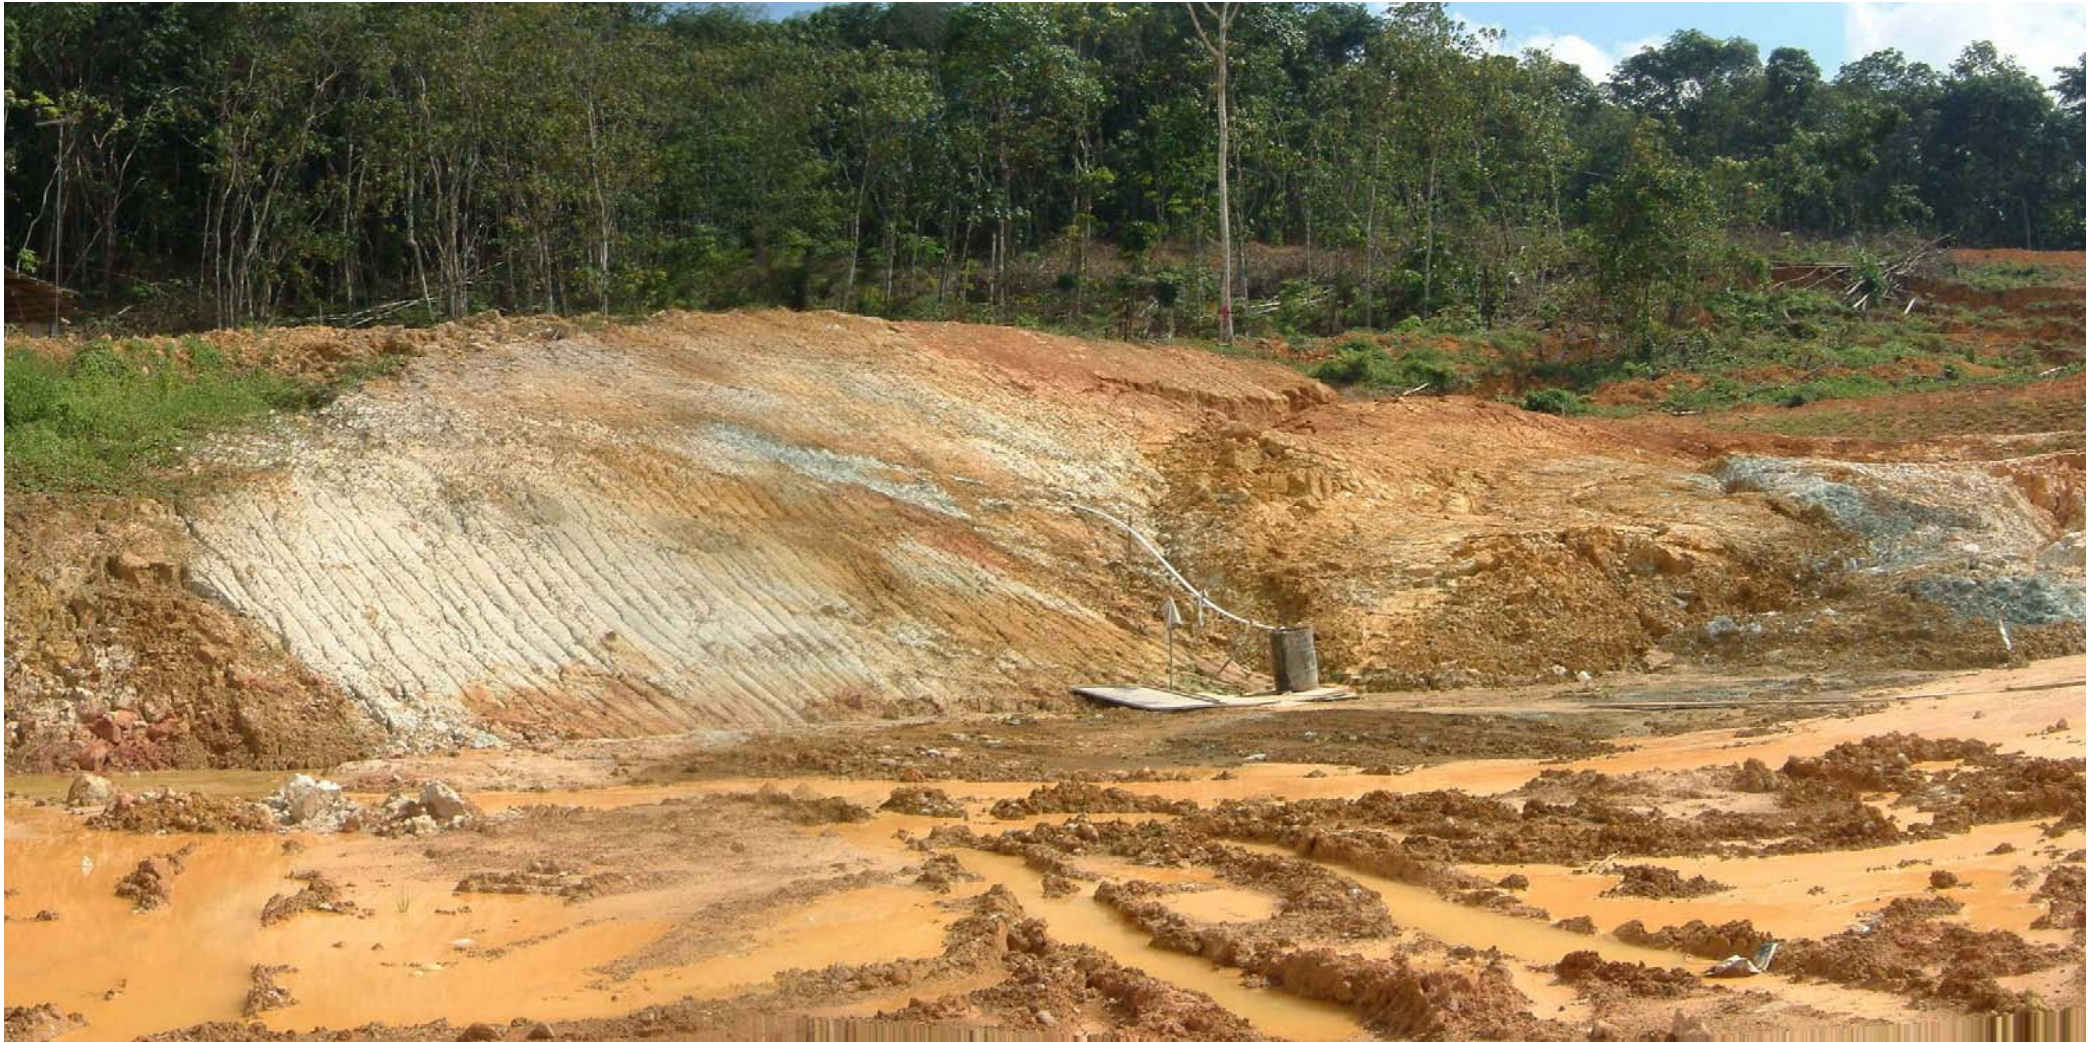
Cut Slope Failure in Johor

- RL54m to RL106m.
- Terrain : Slope.
- Geology: Mainly basic intrusive gabbro and intermediate intrusive.
- Two berms cut slope 1V:1.5H.
- Slope collapsed after heavy downpour.

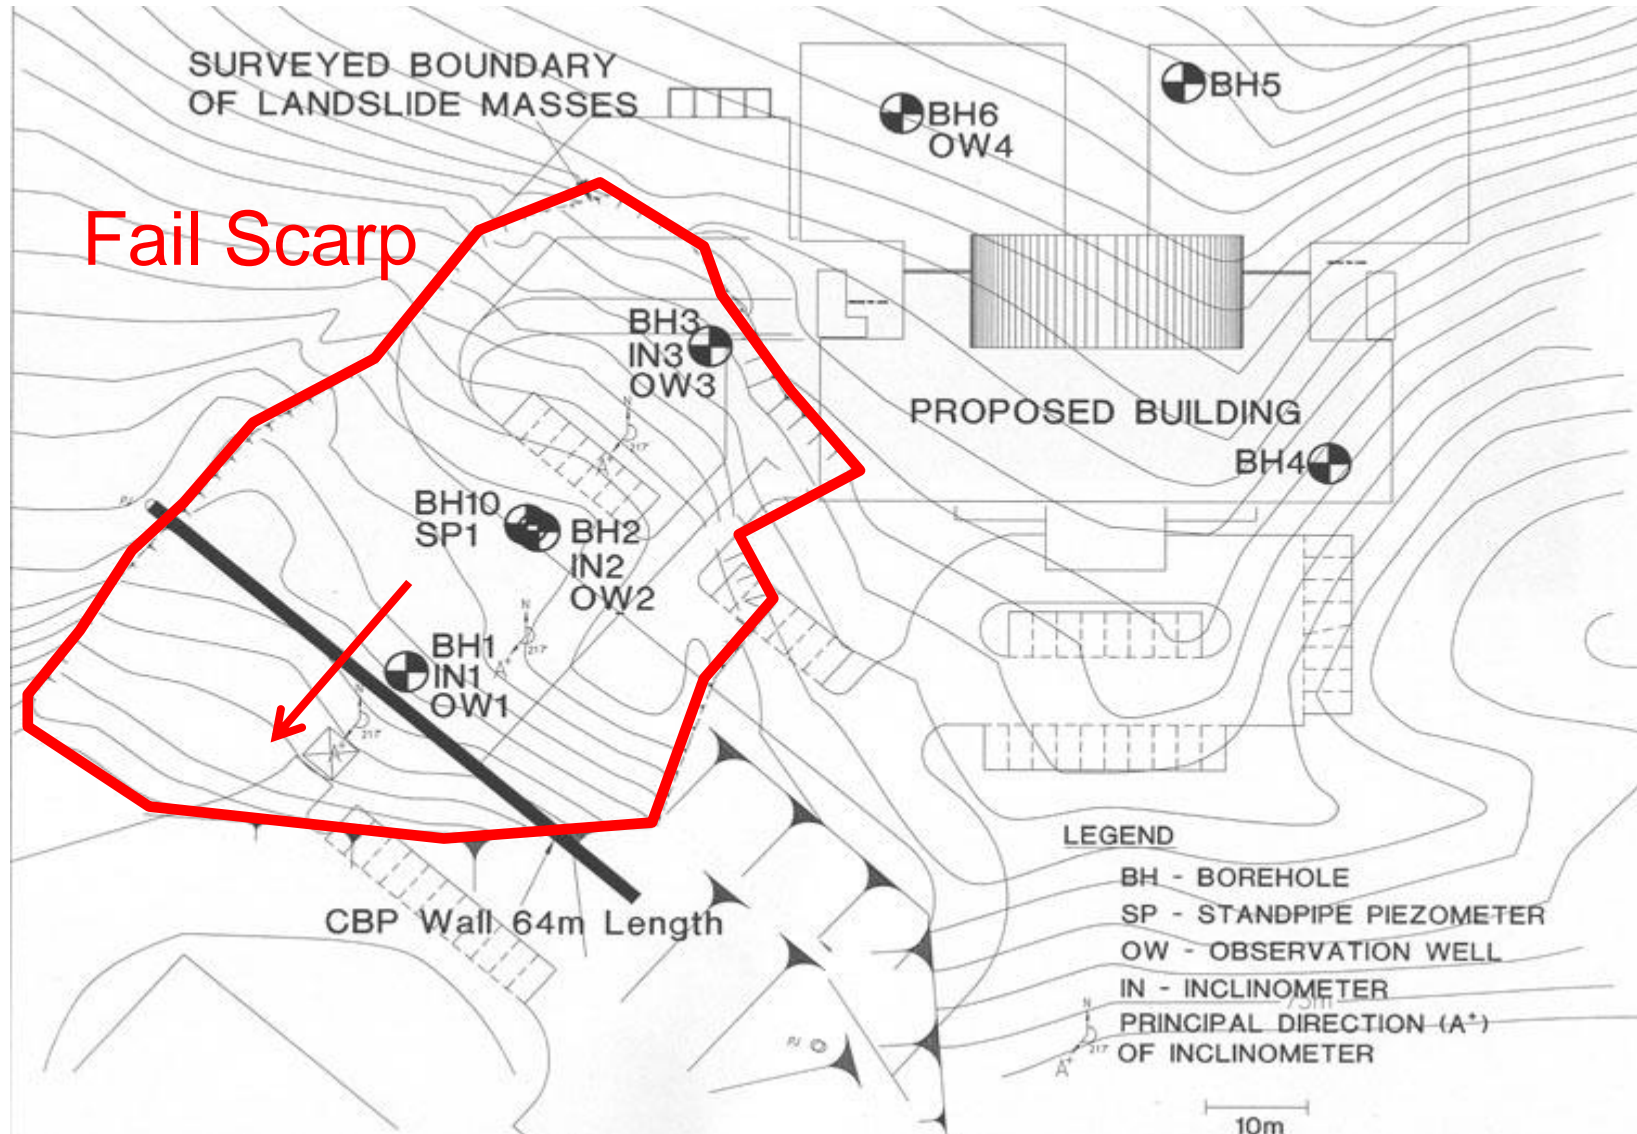
SI Layout Plan

- IN-1 and IN-2 were sheared off at 10.5m and 12.0m below ground.
- IN-3 sheared off at 2.5m below ground.
- Observation wells were also sheared off.

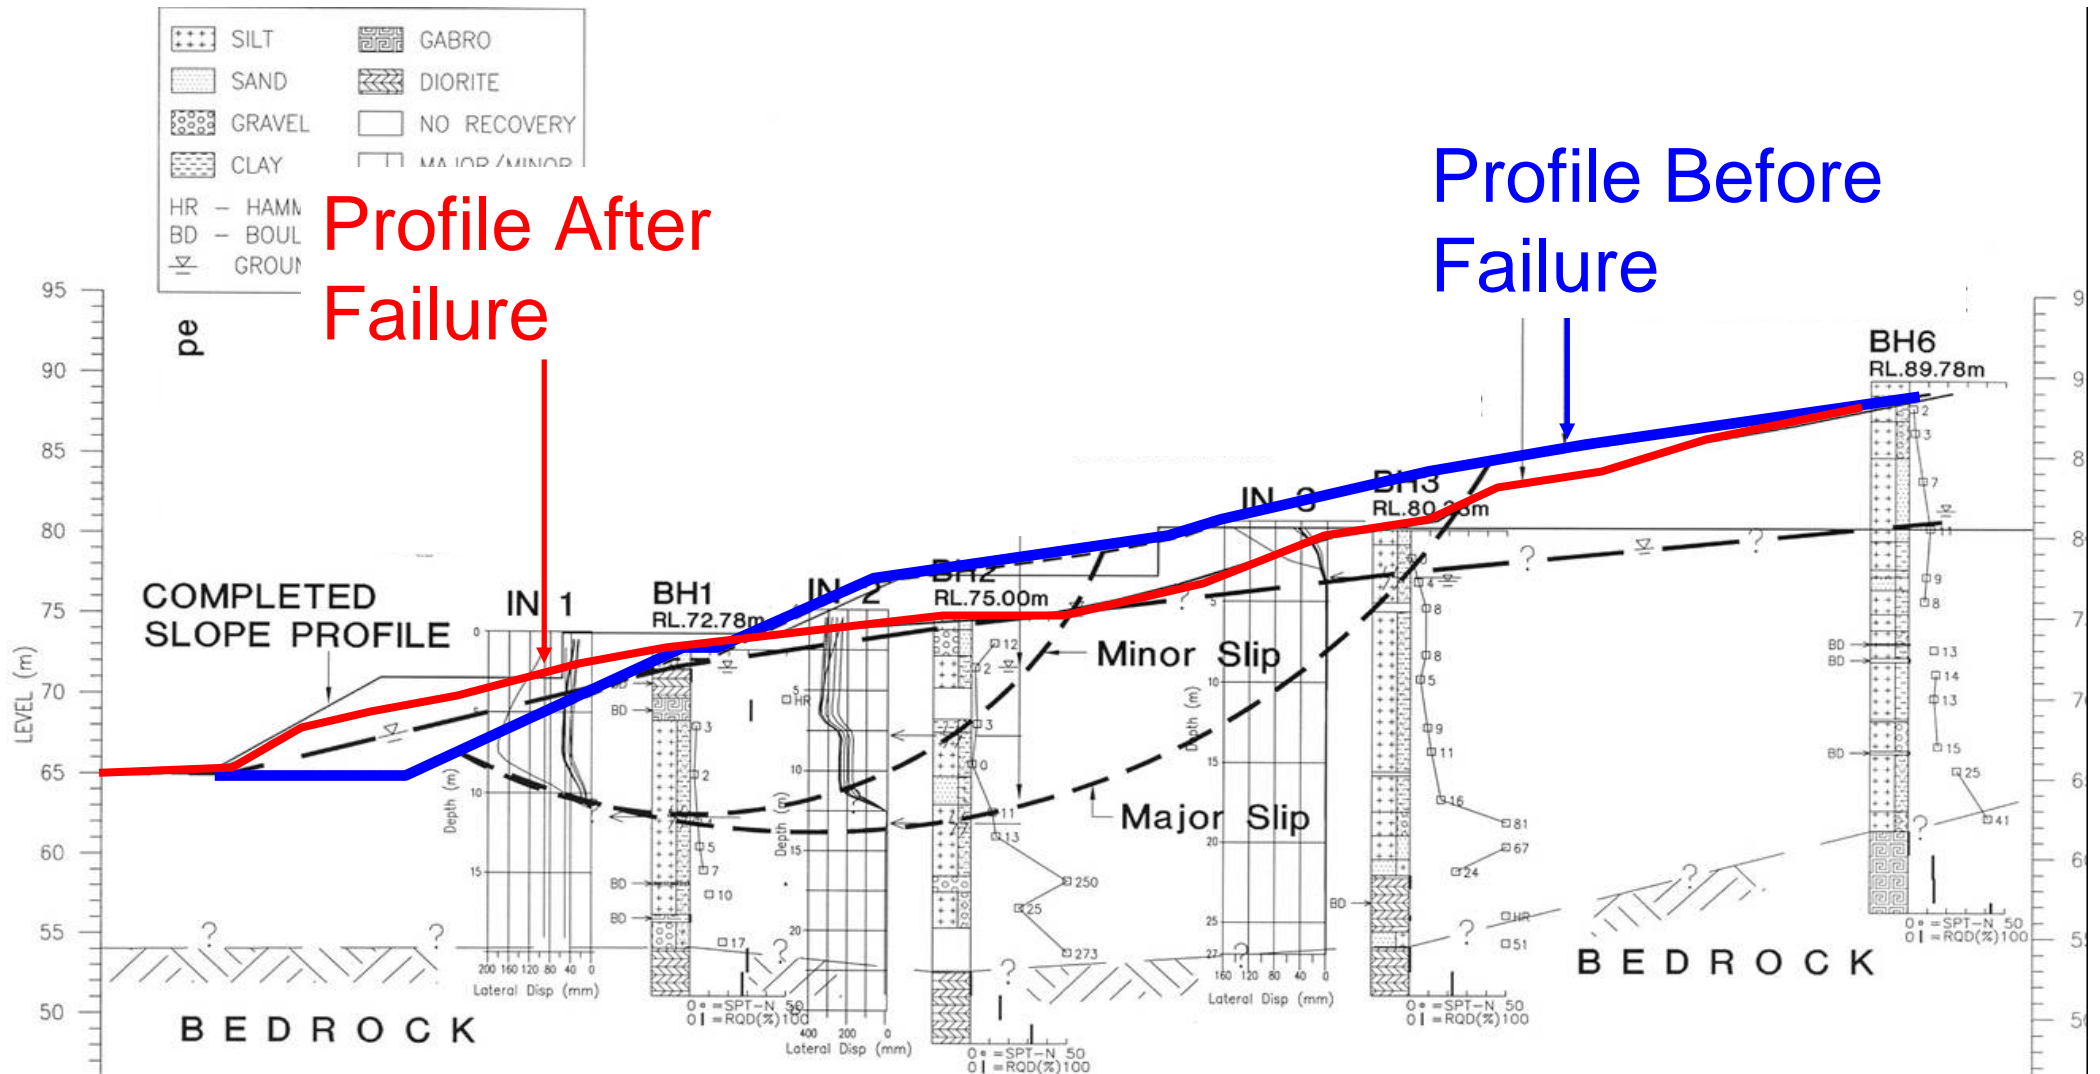
Slope Profile for Back Analysis

- Back-analyses were performed for 2 conditions:
 - a. Slope profile after cutting, before failure. (critical state strength)
 - b. Slope profile after failure. (residual strength)
- The interpreted slip surface and monitored groundwater level is used for back-analysis.

- Back-analyses using PC-Stabl6 and Plaxis.
- Back-analyses results :
 - a. Critical state strength : $c'=0 - 0.5$ kPa, $\phi'=24^\circ - 25.9^\circ$
 - b. Residual strength : $c'=0 - 0.5$ kPa, $\phi'=14.4^\circ - 15^\circ$

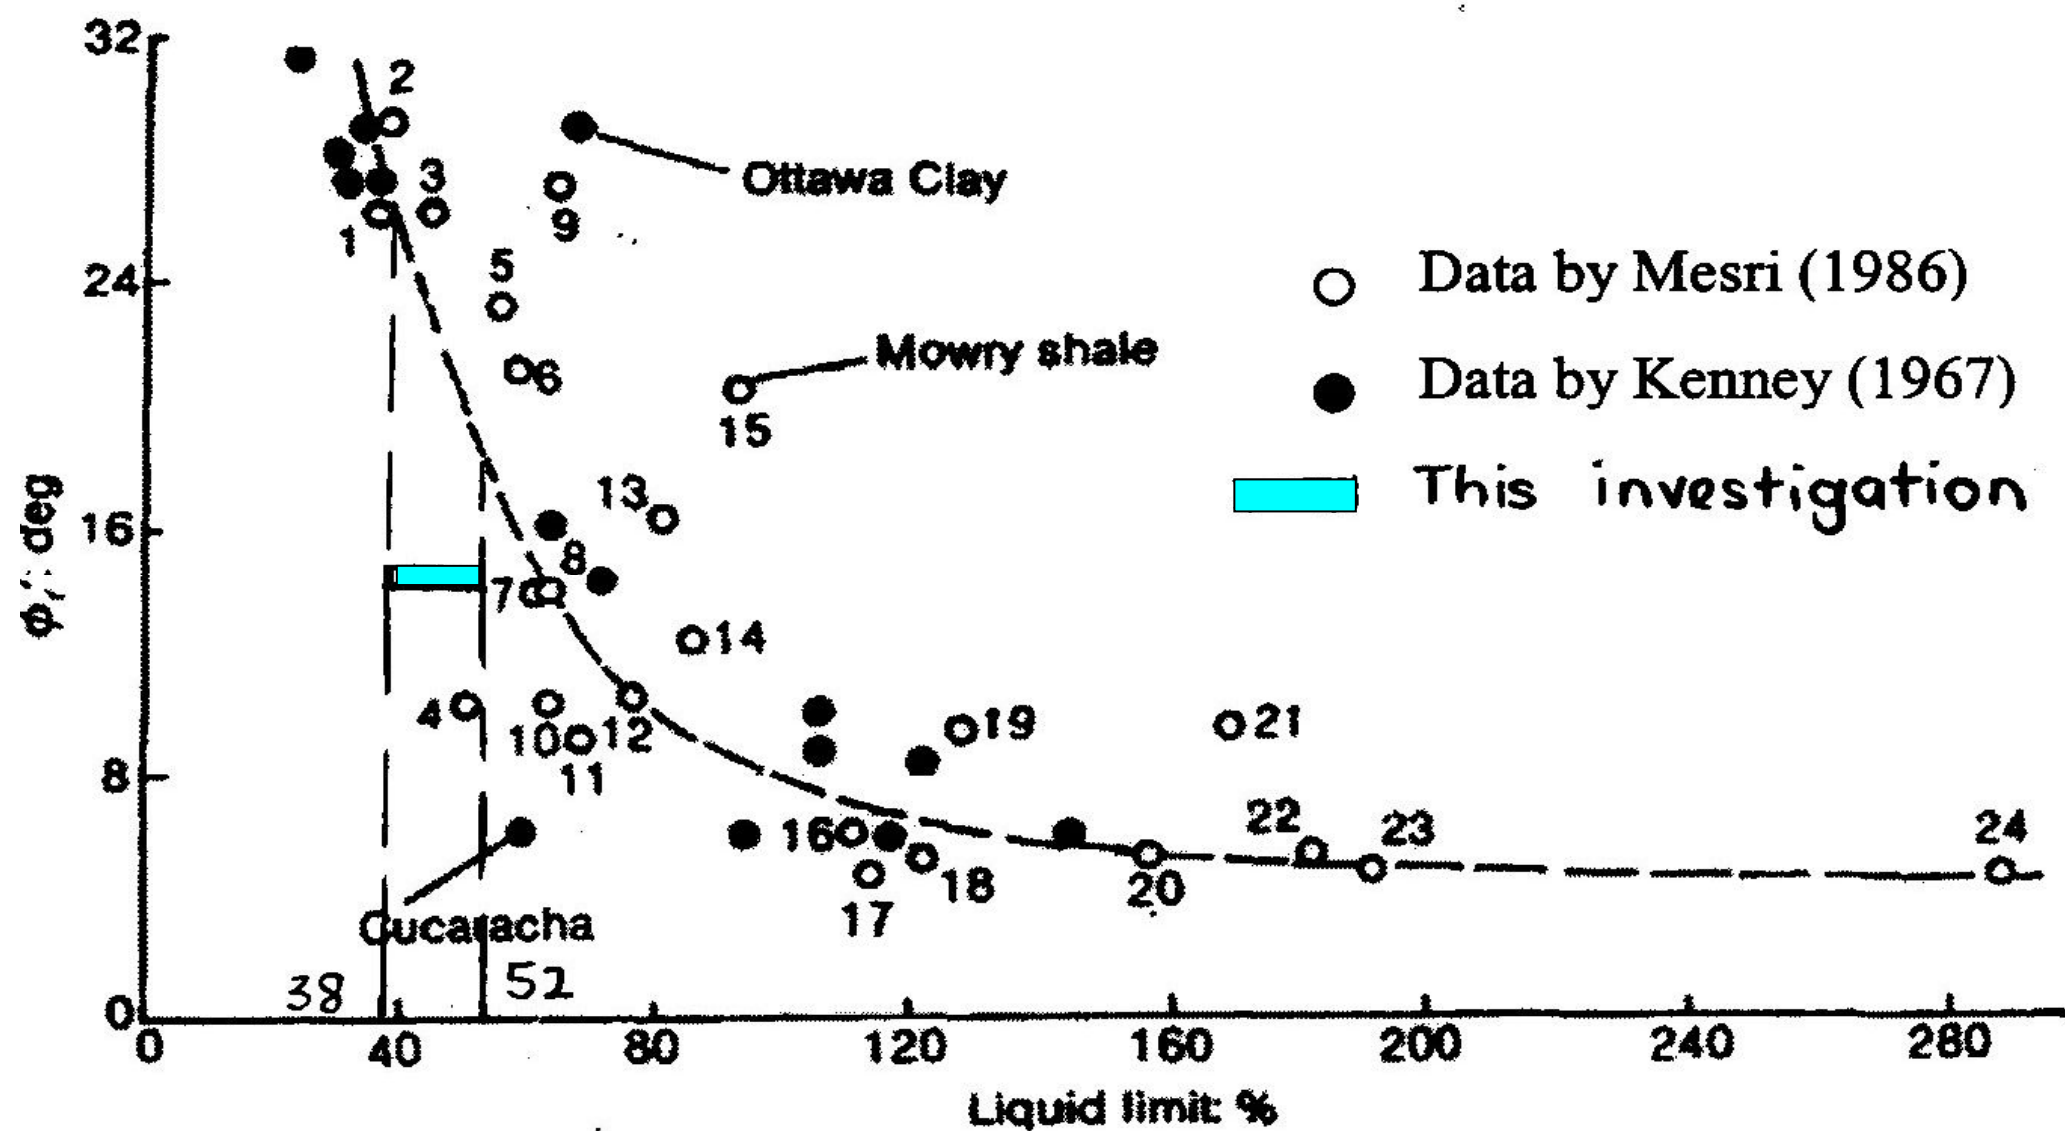
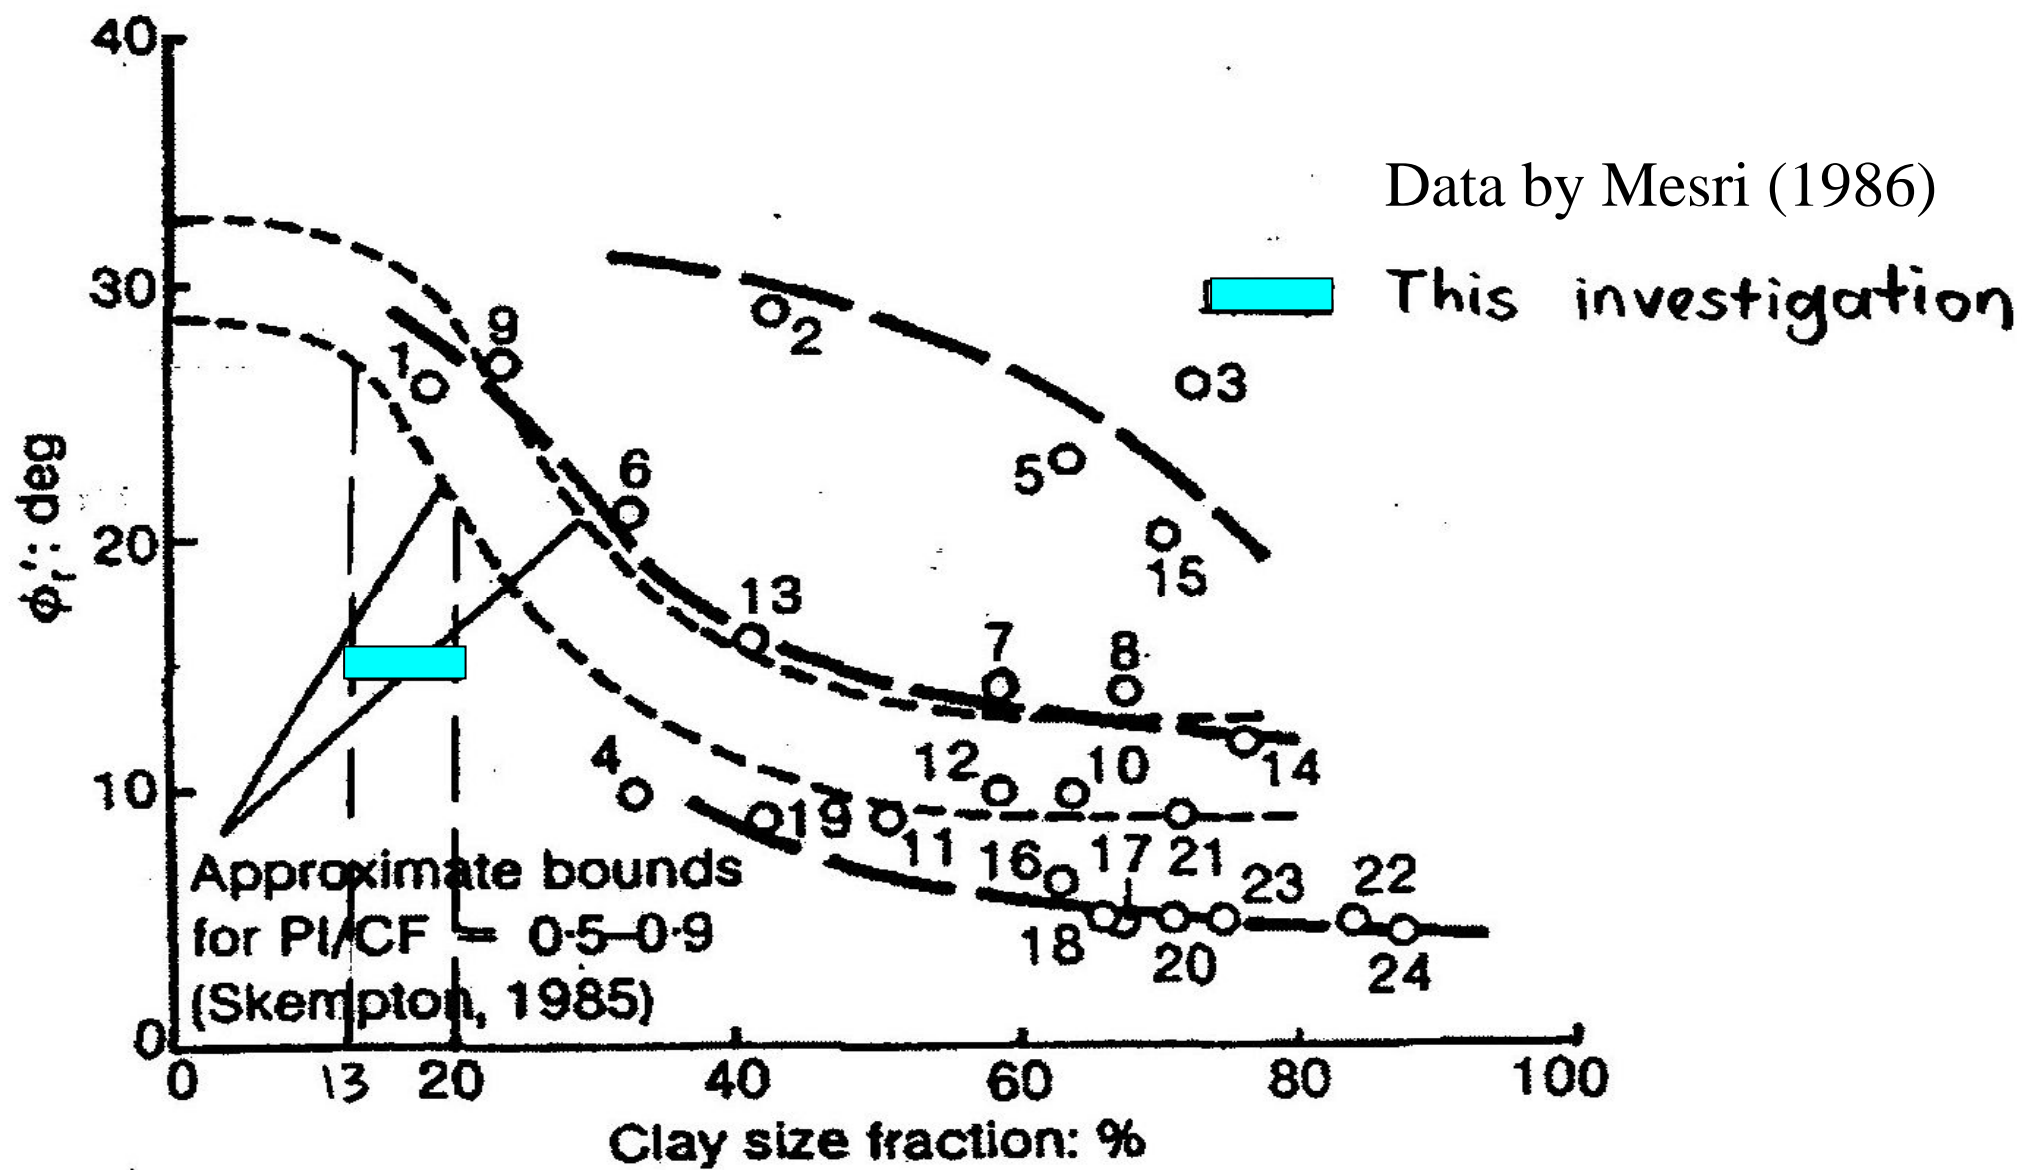
Residual Strength

- Comparisons with literature:
 - a. Residual friction angle – Liquid Limit.
 - b. Residual friction angle – Clay size fraction.
- Back analysed residual friction angle are lower as compared to literatures.

- The investigation deduced that there is a thin layer at the slip surface with low shear strength.
- Boreholes are not able to capture the thin layer and could only be detected by inclinometer.
- Residual shear strength should be used for remedial design works.
