Slope Failures in Tropical Residual Soils

Presented by:
Ir. Dr. Gue See Sew
21 April 2005

- Creep Movement of Slopes, Sabah.
- Cut Slope Failure in Skudai, Johor.
- Cut Slope Failure at Gua Musang, Kelantan.
- Cut Slope Failure at Kuala Lumpur.
- Filled Slope Failure at Salak Tinggi.

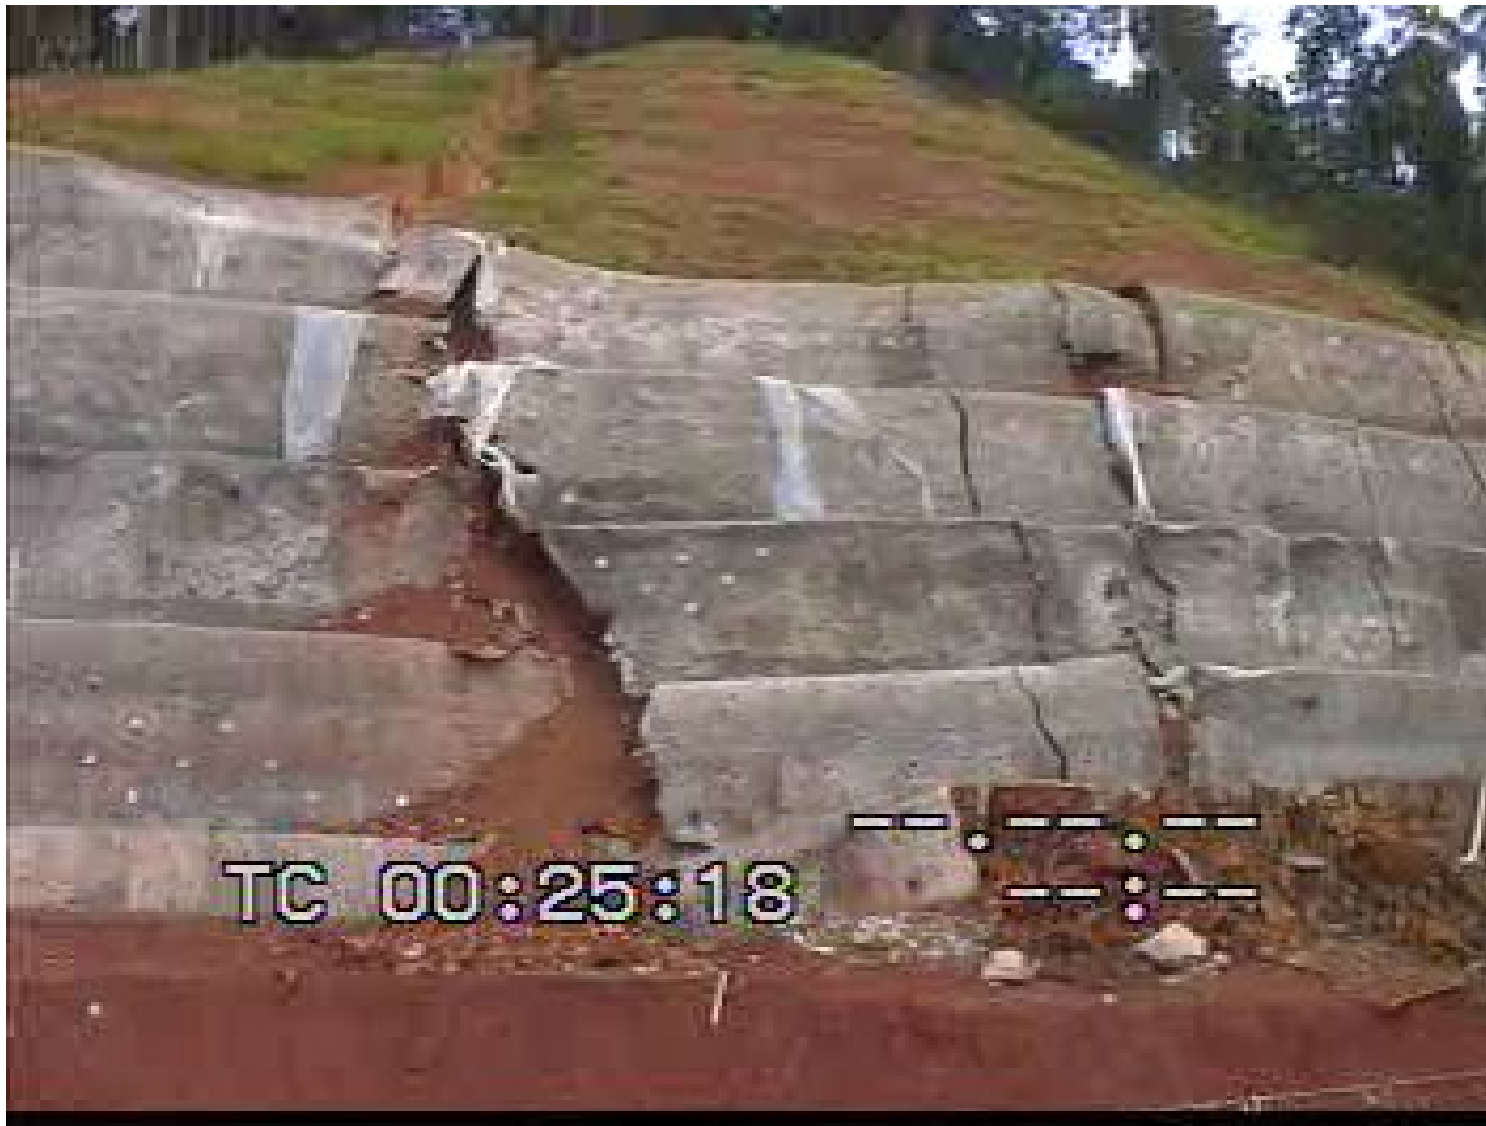
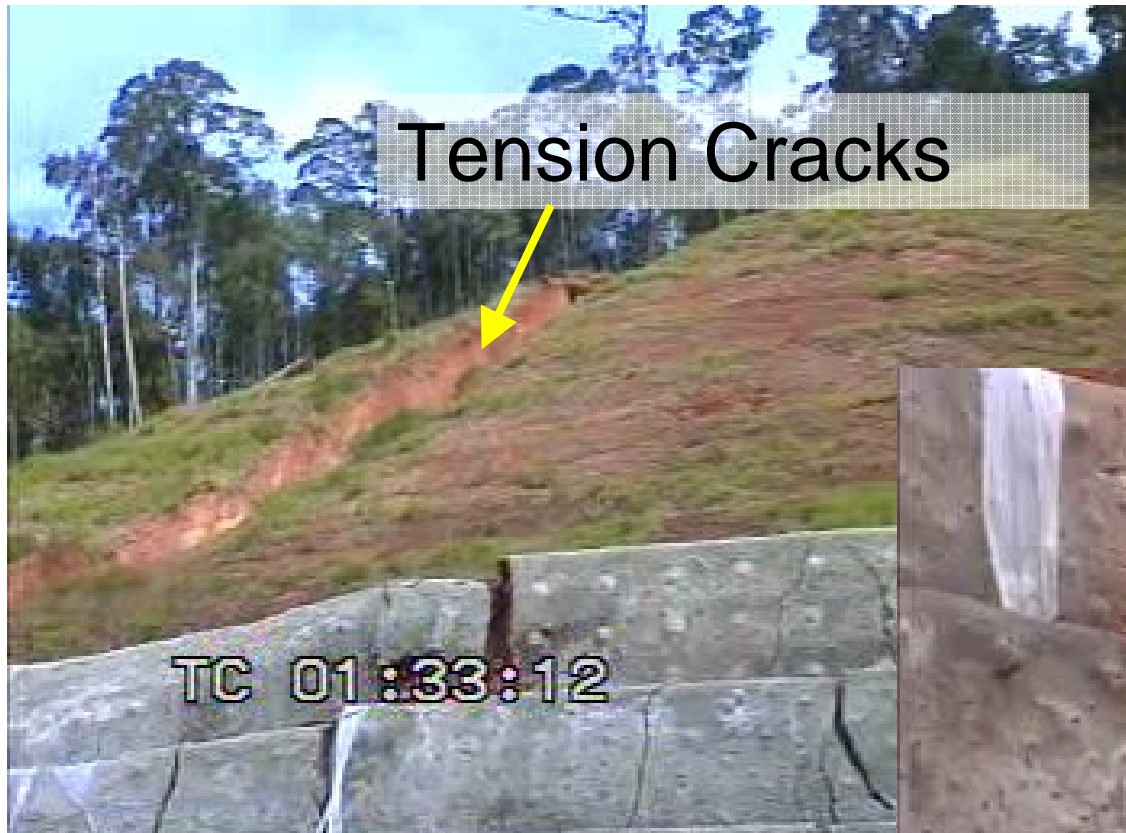
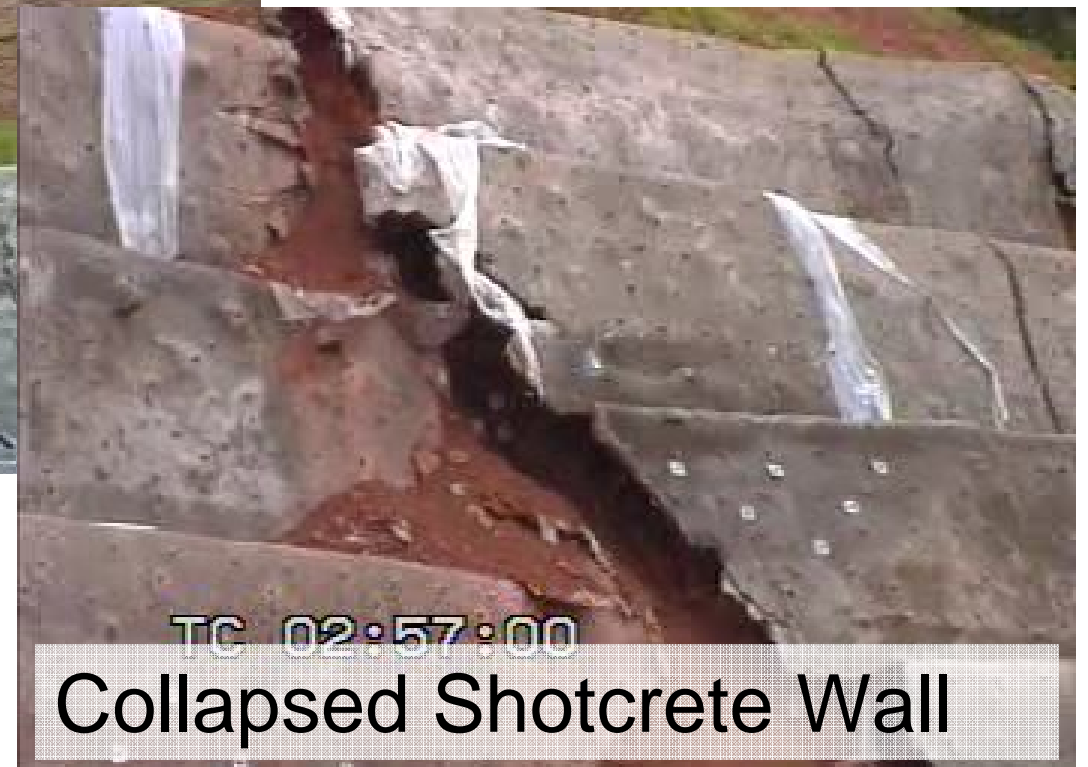
Cut Slope Failure at Gua Musang, Kelantan

- RL210m to RL330m.
- 7 Upper berms of 1V:1H Cut Slope & 5 Lower berms of 4V:1H Soil Nailed Slope
- Soil Nail = 12m with spacing of 1m(V):1m (H)
- Geology: Shale Facies in Gua Musang Formation which mainly consists of Mudstone & Sandstone
- A massive slope failure occurred before soil nails were installed at the lowest berm.

- Steep upper cut slope of 1V:1H.
- Inadequate soil nail length of 12m.
- Day-lighting geological structures of Grade III to V materials at the upper cut slope.
- Progressive failure have leaded to develop of a continuous shear surface.

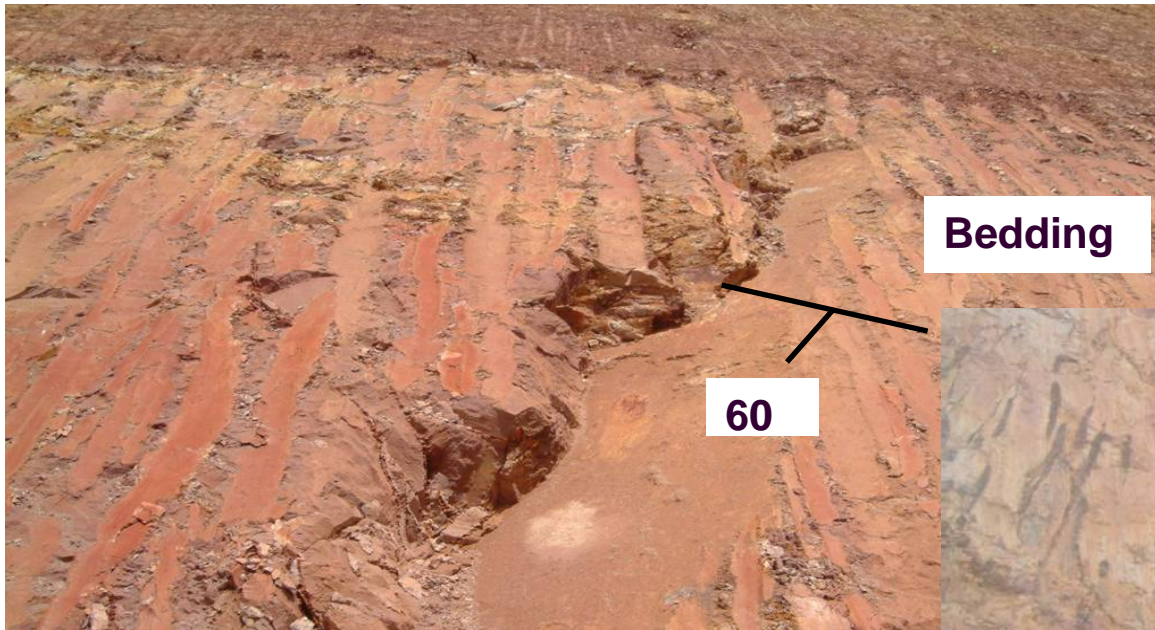
Bedding of Cut Slope Day-lighting Towards Main Road

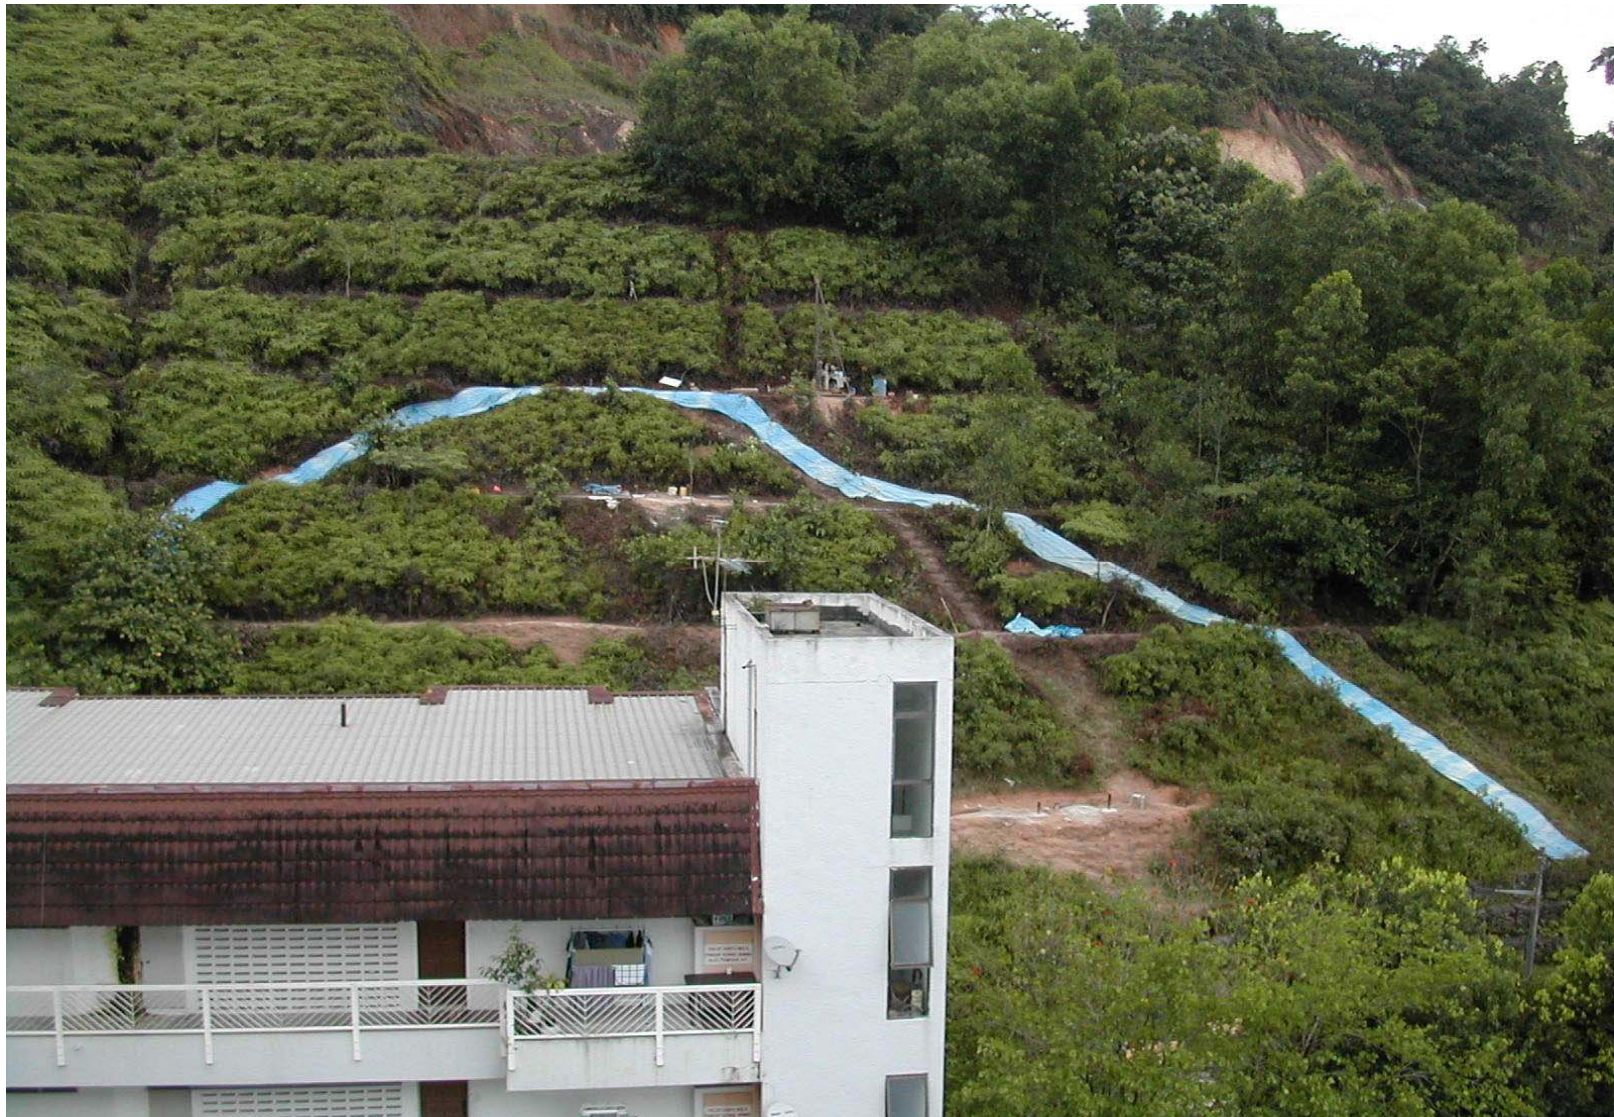
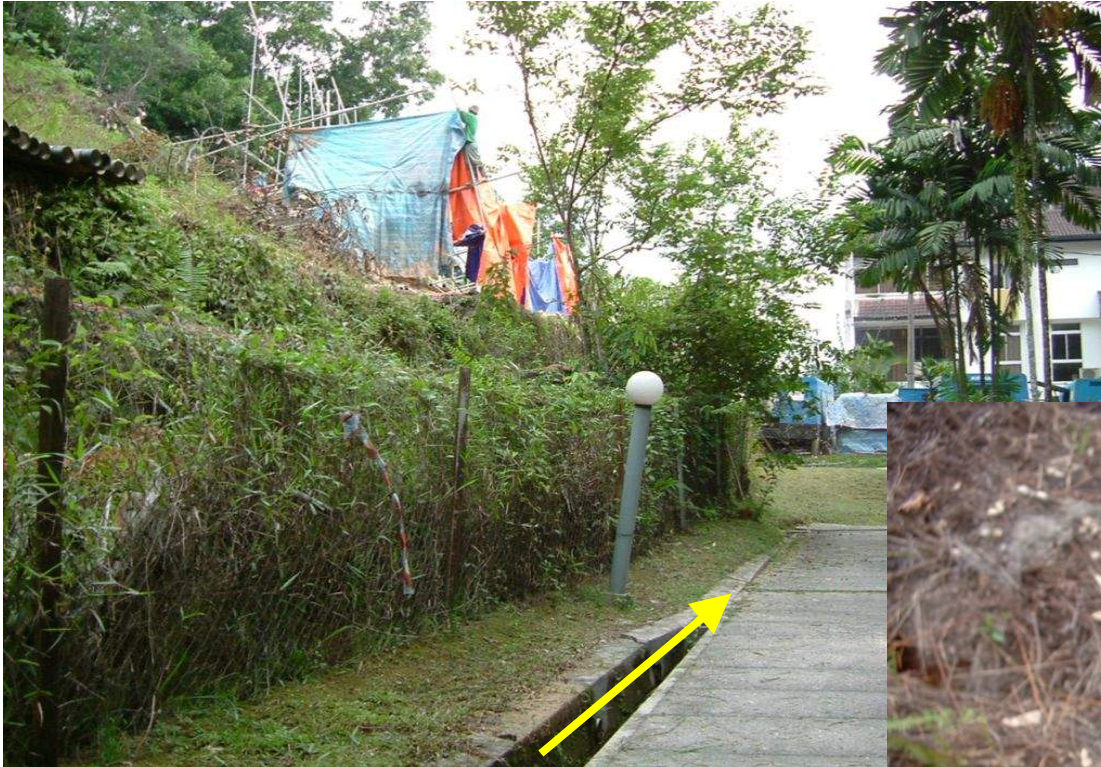
Cut Slope Failure at Kuala Lumpur

- The cut slope with 6 berms was formed in 90s
- Slope gradient varies from 1V:1.72H (lowest berm) to 1V:1H (highest berm)
- RL75m to RL110m.
- Geology: Granite formation.
- Slope movement was detected in Nov 2002 and obvious tension cracks were found at the lowest three berms.

- The gradient of the cut slope is steep and is not stable in long term
- Slope strengthening works with installation of soil nails and subsoil drainage system have proven an effective solution to stabilise the distressed slope.

- Installation of Soil Nails (12m, 18m and 27m).
- Installation of horizontal drains.
- Repairing and re-construction of berm drains.

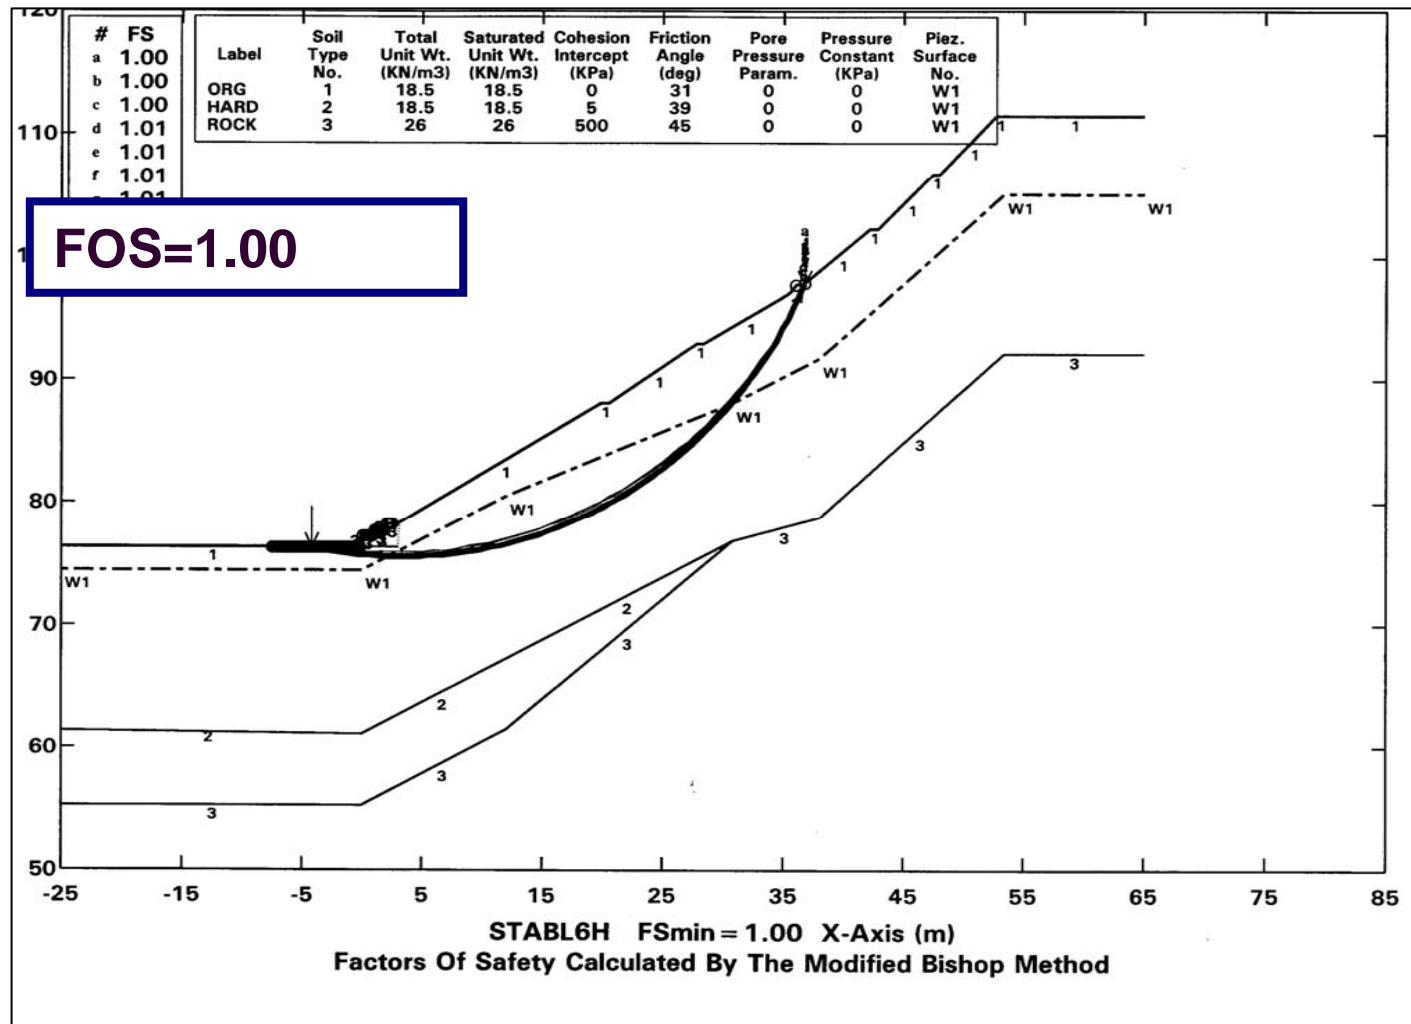
Slope Stability Analyses

- Max lateral movement (IN. 1)
 - ~ 8mm with the depth of shear plane of about 7m tallies with stability analyses.

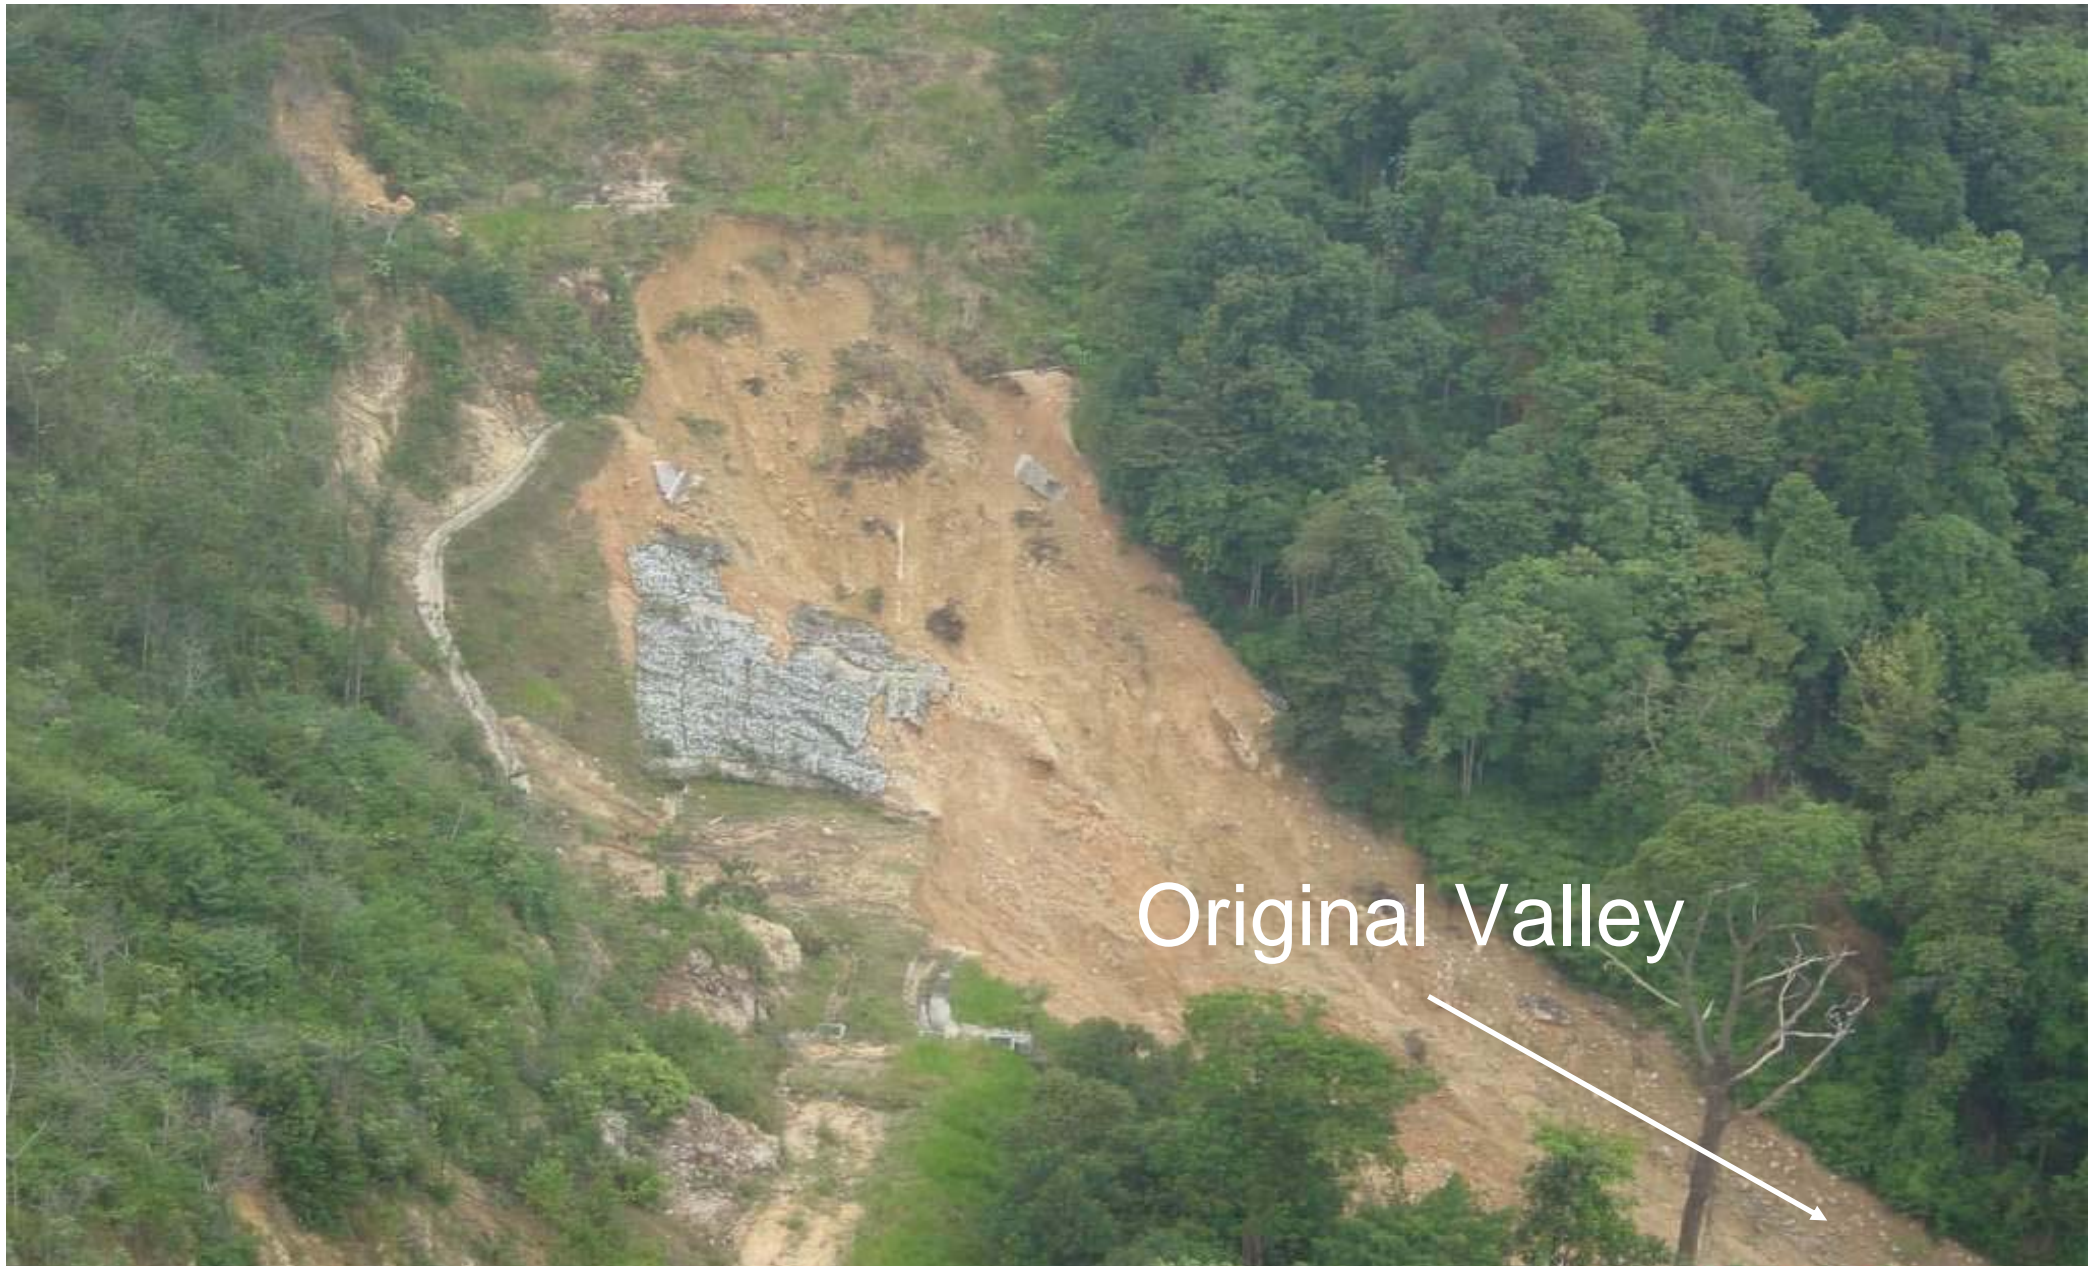
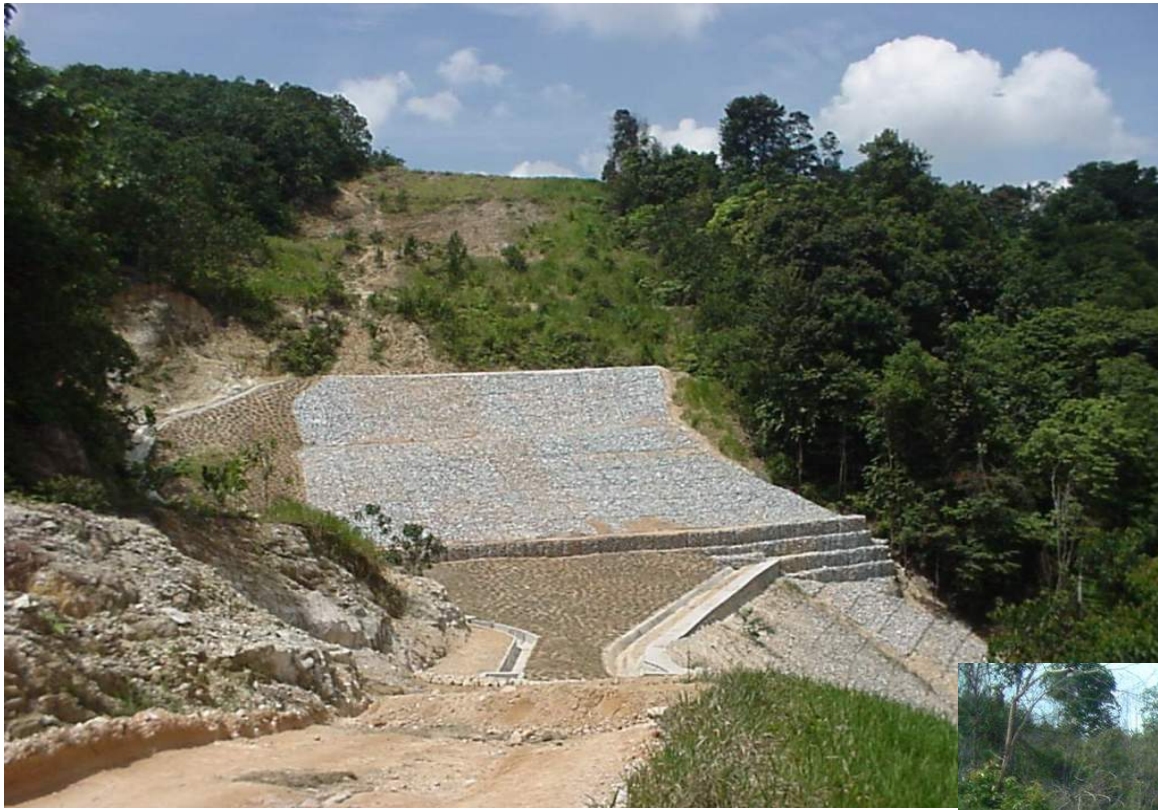
Fill Slope Failure at Salak Tinggi

- Fill slope over a natural valley to form platform.
- Three berms slope : 20m height.
- Another three slopes on top of platform.
- Geology: Kenny Hill formation with interbedded sandstone and siltstone.
- Slope collapsed after heavy downpour.

- Valley terrain.
- Steep fill slope gradient – steepest gradient of 1V:1H.
- Marginal FOS when groundwater level rises near to ground surface.
- Poor drainage system lead to saturation and erosion.

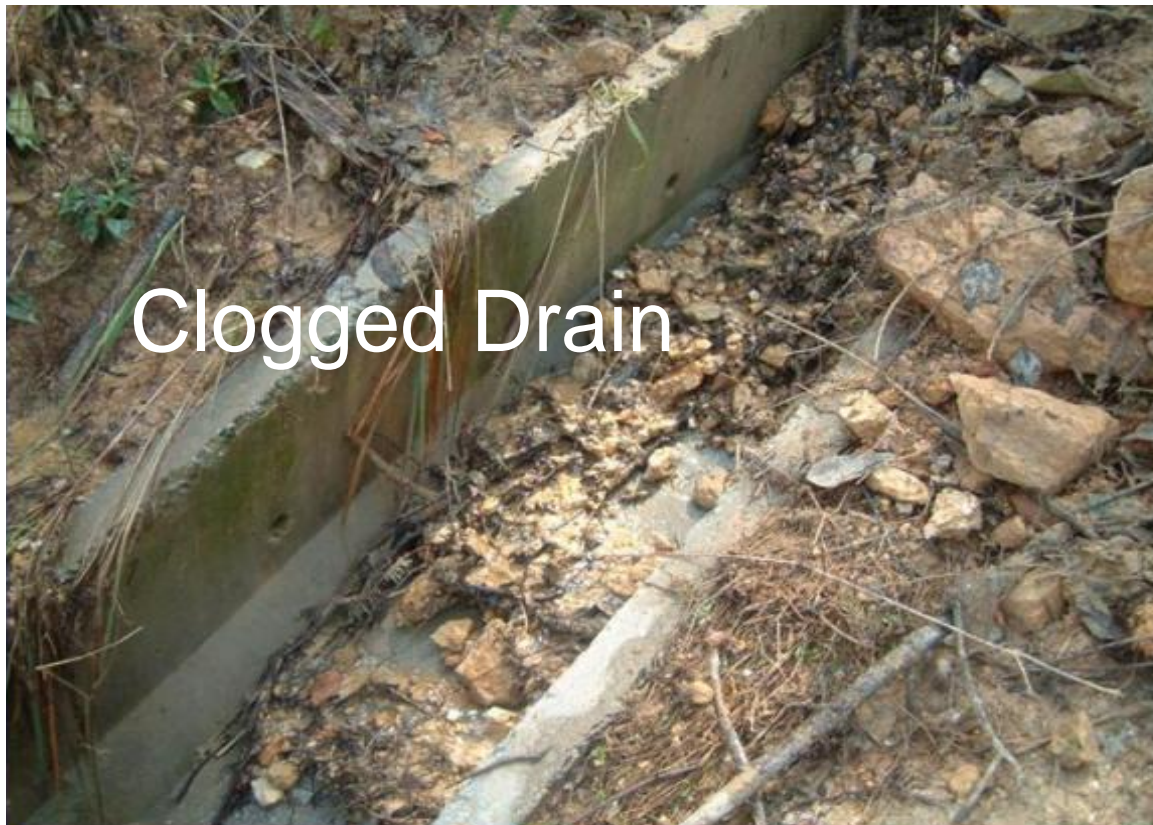
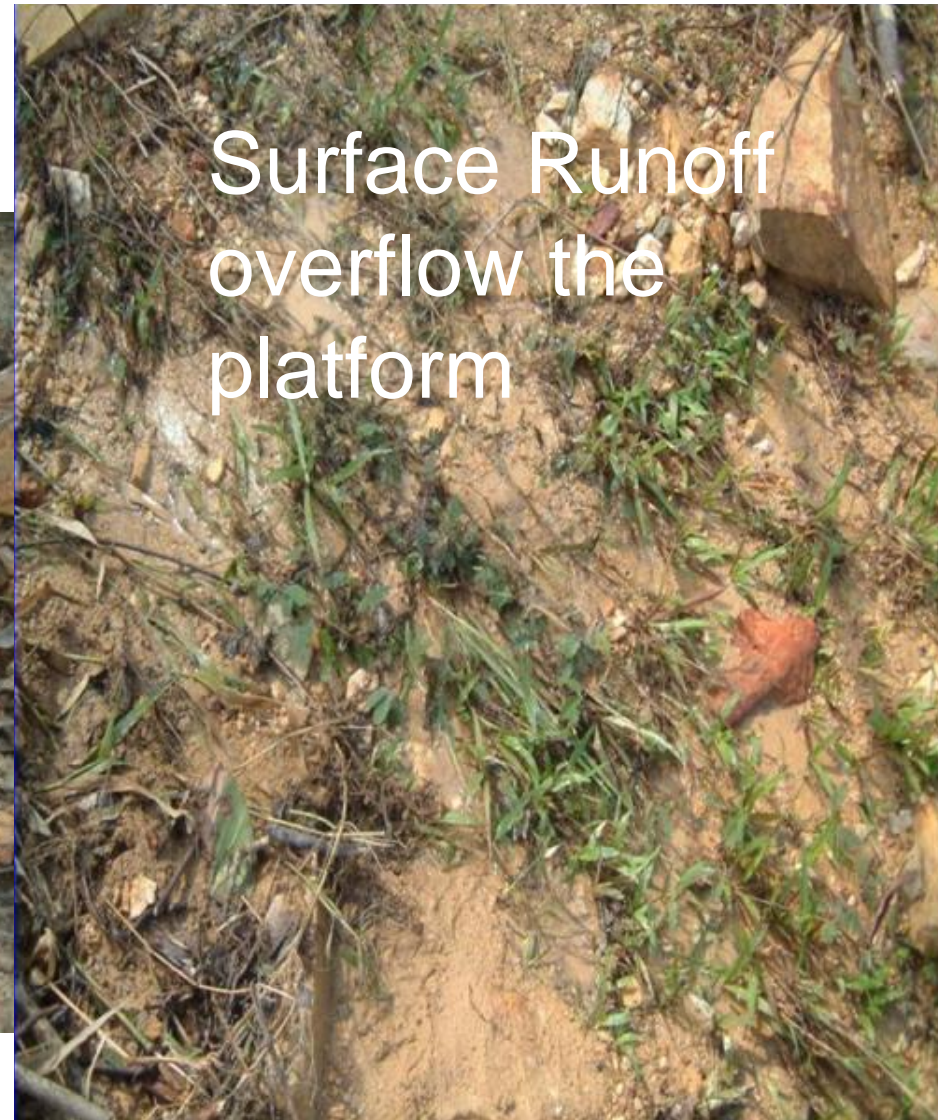
Site Observations

- The platform of pipeline was saturated.
- Concrete drains were clogged.
- Debris, tree trunks and vegetations indicated surface runoff overflowed the platform and traveled downslope to valley.
- Failed mass traveled more than 120m downhill along valley.

- Bedrock was observed at certain parts, indicating the failure resembles a slide along the bedrock surface.
